Cultural Heritage Assessment Report

Memorial Avenue, Kellyville

PACHCI Stage 2 Aboriginal Archaeological Report

Report to Roads and Maritime Services

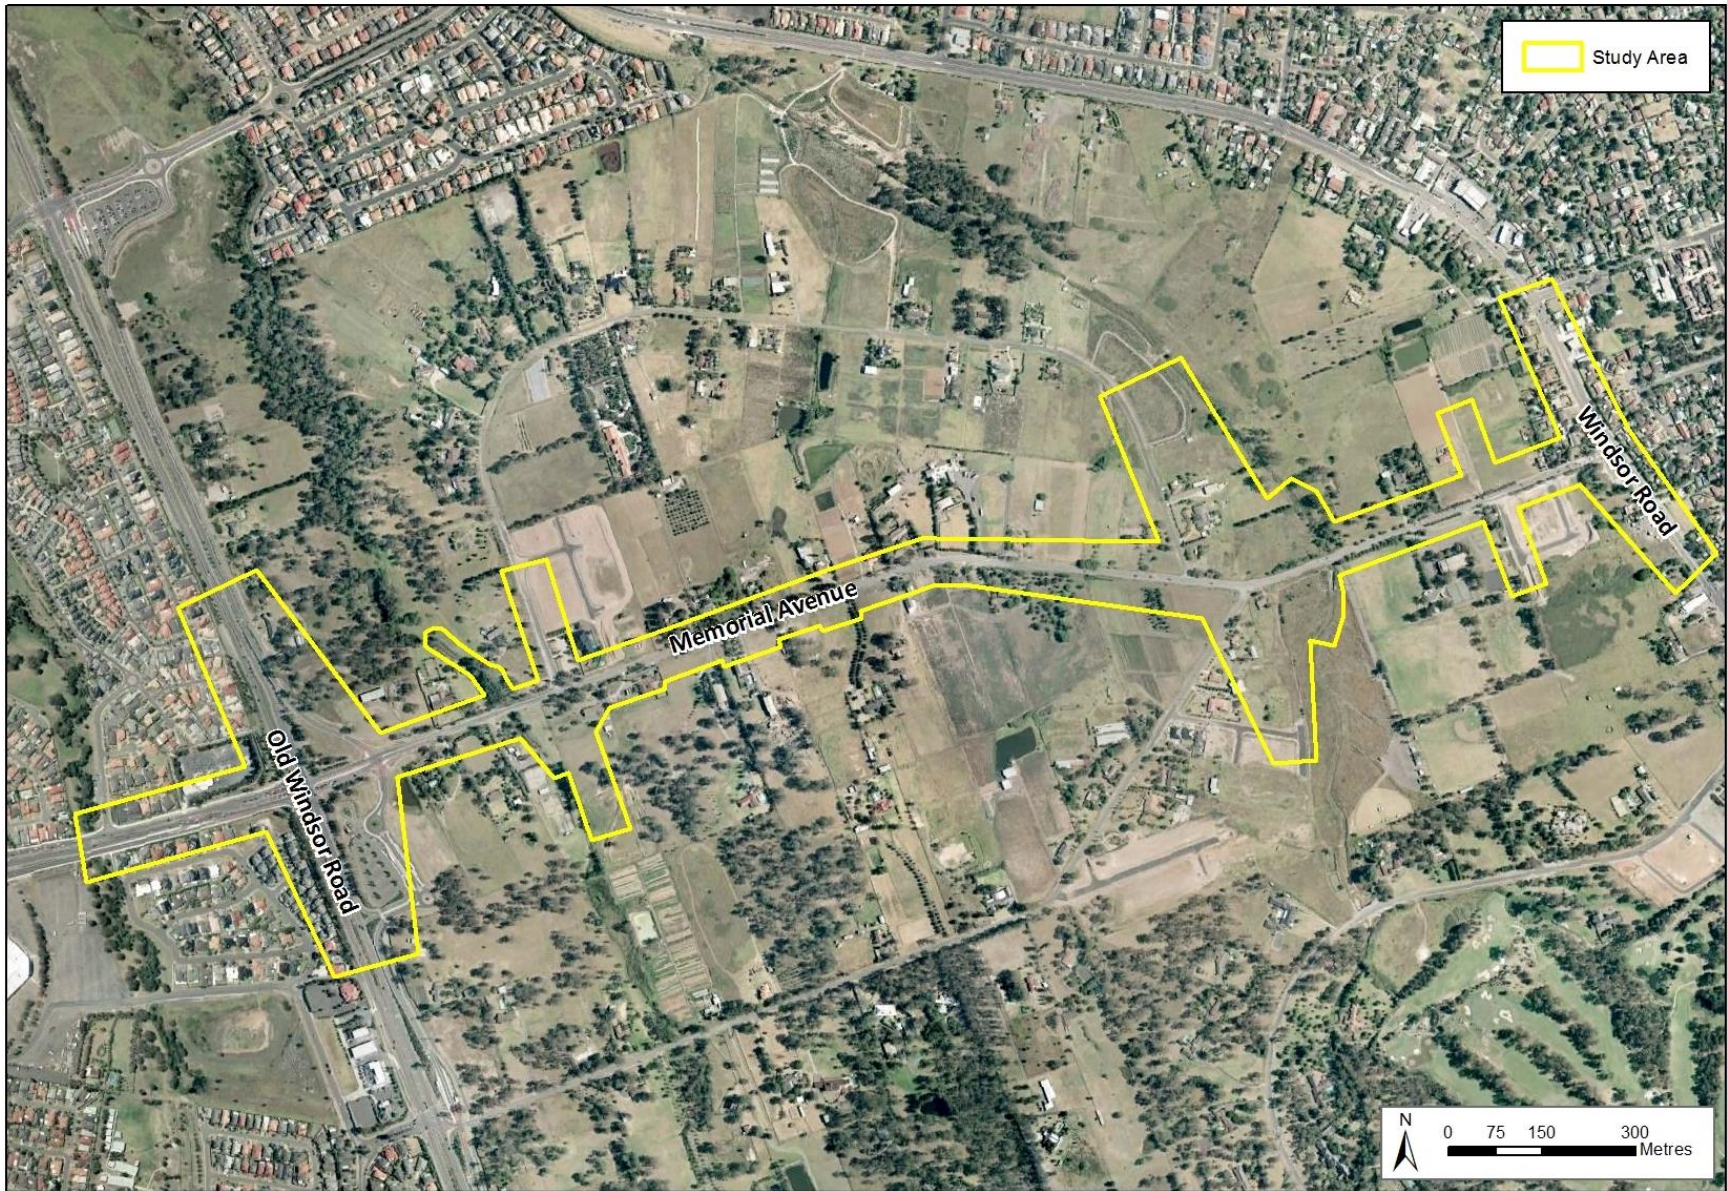
Figure 1: Study area boundary and proposed concept design (background aerial © Google 2014).

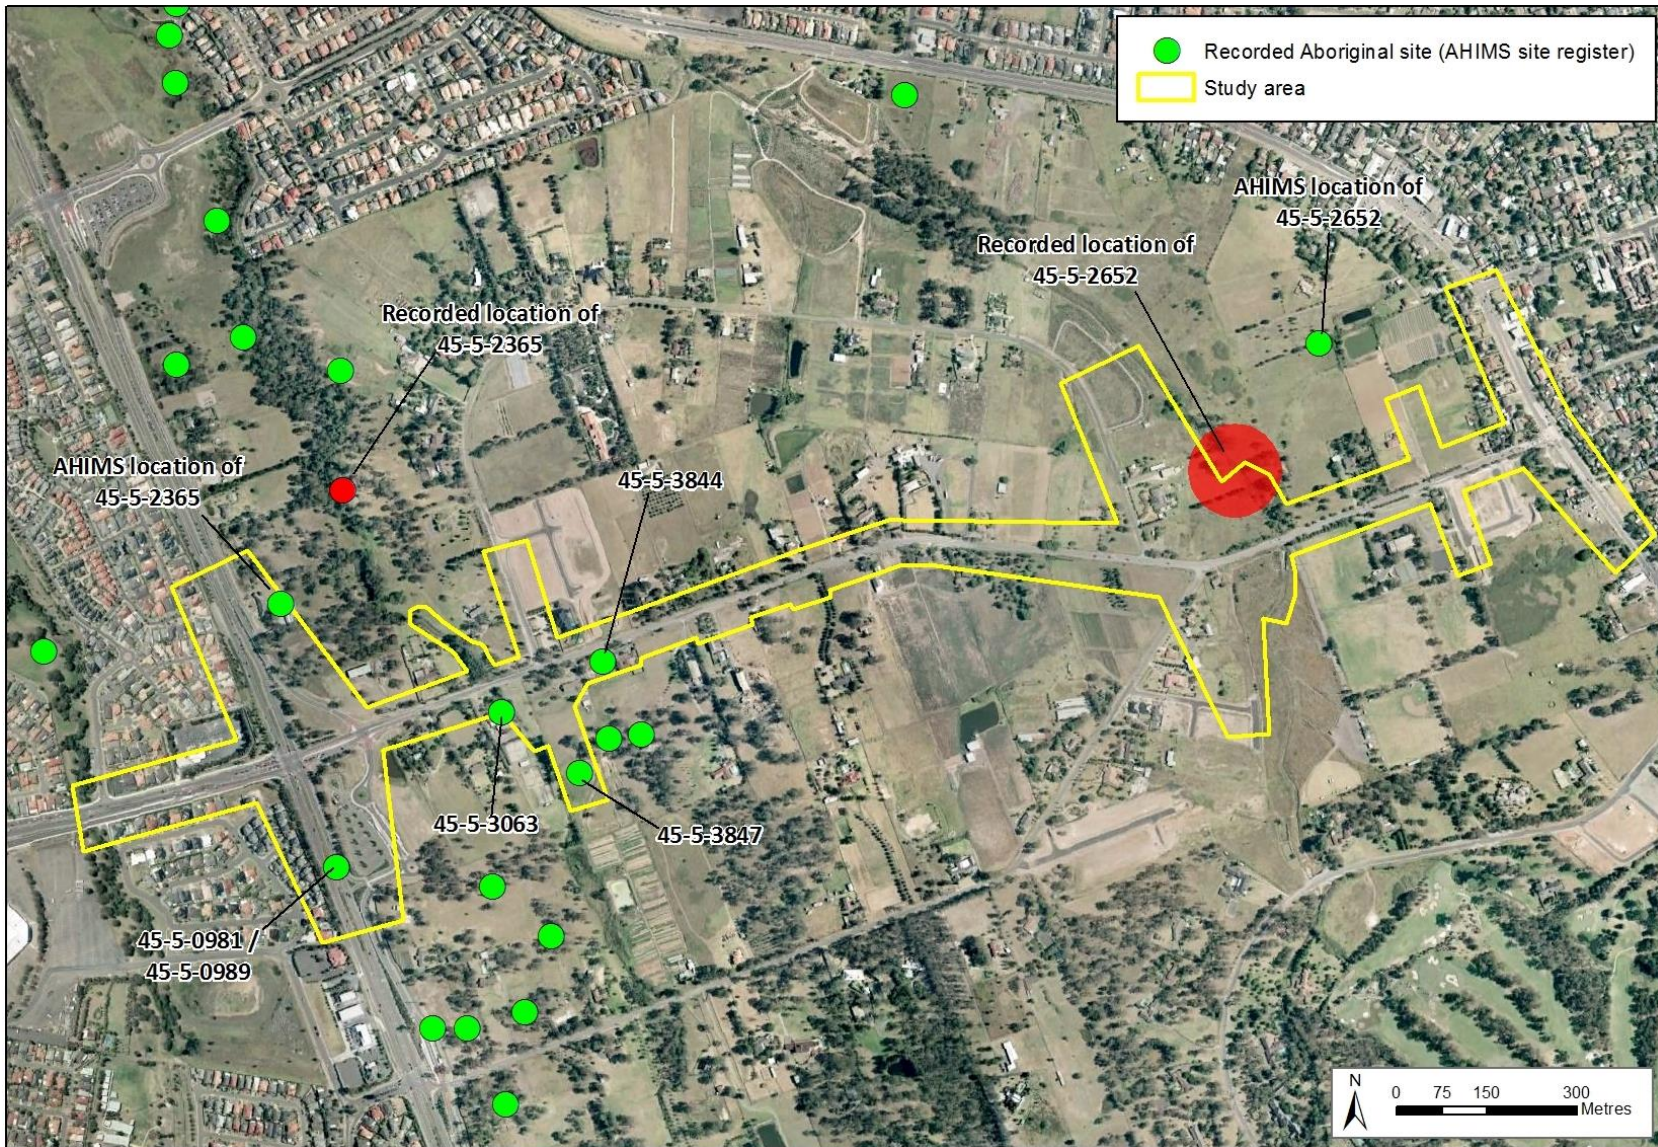
Figure 3: Detail of AHIMS results in relation to the study area (background aerial © Google 2014)

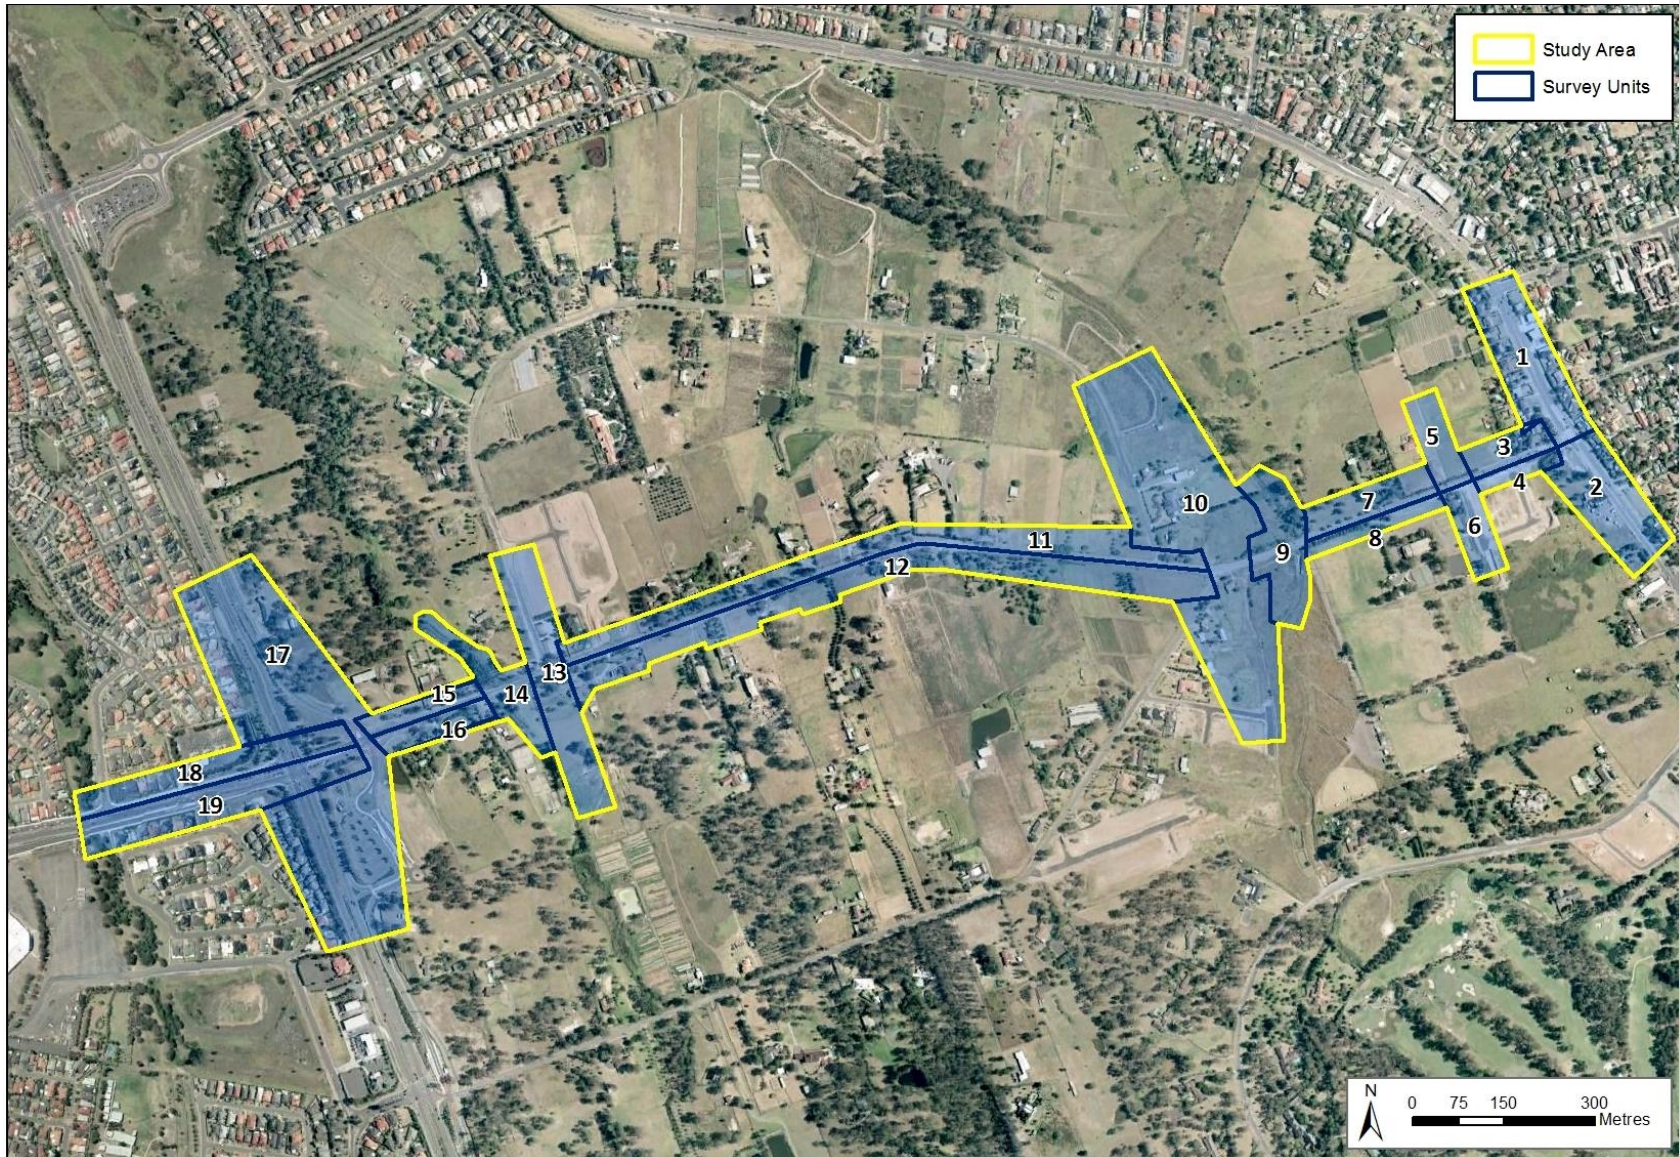
Figure 7: Survey Units (background image © Google 2013)

Due to the size, varying levels of disturbance and landform units across the study area, the study area was broken down into nineteen survey units (see Figure 7). Many of the survey units were of a comparable nature in regards to disturbances, landform, visibility and exposure. As such some of the survey units are discussed and outlined concurrently. All survey units, where possible, were traversed in three survey lines with the survey team spaced between two and four metres apart.

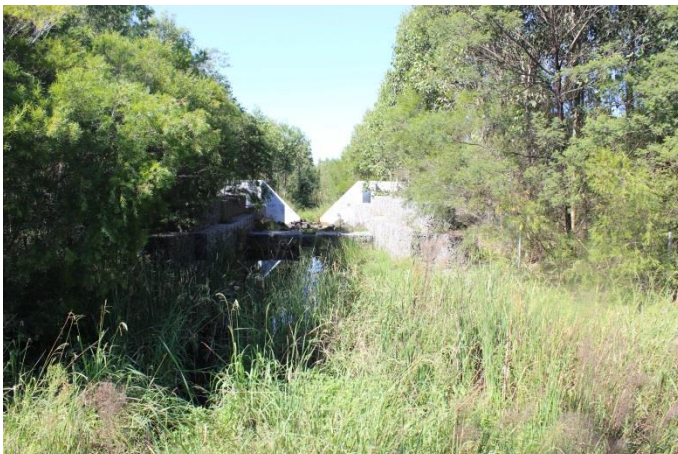
Plate 19: Strangers Creek modification S side of Memorial Avenue.

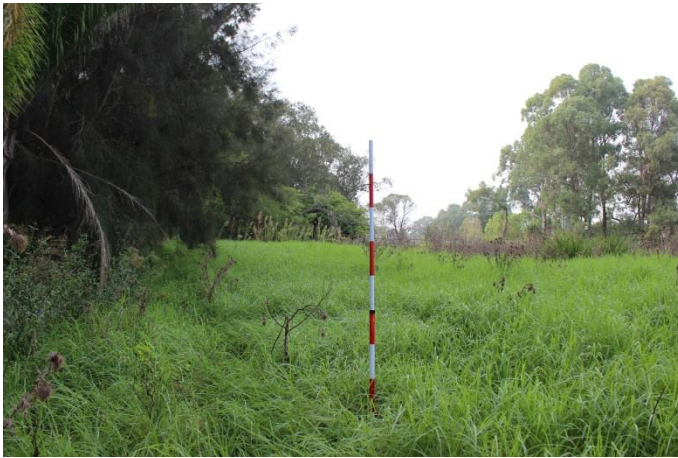
Plate 39: Soil dumping along the creek flat.

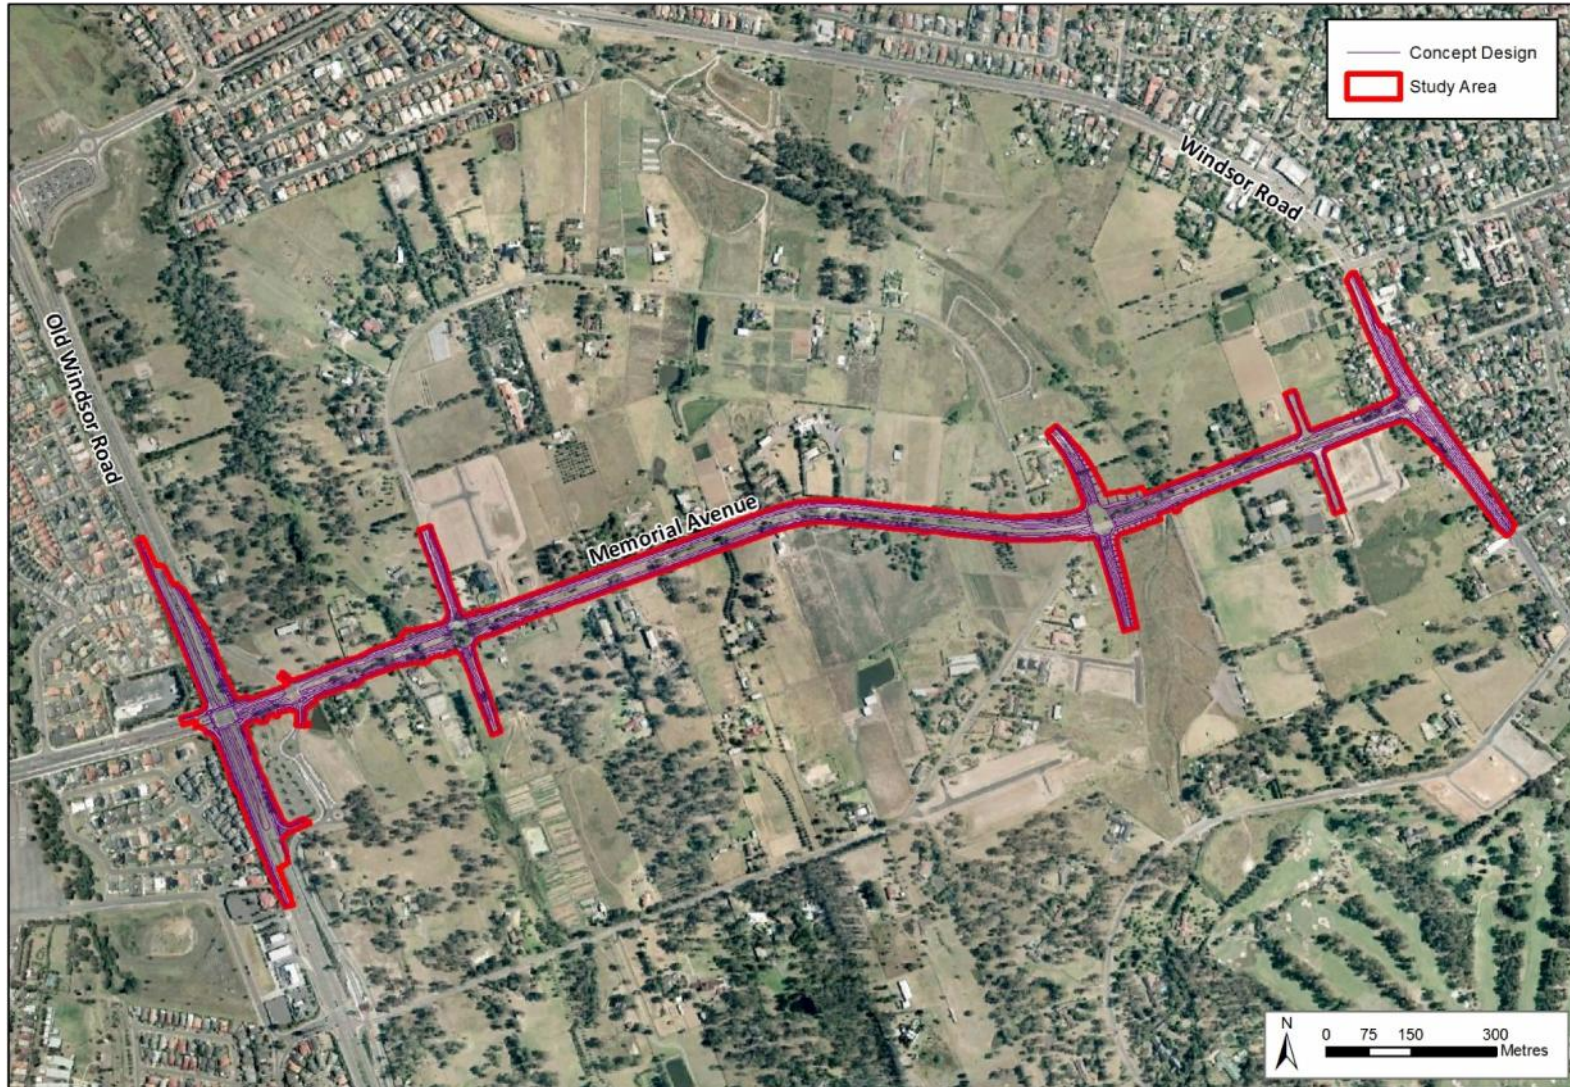
Figure 25: Plan showing the proposal impact area.

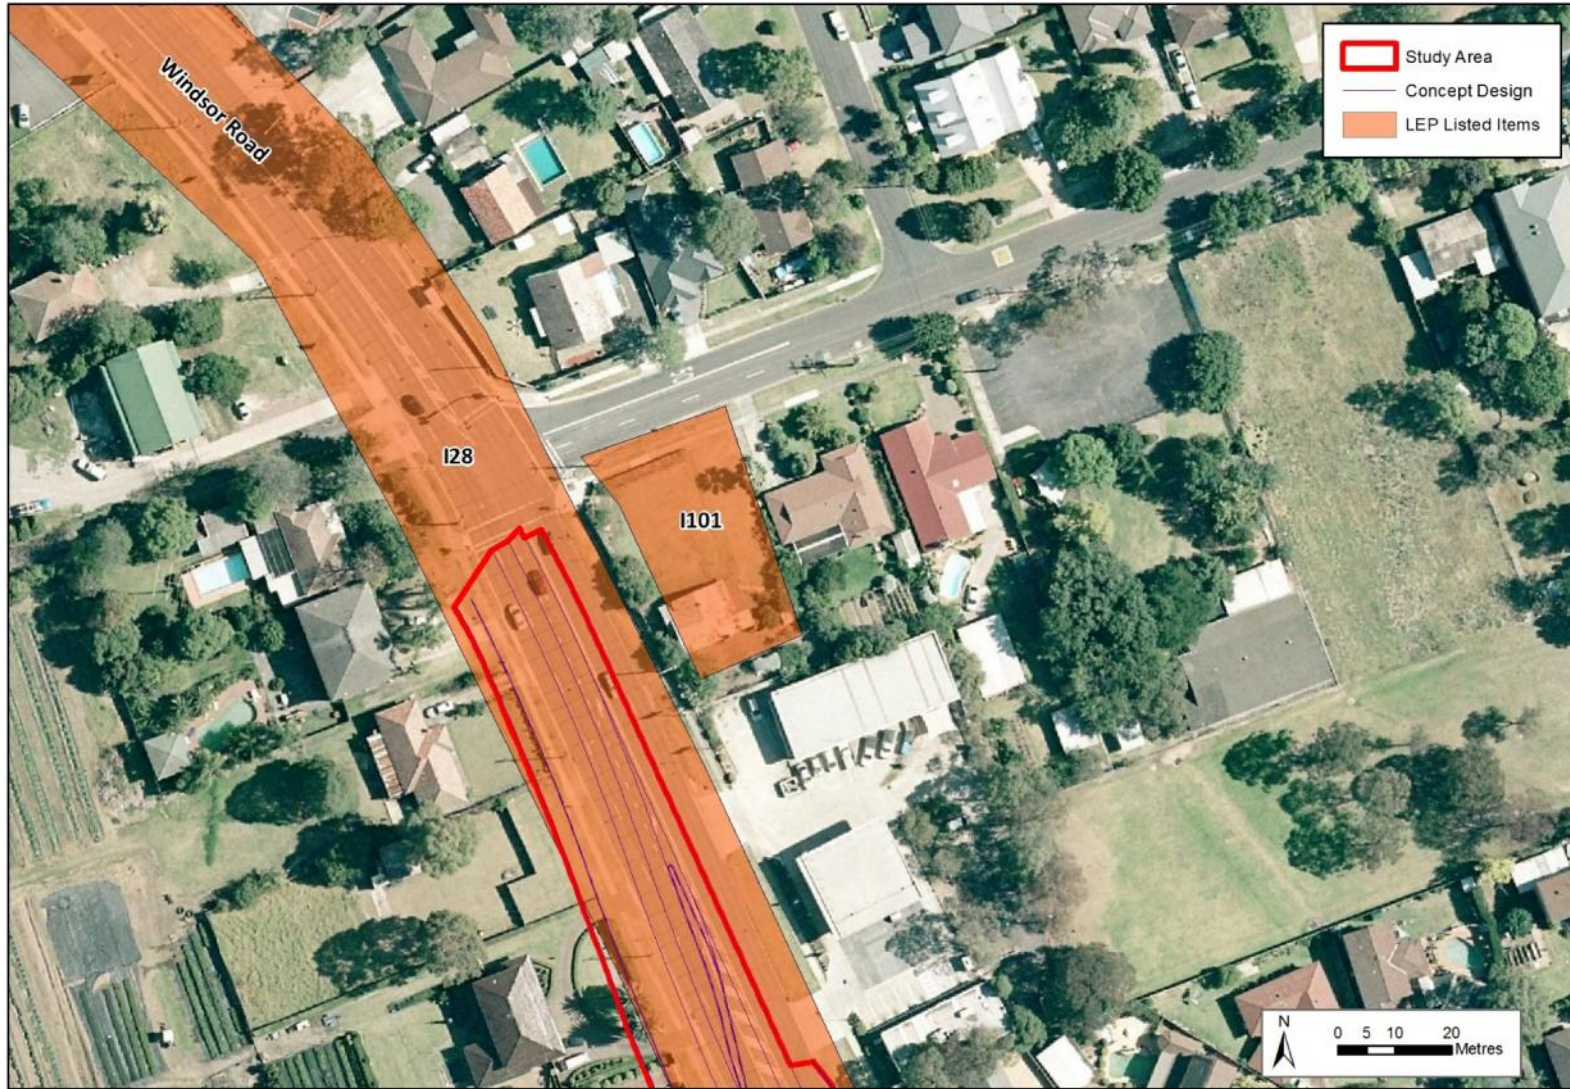
Figure 26: Detail of House at 9-11 Windsor Road (I101).
