M1 Princes Motorway Improvements: Bulli Tops to Picton Road

**Stage 1 – Picton Road to Bellambi Creek
Erosion and Sedimentation Management Report
Final**

**Prepared for: Roads and Maritime Services
Date: November 2016**

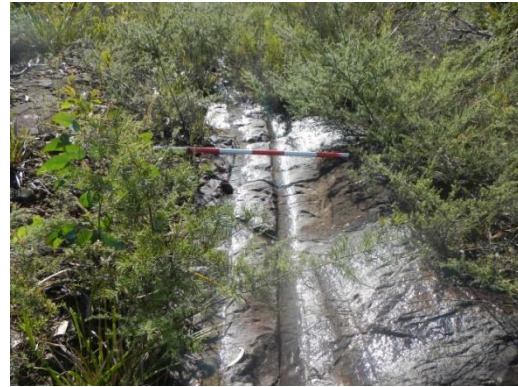
Plate 4: Survey Unit 1 – artificial drainage channel incised into sandstone, view Northeast.

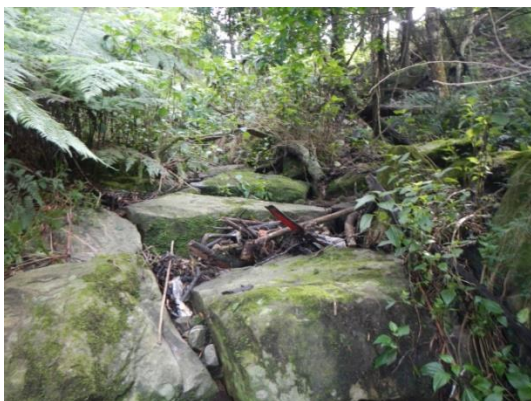
Plate 15: Survey Unit 4 – Artificial drainage channel, view North.
