6 Environmental assessment

6.1 Biodiversity

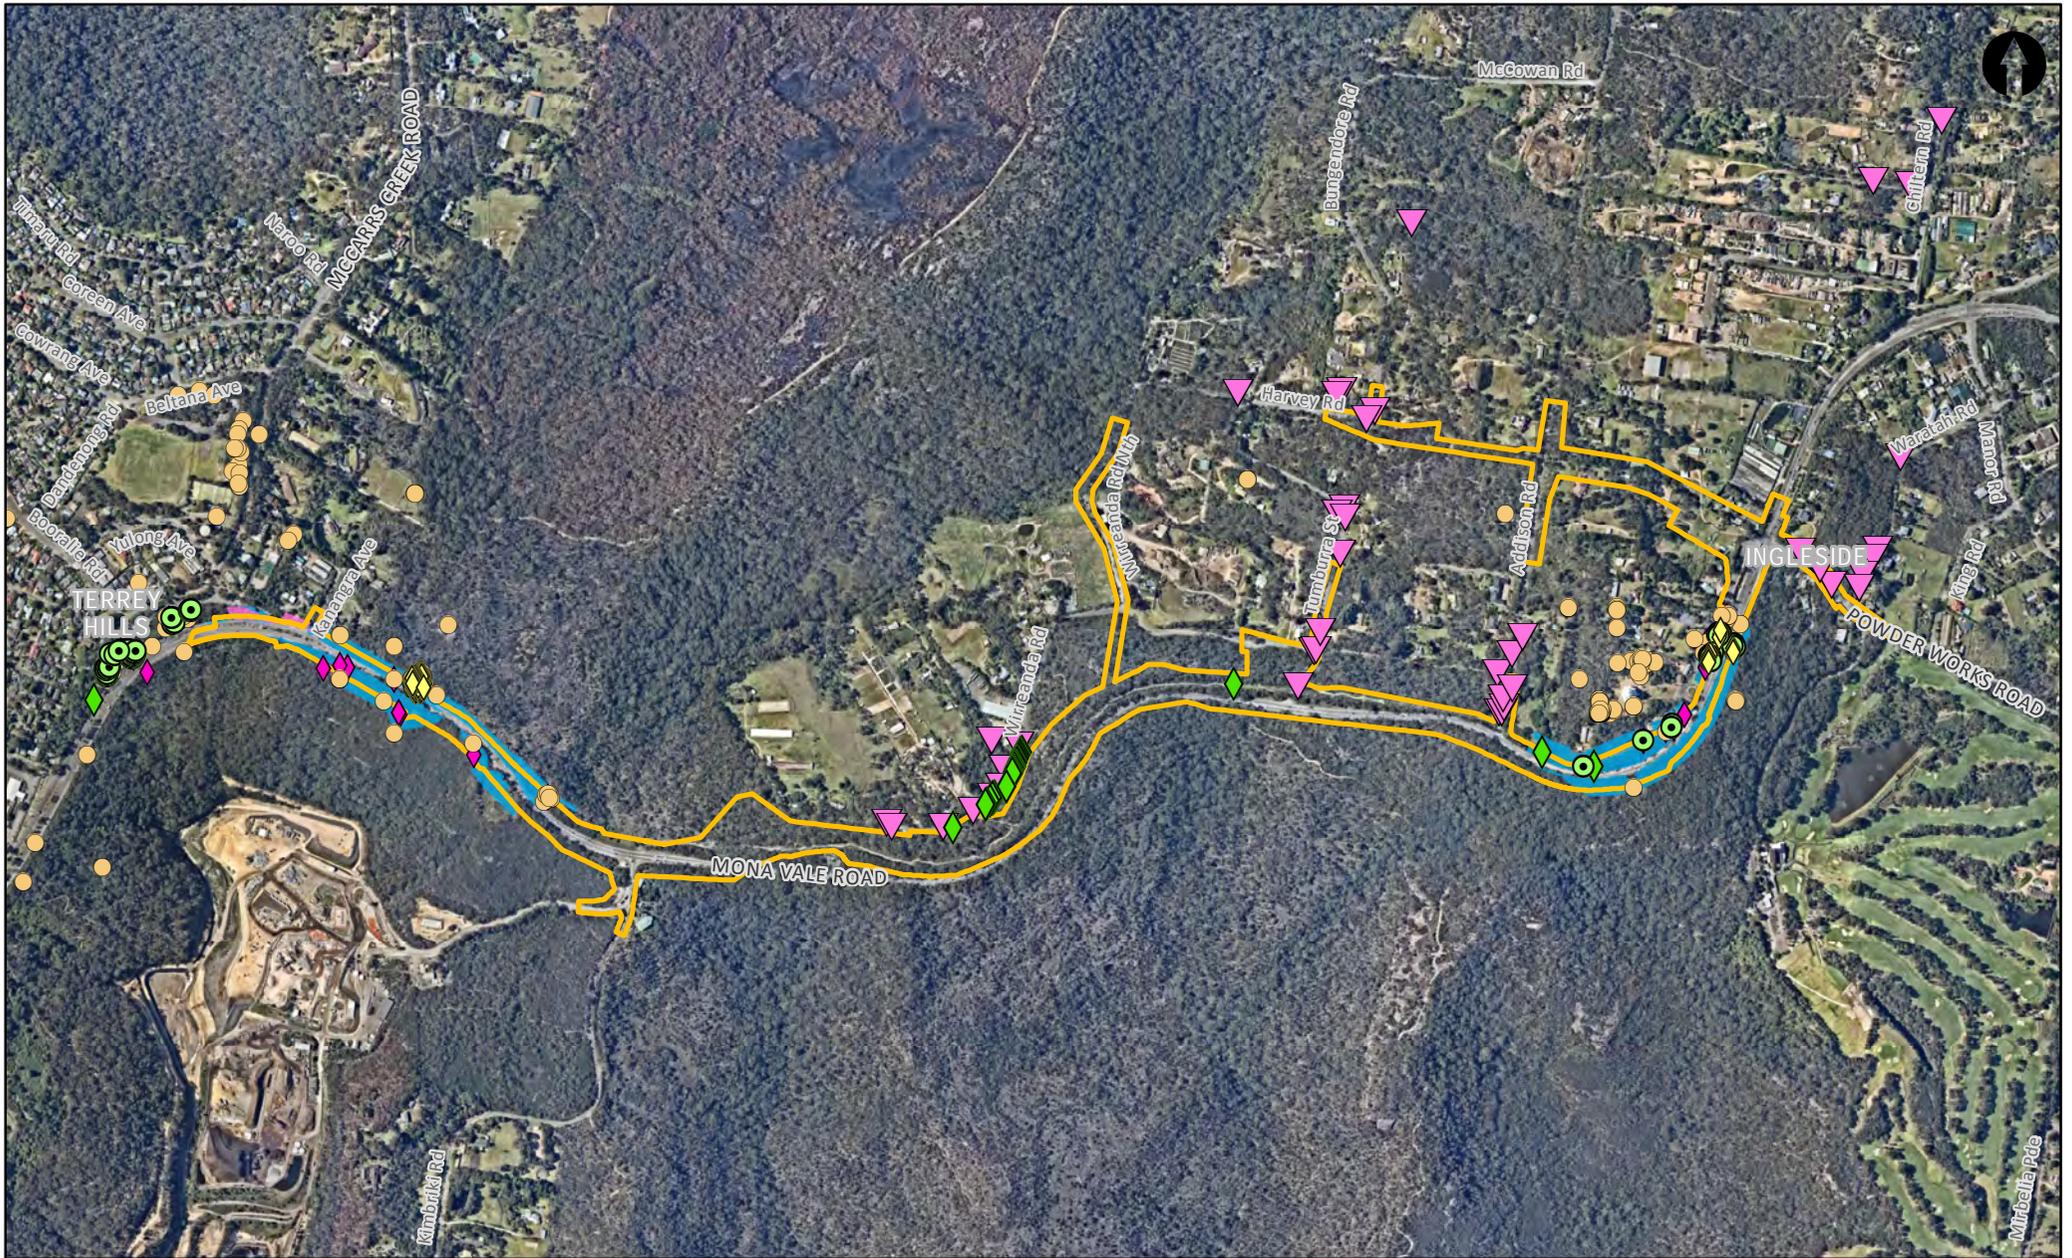
| | <i>Grevillea caleyi</i> (SMEC 2016) | | <i>Grevillea caleyi</i> (Smith and Smith 2011) | | Construction Boundary |
| | <i>Grevillea caleyi</i> (Ecosure 2015) | | <i>Microtis angusii</i> (Ecosure 2015) | | Duffys Forest (Condition: Good) |
| | <i>Grevillea caleyi</i> (BioNet) | | <i>Microtis angusii</i> (Eco Logical 2015) | | Duffys Forest (Condition: Moderate) |

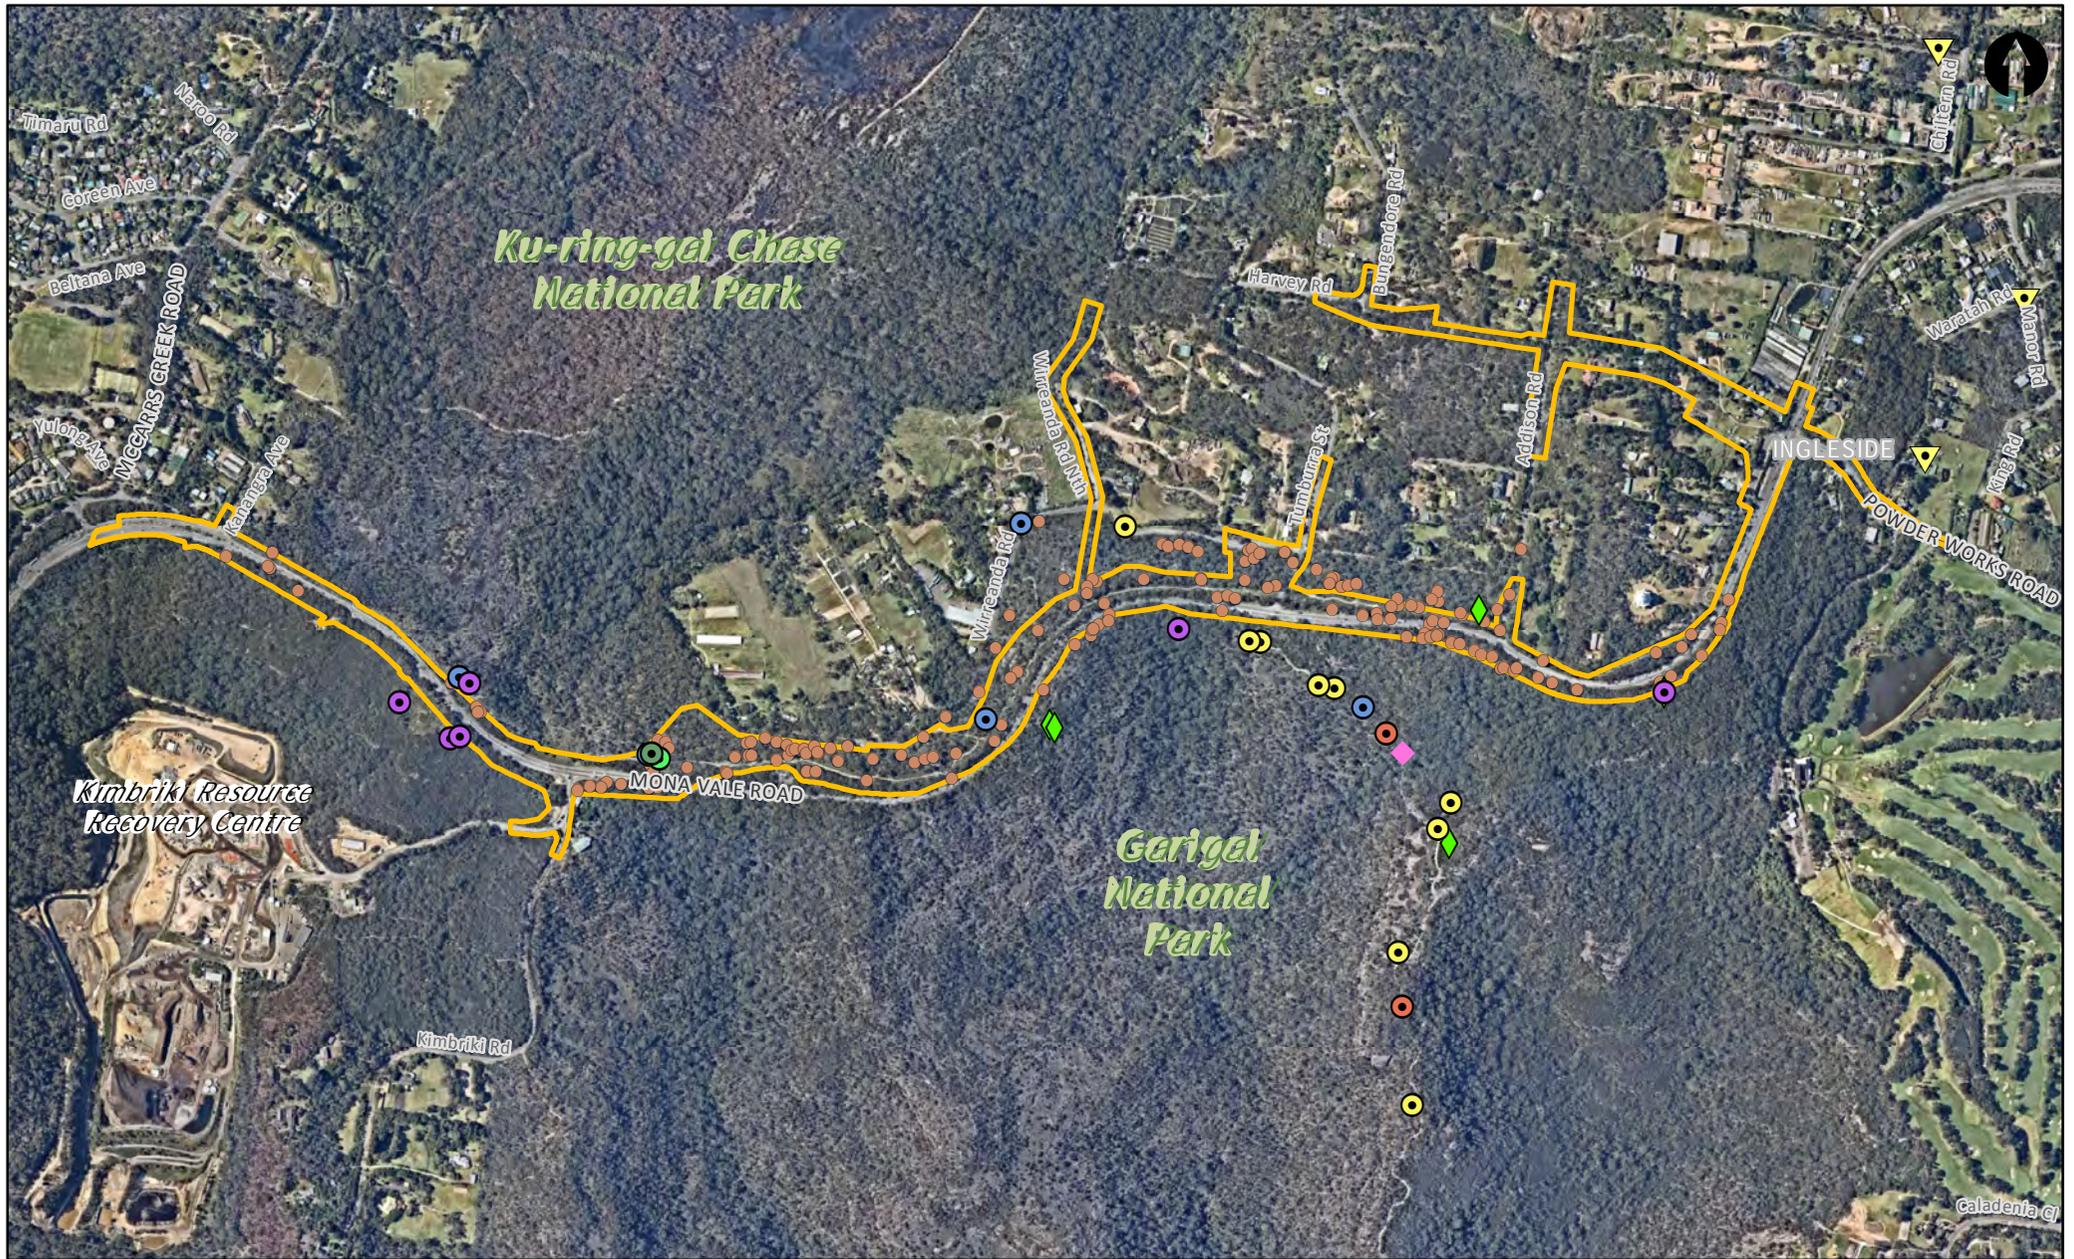
| ▼ Bats (Pittwater Council) | Threatened fauna (Ecosure 2015) | ● Grey-headed flying-fox |

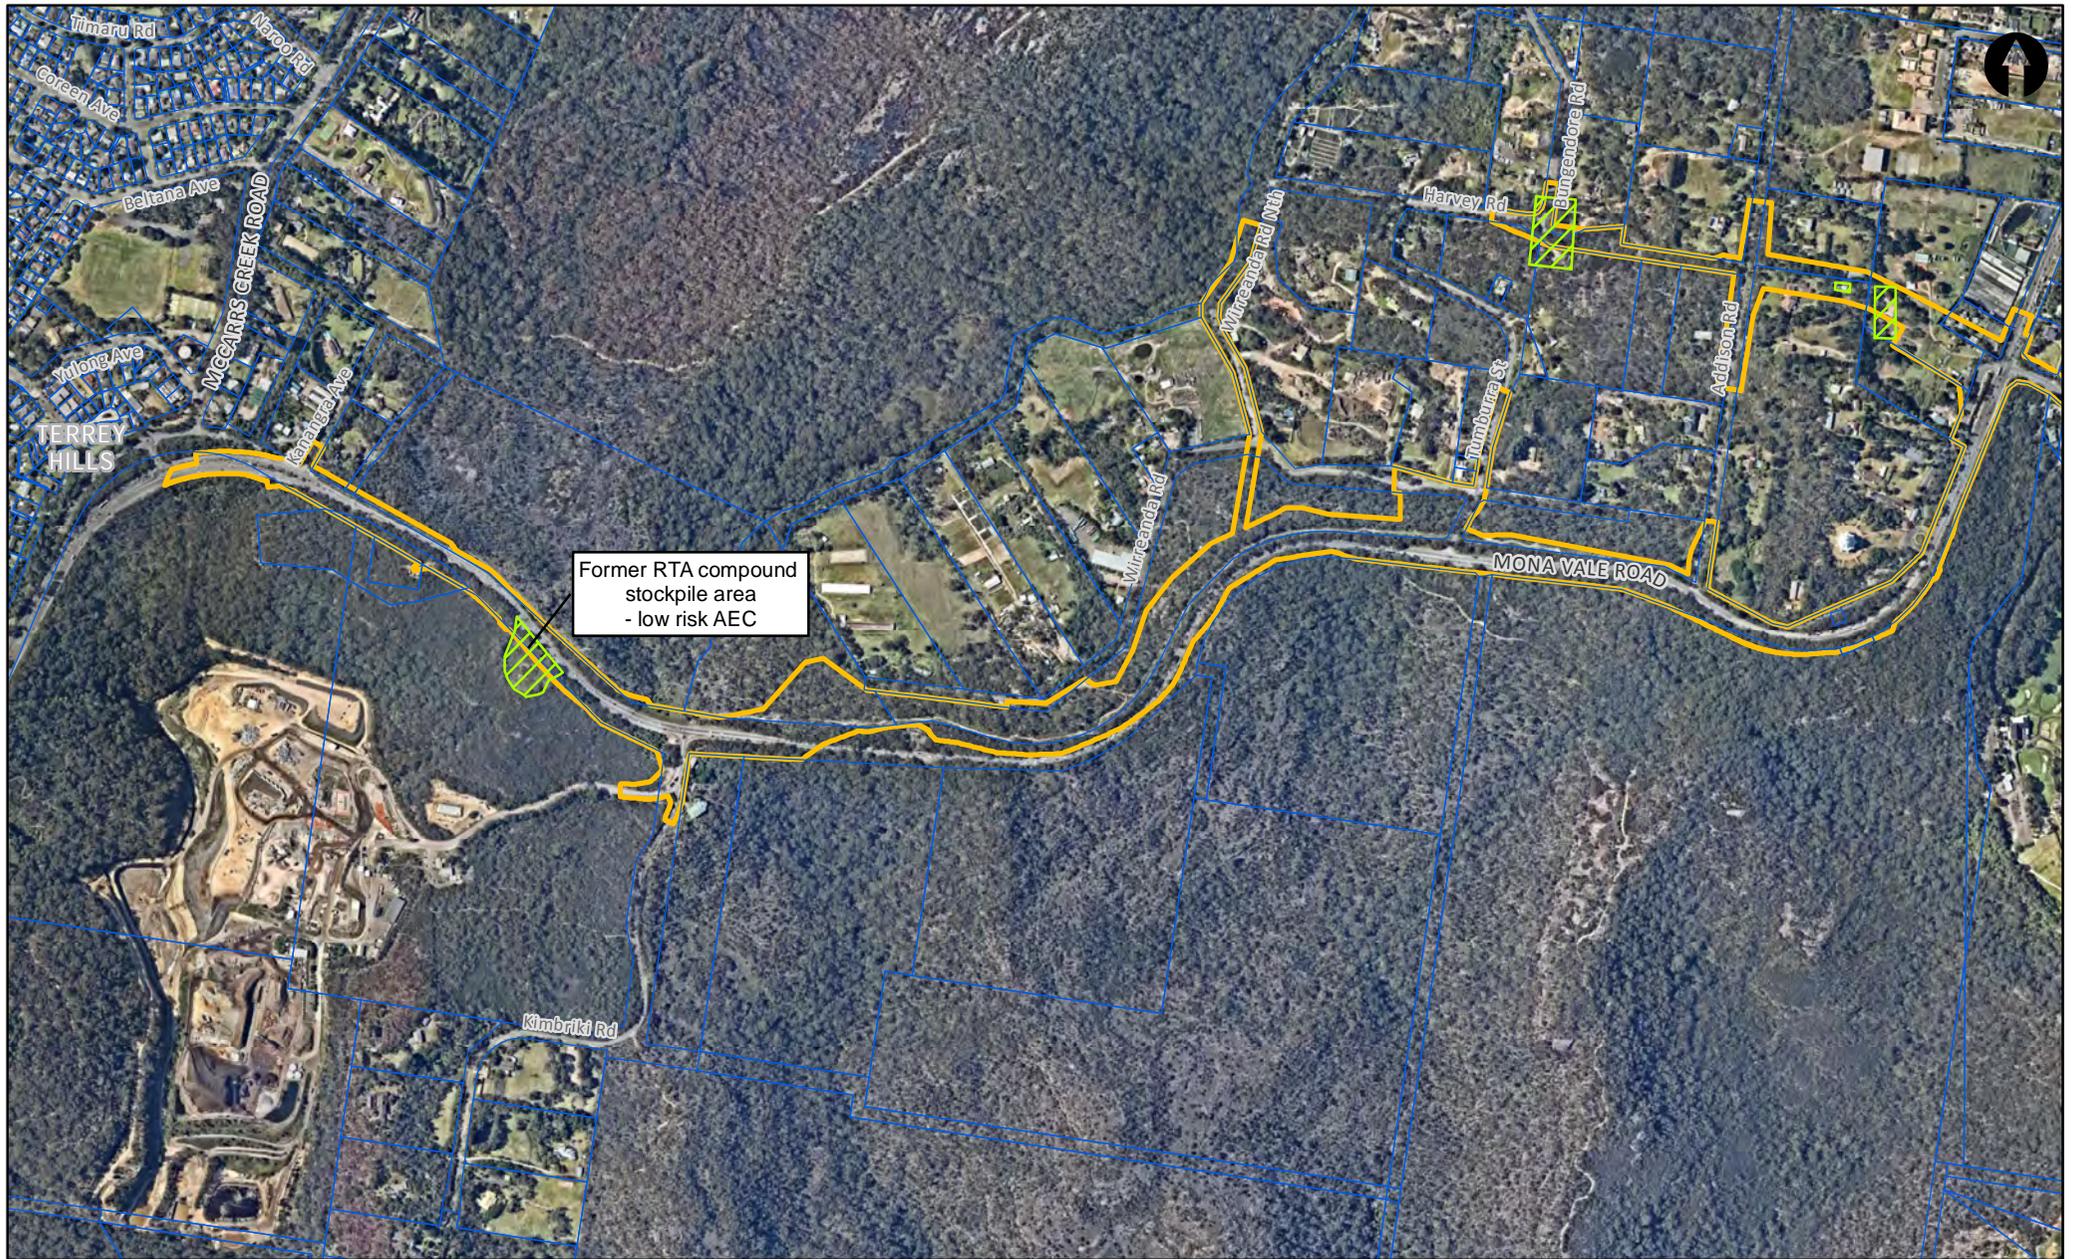
Location of identified AEC Figure 6-4
 Vector base dataset RoadNet © MDS 2016

- Identified AEC
- Cadastral boundaries
- Construction Boundary

- Rural sheds and machinery yard - Aerial photography suggests the presence of a cleared section of land within the rural bushland setting to the south of Bungendore Road, comprising two sheds and parked heavy vehicle machinery. A potential above ground storage tank is present at the site. There is a potential for refuelling and vehicle maintenance activities historically and currently undertaken at the site. There is a high potential for metals, PAHs, TPHs, BTEX and solvent contaminants to be present within excavated soils given the site is evidently being used as a machinery storage yard. Potentially the sheds are used for maintenance activities

- Residential garage/shed - Historical aerial photography suggests the shed currently located within the footprint of the proposed local road extension between Bungendore Street and Powder Works Road is relatively new. There is a low potential for metals, PAHs, TPHs, BTEX and asbestos containing materials (ACM) to be present

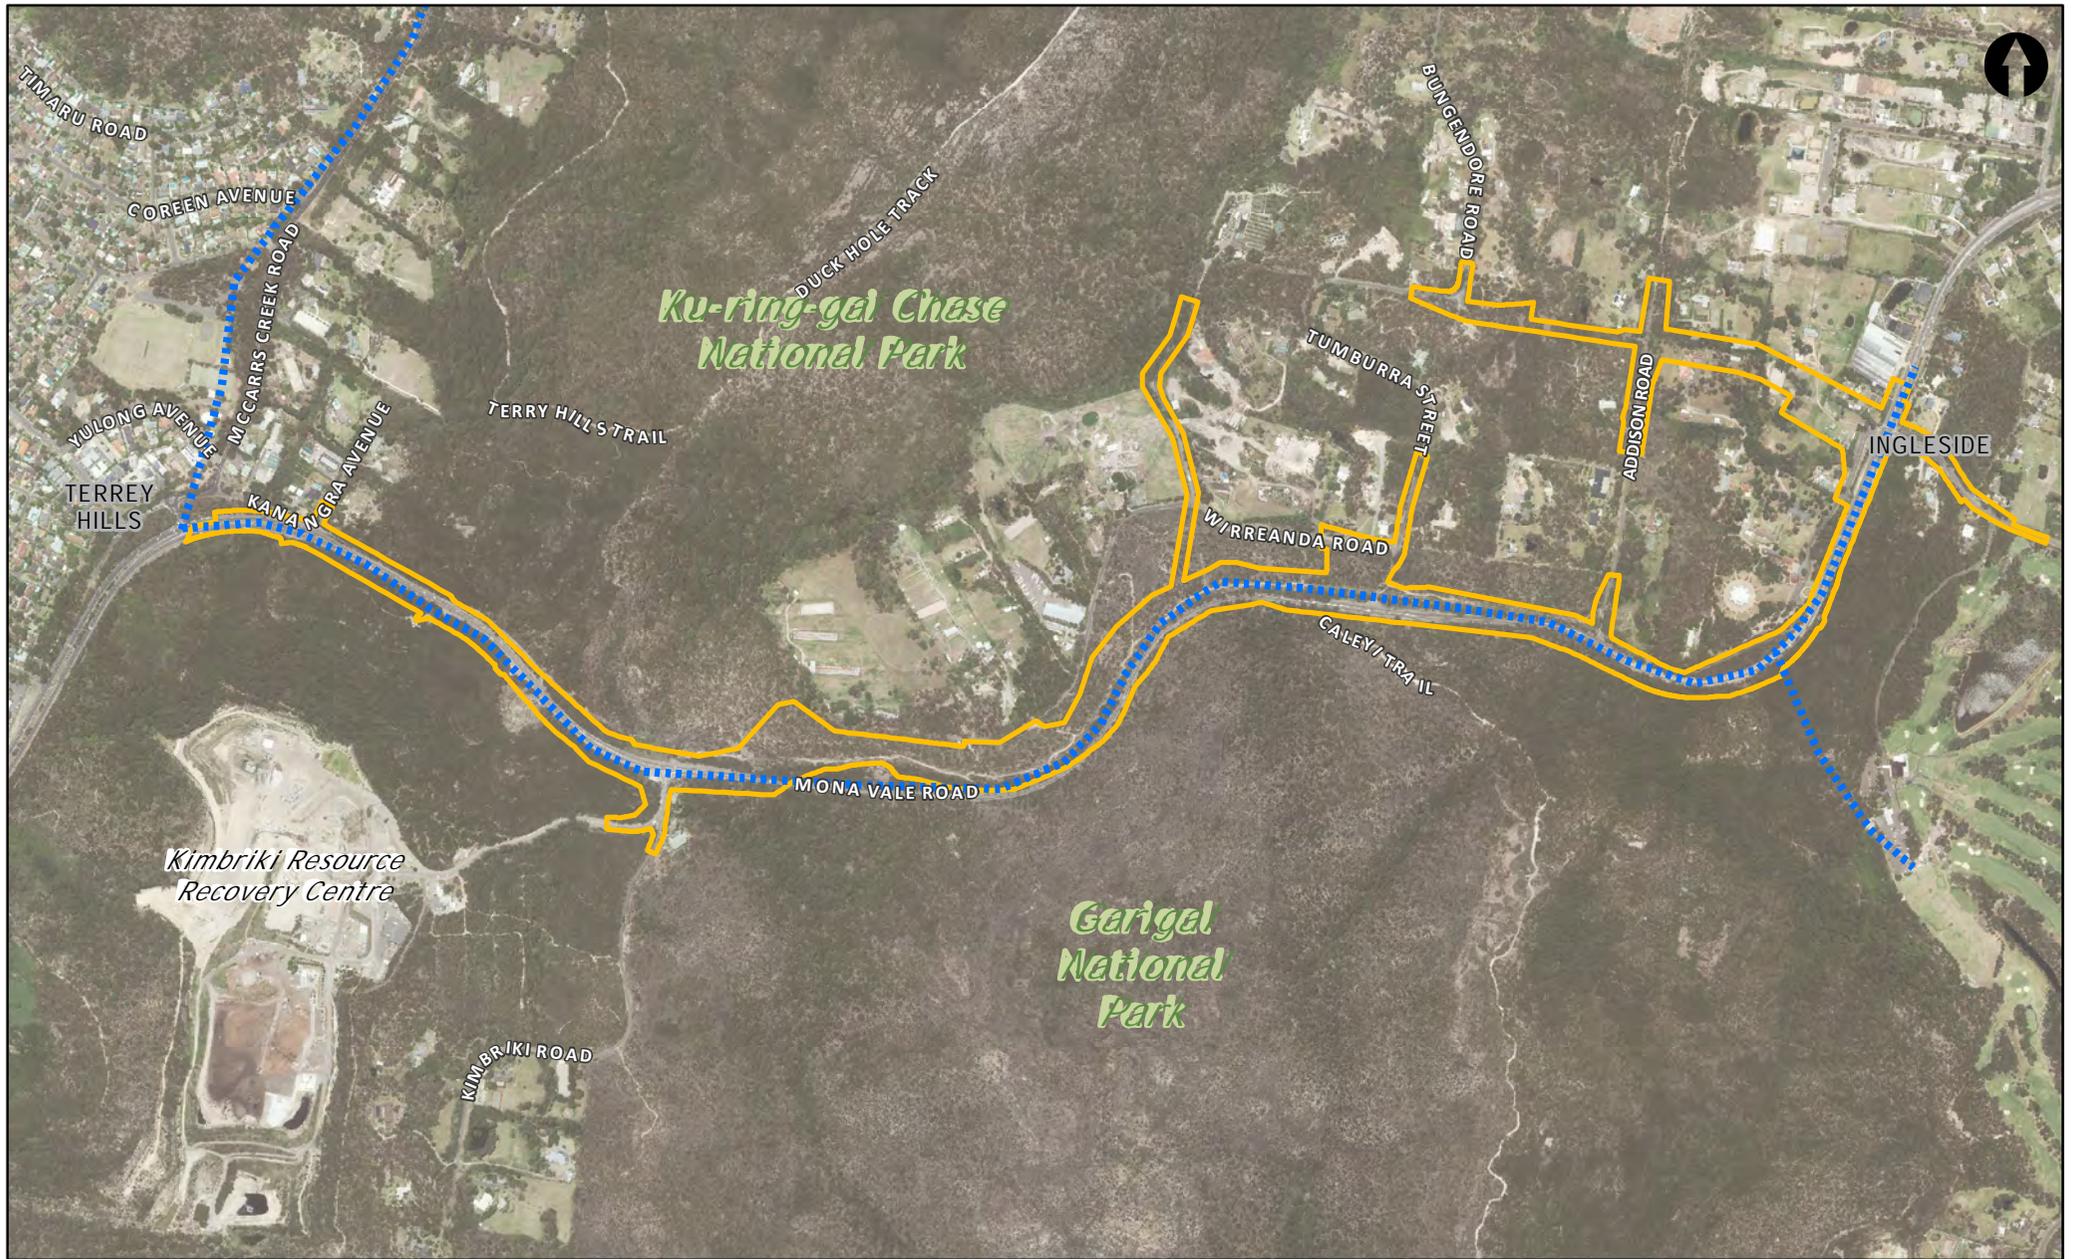
Regional catchments Figure 6-5

- Approximate regional catchment boundaries
- Construction Boundary
