# Newell Highway Heavy Duty Pavements, Narrabri to Moree

Aboriginal and historic archaeological survey report

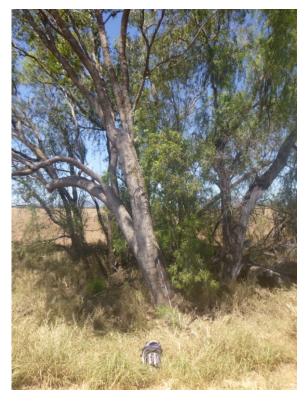
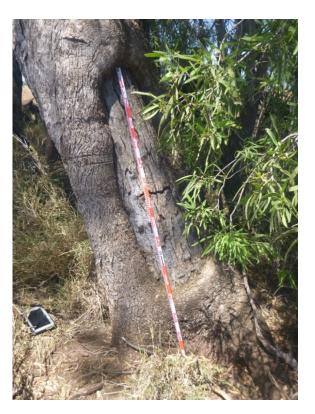
Figure 5-9: Photographs showing an overview of BC-HW17-ST1.

Attribute	Description	Scar dimensions	
Tree species	Bimble box (Eucalyptus populnea)	Length of dry face (cm)	120
Tree condition	Alive - the tree appears to be in good overall health	Width of dry face (cm)	50
Scar orientation	Southwest	Height of base of scar above ground (cm)	30
Type of scar	Oval shaped bark slab (sheet) removal scar	Thickness of overgrowth (radial, from centre of tree) (cm)	15
Scar preservation	The dryface is well preserved	Tree dimensions	
(original attributes)		Diameter at breast height (cm)	270
Scar preservation (physical decay)	Good		
Toe holds	No		
Tool marks	None visible		
Epicormic stem present?	No

2. Overview of the BC-HW17-ST1 bark slab (sheet) removal scar, facing east.

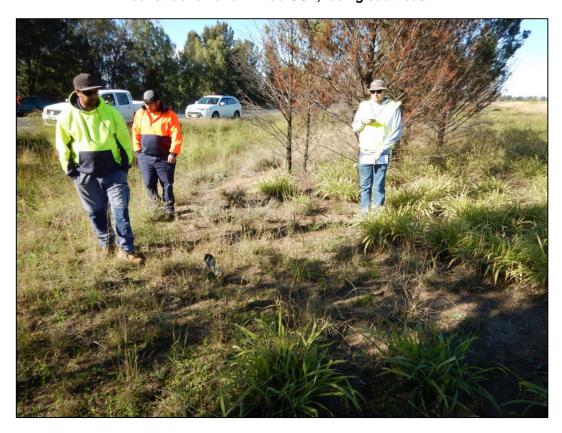
Plate 1: Proposal area 1 showing ground surface disturbance due to the Newell Highway construction and limited GSV, facing southeast.

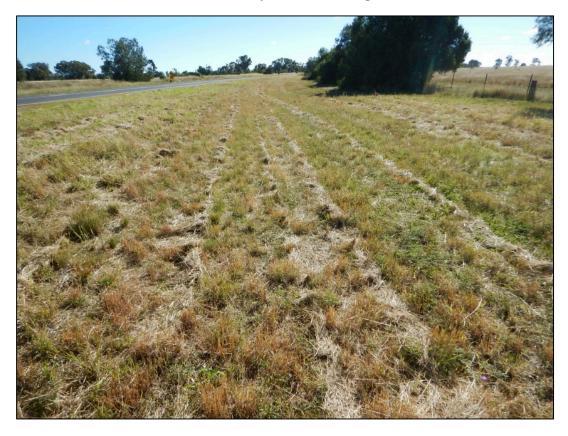
Plate 2: Proposal area 1 showing ground surface disturbance due to the Newell Highway construction and very low GSV, facing southeast.

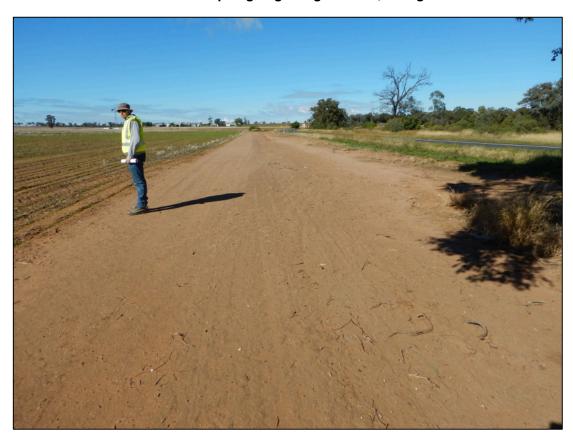
Plate 3: Proposal area 1 showing ground surface disturbance due to the Newell Highway construction and ploughing and good GSV, facing south.

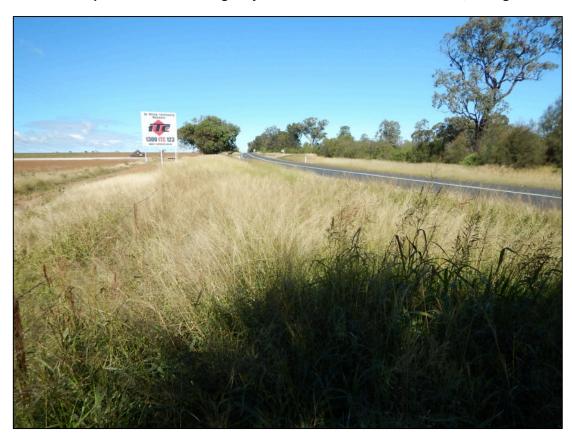
Plate 4: Proposal area 1 showing very low GSV around the creek bank, facing south.

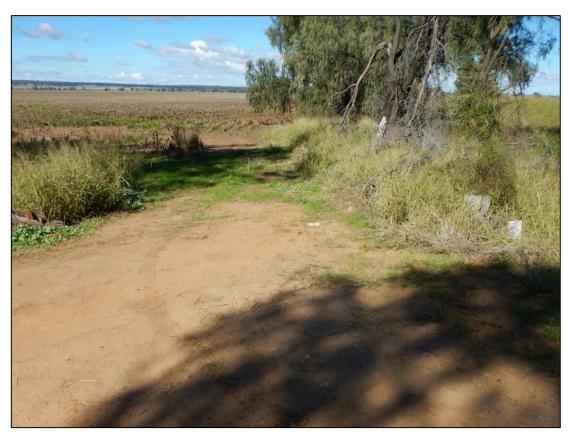
Plate 5: Proposal area 2 showing high levels ground surface disturbance due to the Newell Highway construction and ploughing and good GSV in the offline area south of Bobbiwaa Creek, facing south.

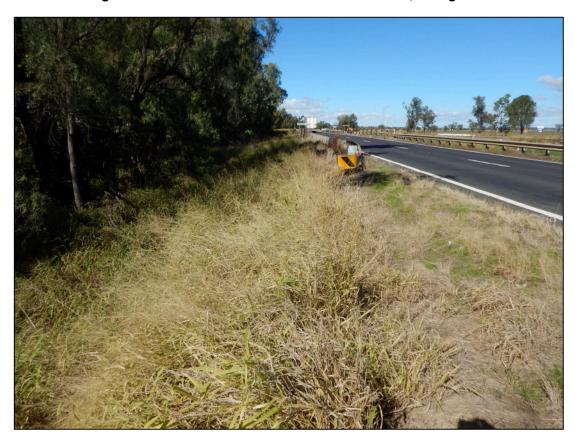
Plate 6: Proposal area 2 showing ground surface disturbance due to the Newell Highway road and bridge construction and low GSV at Bobbiwaa Creek, facing south.

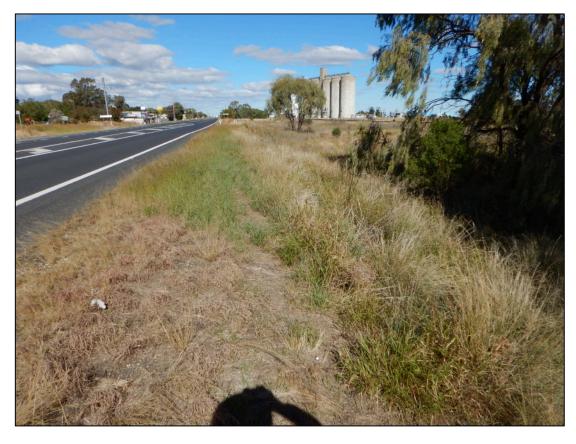
Plate 8: Proposal area 2 showing ground surface disturbance due to the Newell Highway construction and limited GSV, facing south.

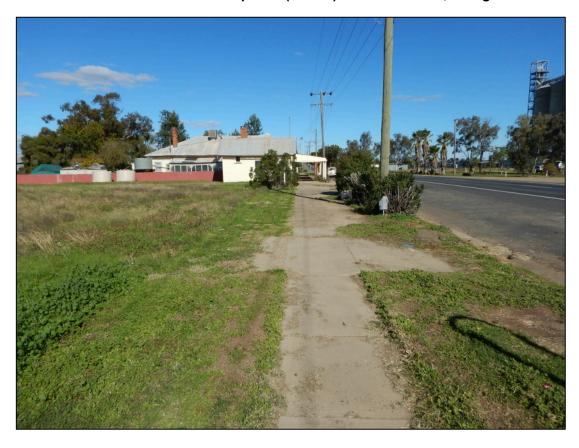
Plate 9: Proposal area 3 showing ground surface disturbance due to the Newell Highway construction and urban development (Bellata) and limited GSV, facing south.

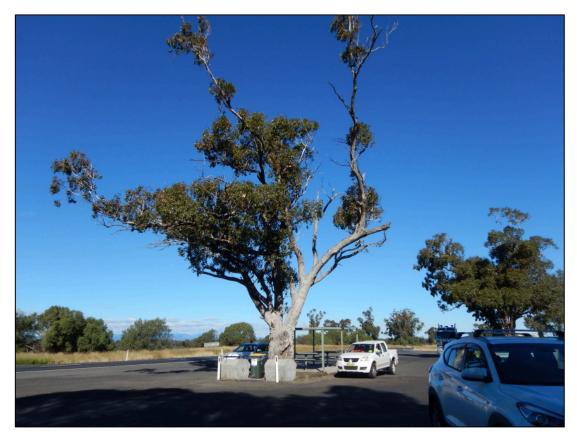
Plate 10: Proposal area 3 showing ground surface disturbance due to the Newell Highway construction and rest area construction and limited GSV, facing southeast.

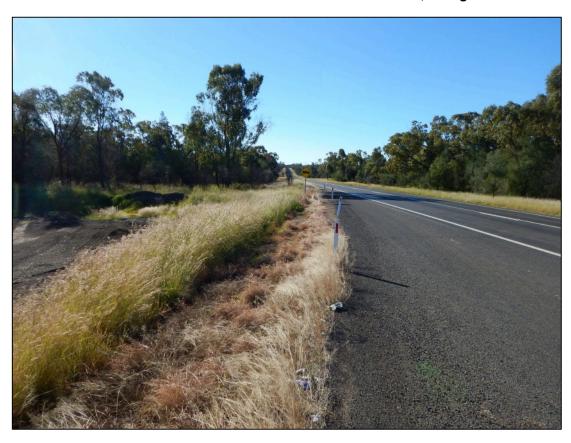
Plate 11: Proposal area 4 showing ground surface disturbance due to the Newell Highway construction and rest area construction and limited GSV, facing north.

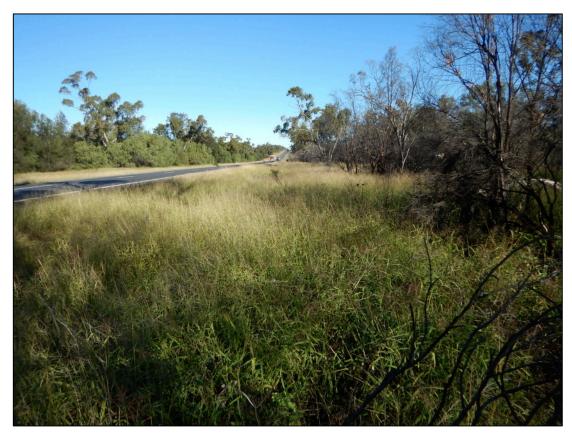
Plate 12: Proposal area 4 showing ground surface disturbance due to the Newell Highway construction and limited GSV, facing south.

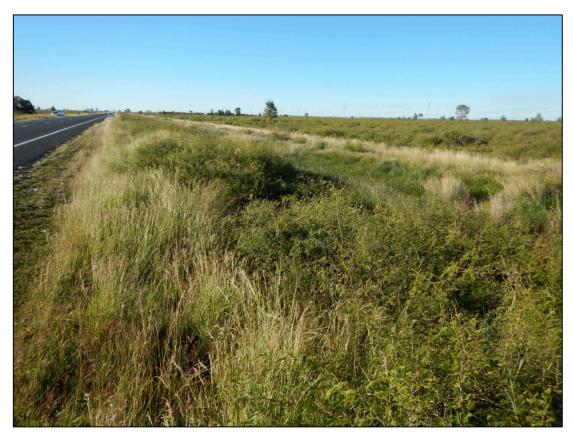
Plate 14: Proposal area 5 showing ground surface disturbance due to the Newell Highway construction and limited GSV around Clarkes Creek, facing south.

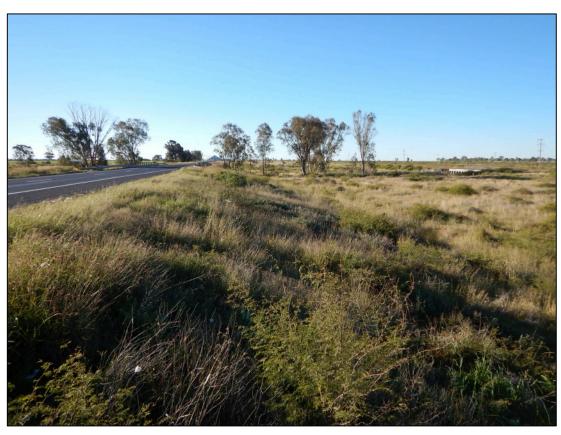
Plate 16: Proposal area 5 showing ground surface disturbance due to the Newell Highway construction and limited GSV around Halls Creek, facing north.
