NELLIGEN BRIDGE REPLACEMENT

Aboriginal Cultural Heritage Assessment

July 2016

Prepared by
Umwelt (Australia) Pty Limited
on behalf of
Roads and Maritime

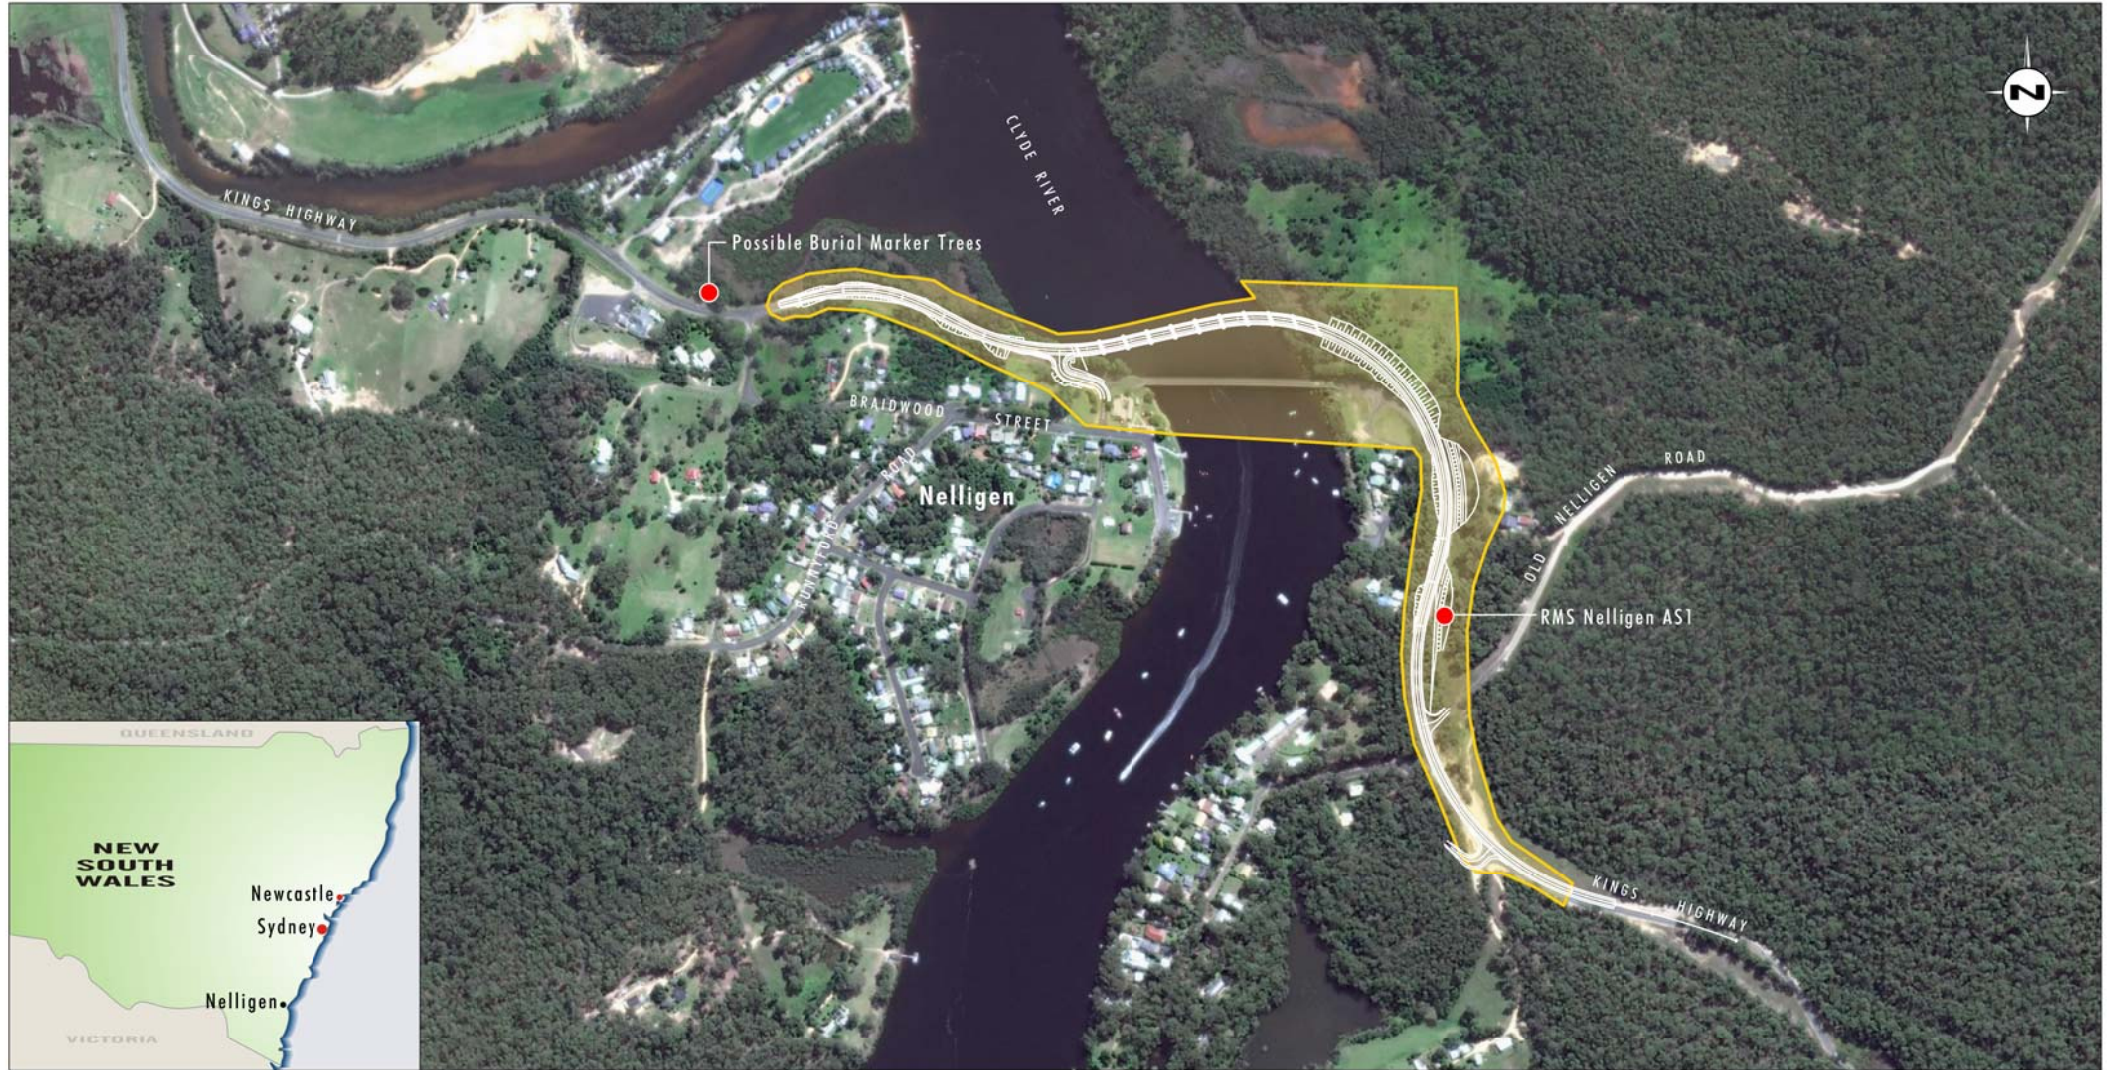
Image Source: Google Earth, DigitalGlobe (2015)
 Data Source: NSW Roads and Maritime (2015)

- Legend**
- Nelligen Bridge - Aboriginal Cultural Heritage Study Area
 - Proposed Design
 - Artefact Scatter

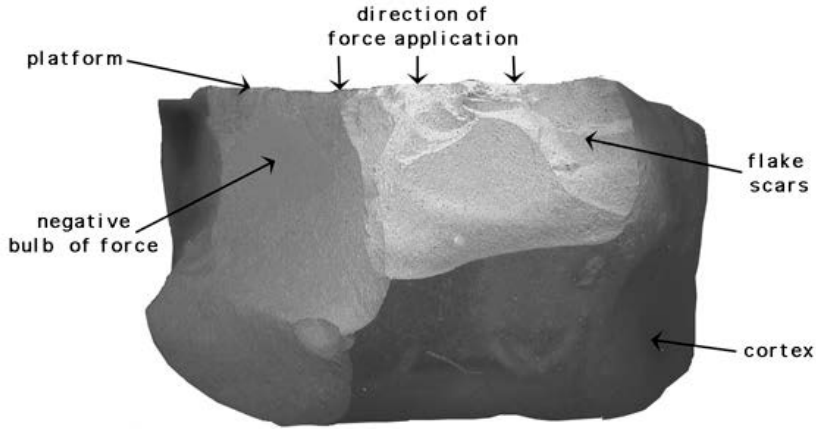
<p>core</p>	<p>A piece of raw material from which flakes have been struck. Cores will always exhibit at least one negative flake scar (refer to Figure 1).</p>

<p>Figure 1 - A single platform core</p>
<p>deposits</p>	<p>In an excavation the term deposit or deposits refers to the material excavated. This includes the soil and all its contents.</p>
<p>Flake</p>	<p>A piece of stone detached from a larger mass (generally termed a core) by the application of force. Attributes of whole flakes are platforms, terminations, lateral margins, a ventral and dorsal surface and a bulb of force.</p>
<p>Flake scar</p>	<p>A concave surface which has resulted from the removal of a flake.</p>
<p>Geomorphic/ geomorphology</p>	<p>Geomorphology is the scientific study of landforms and how they were created. When assessing Aboriginal site formation processes the geomorphic history of the location must be understood in order to recognise the site formation processes that can be related to human behaviour/actions and those that have come about due to natural processes.</p>

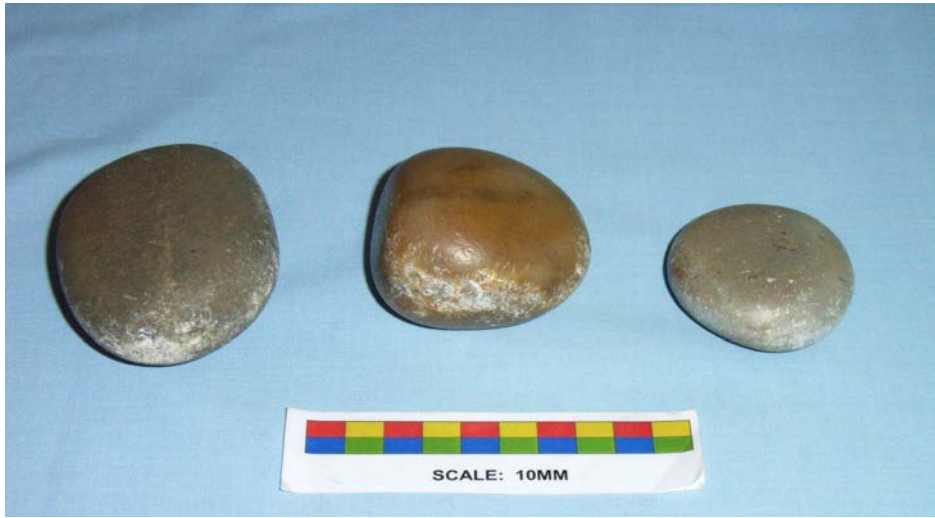
<p>Hammerstone</p>	<p>A stone used to strike another piece of stone (a core) to remove flakes. Often a rounded pebble.</p>
