## **NELLIGEN BRIDGE REPLACEMENT**

Subsurface Testing Archaeological  
Excavation Report

Prepared by  
**Umwelt (Australia) Pty Limited**  
on behalf of  
**Roads and Maritime**

Project Director: Jan Wilson  
Project Manager: Kym McNamara  
Technical Director: Jan Wilson  
Technical Manager: Kym McNamara  
Report No. 8093/R02  
Date: July 2016

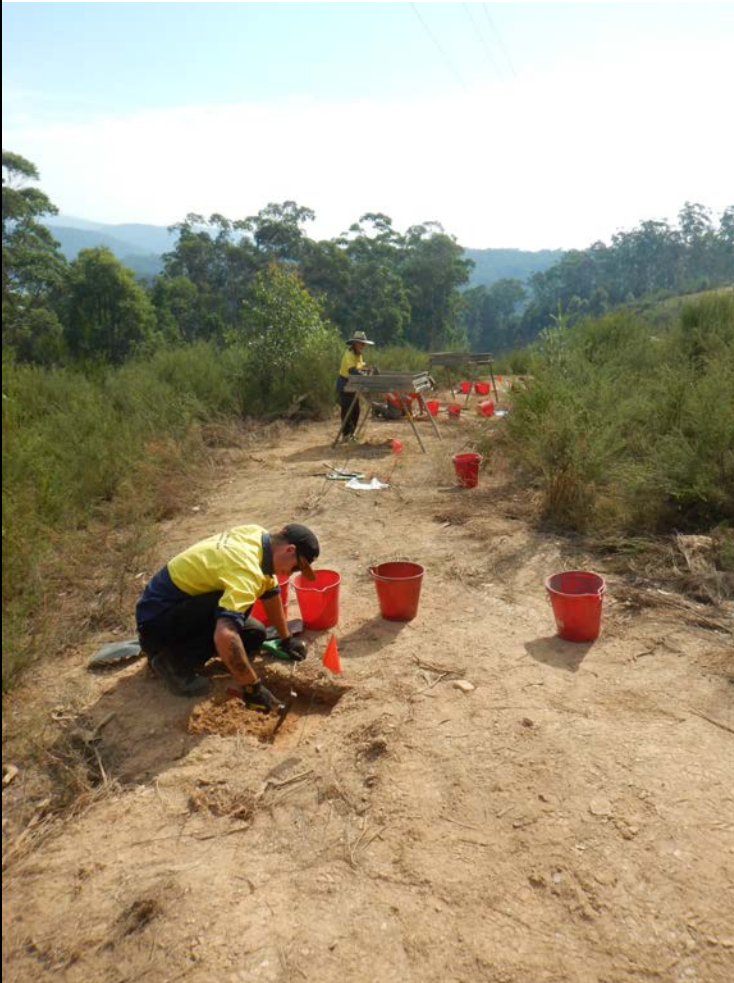
**Plate 4.1**

Subsurface testing of Roads  
and Maritime Nelligen  
PAD1 view north-north-  
east

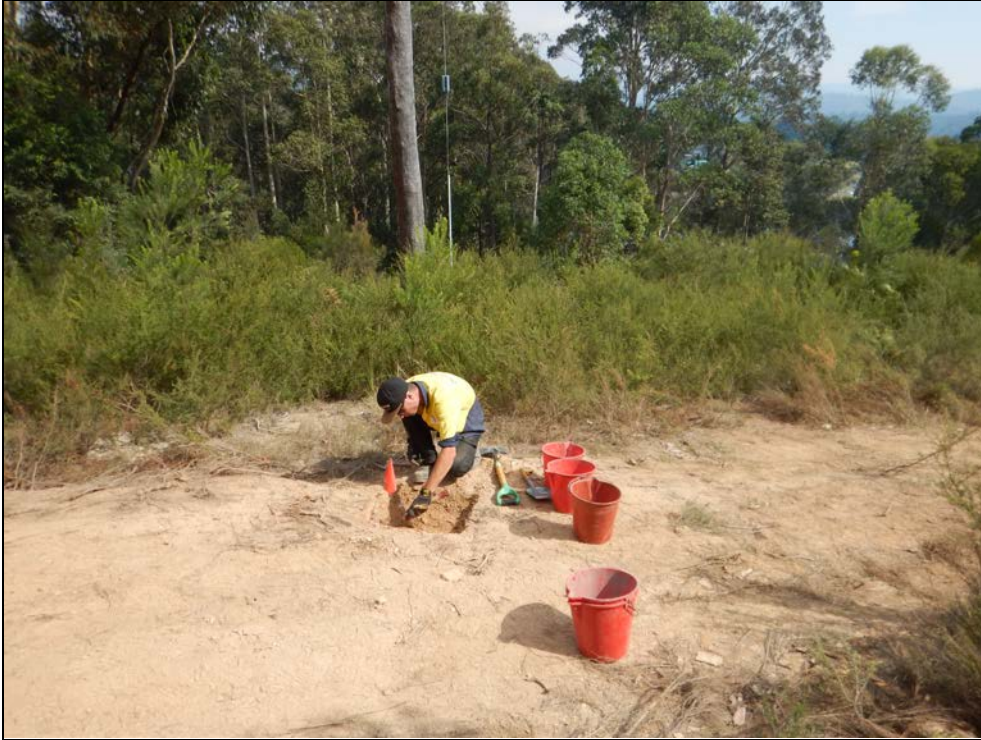
**Plate 4.2**

Subsurface testing of Test Pit 1, Roads and Maritime Nelligen PAD1 view west

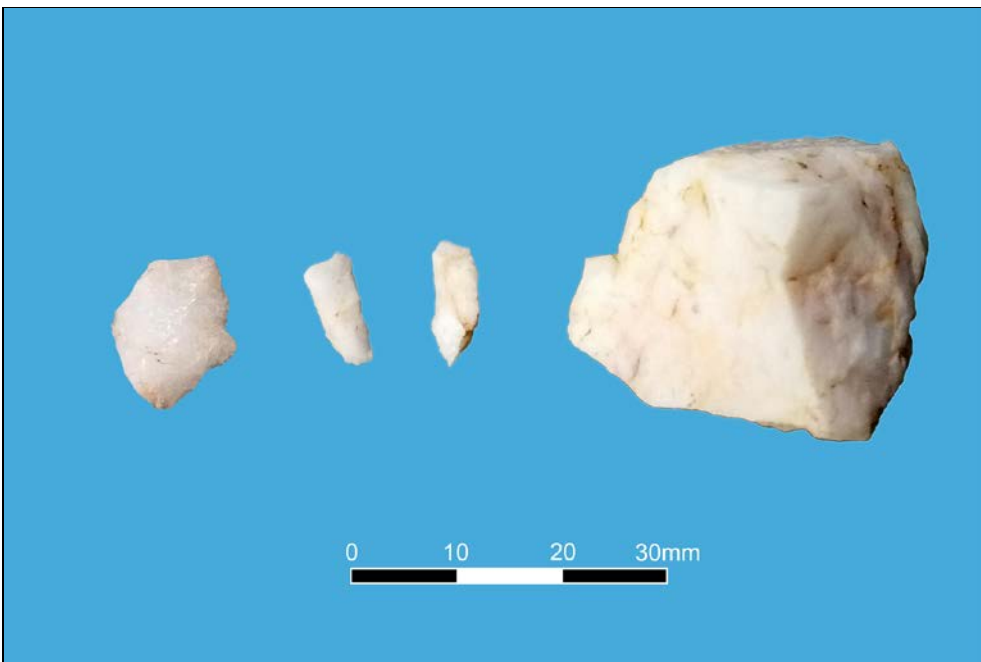
**Plate 4.3**

An example of quartz artefacts from the subsurface testing of Roads and Maritime Nelligen PAD1

A total of 14 artefacts were recovered from the test excavations at Roads and Maritime Nelligen PAD1. The assemblage was comprised of 8 broken flakes, 3 complete flakes, 2 cores and 1 flaked piece. All of the artefacts were manufactured from quartz. Six artefacts were located in Test Pit 1, two in Test Pit 2, four in Test Pit 3 and two in Test Pit 4 as detailed below in **Table 4.1**. The artefacts were spread throughout the four spits, with Spit 3 having the highest number (7 or 50 per cent of the assemblage). The quartz used for artefact manufacture was of a slightly higher quality than the local quartz gravel. It was observed that some of the quartz in the soil profile had been crushed and broken from prior works. All quartz that had the appearance of artefacts was retained for analysis after being washed and inspected to be certain that no artefacts were missed and non-artefactual material was mistakenly recorded.
