Newell Highway Coonabarabran Bypass

Preliminary Site Investigation

Author: Erin Knaap – Environmental Consultant
Date: April 2020
Version: 3
Reference:
Division:
Review date: April 2020

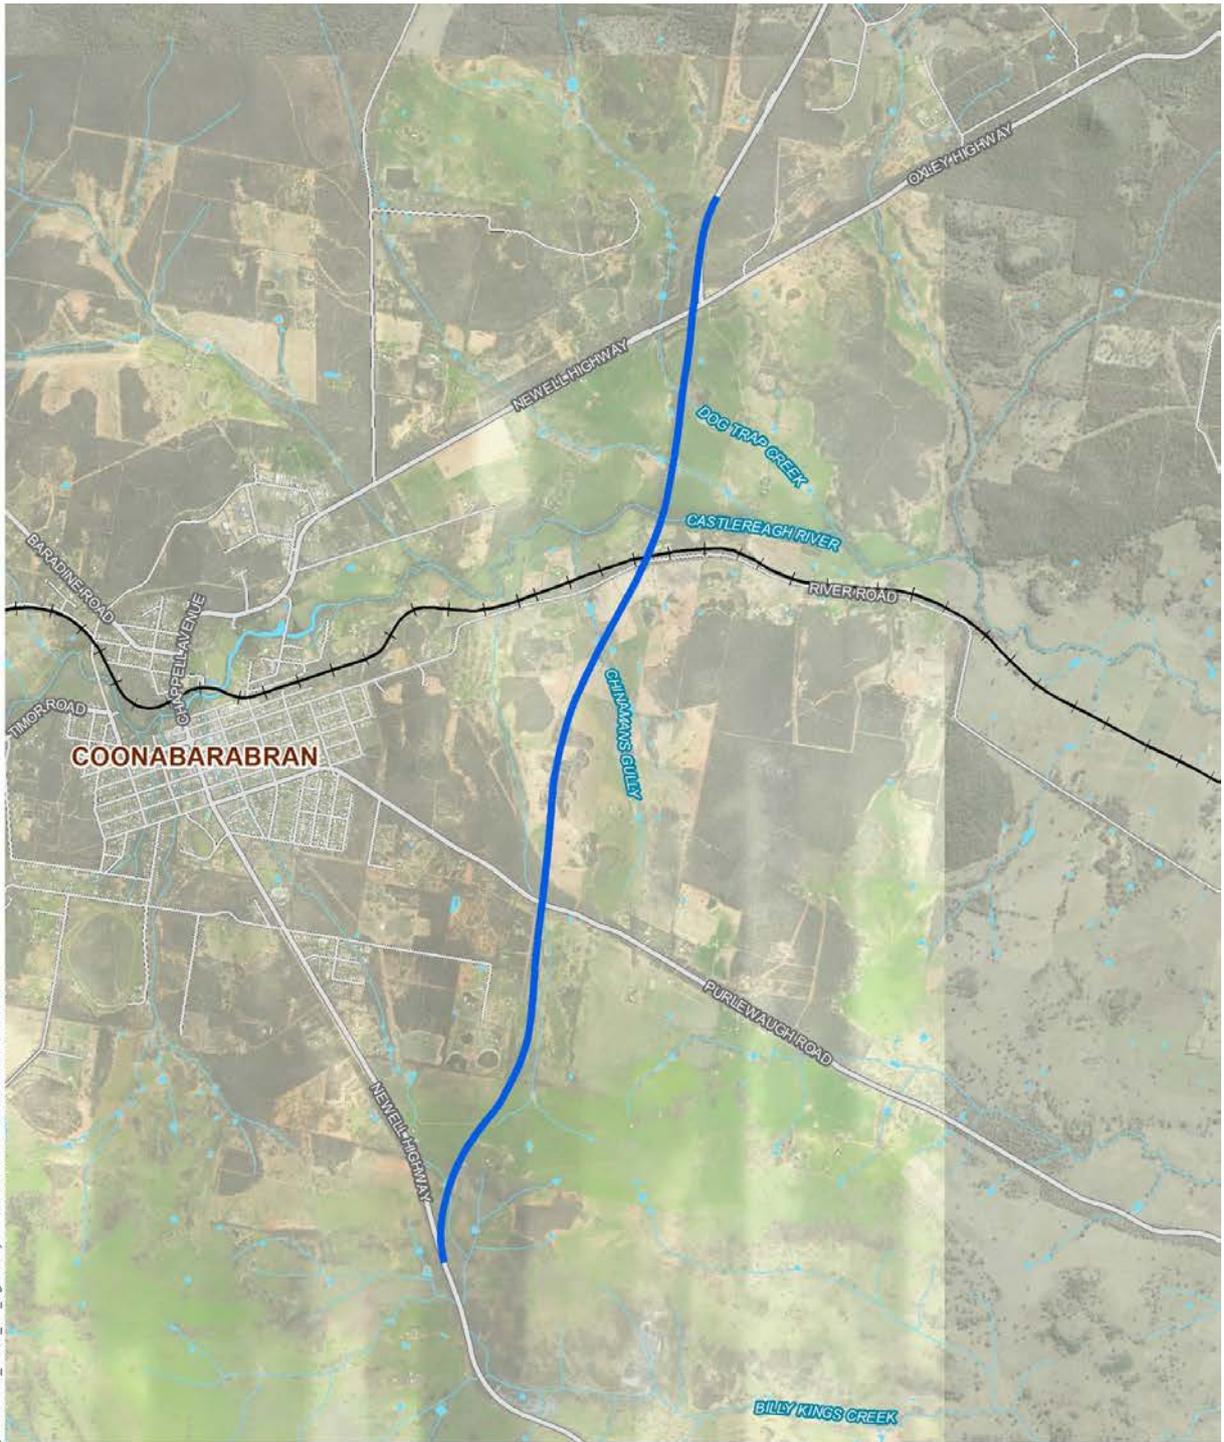
FIGURE 1.1: Project Overview

Refer to Figure 1-1 for the proposal overview.

Coonabarabran is located between the Central West and North West Slope regions of New South Wales. Topography within the study area features gentle undulating hills, with elevation ranging from 490 metres Australian Height Datum (mAHD) at the intersection with Castlereagh River, to 580 mAHD at the intersection with Newell Highway. The study area intersects a number of creeks and drainage lines, the most notable being the Castlereagh River, Dog Trap Creek and Chinamans Gully (refer to Figure 1-1).

The hydrology and drainage features in the area is shown in Figure 1-1. Given the watercourses present and the topography of the area, surface water is expected to flow from the drainage lines into Castlereagh River, running east-west through the study area. Table 3-3 summarises each watercourse and its relevance to the study area.

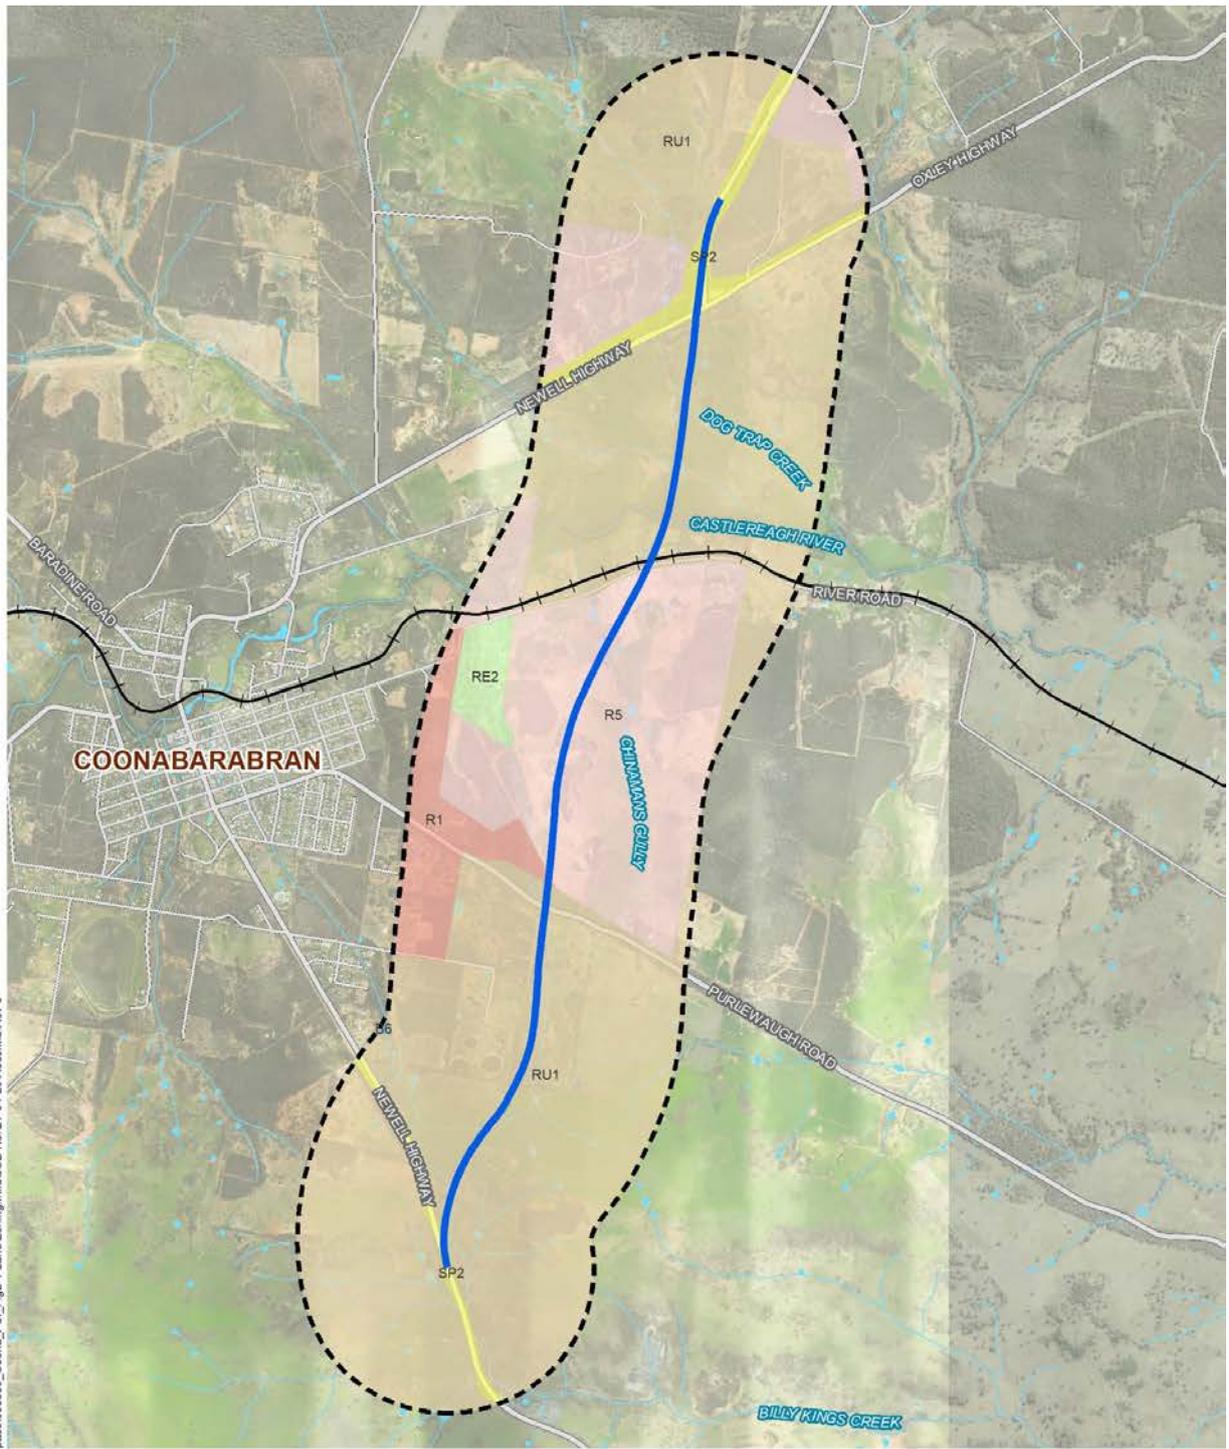
FIGURE 2.1: Land Zoning

The study area is located within the Warrumbungle Shire Council and the relevant local environmental plan (LEP) is the Warrumbungle LEP 2013. Land use zoning include the following:

- SP2 - Infrastructure
- RU1 - Primary Production
- R1 - General Residential
- RU5 - Large Lot Residential.

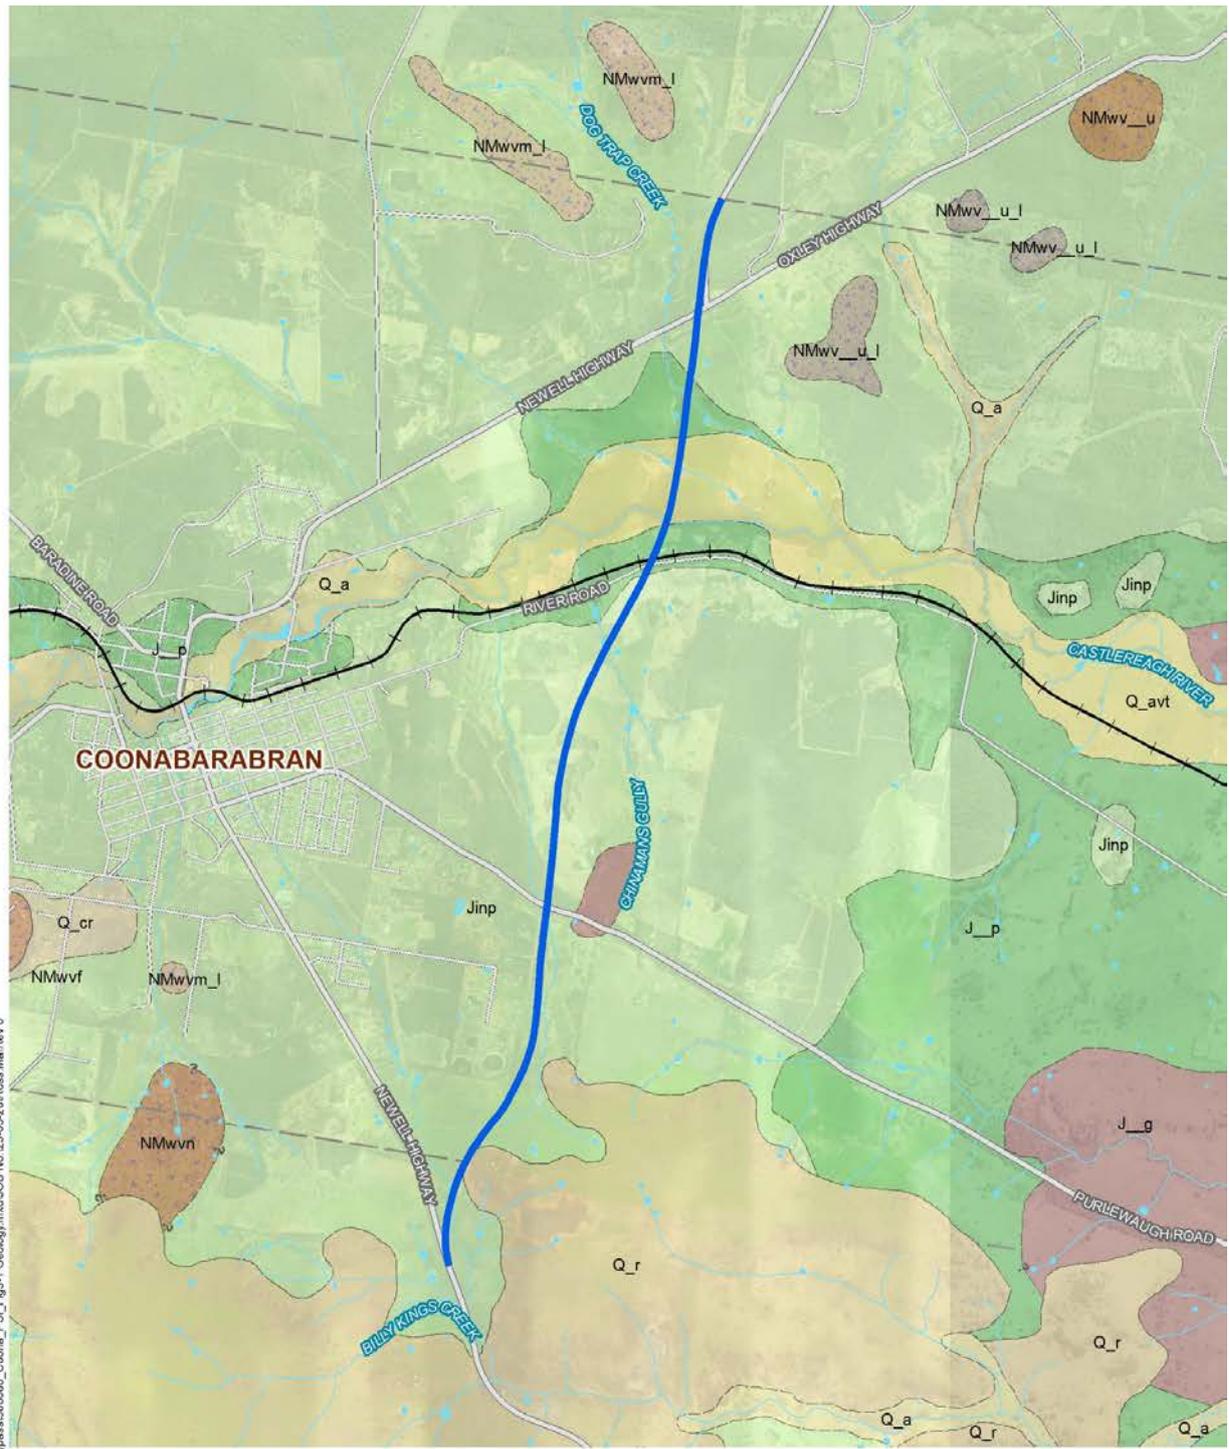
FIGURE 3.1: Geology

The study area is located on the Gilgandra 1:250 000 Geological Map (SH/55-16). Five different geologic formations from Cenozoic to Mesozoic time frames are present within the study area, with the Purlawaugh Formation being the most predominant. A map of geology throughout the study area is presented in Figure 3-1. A description of each geological formation is summarised in stratigraphic order in Table 3-1.

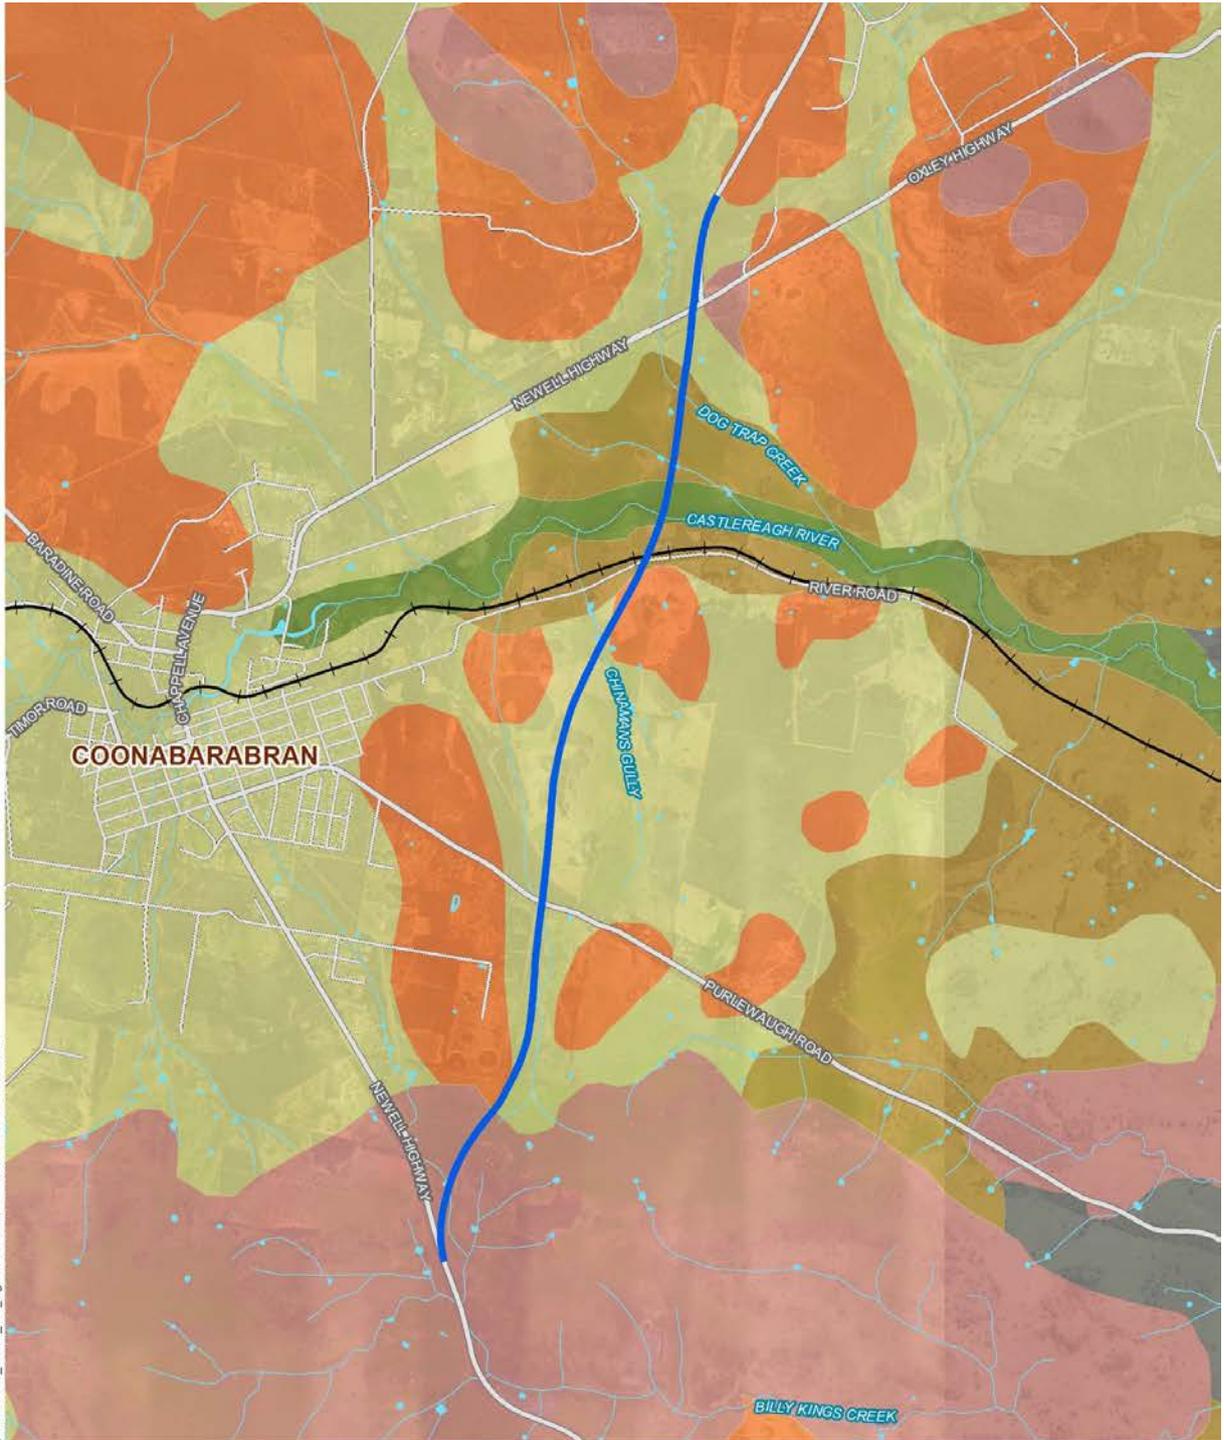
FIGURE 3.2: Soil

Soil classifications were assessed using the Office of Environment and Heritage eSPADE 2.0 Web Application (eSPADE) and the Australian Soil Classification. The study area spans over a variety of soil classifications including Kandosols, Sodosols, Ferrosols, Kurosols and Chromosols (Figure 3-2). Descriptions of each soil classification is summarised in Table 3-2.

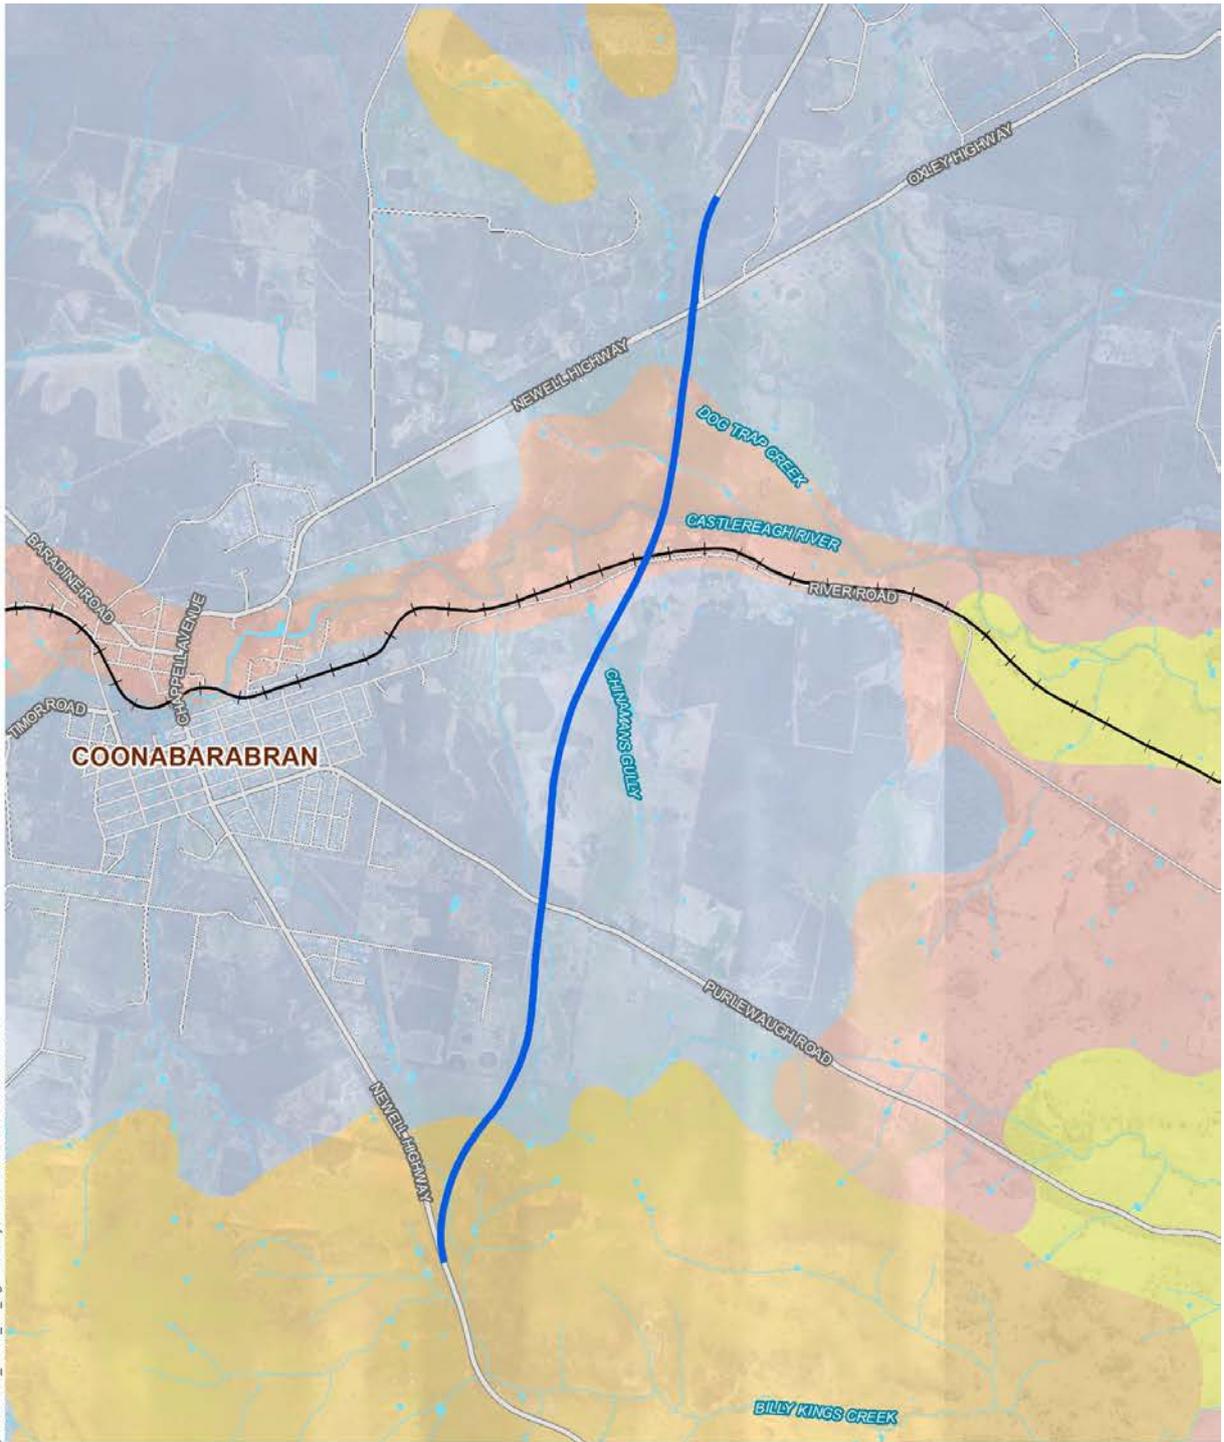
FIGURE 3.3: Salinity

A review of information available through eSPADE indicates the study area is located within the following salinity hazard areas, presented in in Figure 3-3:

- low salinity hazard in the northern and mid portion of the study area
- very high salinity hazard in the mid portion of the study area, following Castlereagh River and Dog Trap Creek watercourses
- high salinity hazard in the most southern portion of the study area.

The HGL pattern is identical to the overall salinity hazard as shown in Figure 3-3 and Figure 3-4 with the following correlations present:

- Coonabarabran HGL and low overall salinity hazard
- Purlewaugh/Napperby HGL and very high overall salinity hazard
- Goorianawa HGL and high overall salinity hazard.

- Areas of high to very high land salinity hazard have been identified along the proposed alignment (Refer to Figure 3-3) and pose a moderate landscape influenced risk. Salinity hazard should be considered as part of future engineering designs including durability for concrete and steel and hydrologic design of road drainage lines, sediment basins and element that may have a detrimental effect on salinity expression in the surrounding landscape.

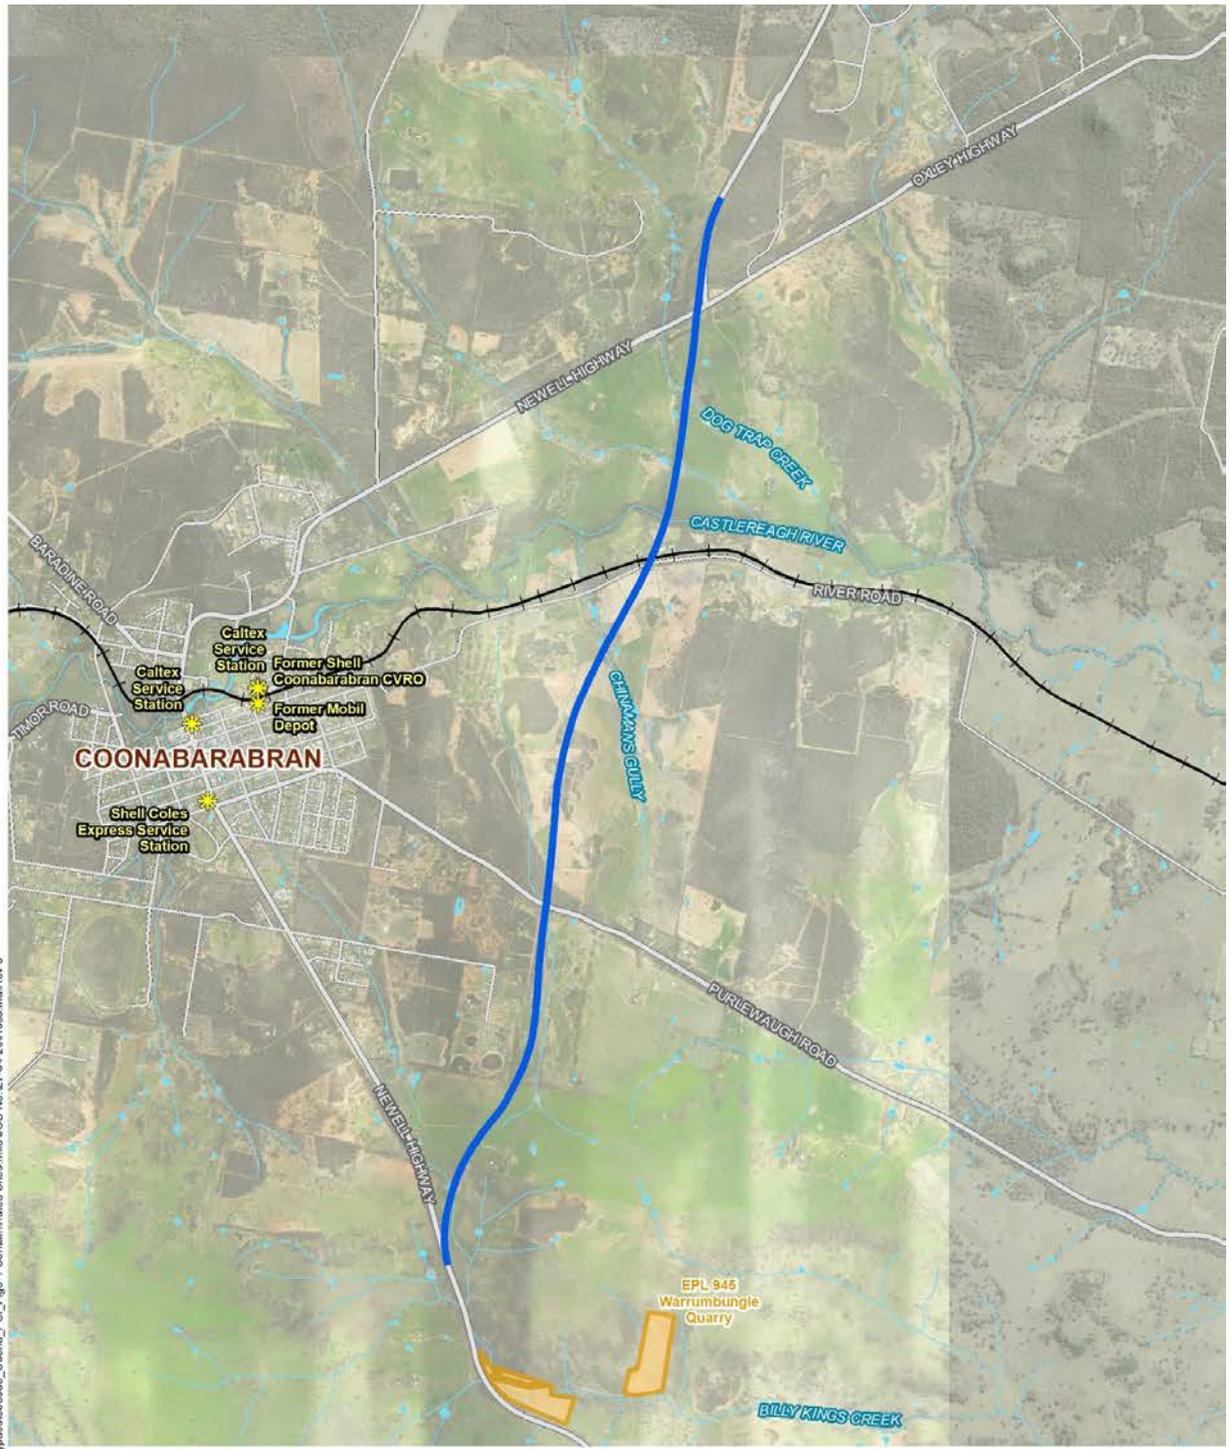
A search of the Contaminated Land Record NSW EPA Search Register revealed no records of current or formerly regulated contaminated land in Coonabarabran.
