# Parkes Bypass

## Aboriginal and Non-Aboriginal heritage assessment report

Roads and Maritime Services | October 2018

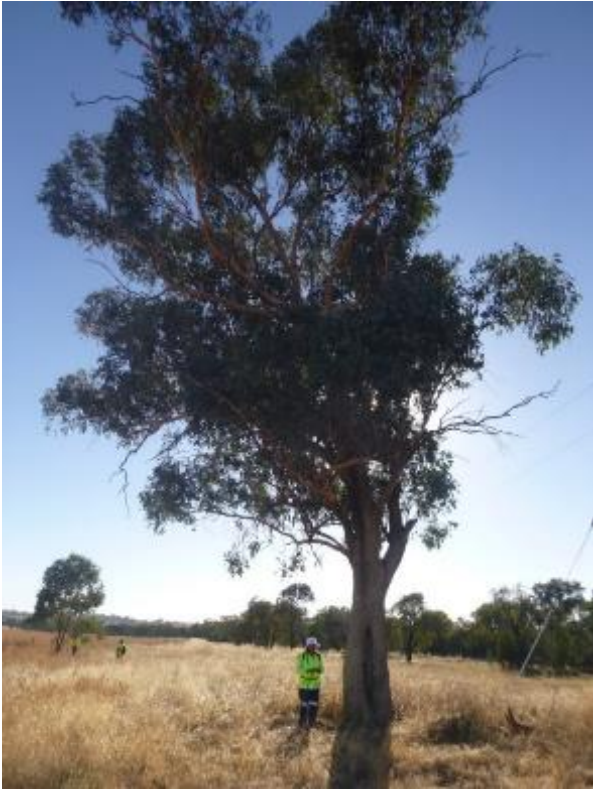
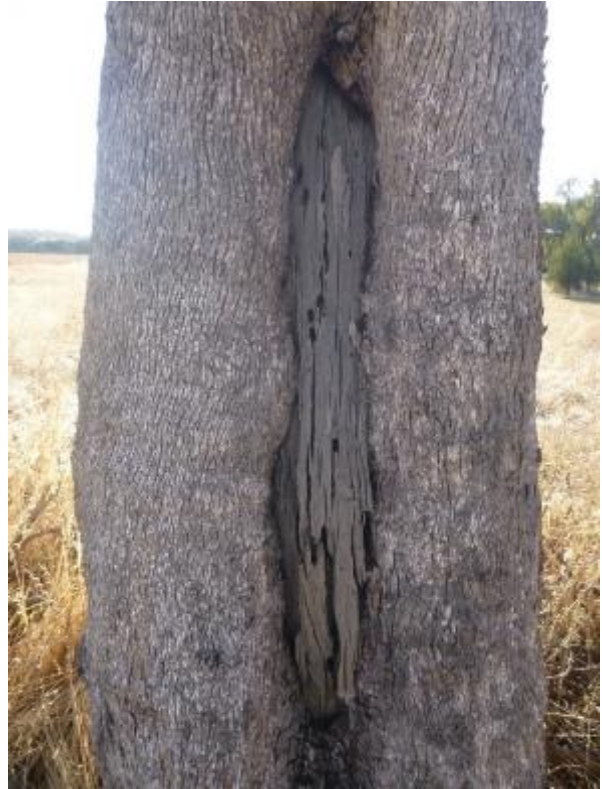
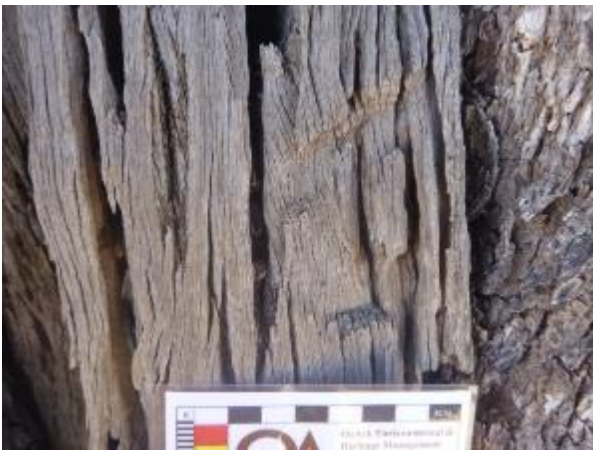
Figure 6-4 Barkers Road-ST1. View of site and up close view of scars

**Description of Site:** Barkers Road-ST1 consists of a box tree displaying one elongated scar (Table 6-4 and Figure 6-4). The tree has a circumference of 250 centimetres at the position of the scar and is alive. The scar displays steel axe marks on the dry face of the scar which is heavily weathered.

<b>Attribute</b>	<b>Dimensions/observation</b>
Scar Length	171 centimetres
Scar Width	20 centimetres
Scar Depth	15 centimetres
Regrowth	12 centimetres
Scar Shape	Elongated
Orientation	West
Condition of scar	Good

1. View of Barkers Road-ST1. View east northeast

2. Close up view of Barkers Road-ST1 scar

3. Close up view of steel axe marks

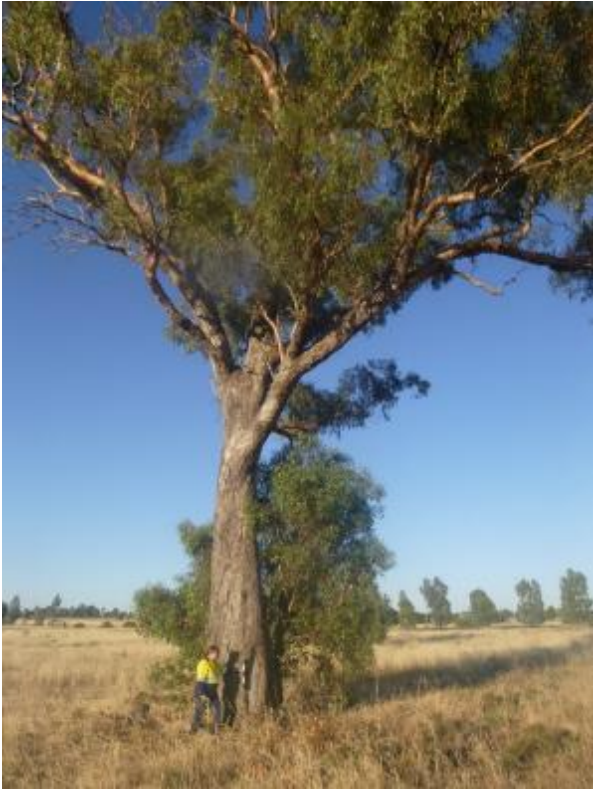
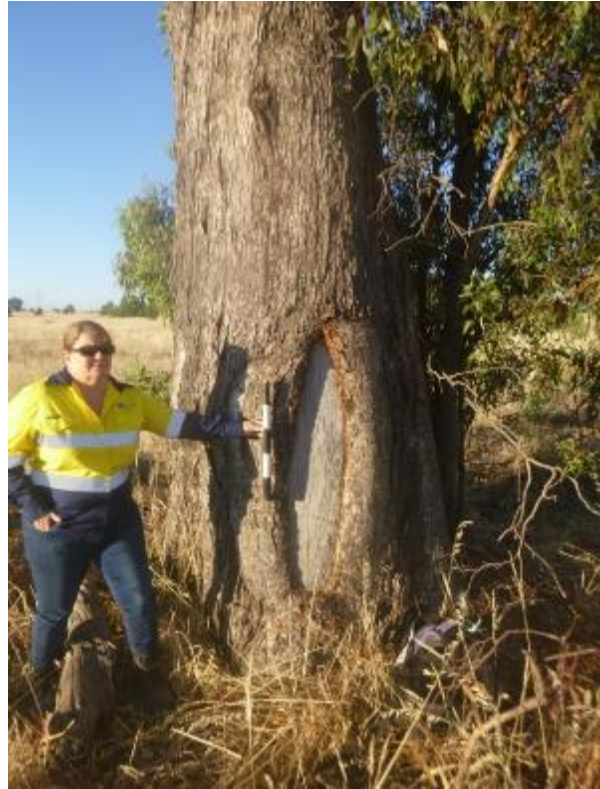
Figure 6-6 Westlime Road-ST1. View of site and up close view of scars

**Description of Site:** Westlime Road-ST1 consists of a box tree displaying one elongated scar (Table 6-5 and Figure 6-6). The tree has a circumference of 270 centimetres at the position of the scar and is alive. The scar displays no stone or steel axe marks.

Attribute	Dimensions/observations
Scar Length	180 centimetres
Scar Width	25 centimetres
Scar Depth	6 centimetres
Regrowth	7 centimetres
Scar Shape	Elongated
Orientation	North east
Condition of scar	Good

1. View of Westlime Road-ST1. View southwest

2. Close up view of Westlime Road-ST1 scar

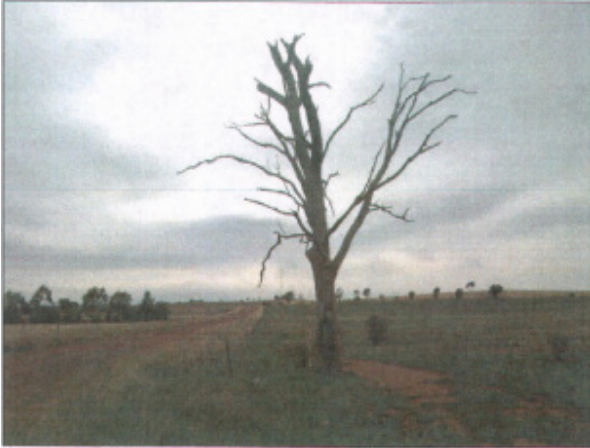
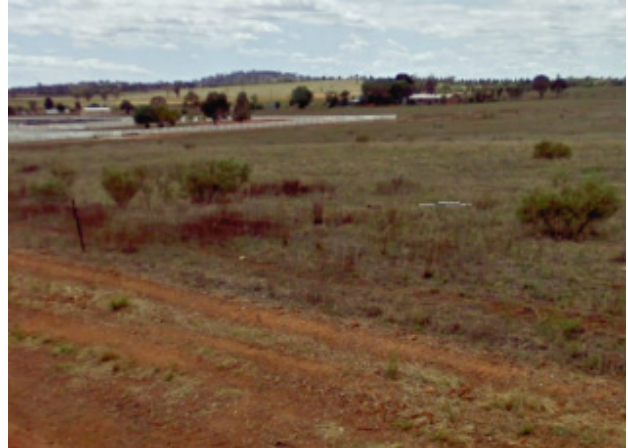
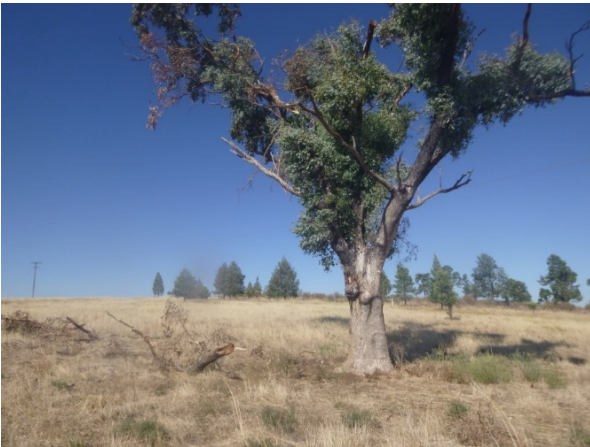
Figure 6-7 Site #43-3-0059 showing photos at the time of the recording in 2004 and the locations ground-truthed in 2017

Previously recorded AHIMS site, #43-3-0059, was recorded by Comber in 2004 immediately to the east of the survey area *This text has been removed for confidentiality purposes* (Section 4.3 and Figure 4-3). Attempts were made ground-truth the location of the scarred tree during the survey. The location provided by the AHIMS register and the location described on the site card were both inspected. Despite having photos of the scarred tree, it was unable to be located at either location (Figure 6-7). The site, which was recorded as being dead but standing at the time of recording, was noted by OzArk (2014) as likely being no longer extant as a result of natural deterioration or possibly being felled without knowledge of its registration<sup>5</sup> (Section 4.3.1).

1. Site #43-3-0059 at the time of recording. View to the north. (Source: Comber 2004a: 31)

2. Site card location of site #43-3-0059. View to the northeast

3. AHIMS register location of site #43-3-0059. View to the southwest

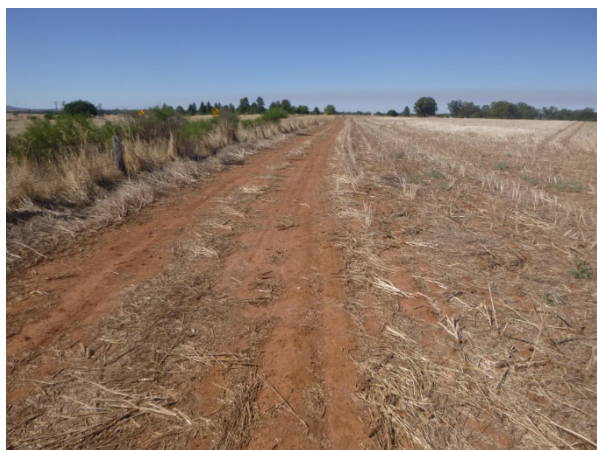
Figure 6-8 AHIMS register location of site #43-3-0061

The AHIMS register location of AHMS site #43-3-0061 was also inspected during the survey in order to further confirm that the site is not located within the survey area. Figure 6-8 below, shows the location of AHIMS site #43-3-0061 as provided by AHIMS within a cleared and ploughed paddock.

1. AHIMS register location of site #43-3-0061. View to the east

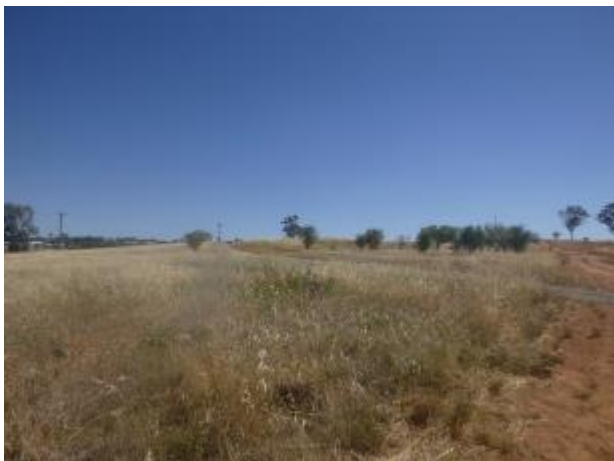
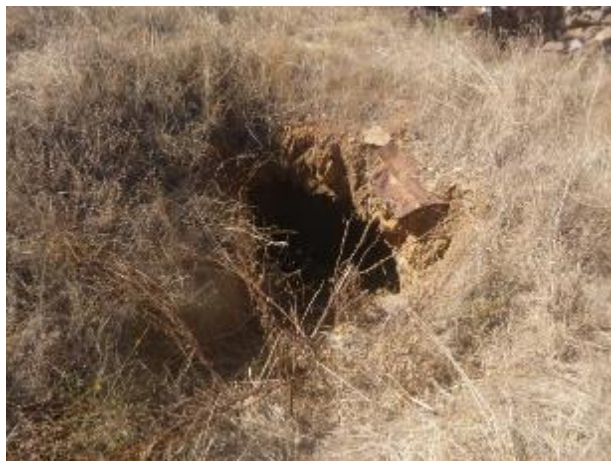
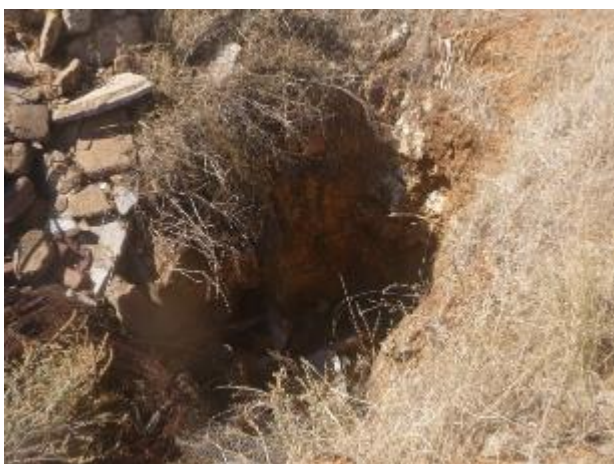
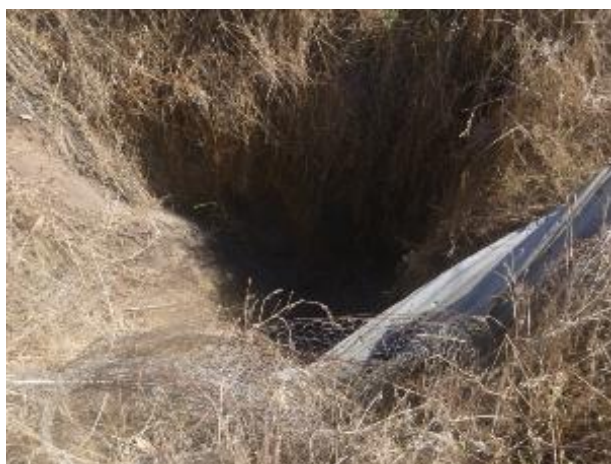
Figure 9-3 Reedsdale Road-HS01. View of site and sample view of shafts

**Description of Site:** Reedsdale Road-HS01 is a disused gold mine with six visible shafts. The majority of the identified shafts appear to have either been backfilled with sediment or not excavated deep enough for use. One of the shafts appears to have been utilised in attempts of gold procurement, however, it did not contain any other features which would allow for its interpretation as a gold mine shaft. The shafts have more recently been utilised by locals for the dumping of unwanted materials including water tanks and farm infrastructure (Figure 9-3).

1. View of Reedsdale Road-HS01 on a low crest landform. View north

2. Close up view of one shaft

3. Close up view of one shaft and rubbish fill

4. Close up view of one shaft and rubbish fill

1. An exclusion zone should be installed around the extent of Reedsdale Road-HS01 to ensure impacts are avoided during construction (Figure 10-1). High-visibility fencing can be used and Table 7-1 provides the coordinates.
2. Site inductions will be provided to workers on the project to inform them of the location of the recorded sites and their legislative protection under the Heritage Act.
3. Should impacts to this site be required, then a SOHI would need to be prepared. This would determine whether the site should be subject to a photographic archival recording.

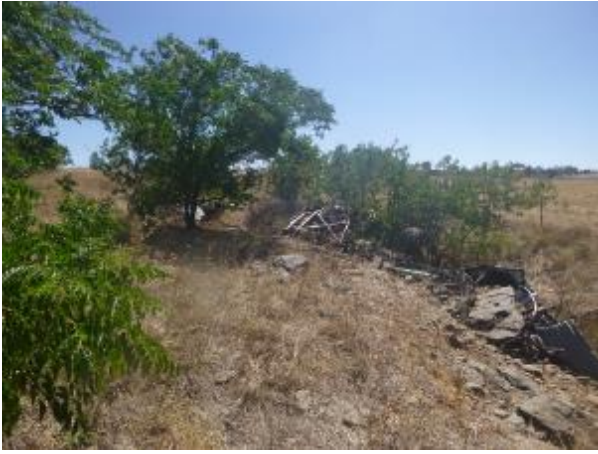
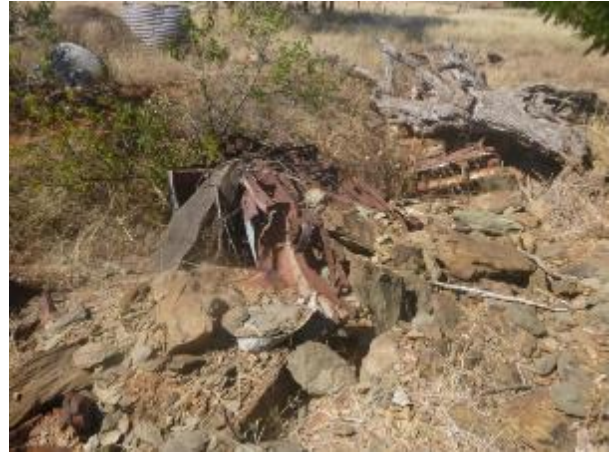
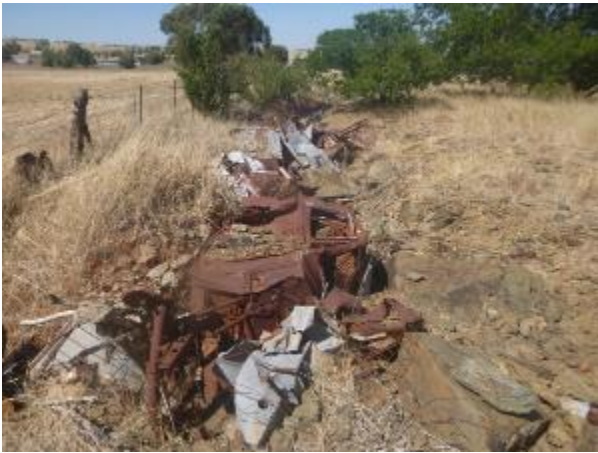
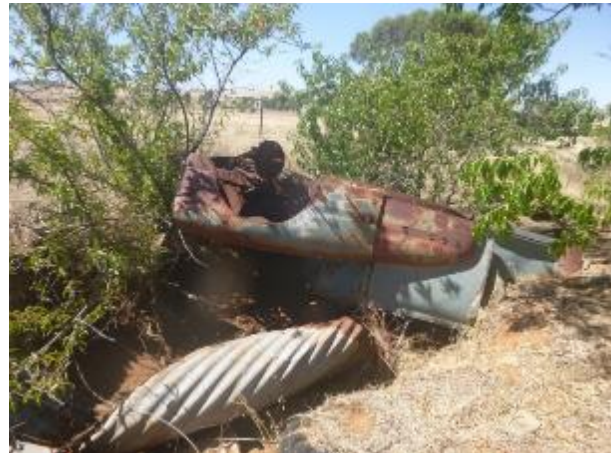
Figure 9-5 Reedsdale Road-HS02. View of site and sample view of historic items

**Description of Site:** Reedsdale Road-HS02 comprises an old rubbish tip, possibly dating to around the 1940s. The rubbish tip contains old vehicles, including Chevrolet and Holden models, and agricultural infrastructure which has been left along outcropping shale bedrock (Figure 9-5). According to local accounts, the tip was utilised by locals where necessary car parts or infrastructure could be acquired. Today, the vehicles and infrastructure are heavily rusted and in poor condition.

1. View of Reedsdale Road-HS02 along an outcropping shale bed. View north

2. Close up view of rubbish fill. View south

3. Close up view of rubbish fill. View south

4. Close up view of rubbish fill. View southeast

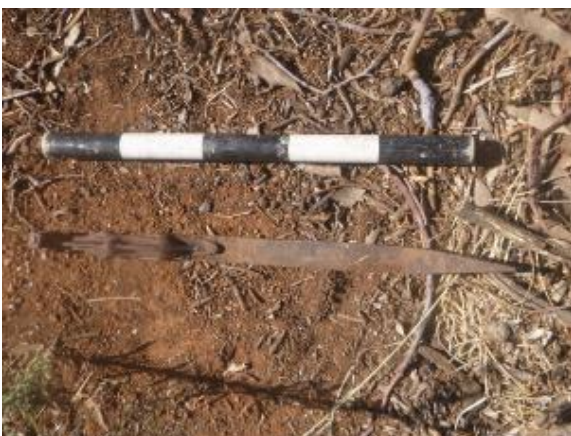
Figure 9-7 Reedsdale Road-HS03. View of historic item

**Description of Site:** Reedsdale Road-HS03 consists of a single plough blade which has been dislodged from a piece of larger machinery (Figure 9-7).

1. View of Reedsdale Road-HS03

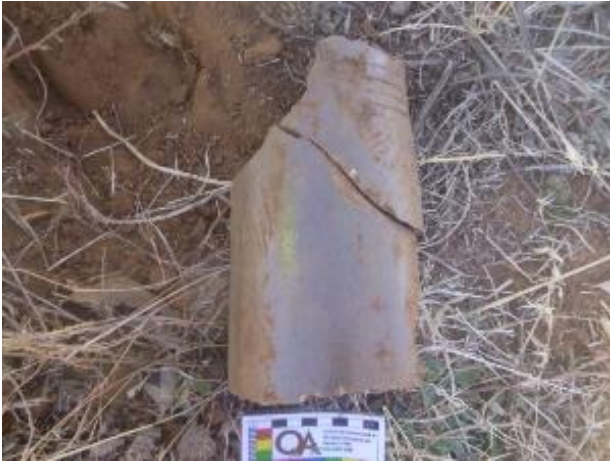
Figure 9-8 Reedsdale Road-HS04. View of historic item

**Description of Site:** Reedsdale Road-HS04 consists of a conjoined piece of terracotta pipe which features four parallel indentations at the proximal end (Figure 9-8).

1. View of Reedsdale Road-HS04

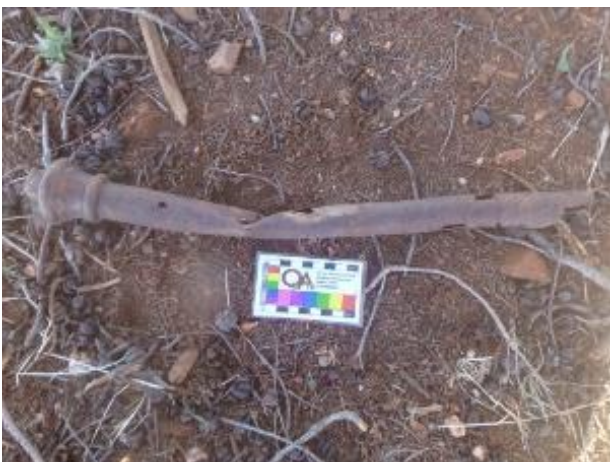
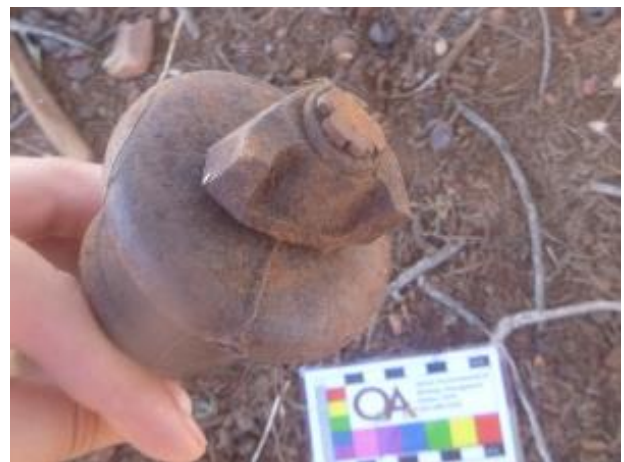
Figure 9-9 Reedsdale Road-HS05. View of historic item

**Description of Site:** Reedsdale Road-HS05 is a metal pipe feature, likely used for agricultural purposes. The pipe has a nut and bolt at the proximal end (Figure 9-9).

1. View of Reedsdale Road-HS05

2. Close up view of Reedsdale Road-HS05

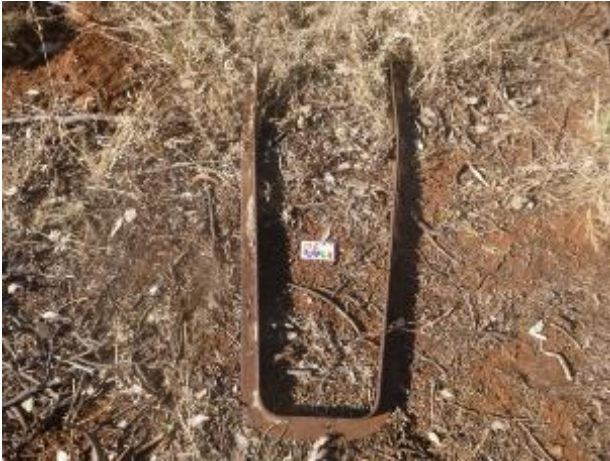
Figure 9-10 Reedsdale Road-HS06. View of historic item

- Site Type:** Metal frame
- GPS Coordinates:** GDA Zone 55 608237E 6334856N
- Location of Site:** Reedsdale Road-HS06 is located within Lot 7044 DP1059946, a designated TSR, along Reedsdale Road. The site is west of Reedsdale Road and east of Lot 1086 DP750152 (Figure 9-1).
- Description of Site:** Reedsdale Road-HS06 is a rectangular frame made from metal, likely used for agricultural purposes (Figure 9-10).

1. View of Reedsdale Road-HS06

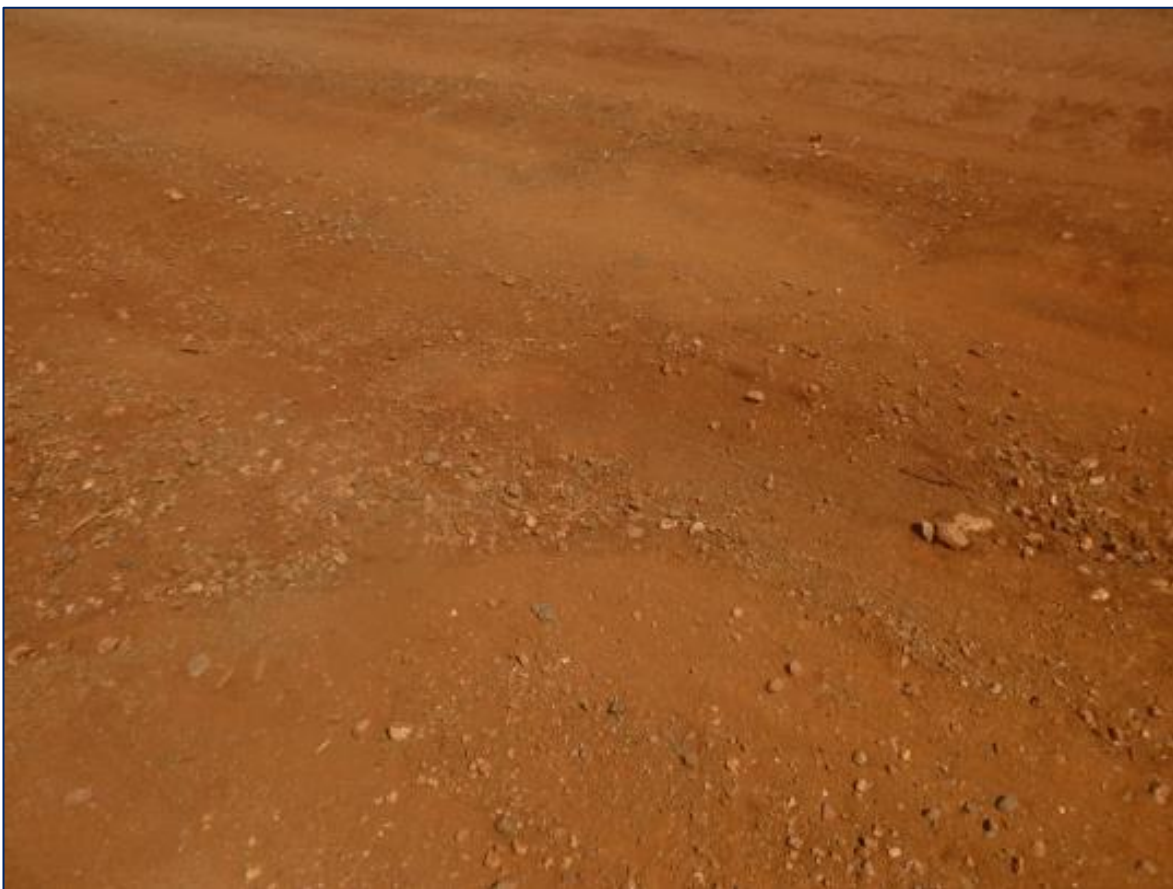
The soil of the survey area is variable as it crosses differing landforms. Generally sedimentology was observed to be a red, coarse, sandy loam which was highly friable and has been subject to erosion due to agricultural practices such as ploughing and vegetation clearance making the soil more susceptible to movement down-slope (Plate 4). Stone material evident within exposures was predominantly small pebbly gravel and soft shale-type materials with outcrops of large basalt pieces and coarse quartz (Plate 5).

Plate 4: View of the red, sandy soils present. Note the high GSV

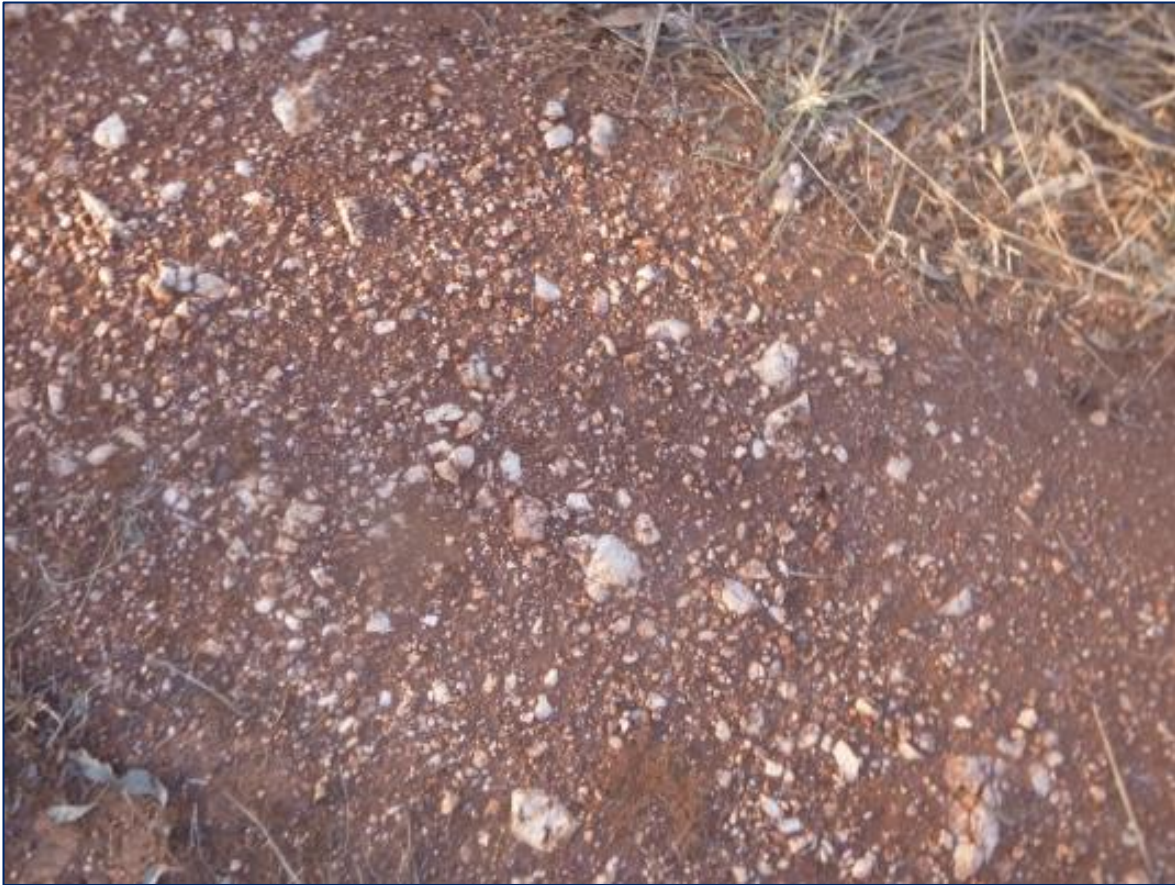
Plate 5: View of quartz gravels present within ploughed paddock
