Richmond Road Upgrade, Elara Boulevard to Clydesdale

Non-Aboriginal Statement of Heritage
Impact (SoHI)

Report to Roads and Maritime
Services

May 2019

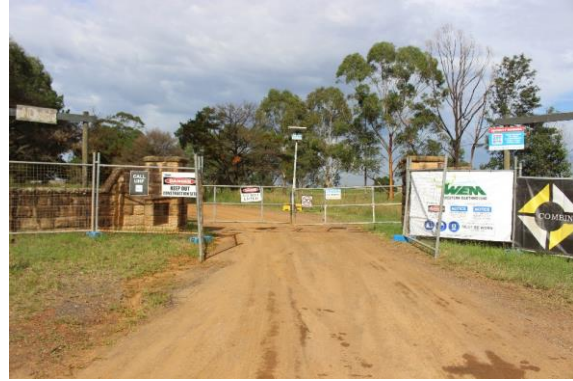
Figure 19. Sandstone Walls and Gate of Clydesdale, western aspect

The current entrance to Clydesdale Estate is located within the study area on the western side of Richmond Road (Figure 18). The entrance is comprised of several components, including a sandstone wall (Figure 19), a timber slatted fence either side of the gateway, a metal gate between the sandstone components, and a metal and barbed wire fence extending along the property boundaries either side of the main entrance. Two symmetrical tall wooden fences are located behind the sandstone wall on either side of the access gate, with the southern fence hanging a sign (heavily damaged) reading '*d Dairie*' but would have previously read 'Associated Dairies' (Figure 20). At the time of the site inspection, several temporary construction fences and company advertisements were present at the front gate in addition to development notification signs from Blacktown City Council.

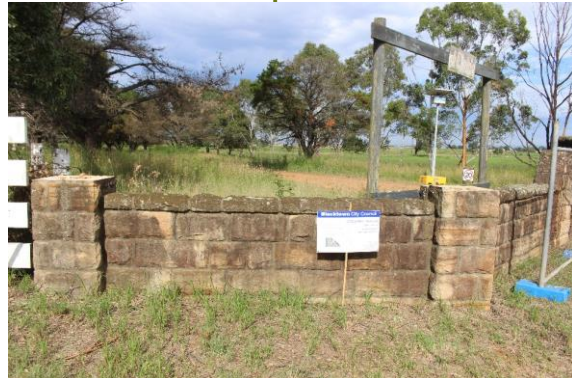
Figure 21. Sandstone wall with coping removed, western aspect

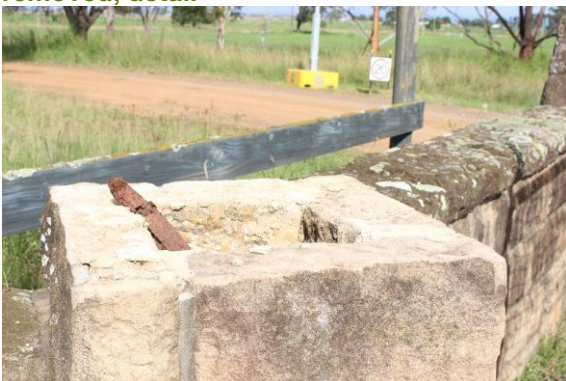
Figure 22. Sandstone wall with coping removed, detail

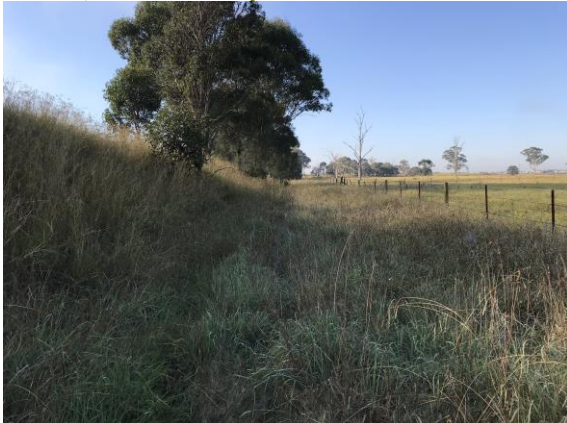
Figure 29. Embankment along Clydesdale Estate, southern aspect

In the northern portion of the study area close to South Creek the road easement consists largely of a large earthen embankment with a shallow drainage ditch running parallel to the base of the embankment (Figure 29 and Figure 30). Two separate drainage points beneath the embankment were observed, both consisting of large modern concrete culverts (Figure 35. View to Clydesdale from road easement, north-western aspect and Figure 36. View to Clydesdale, north-western aspect).

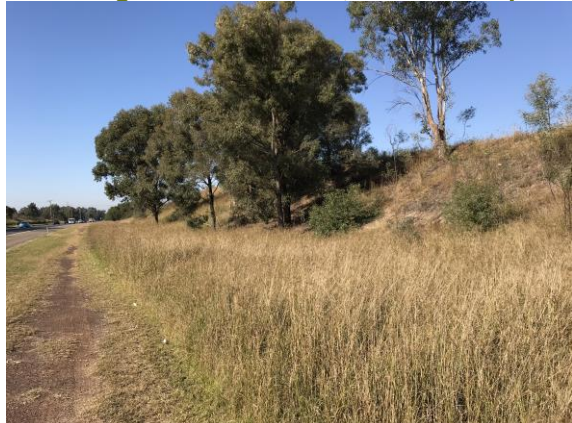
Figure 30. Embankment and drainage ditch brodering Richmond Road, southern aspect

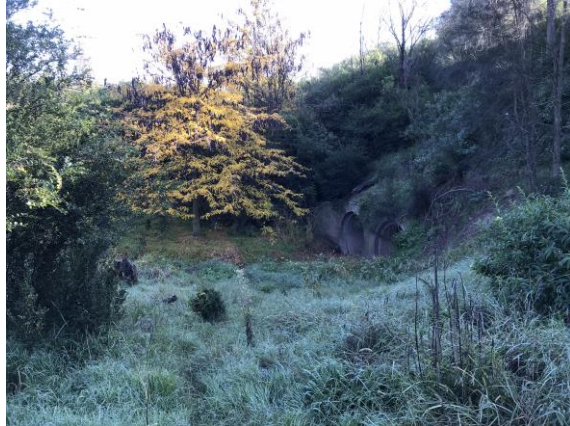
Figure 32. Embankment and culverts under South Creek Bridge, northern aspect

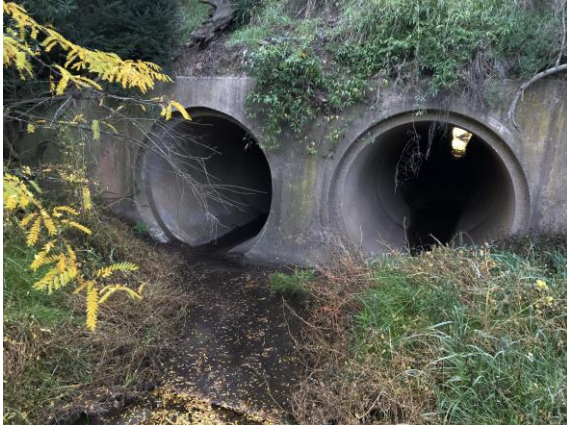
Figure 33. C.1980s culverts beneath Richmond Road, north-eastern aspect

In 1881 the 'Fitzroy Bridge' was constructed to replace the second South Creek Bridge. From 1979 and into the early 1980s the Department of Main Roads (DMR) embarked on a major project to replace the Fitzroy Bridge and as part of that upgrade the section of Richmond Road that crosses South Creek was realigned to become straight, rather than deviating to the northeast between St Phillips Church Cemetery and South Creek.

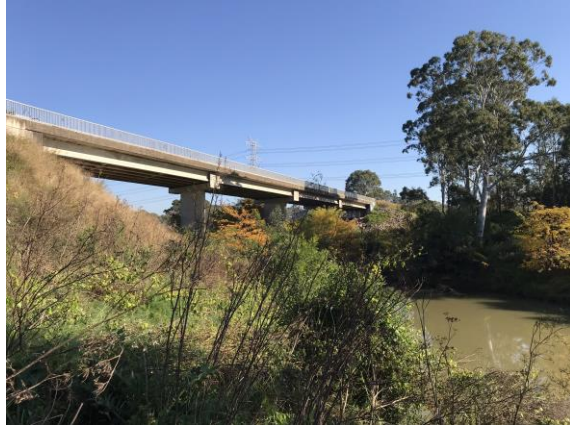
Figure 34. South Creek Bridge from eastern side of Richmond Road, northern aspect

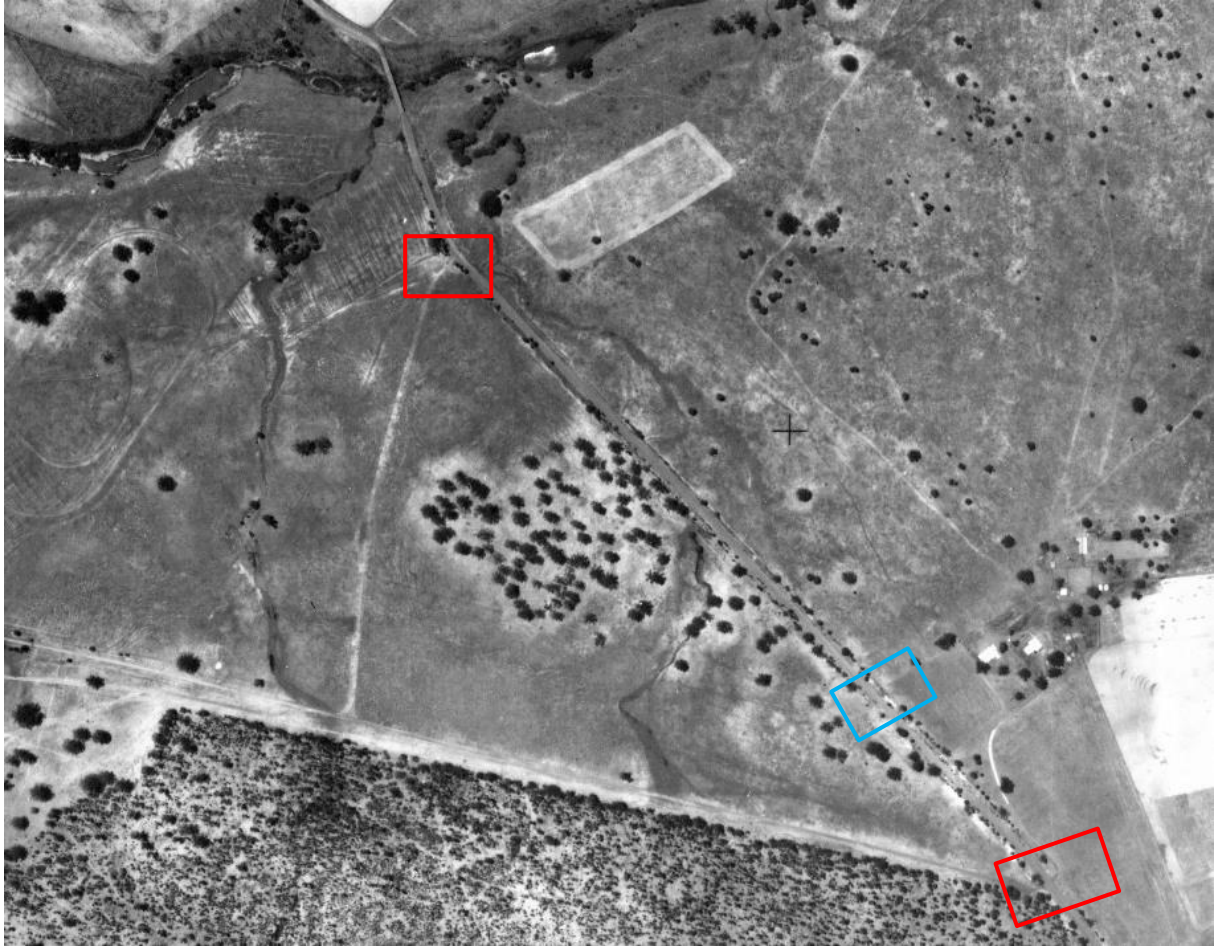
Figure 55. 1947 aerial imagery of Clydesdale and Echo Vale Farm, with the entryways marked in red. The current (1979-present) entryway to both properties is marked in blue.
