**RICHMOND ROAD UPGRADE  
ELARA BOULEVARD TO HERITAGE ROAD**

**Aboriginal Archaeological Survey Report  
Stage 2 PACHCI**

Prepared for Roads and Maritime Services

March 2019

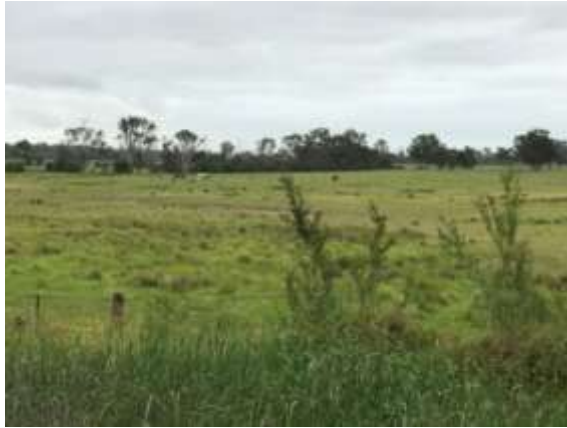
**Plate 1. Survey Unit 1 overlooking MPAS6 (AHIMS 45-5-5003) showing low levels of ground surface visibility and trees bordering South Creek in background.**

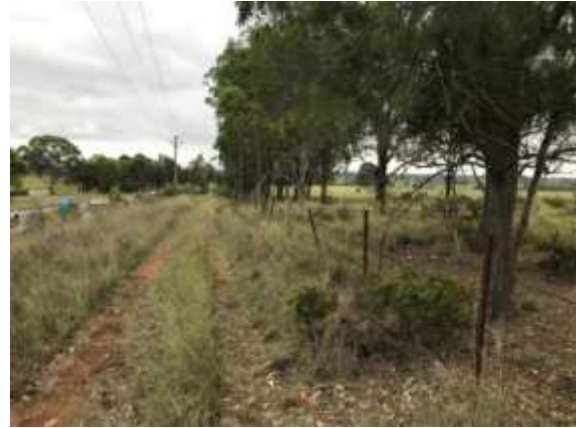
**Plate 2. Survey Unit 1 facing northwest on low crest landform, demonstrating visibility on exposed vehicle tracks and increased vegetation along fenceline.**

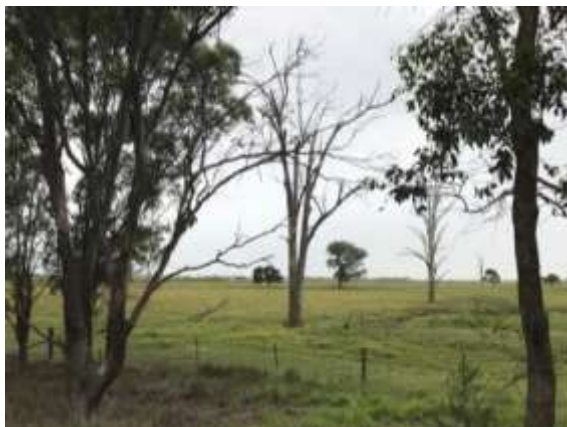
**Plate 3. Survey Unit 1 facing scarred tree C-ST-1 (AHIMS 45-5-2753) (centre).**

The site was revisited during the current archaeological survey and confirmed the location of scarred tree C-ST-1. The site was assessed as being of moderate archaeological significance.

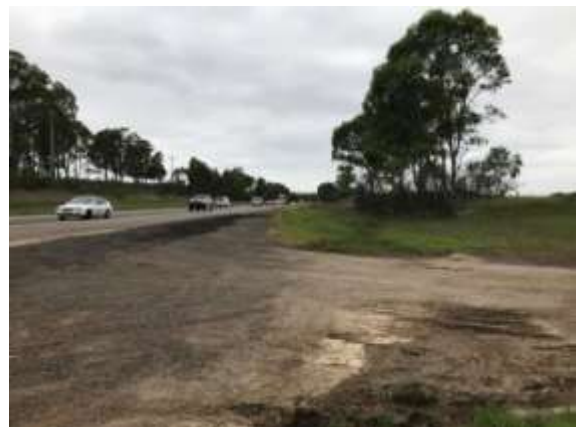
**Plate 4. Survey Unit 1 facing south east demonstrating exposures present on unsealed driveway.**

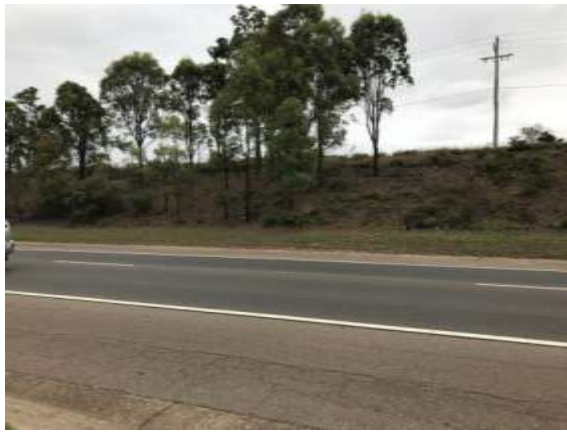
**Plate 5. Survey Unit 1 facing north, showing Richmond Road cut through low ridgeline.**

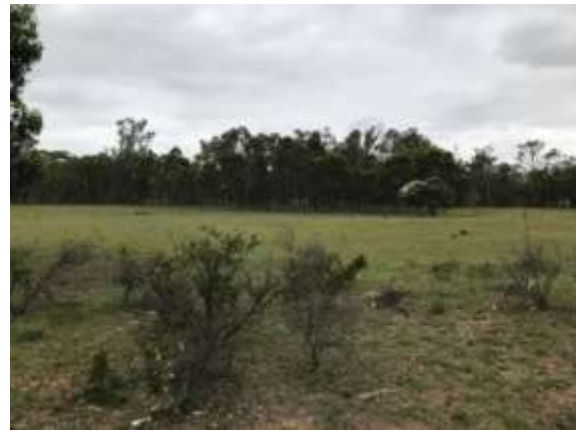
**Plate 6. Survey Unit 2 looking north east towards remnant vegetation along tributary of South Creek.**

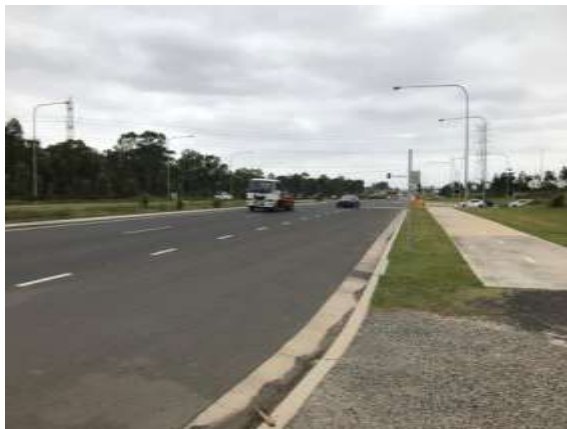
**Plate 7. Survey Unit 2 facing southwest showing disturbance associated with road construction.**

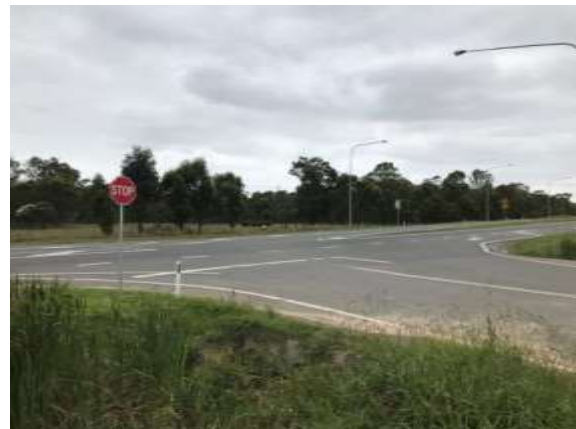
**Plate 8. Survey Unit 2 showing disturbance associated with new intersection. Note increased vegetation north of Richmond Road in the background.**
