**RICHMOND ROAD UPGRADE  
ABORIGINAL ARCHAEOLOGICAL ASSESSMENT**

**Addendum to Stage 2 PACHCI Report**

Prepared for Transport for NSW

Ref. 1943

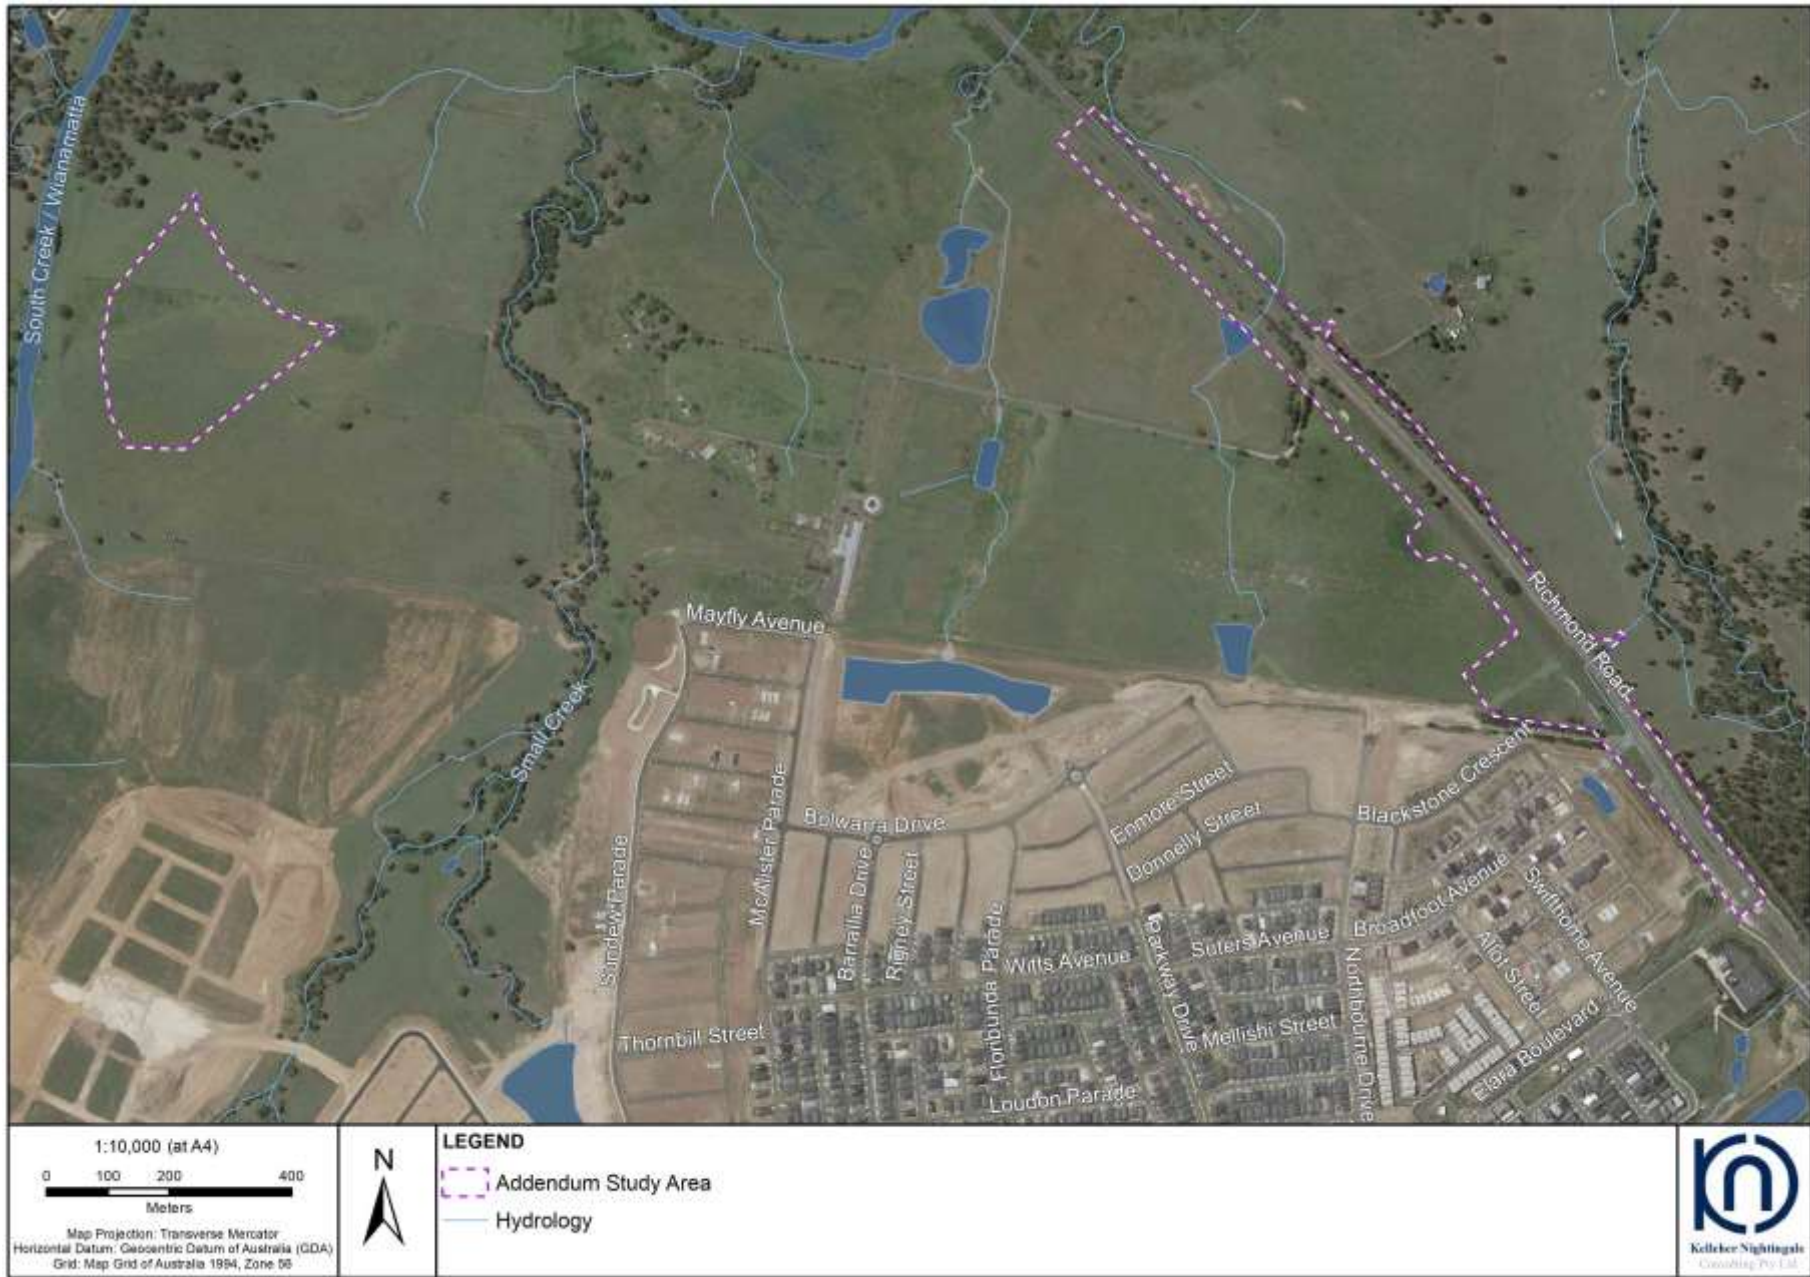
Figure 2. Addendum study area

KNC were engaged by TfNSW to undertake an addendum Aboriginal archaeological assessment for the additional areas and the altered construction footprint along Richmond Road (hereafter referred to as the addendum study area). The location of the addendum study area is shown on Figures 1 and 2.

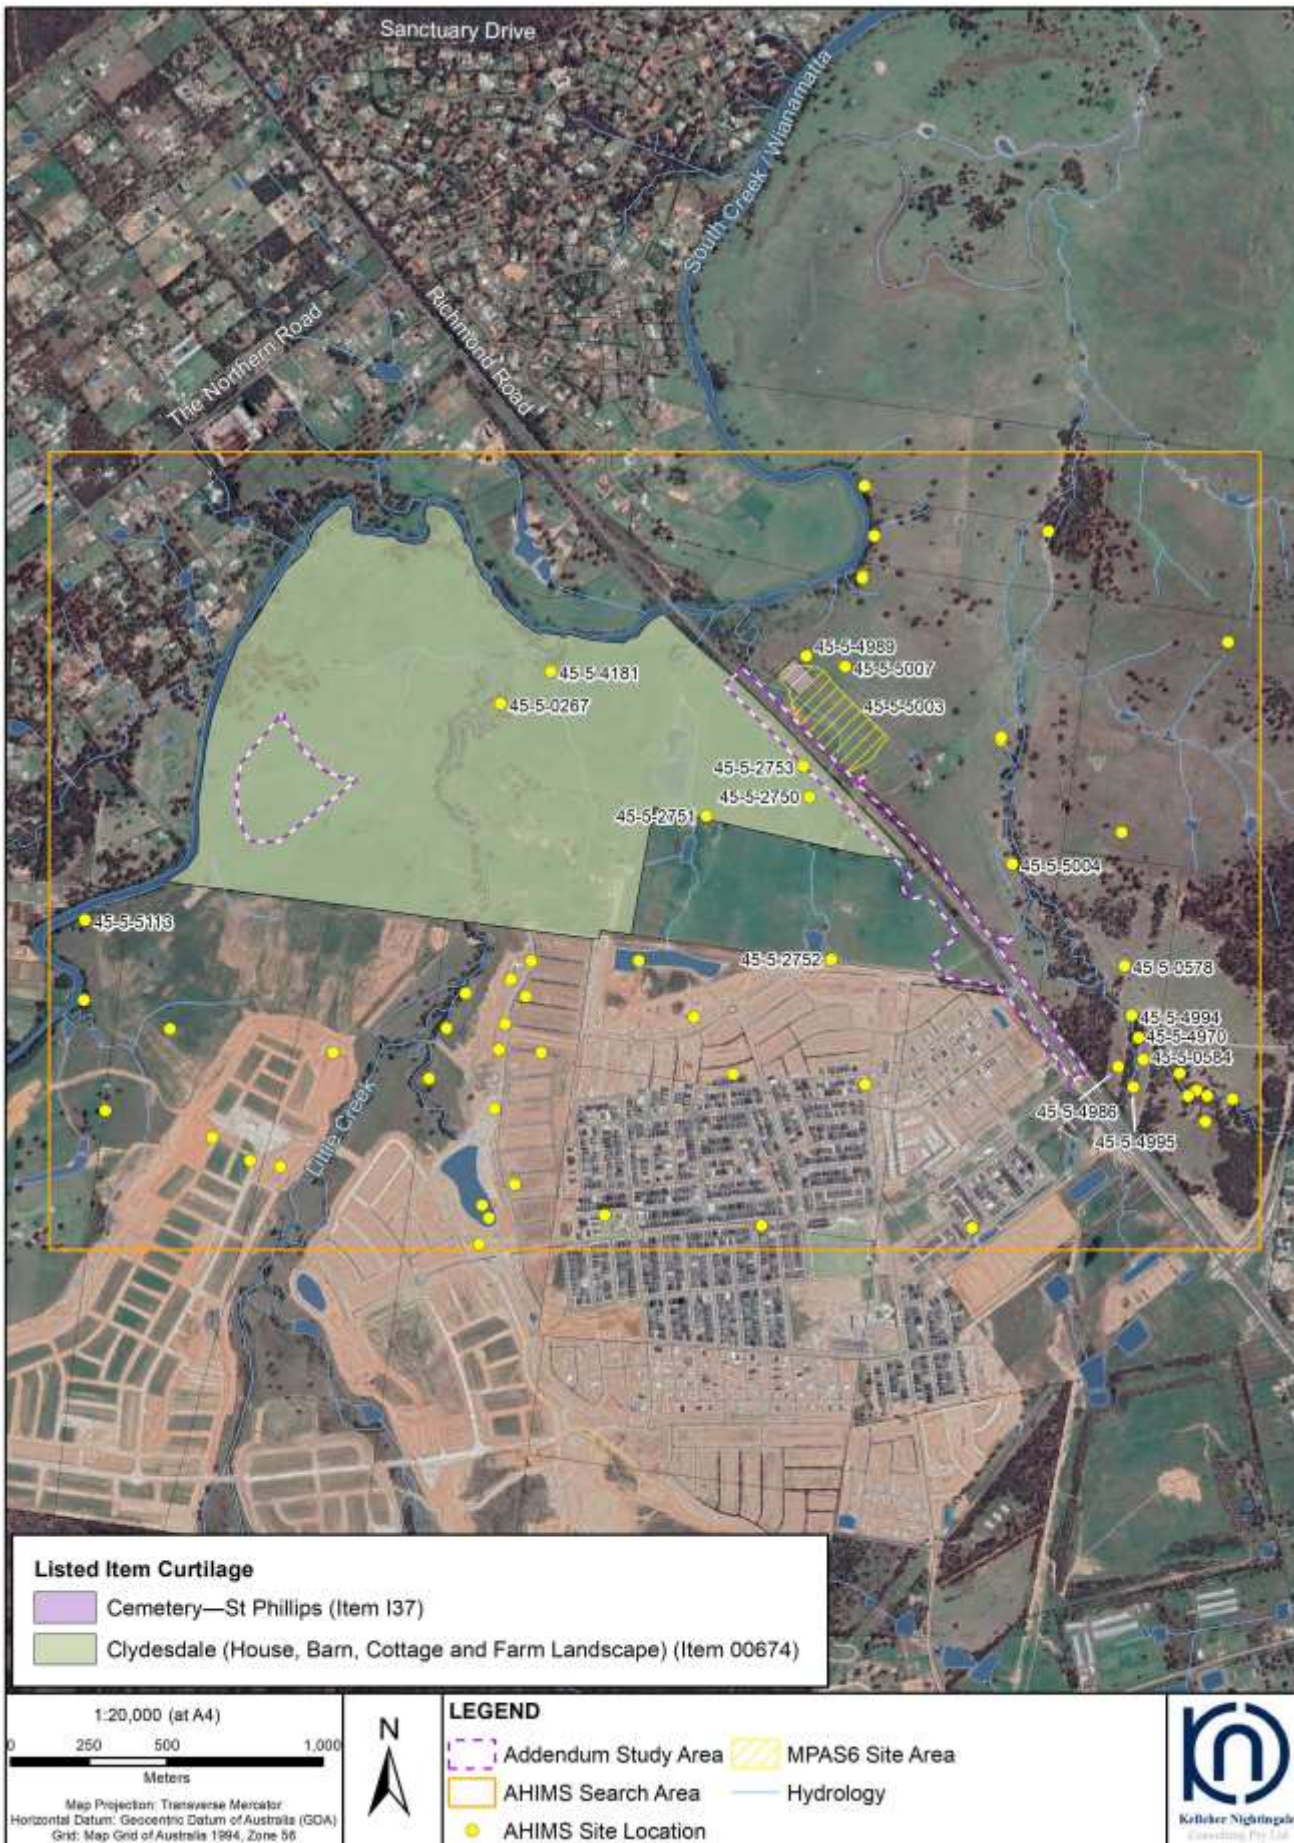
Figure 3. AHIMS search results for the addendum study area

The distribution of recorded Aboriginal sites within these coordinates is shown on Figure 2. The frequencies of site types (site context/features) within the AHIMS database search area are listed in Table 1.

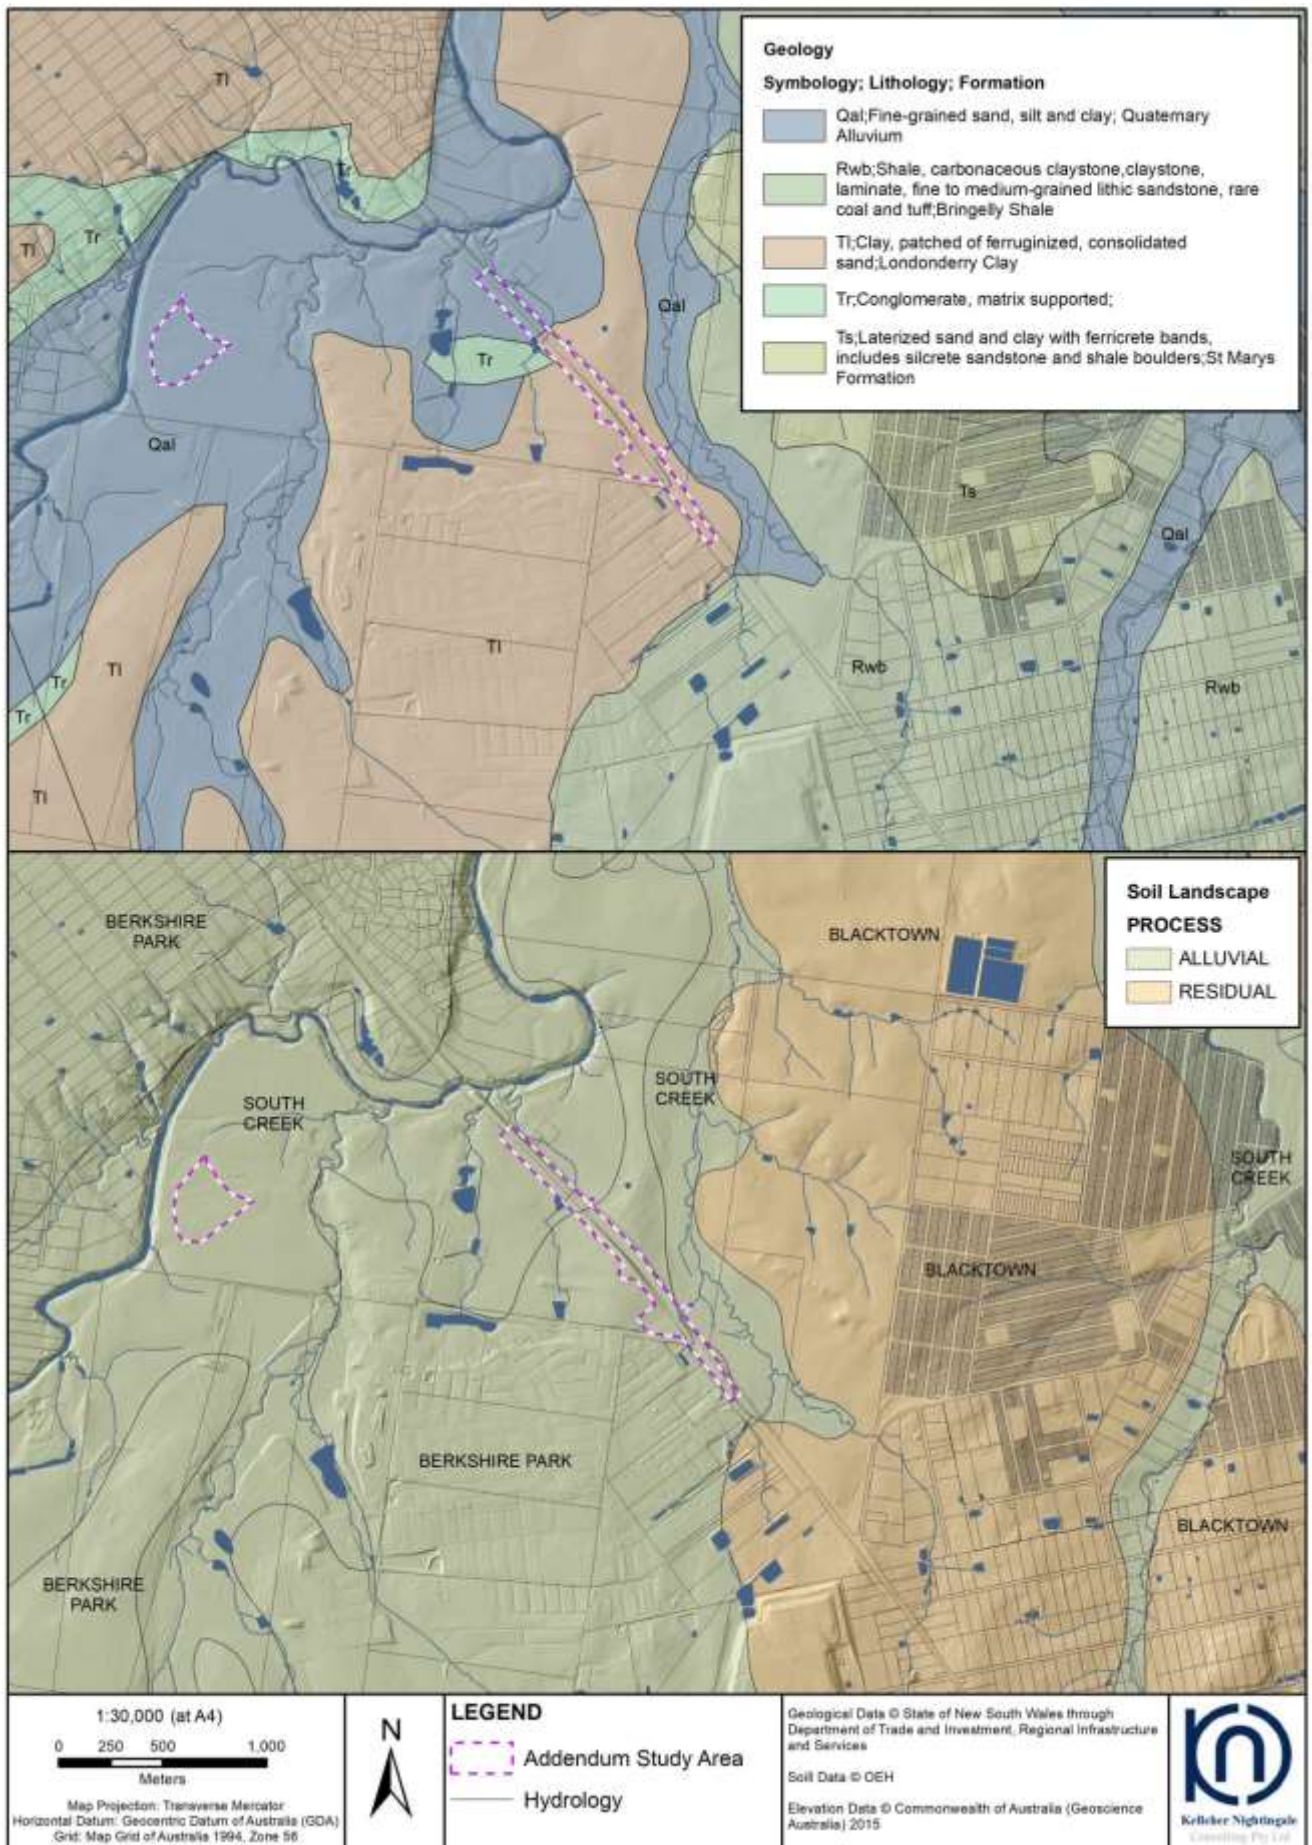
Figure 4. Soils and geology of the addendum study area

The underlying geology of the study area comprises three units associated with the South Creek floodplain (Figure 5). Quaternary Alluvium is a relatively recent deposit of fine-grained sands, silts and clays. Quaternary alluvial deposits across the Cumberland Plain occur in association with more permanent waterways and cyclical episodes of fluvial erosion and deposition, in this case occurring along South Creek and associated floodplain. Fluvial activity during the Tertiary Period resulted in the deposition of gravels and finer sediments called Londonderry Clay. Londonderry Clay is present across the majority of the study area. The Londonderry Clay consists of mottled red-grey, moderately to highly plastic clay with sandy lenses and iron-cemented sand clay aggregates. Patches of ferruginized consolidated sand are also present and influence the soil deposits within the study area. Exposed deposits of Rickabys Creek gravels are noted within the vicinity and often associated with Aboriginal archaeological sites as they were exploited for the quality stone material consisting of chert and silcrete.

Soils within the addendum study area are related to the underlying geology and topography. The South Creek soil profile can be found along the floodplain of South Creek and its associated tributaries. The South Creek soil landscape is characterised by deep to very deep alluvial sediments, loams and clays, susceptible to erosion and frequent flooding. In general, the South Creek soil profile of the study area matches the distribution of the Quaternary Alluvium. Moving away from the floodplain of South Creek, the Berkshire Park soil profile can be found in the elevated central portion of the study area. Berkshire Park soils are characterised by often mottled orange heavy clays and clayey sands with ironstone nodules throughout. The Berkshire Park soil profile is associated with both the Rickabys Creek Gravel and the Londonderry Clay geologic formations.

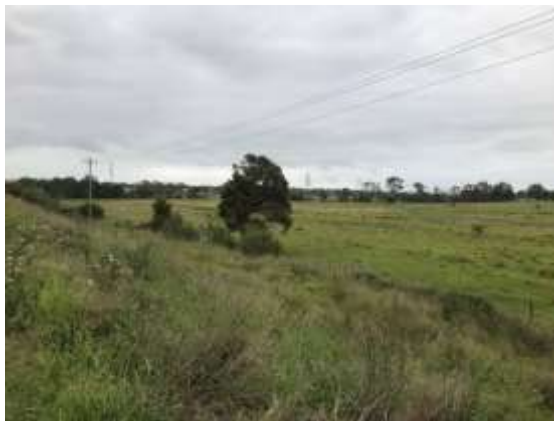
Particular attention was paid to the site location for previously registered artefact scatter MPAS6 (AHIMS 45-5-5003) to determine the exact location of the previously identified site boundary. The site location was revisited and inspection confirmed that the site did not extent into the addendum study area and will not be impacted by the proposed works.

**Plate 1. View facing north, showing ground surface modification and filled sloping road embankment to fenceline (left) with location of AHIMS site MPAS6 in background(right).**

No Aboriginal archaeological objects/sites or areas of archaeological potential will be impacted by the proposed works within the addendum study area. The location of the identified archaeological sites (Figure 4) should be avoided by all pre-construction and construction activities. MPAS6 (AHIMS 45-5-5003) and C-ST-1 (AHIMS 45-5-2753) should be demarcated on the CEMP, temporary fencing may be appropriate along the project boundary at these locations to ensure no inadvertent impacts.

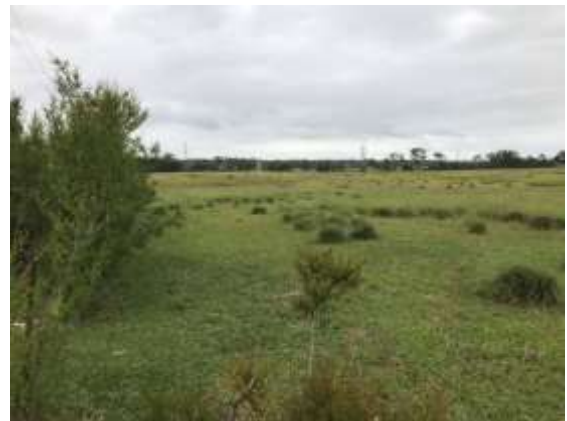
**Plate 2. View north across AHIMS site MPAS6 within paddock north of the Richmond Road corridor, along boundary of addendum study area.**

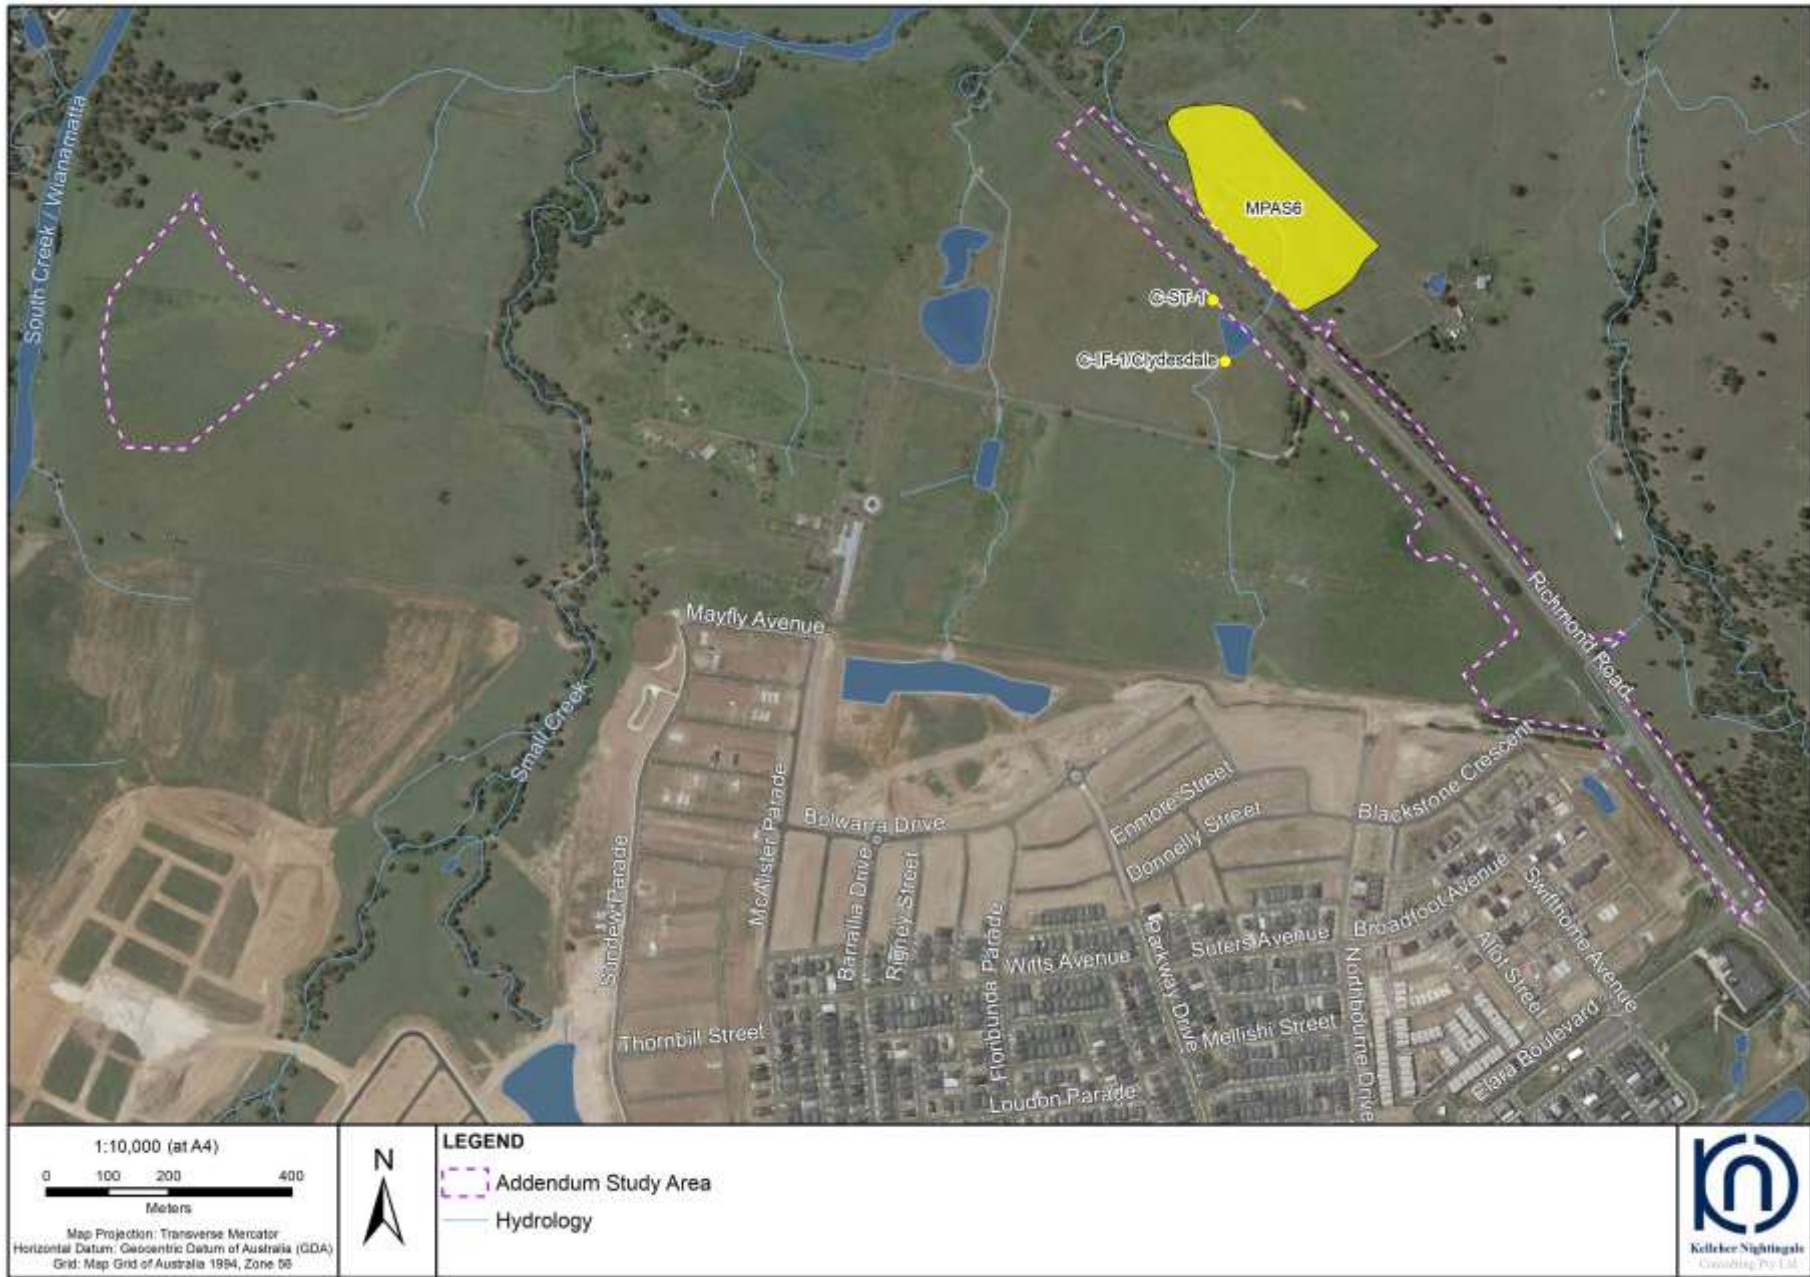
Figure 5. Survey results showing Aboriginal heritage bordering the addendum study area

One previously registered AHIMS site (MPAS6) was identified immediately north of the current addendum study area along Richmond Road. Previously registered site C-ST-1 (AHIMS 45-5-2753) was identified within close proximity to the addendum study area. Inspection of the site area boundary and the addendum study area boundary confirmed that MPAS6 (AHIMS 45-5-5003) did not extend into the addendum study area which encompassed the disturbed road verge.

The inspection found that the addendum study area had been extensively altered by ground surface disturbance related to road construction, drainage and utilities, reducing the likelihood of Aboriginal objects or intact archaeological deposit to occur. Desktop assessment and survey confirmed that the addendum study area displayed no potential for intact archaeological deposits.
