Northern Beaches Hospital Connectivity and
Network Enhancements Project:
Ecological Monitoring Program Implementation 2016/17

FINAL REPORT

Prepared for Ferrovial York Joint Venture

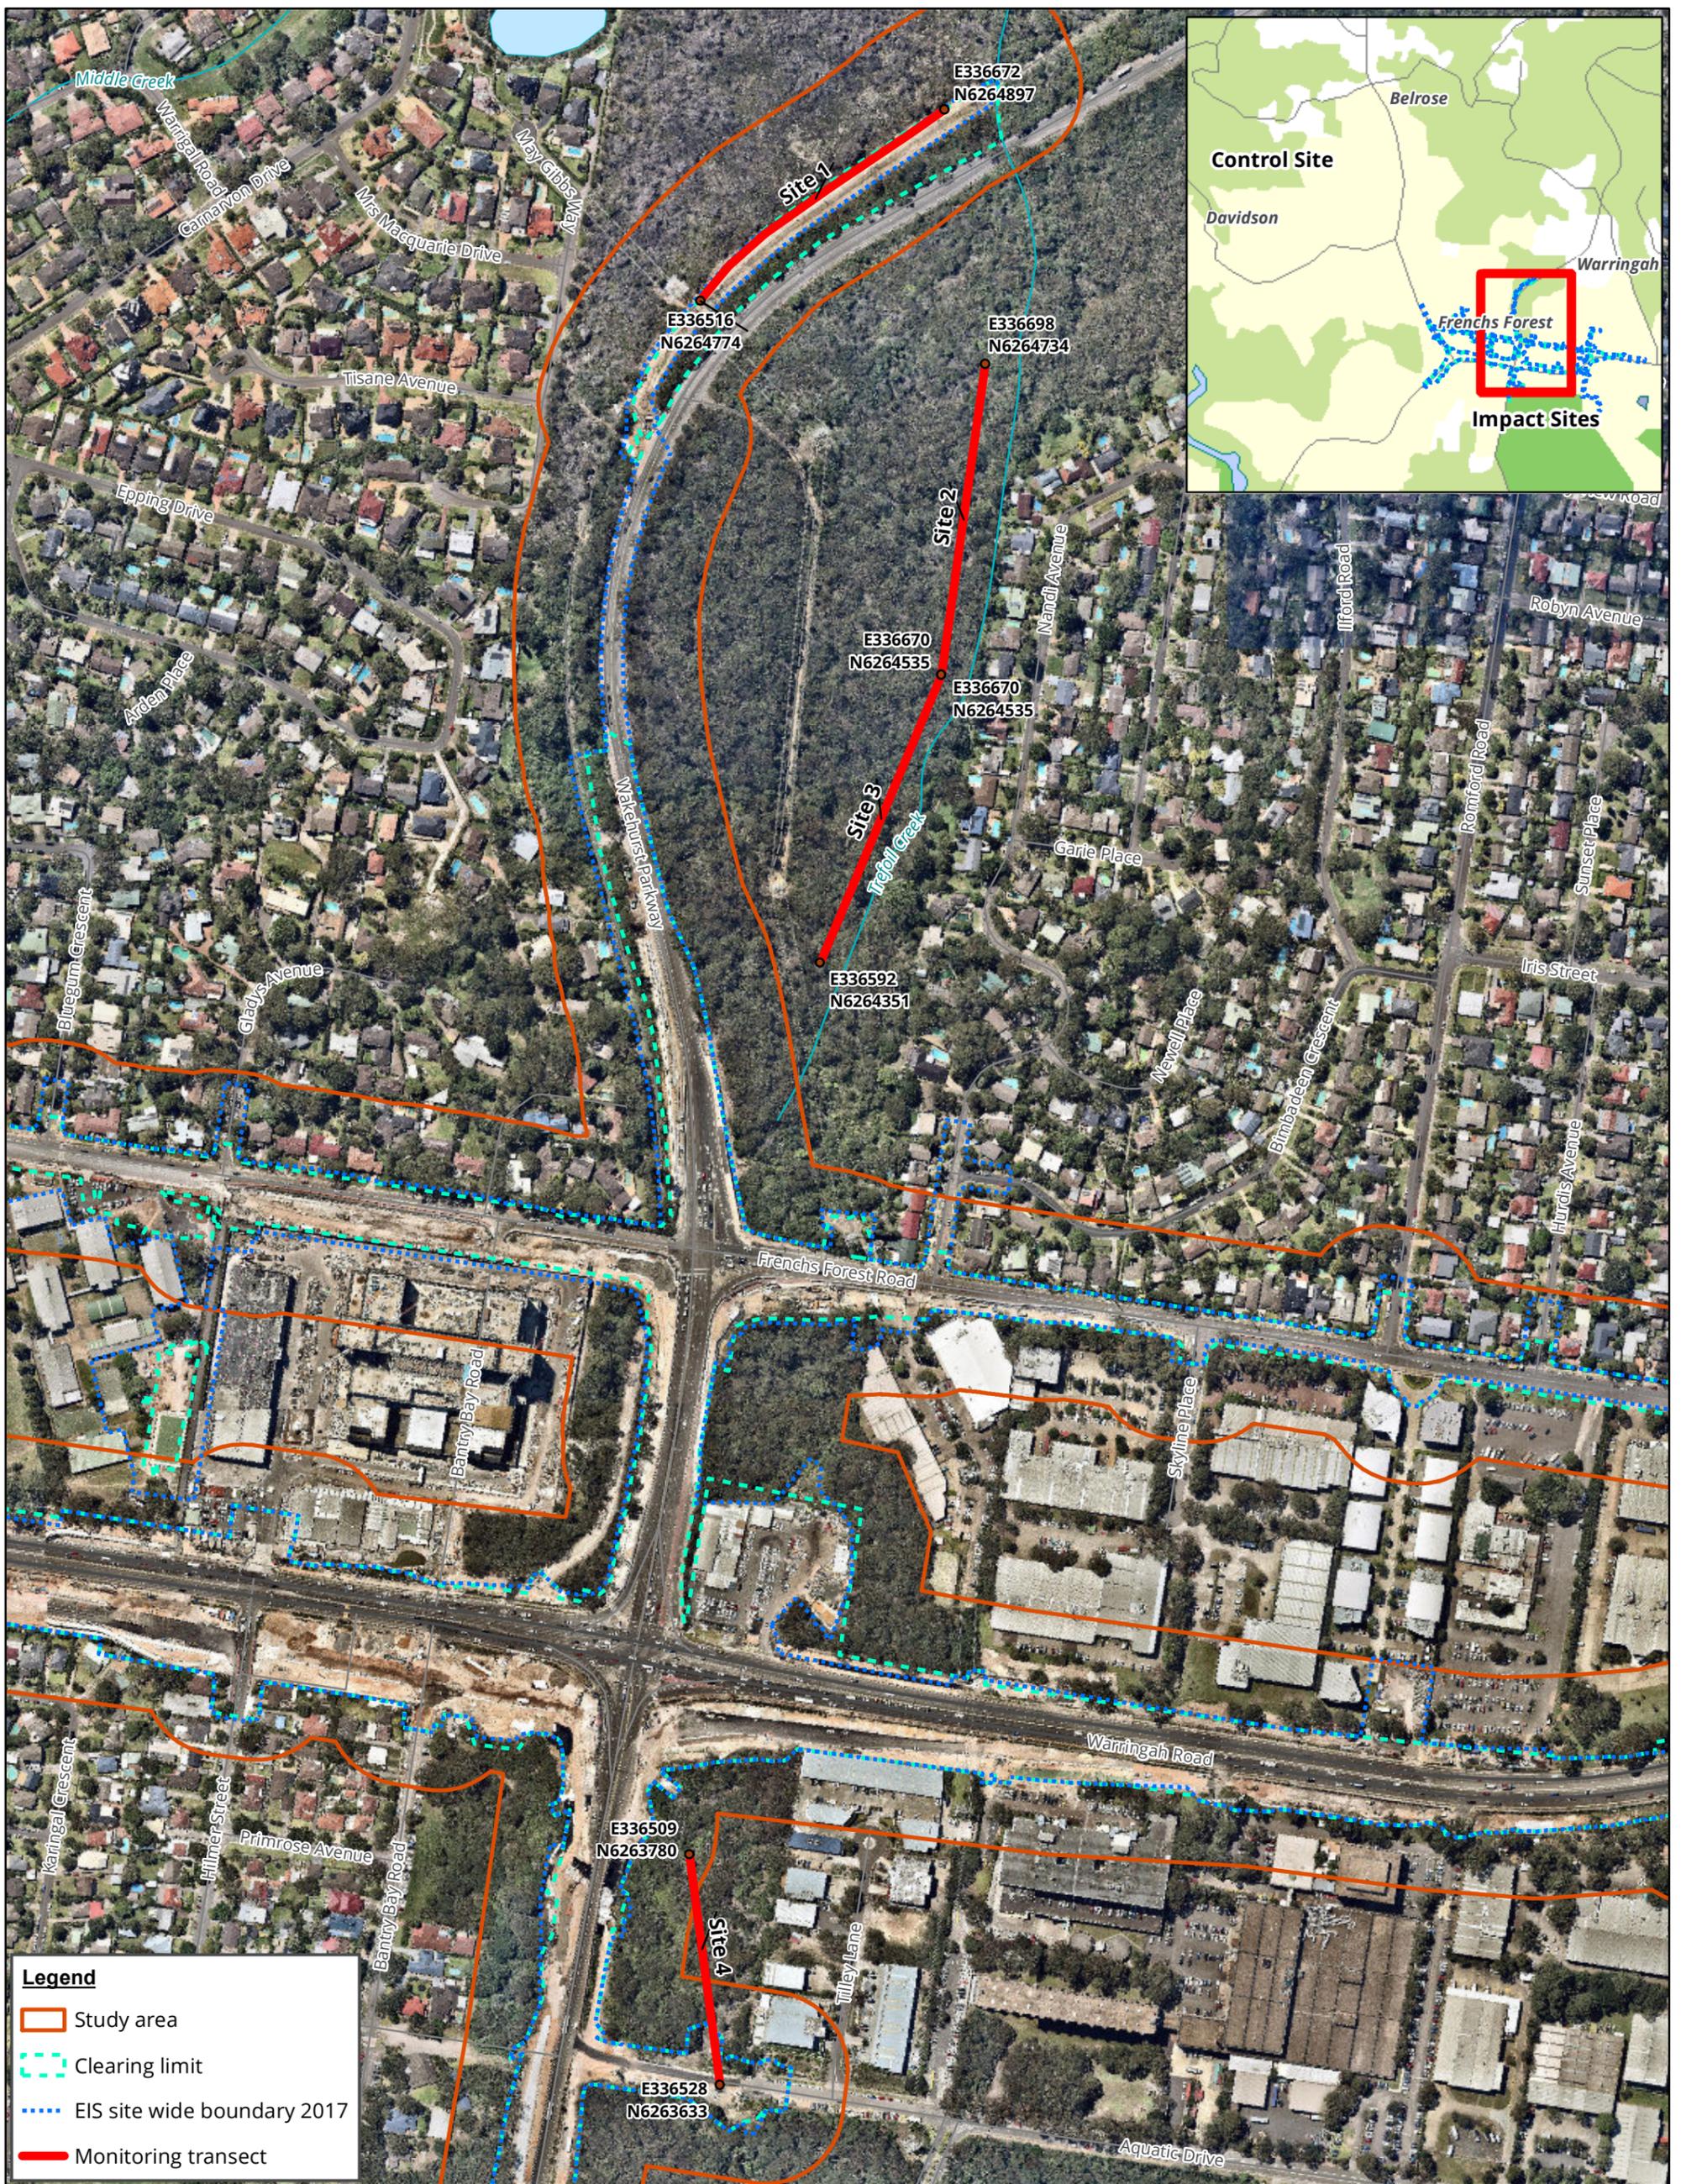
Figure 2a: Red-crowned Toadlet Monitoring Sites (Impact)

Red-crowned Toadlet surveys for the spring 2016 and autumn 2017 monitoring periods were undertaken at a total of six monitoring sites, including four impact sites and two control sites. The locations of all survey sites are shown in Figure 2.

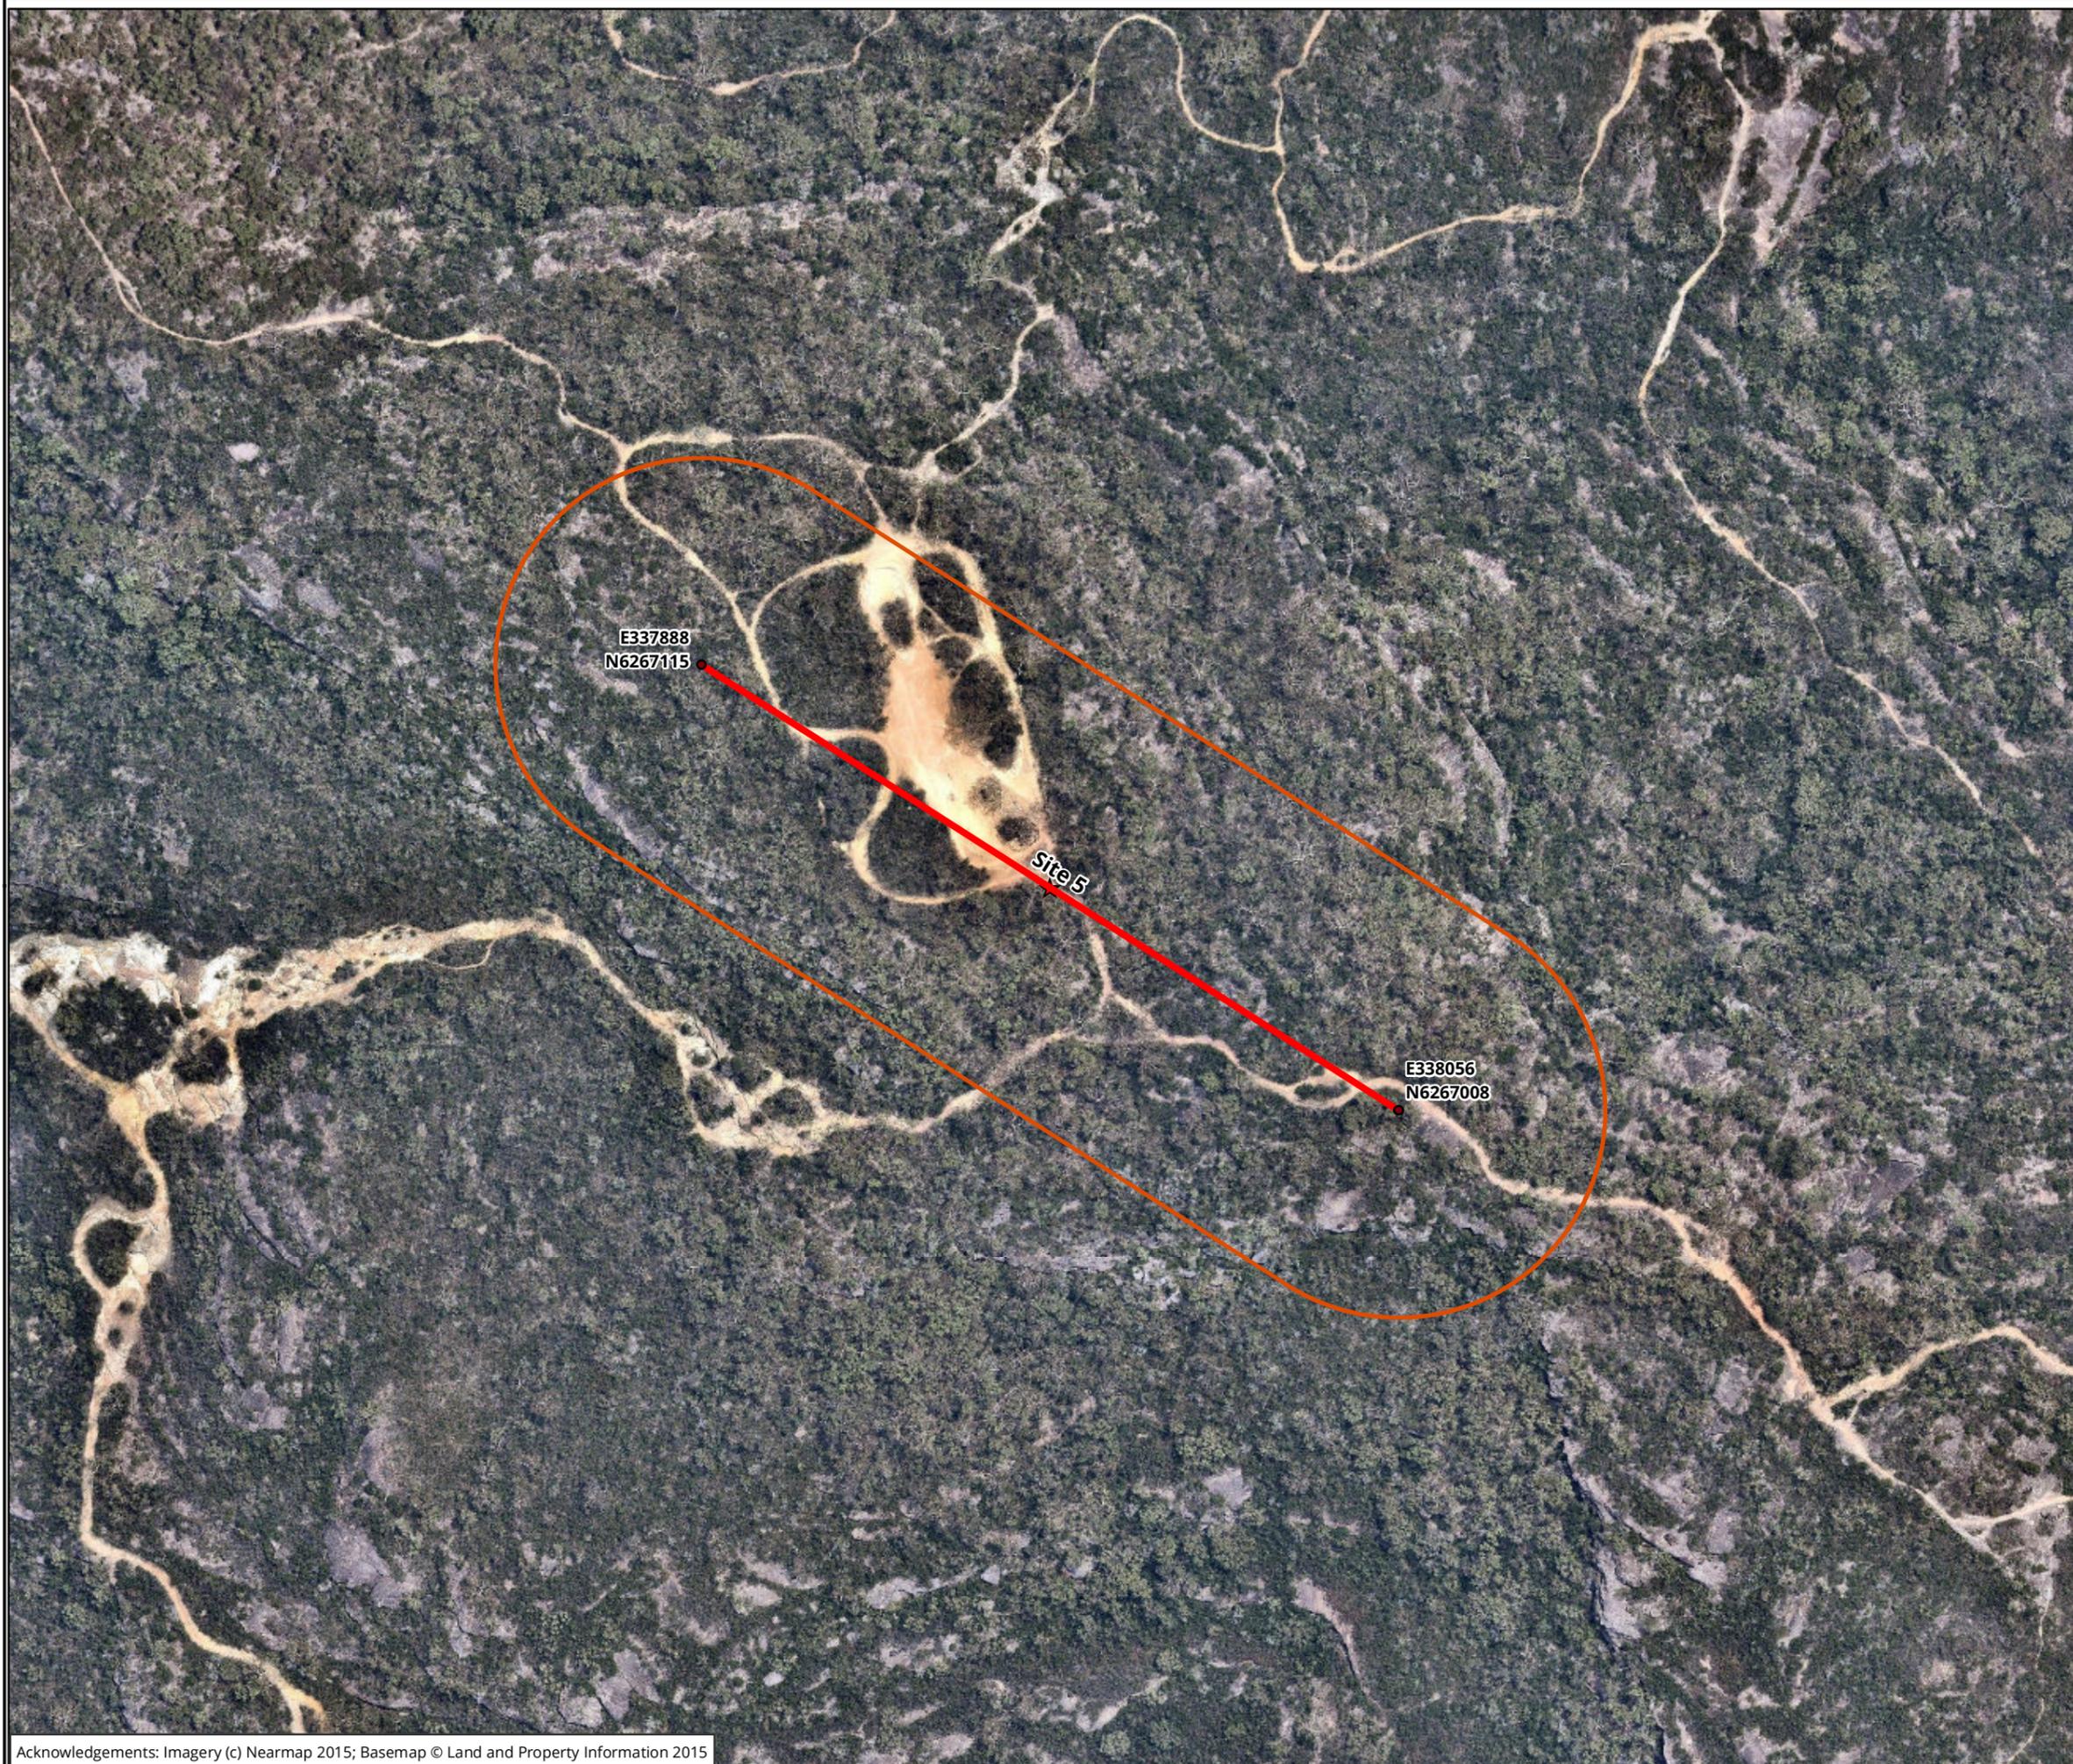
Figure 2b: Red-crowned Toadlet Monitoring Sites (Control - Site 5)

- Study area
- Monitoring transect

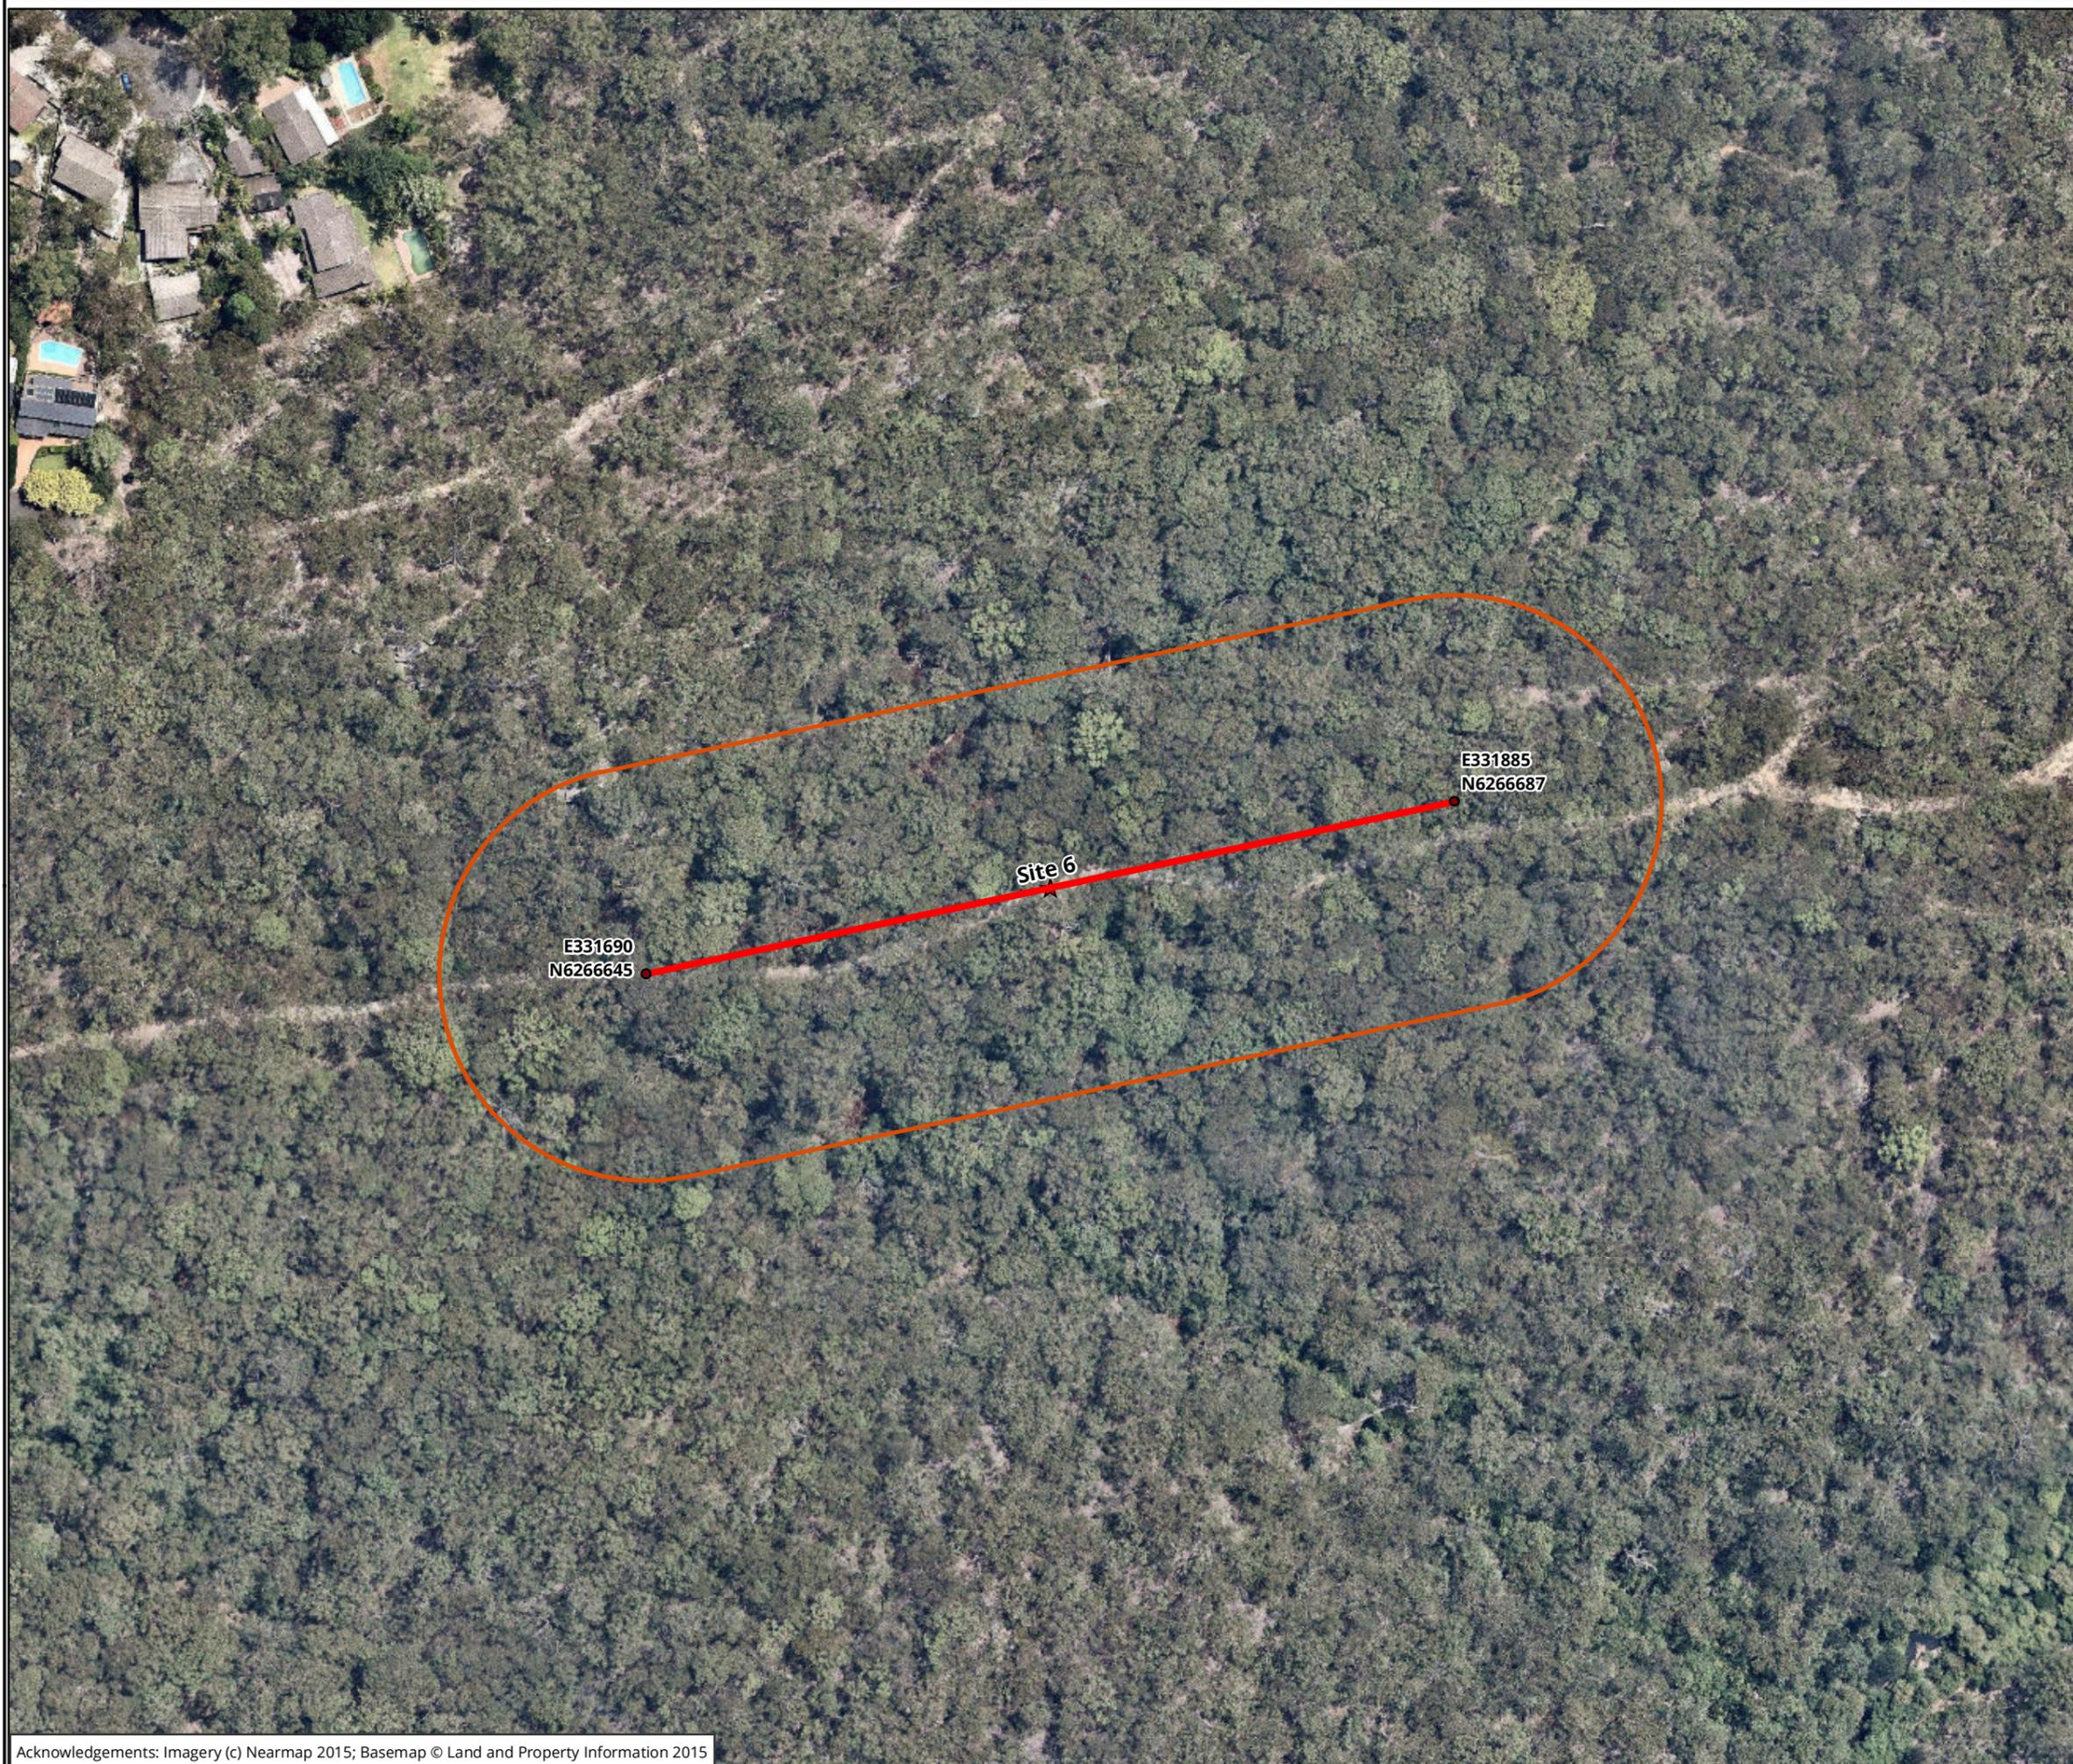
Figure 2c: Red-crowned Toadlet Monitoring Sites (Control - Site 6)

Monitoring transect

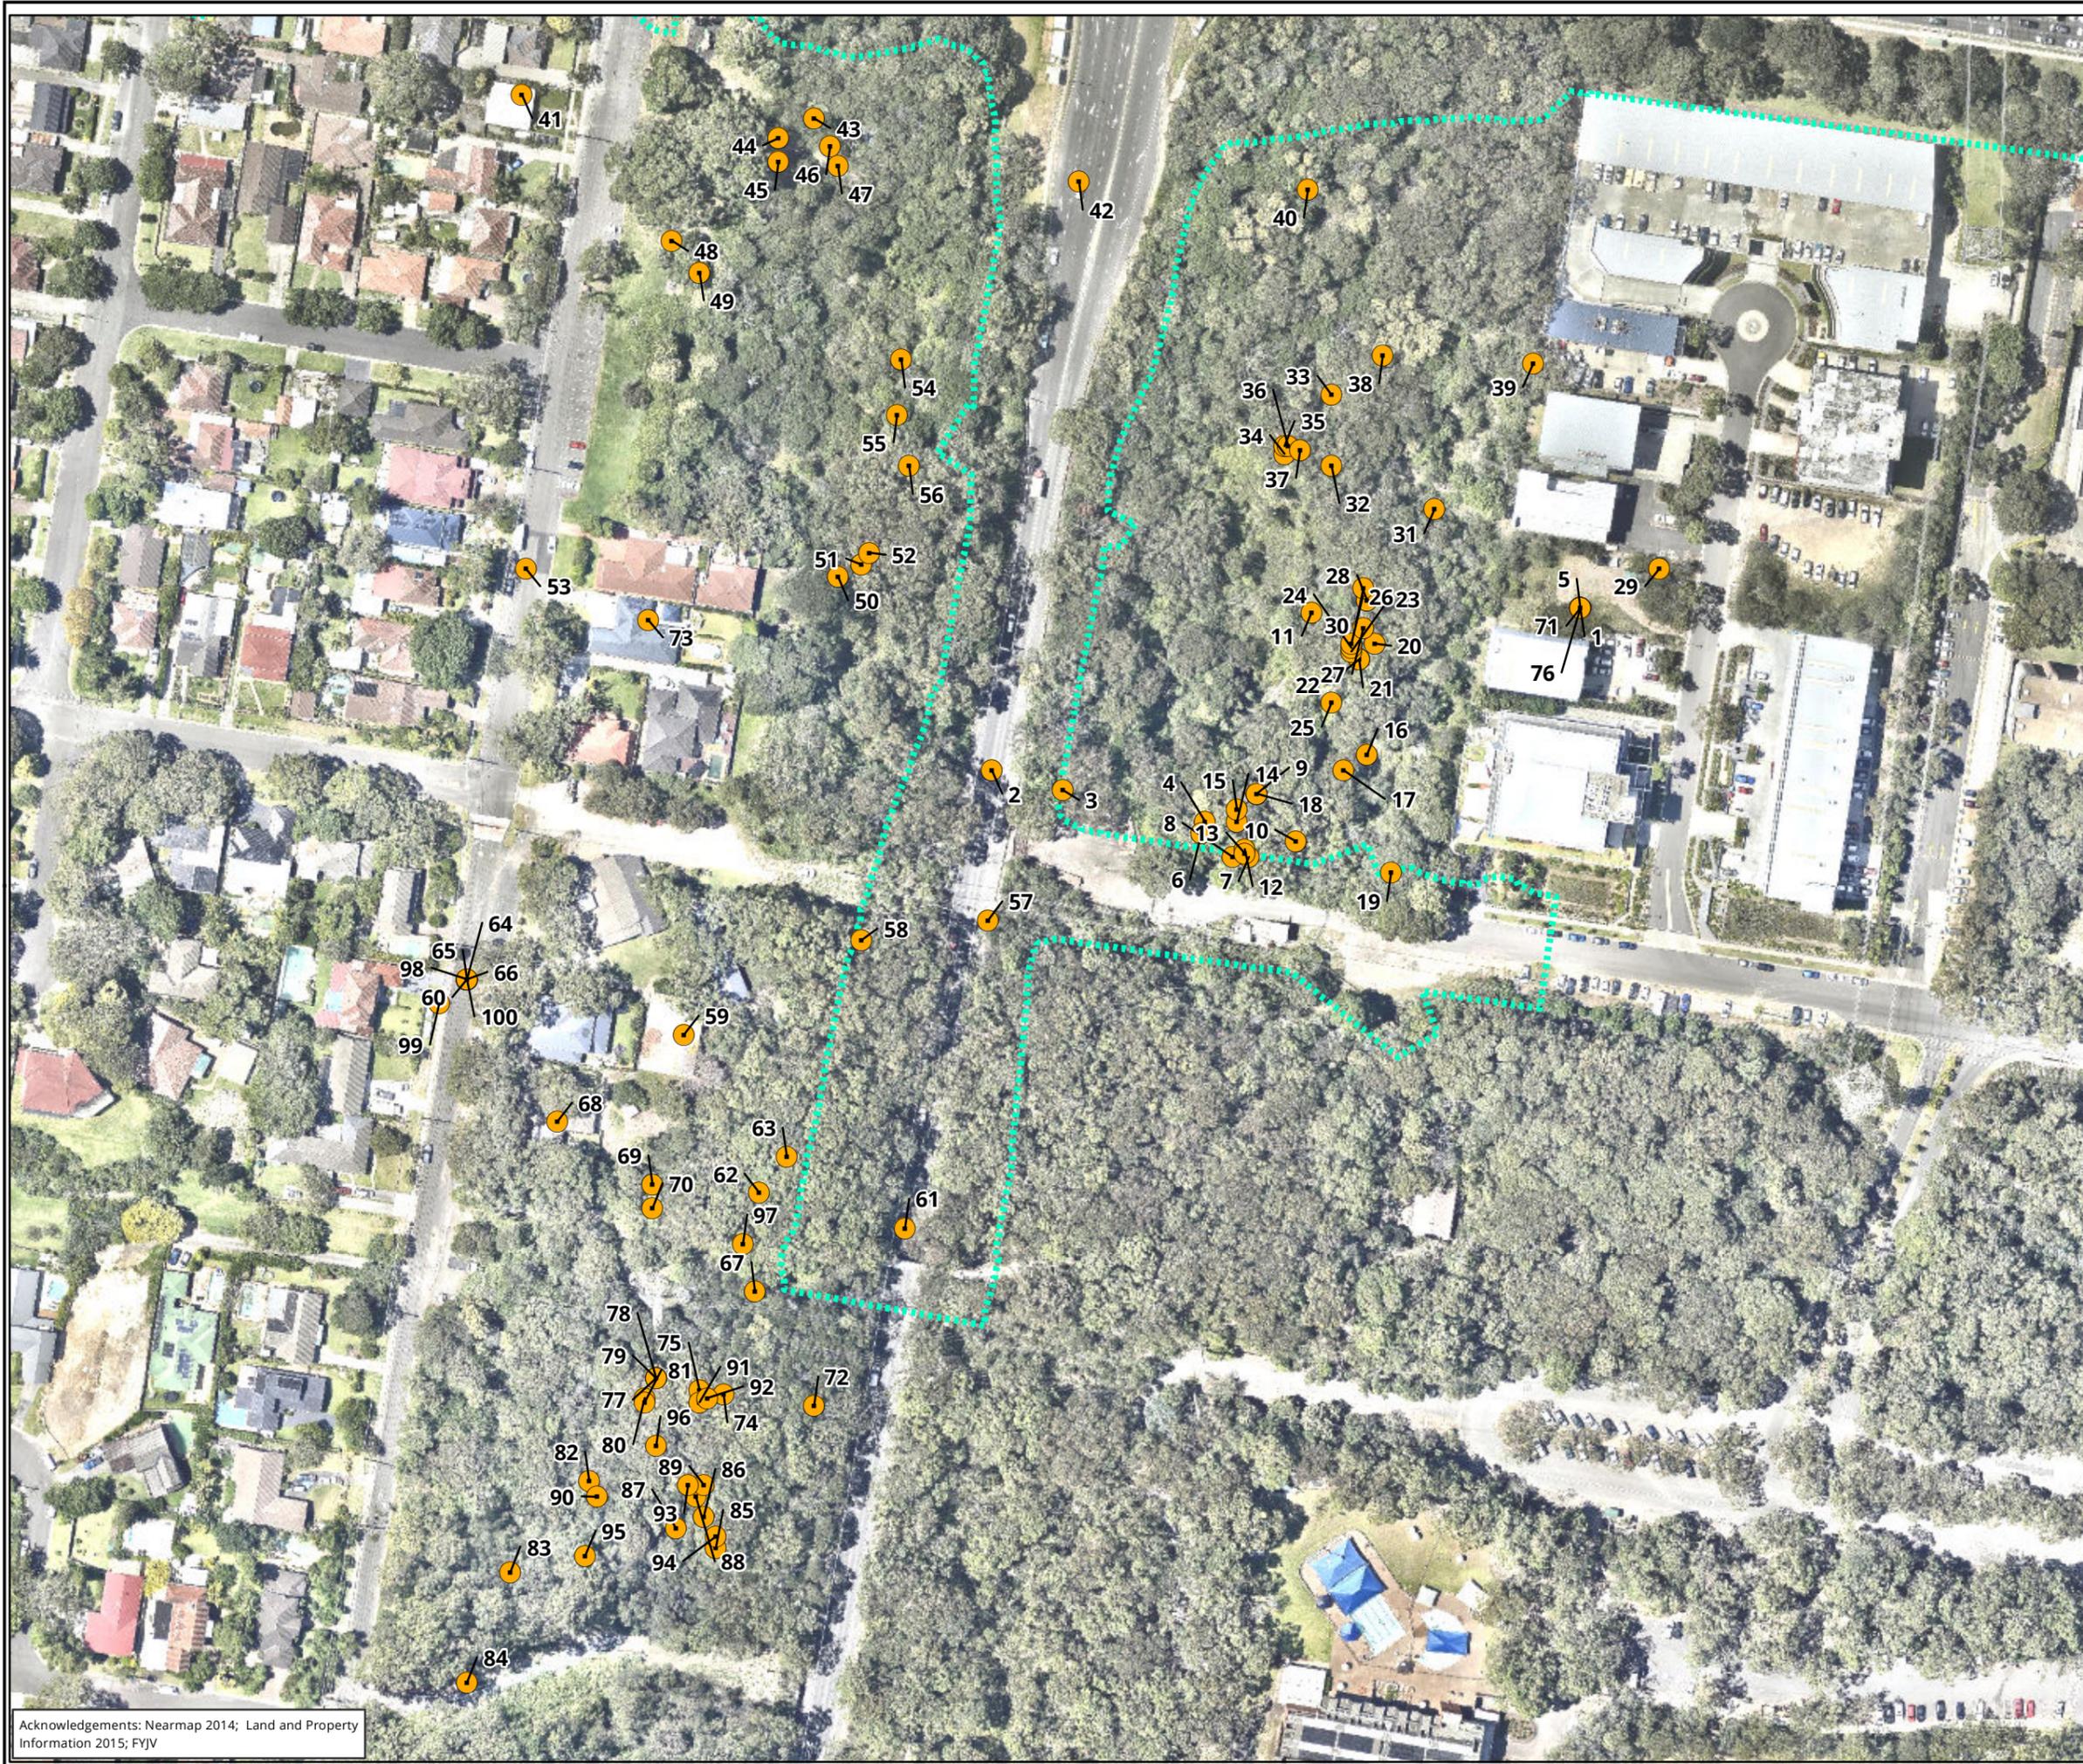
Figure 1: Nestbox locations

Monitoring data from the 144 total boxes monitored has been collated following inspections and is provided in Table 5. The location of the trees utilised for the nest boxes is provided in Figure 3.
