# Clarence River Crossing

## Construction Compliance Report

*Report 3*

*18 October 2017 - 17 April 2018*

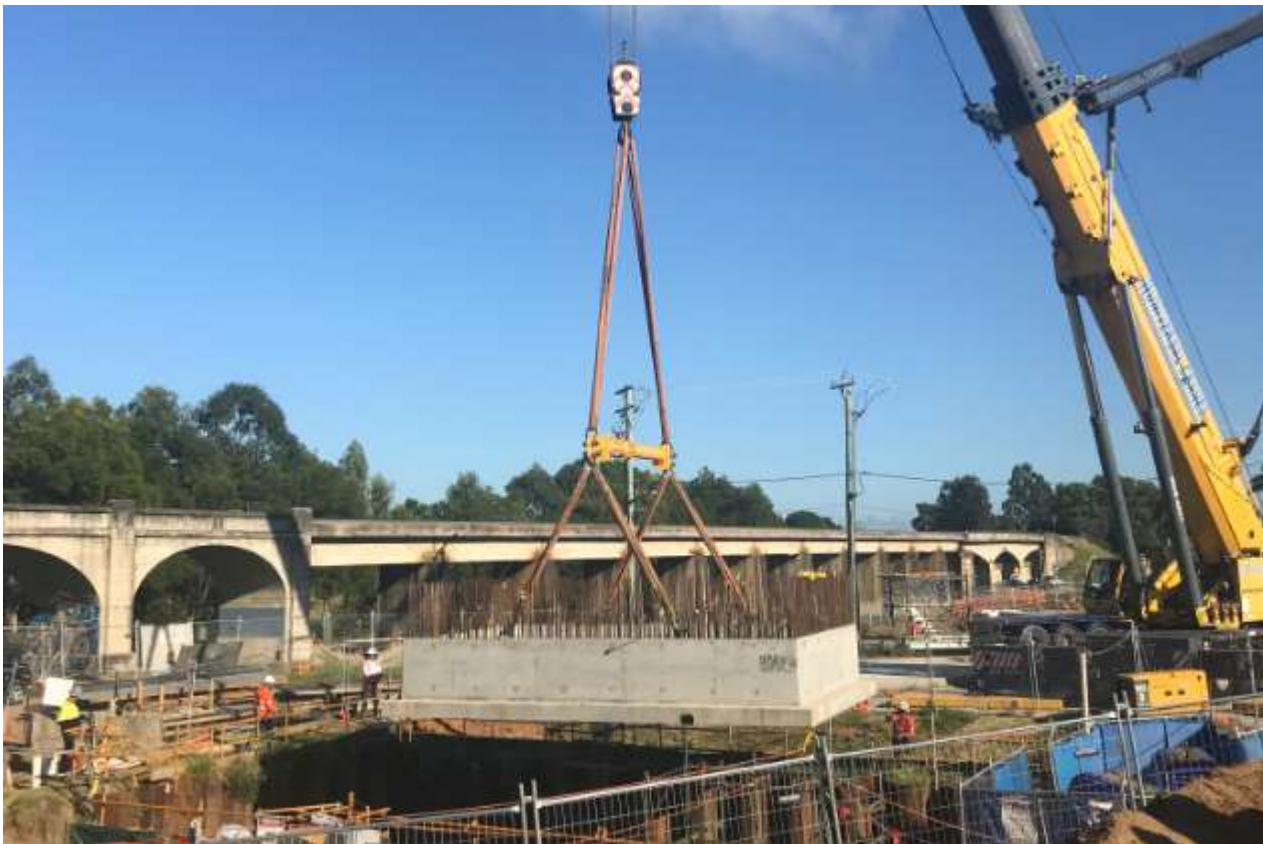
*Figure 1 Pump station being lifted into place at Kent Street*

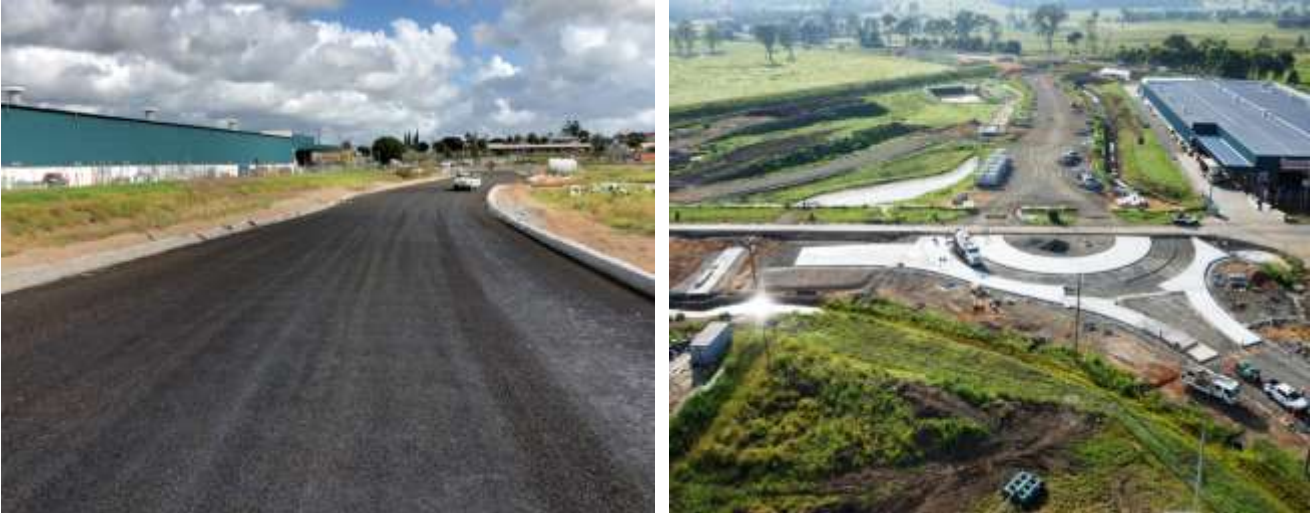
Figure 2 Seal and subsoils place on fill 2 (left) and construction of the new roundabout at Iolanthe and Through Street (right)

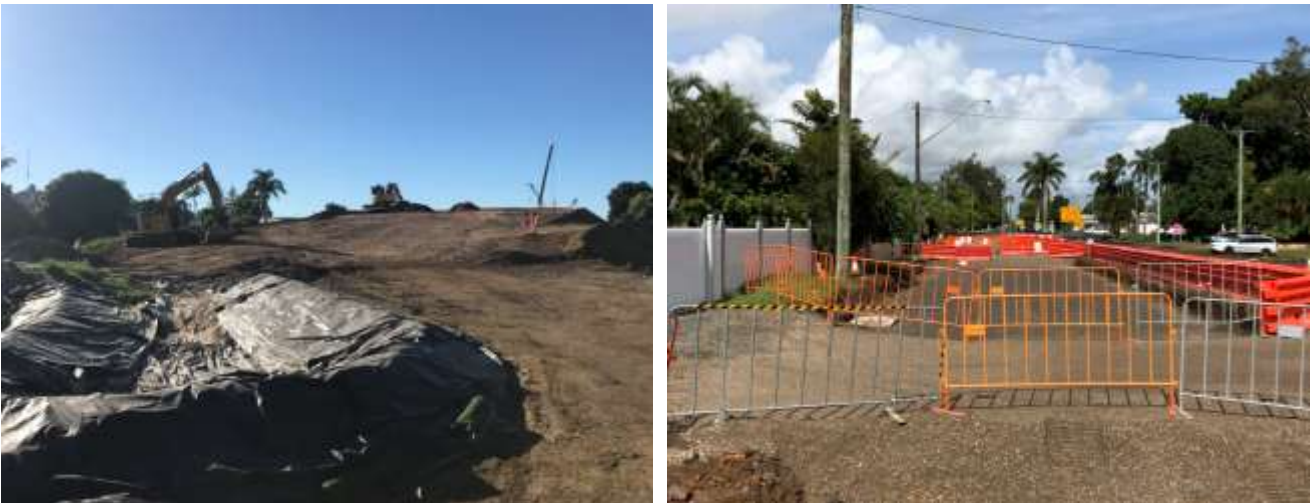
Figure 3 Fill placed at abutment B to pre-load level (left) and upgrades to local roads, Clarence Street, in Grafton being undertaken (right)

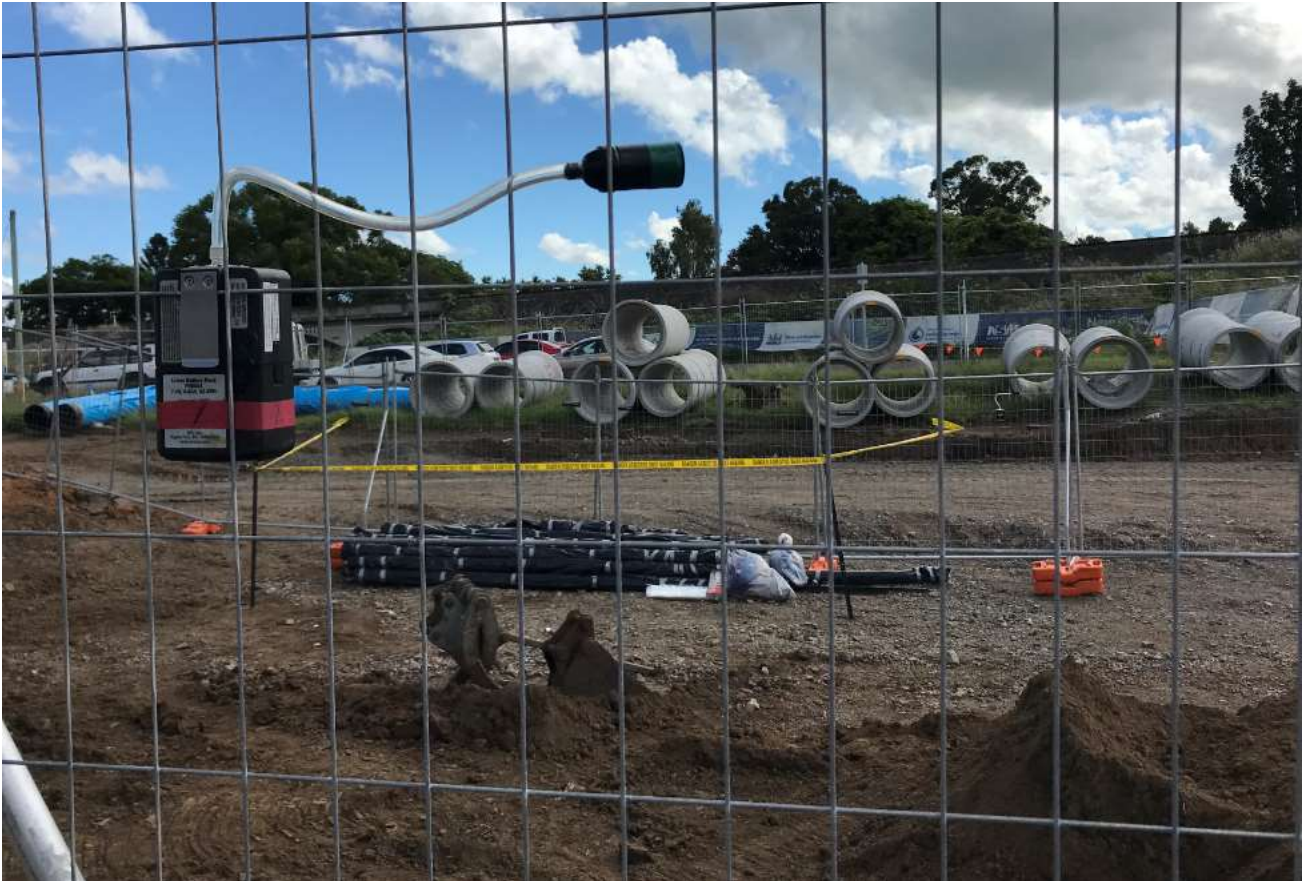
- Asbestos water mains were removed from under the pavement in Pound Street
- Asbestos conduits for the communications services were removed ahead of the new stormwater line which lies on the same alignment
- Asbestos Telstra pits were removed during the communications relocation works

*Figure 4 Removal of asbestos pipes from Pound Street, photo shows the pipes wrapped, exclusion zone around the area and air monitoring device on the fence*

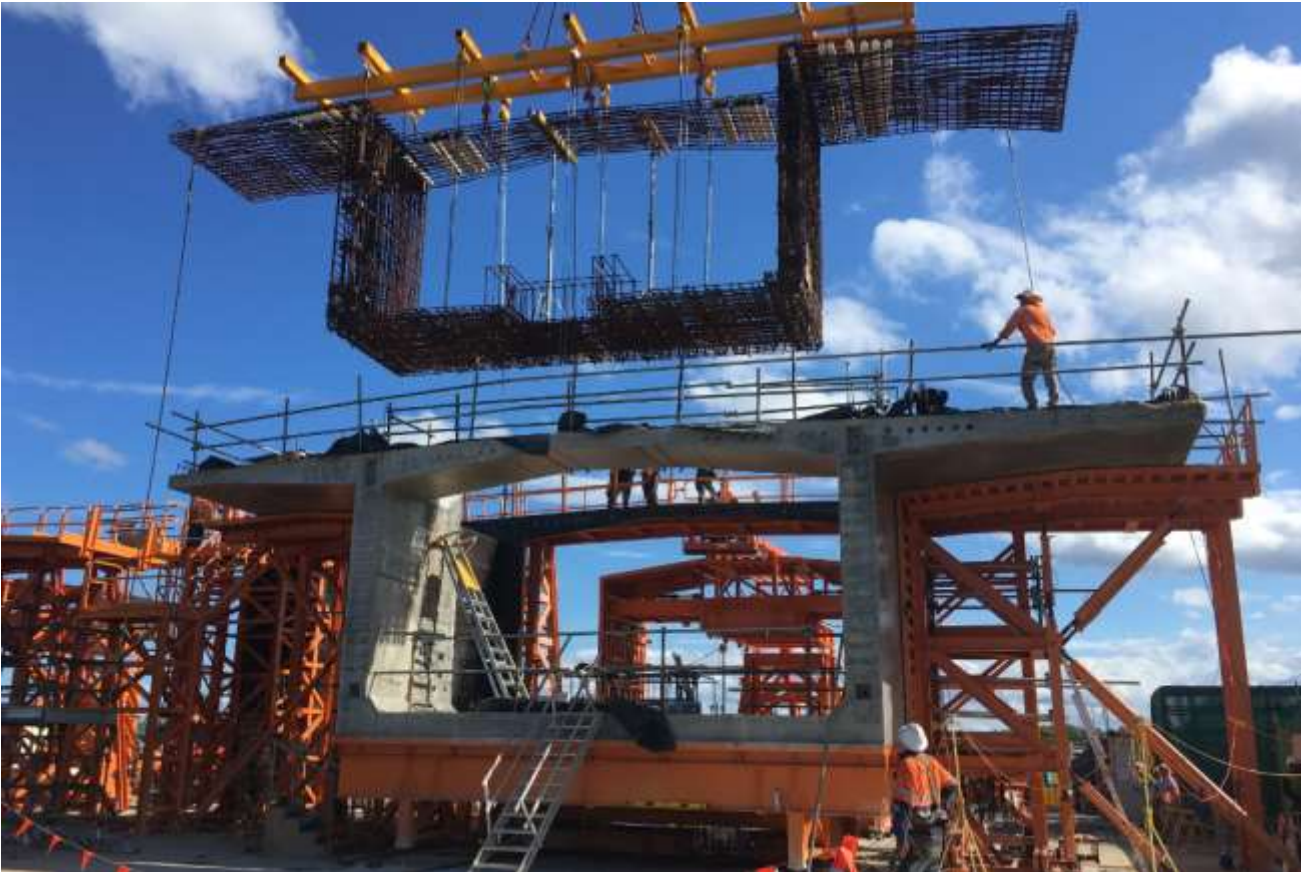
Figure 5 Pre-fabricated reo cage being placed into the mould with pre poured segment placed in front for match casting

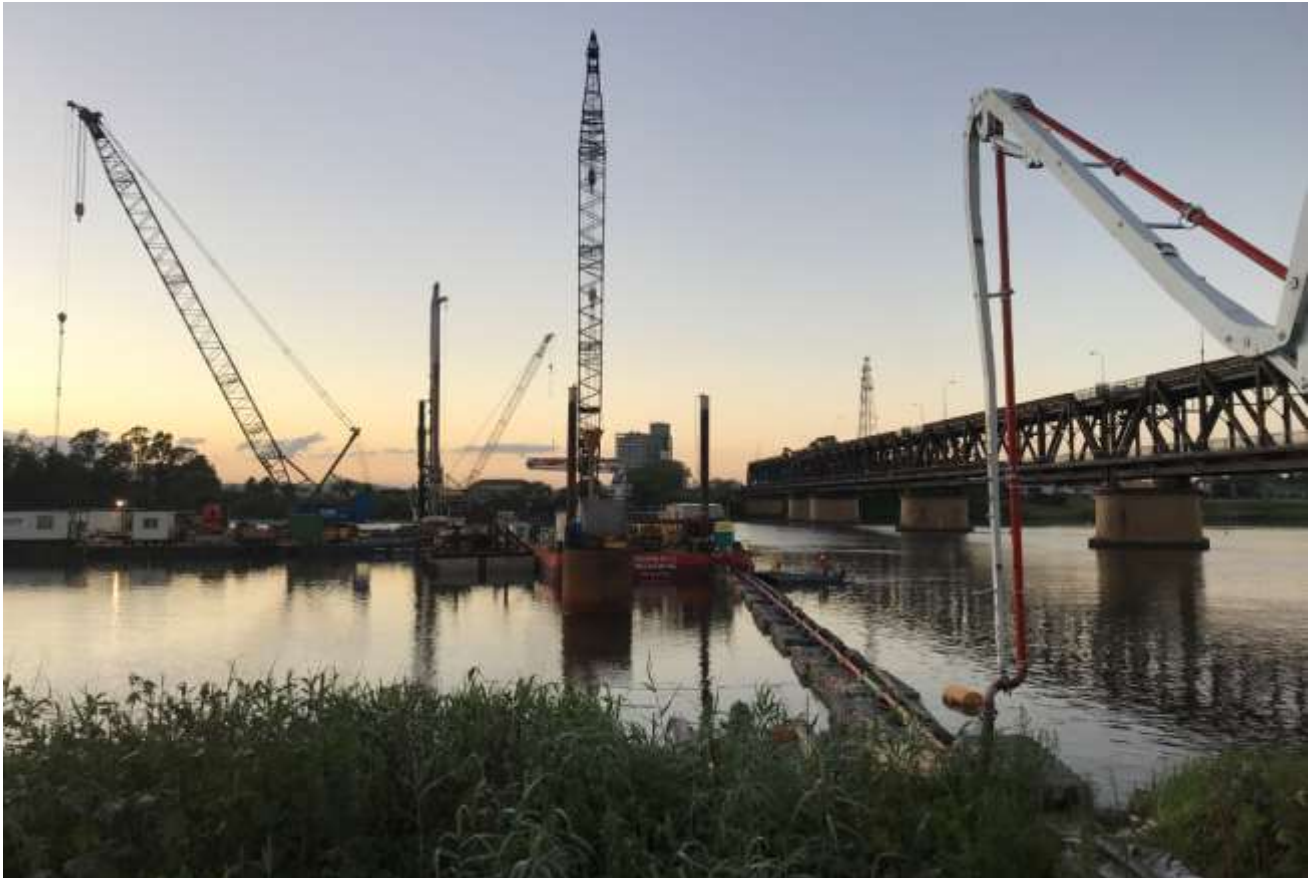
- Floated concrete lines taking high pressure concrete from land to the piles was generally managed very well. An incident did occur when a line became blocked on the north side but crews responded immediately. The incident didn't result in measurable impacts on the river.

*Figure 6 Early morning pile pour at Pier 6, floated concrete and water line back to shore*

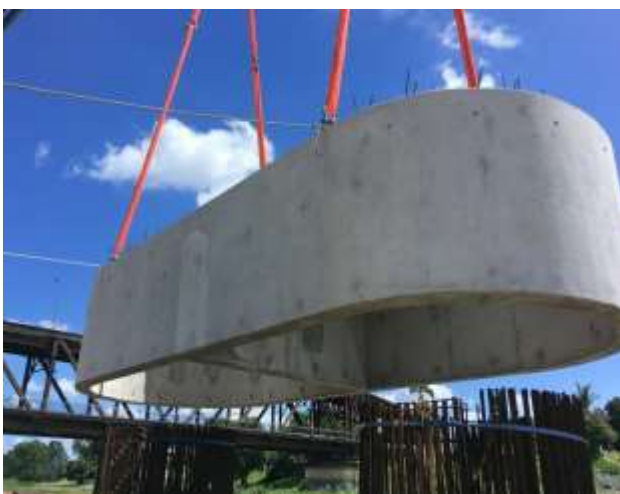
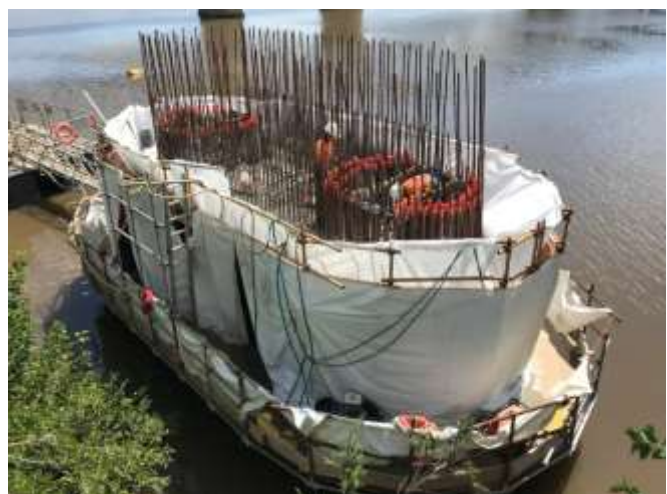
All 5 pier skirts were installed post piling completion. This has allowed for the construction of the bridge piers to begin. Both Pier 2 and 3 stage 1 pours have been completed with construction for the stage 2 pours well underway. All piers are expected to be completed within the next reporting period.

*Figure 7 Last of the pier skirts being lifted into place at Pier 6 (left) and construction of Pier 2 with environmental controls in place on the river (right)*

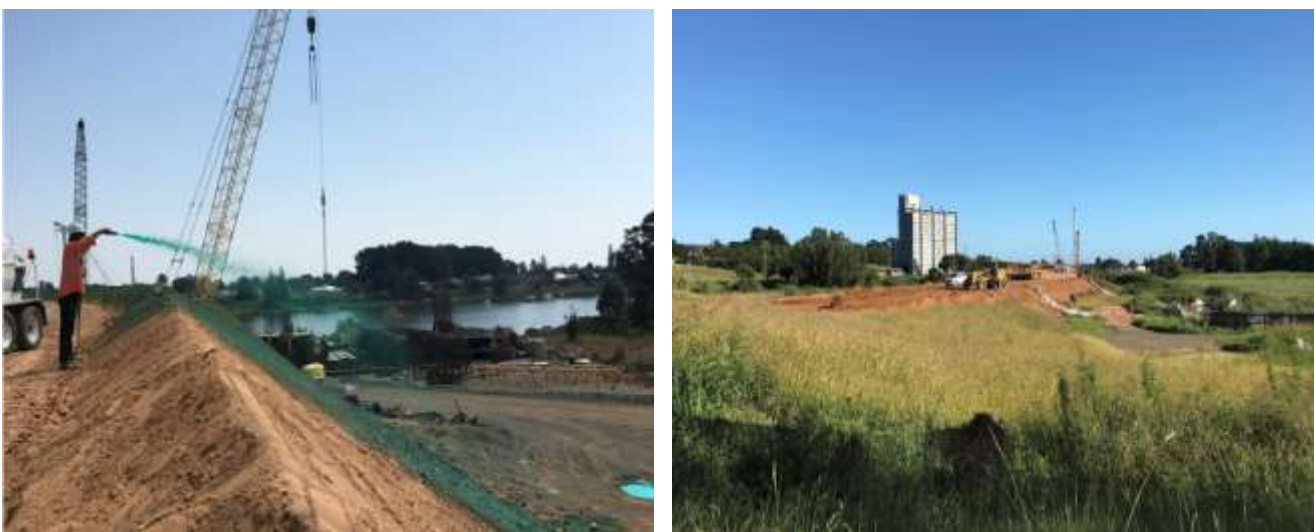
*Figure 8 Polymer application to exposed dirt in South Grafton at Abutment A (left) and new grass growth at the Hydroseeded area in Fill 1 (right)*

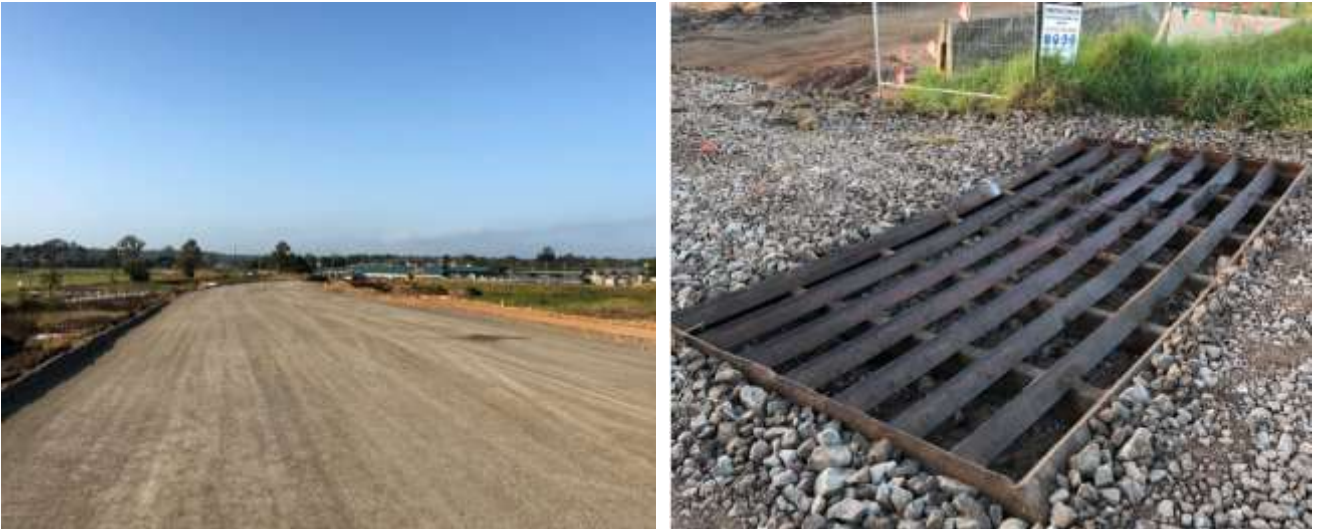
Figure 9 SMZ placed at fill 1 (left) stabilised access and egress points (right)

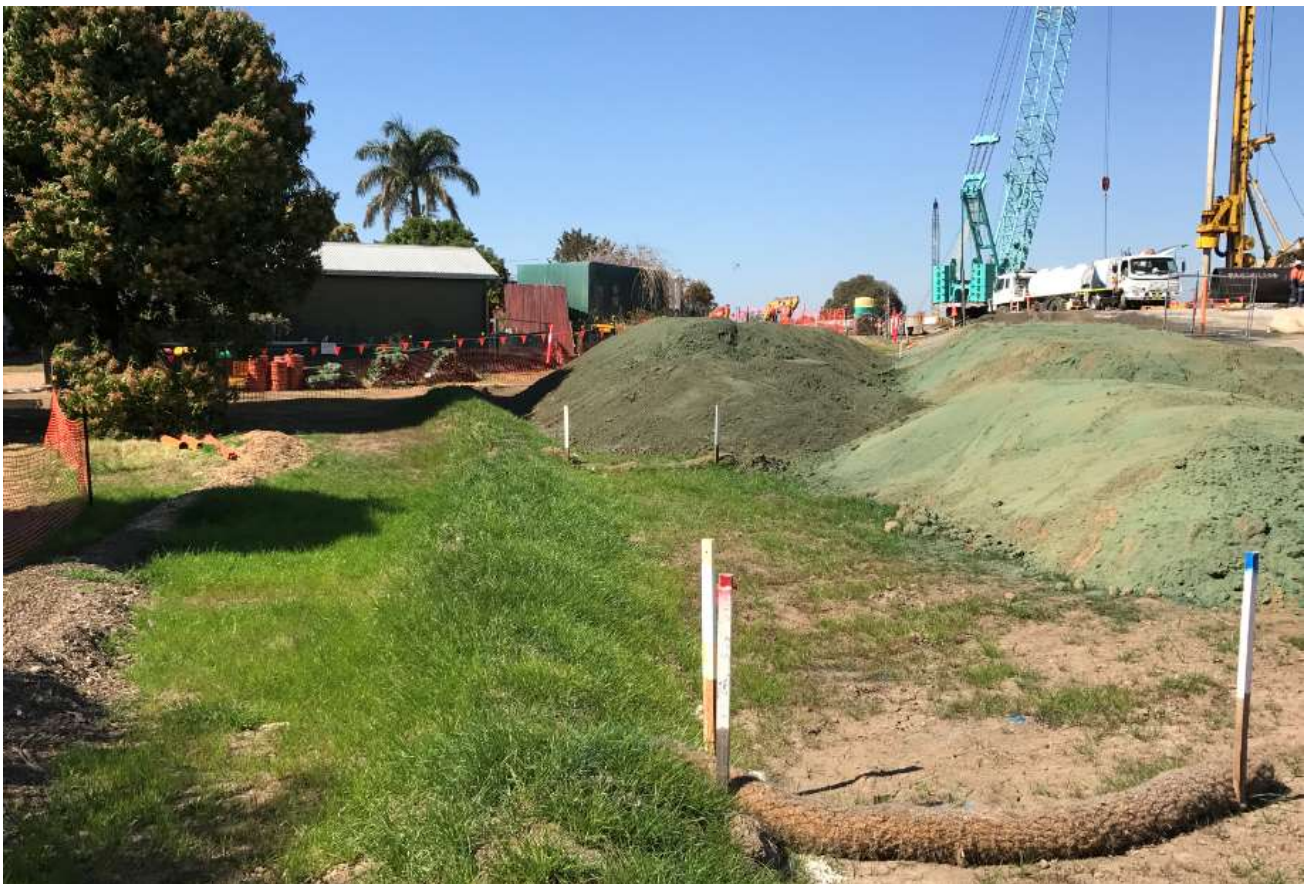
Figure 10 Grass strike and controls installed near abutment B in Grafton

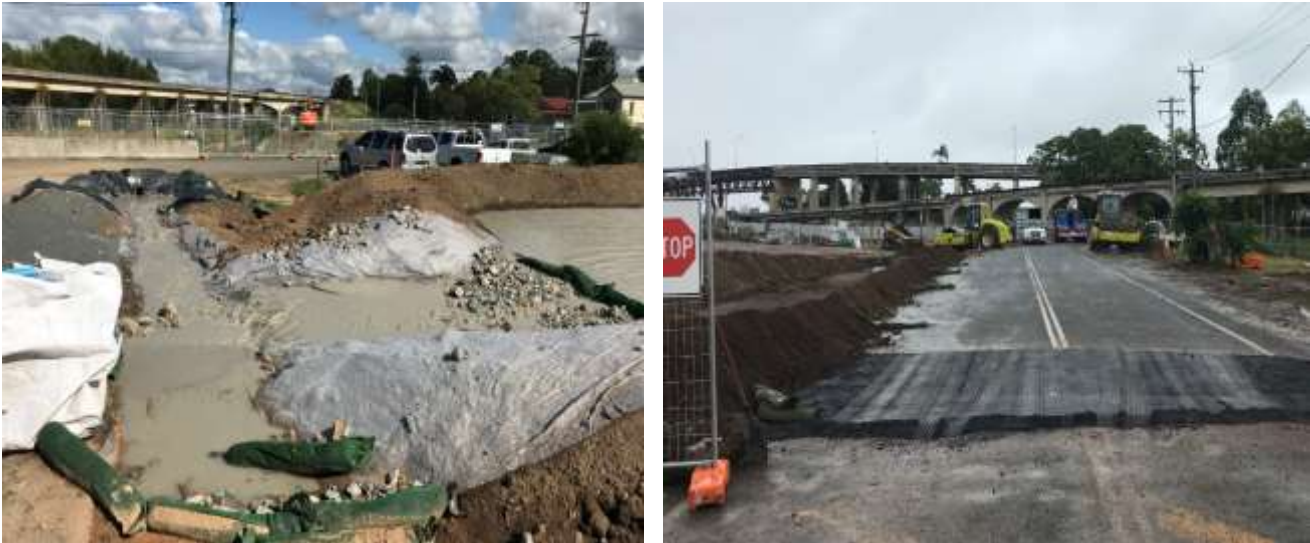
Figure 11 Controls installed to manage piling water during air lifts and pile pours in Grafton (left) and additional controls and drains installed along Kent Street, Grafton to manage potential dirty water run off (right)

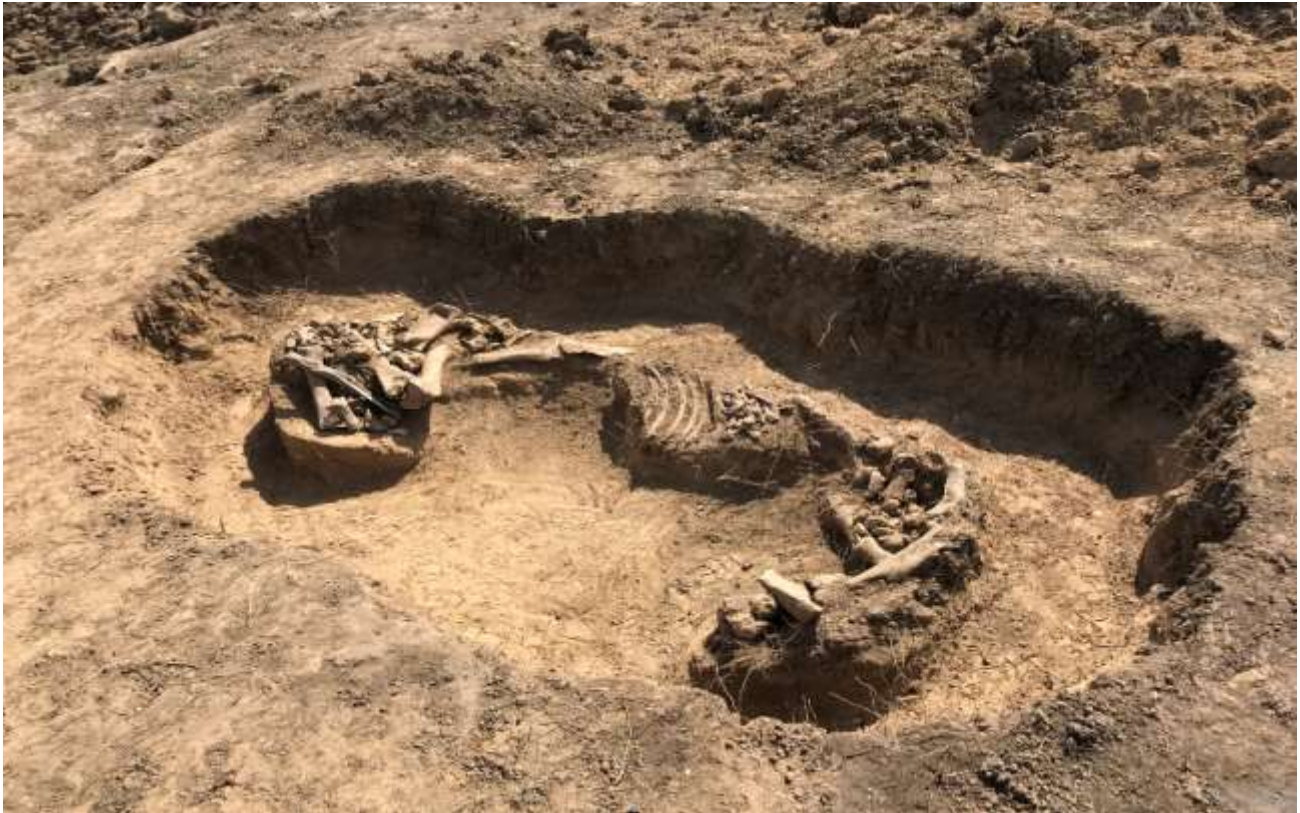
The third find occurred during the stripping back of soil for piling pad construction and the railway viaduct and consisted of a roughly 40mm long bone. After thorough investigations, the bone was deemed to be a baby cow and works were permitted to continue.

*Figure 12 Excavation from bone find near the railway viaduct on the corner of Bridge and Pound Street, Grafton*

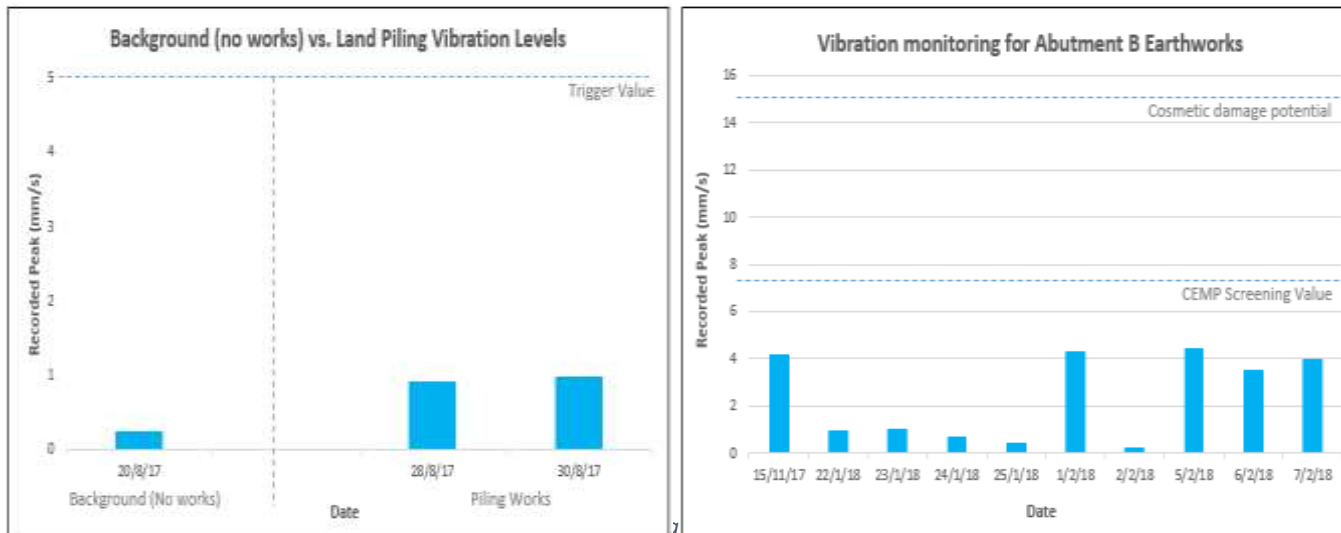
At no point throughout the reporting period was the monitoring trigger value (5mm/s) exceeded. All recorded levels were within acceptable parameters described in the approve Noise and Vibration Management Plan – see figure below.

activities show results below the project screening value (5mm/s) and the CEMP trigger value (7.5mm/s)

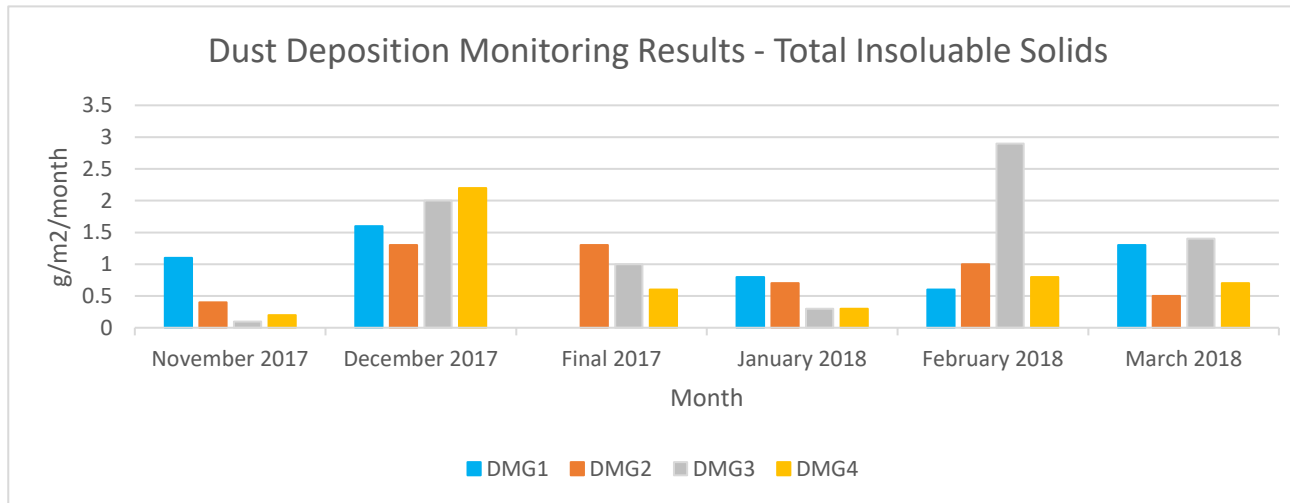
Figure 14 Air monitoring results for the reporting period

An anomaly was found in the data set during this reporting period where an additional reading was undertaken for the year – these results are labelled as final 2017 in the data set. Results were comparative to the rest of the reporting period results with one noted exceedance. This exceedance was 27g/m<sup>2</sup>/month over the allowable limit from a period that included the two week Christmas shut down and high rainfall (176mm). The exceedance is well outside the range of what would be considered normal air conditions. The measured value is extreme and clear anomaly of data when compared to all other monitored months at this location. It is therefore concluded that there was contamination of the gauge not representative of construction or background conditions.

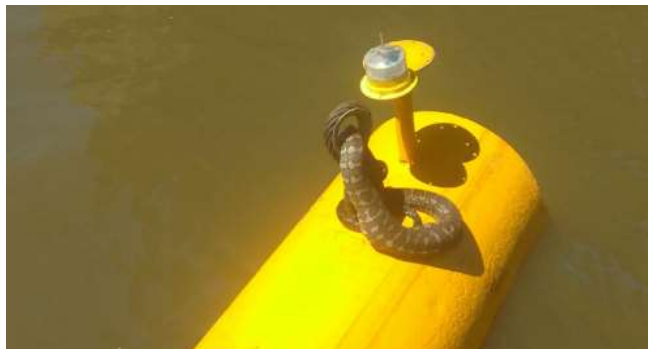
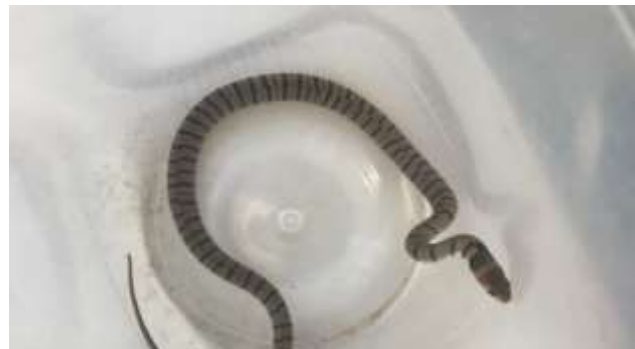
Figure 15 Carpet python spotted on top of one of the buoys on the river (left) and a baby eastern brown snake found trying to climb to reo at Pier 3 (right)
