GUNNEDAH SECOND ROAD OVER RAIL BRIDGE - CONCEPT OPTIONS

Geotechnical and Environmental Desk Study

127622030-002-Rev1

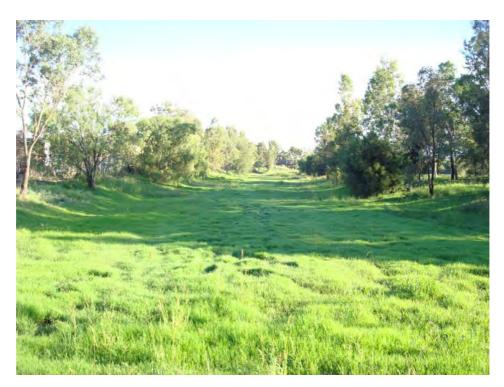
Photograph D- 1: Blackjack Creek watercourse, looking north from the Oxley Highway

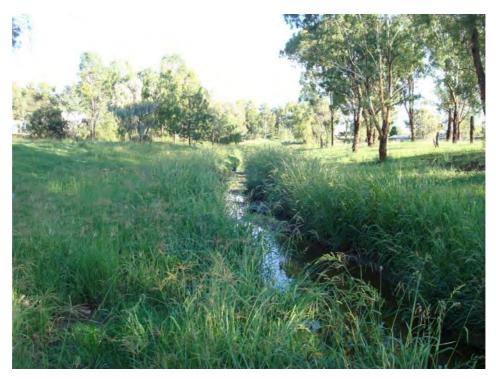
Photograph D- 2: Ashford Water Course, looking north-west from New Street. Note running water and flood debris on the right.

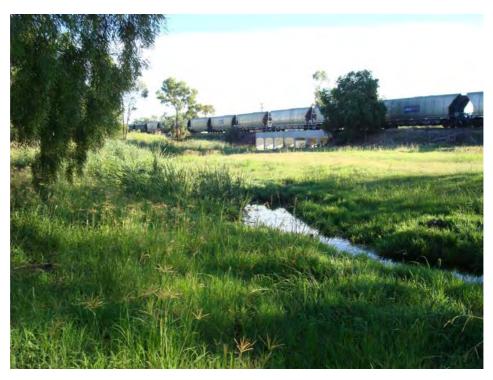
Photograph D- 3: Rail Culvert over Blackjack Creek constructed in 2011

- Existing Culvert (near New Street level crossing): Settlement of this structure and or damage to the structure may occur if subject to additional loadings. A structural assessment and possible investigation of the underlying ground should be undertaken to assess whether this structure can be incorporated into the concept deign.

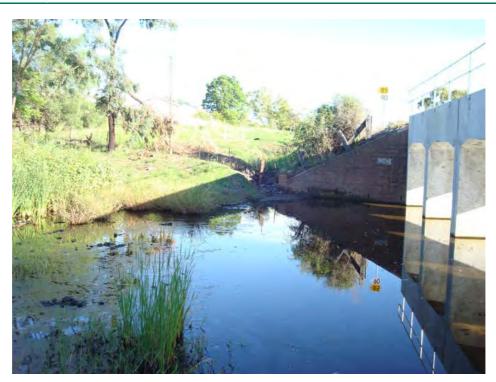
- Within Blackjack Creek, running surface water to depths of about 0.2 m was observed at the time of the site walkover. In areas further upstream and downstream of the rail bridge, water depths were observed to be greater than 1 m and extensive beds of reeds had developed.

Photograph D- 5: Blackjack Creek upstream of the Rail Culvert, looking west. Note the stagnant water and reed growth.

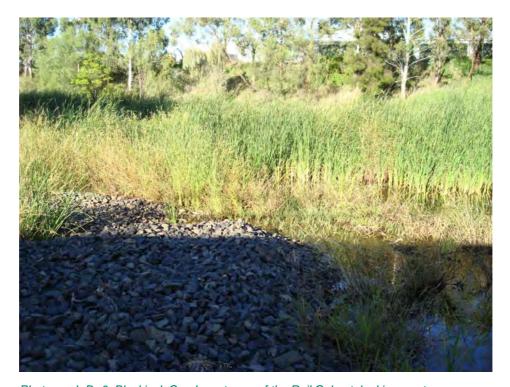
Photograph D- 6: Blackjack Creek upstream of the Rail Culvert, looking west. Note the stagnant water, reed growth and the rail ballast working platform.
