## GUNNEDAH SECOND ROAD OVER RAIL BRIDGE - CONCEPT OPTIONS

# Geotechnical and Environmental Desk Study

**Report Number.** 127622030-002-Rev0

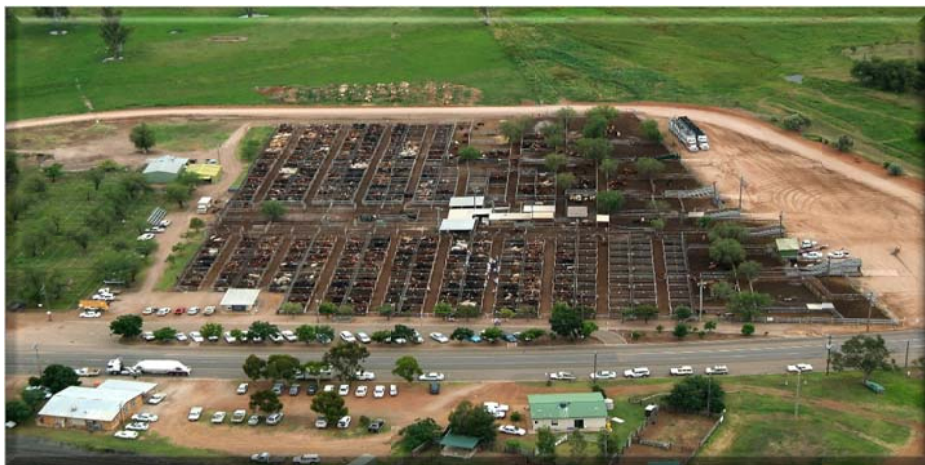
Figure 4: Gunnedah Saleyards

- Gunnedah Regional Saleyards has been located near Kamilaroi Highway, since 1959. Gunnedah Saleyards is one of the largest stock selling centres in NSW and is located on the edge of town 1 km from the town centre on the Narrabri Road. The selling area can accommodate 5000 head. There is a truck wash area, cattle crushes with veterinarian facility and water treatment works as shown in Figure 4 and Figure 5. (Reference <http://www.saleyards.info>).

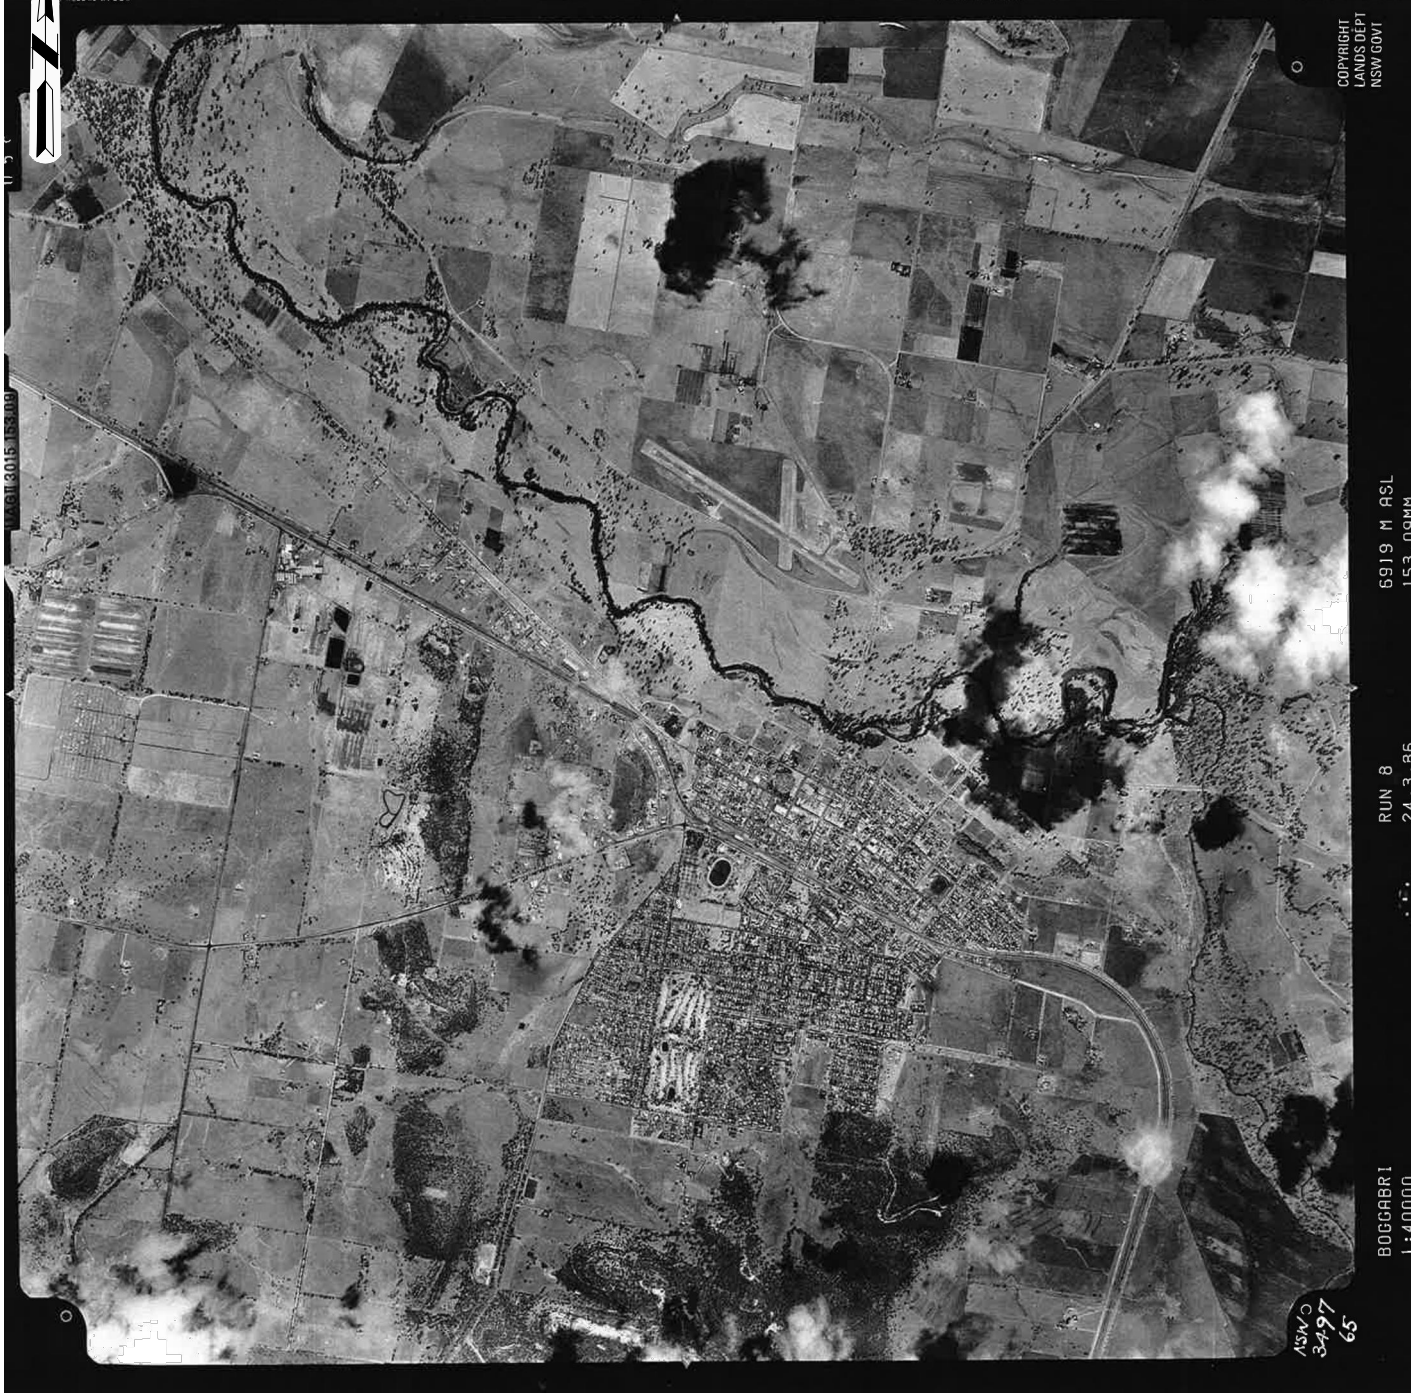
Date	Scale	Comments (Study Area and Surrounding land)
1986	1:40,000	<p>North: Gunnedah Regional Saleyards appeared to have undergone continued development.</p> <p>South: The Flour Mill had undergone significant continued development since the previous aerial photograph 1966, with several buildings removed from the area. The rail line easement appeared relatively unchanged. There were a few industrial buildings on the corner of Oxley Highway and Farrar Road.</p> <p>East: The residential infrastructure on the east remained relatively unchanged.</p> <p>West: The accommodation precinct appeared to have undergone continued development since the previous aerial photograph (1966). New buildings, likely to be residential units, were visible in the western portion of the study area. Farming was the dominant surrounding land use, and the Wandobah Reserve appeared unchanged.</p> <p>The surrounding area was relatively unchanged from the 1966 photograph.</p>

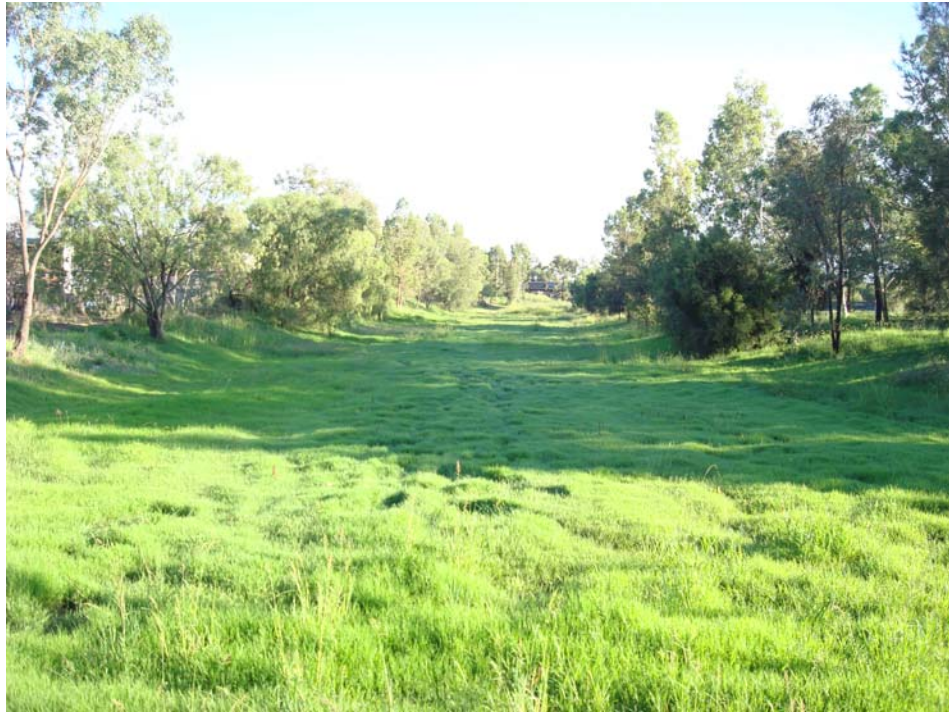
*Photograph D- 1: Blackjack Creek watercourse, looking north from the Oxley Highway*

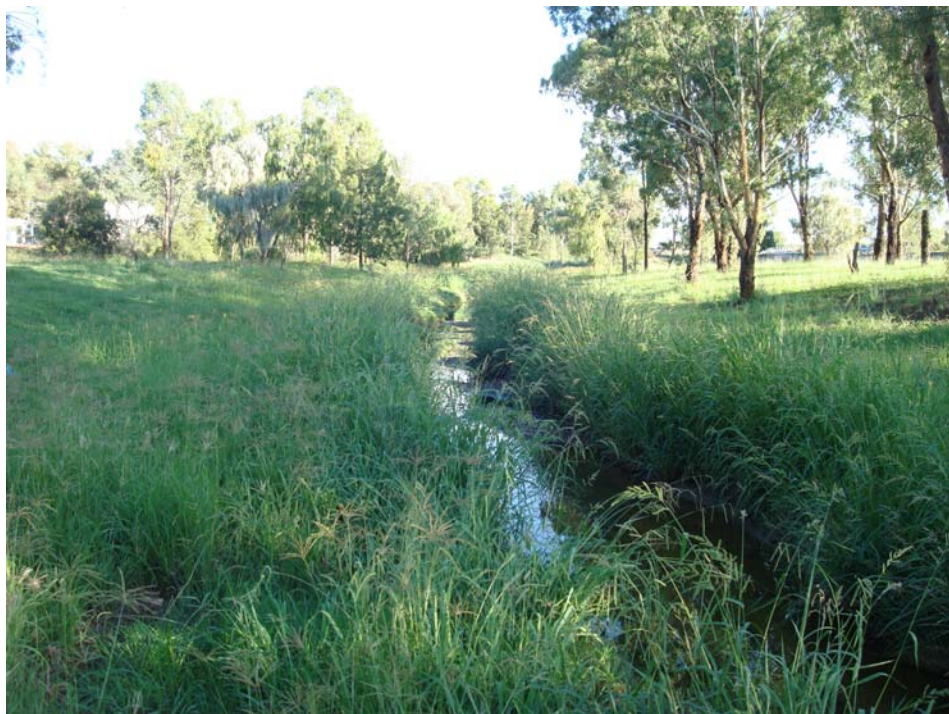
*Photograph D- 2: Ashford Water Course, looking north-west from New Street. Note running water and flood debris on the right.*

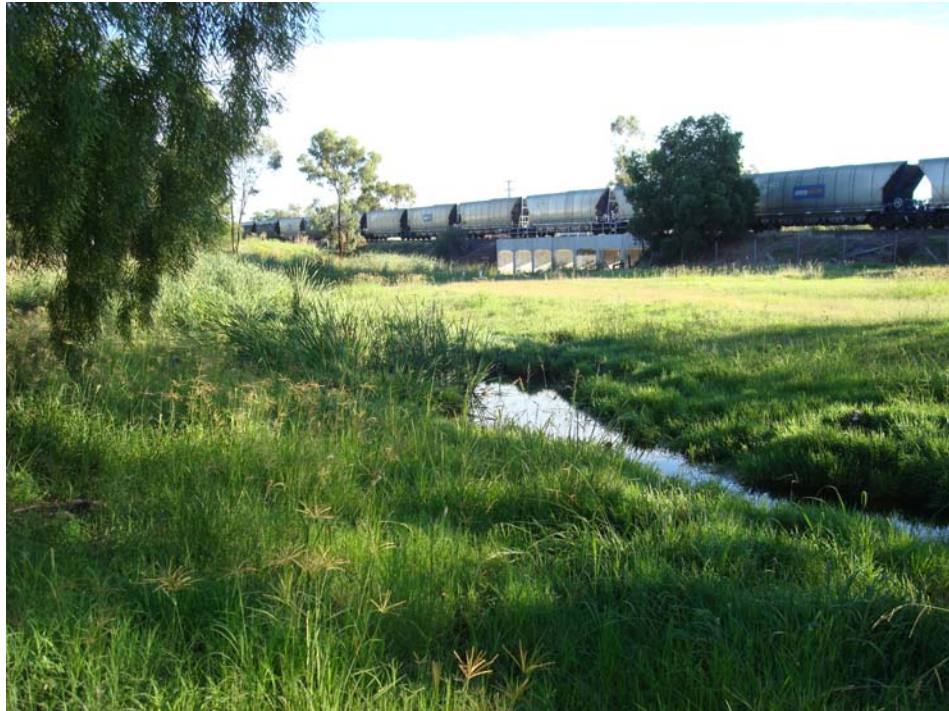
*Photograph D- 3: Rail Culvert over Blackjack Creek constructed in 2011*

- Existing Culvert (near New Street level crossing): Settlement of this structure and or damage to the structure may occur if subject to additional loadings. A structural assessment and possible investigation of the underlying ground should be undertaken to assess whether this structure can be incorporated into the concept design.

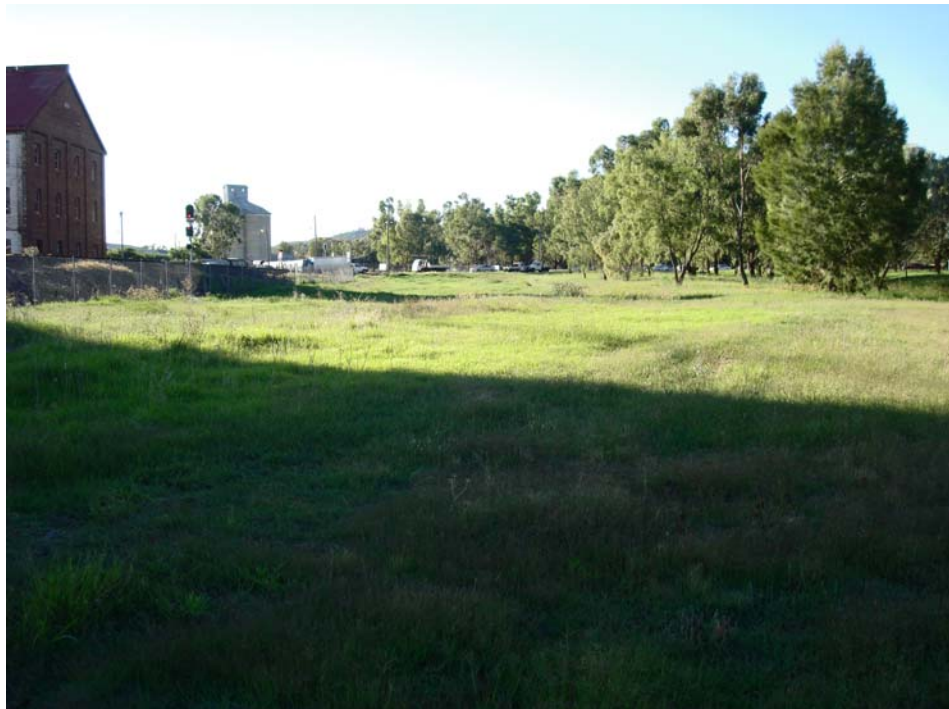
*Photograph D- 4: Site Access from the South from New Street to the Rail Culvert. The mill and grain storage silos can also be seen.*

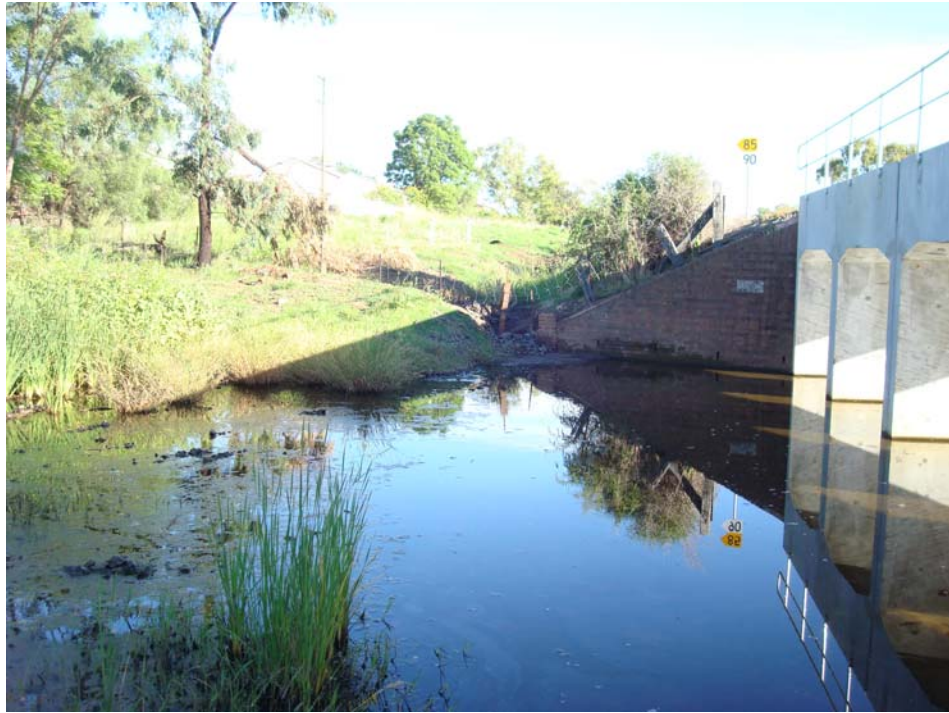
*Photograph D- 5: Blackjack Creek upstream of the Rail Culvert, looking west. Note the stagnant water and reed growth.*

- Within Blackjack Creek, running surface water to depths of about 0.2 m was observed at the time of the site walkover. In areas further upstream and downstream of the rail bridge, water depths were observed to be greater than 1 m and extensive beds of reeds had developed.

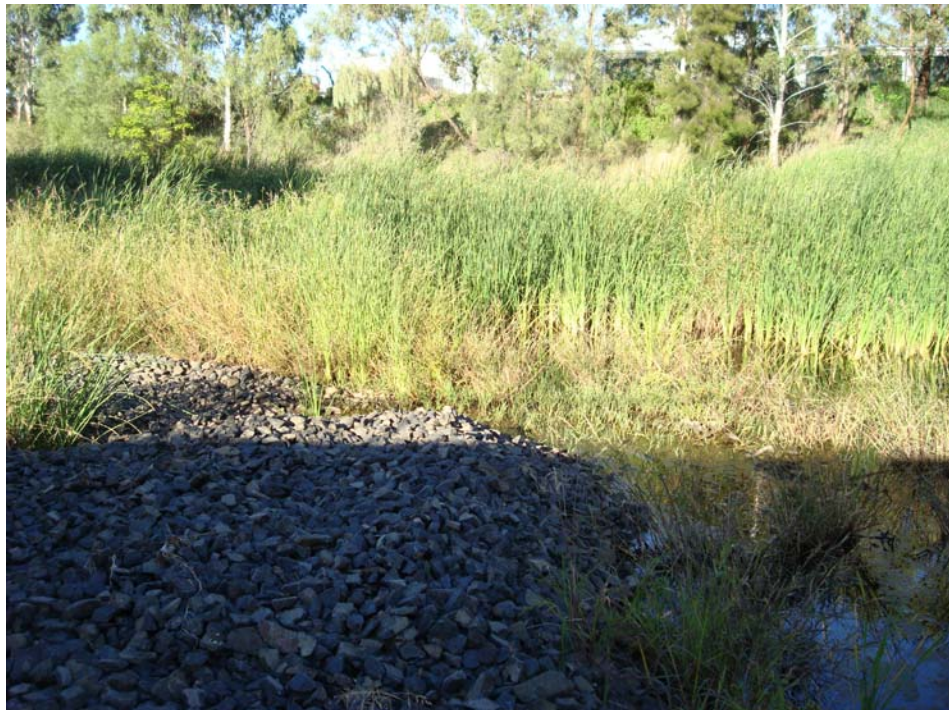
*Photograph D- 6: Blackjack Creek upstream of the Rail Culvert, looking west. Note the stagnant water, reed growth and the rail ballast working platform.*

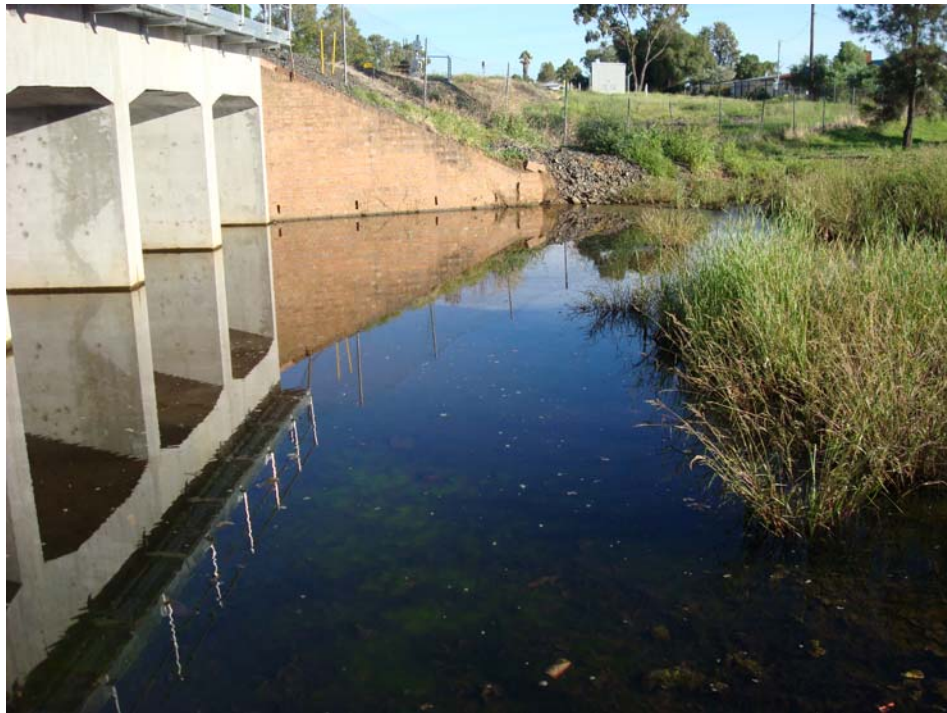
*Photograph D- 7: Blackjack Downstream of Culvert*

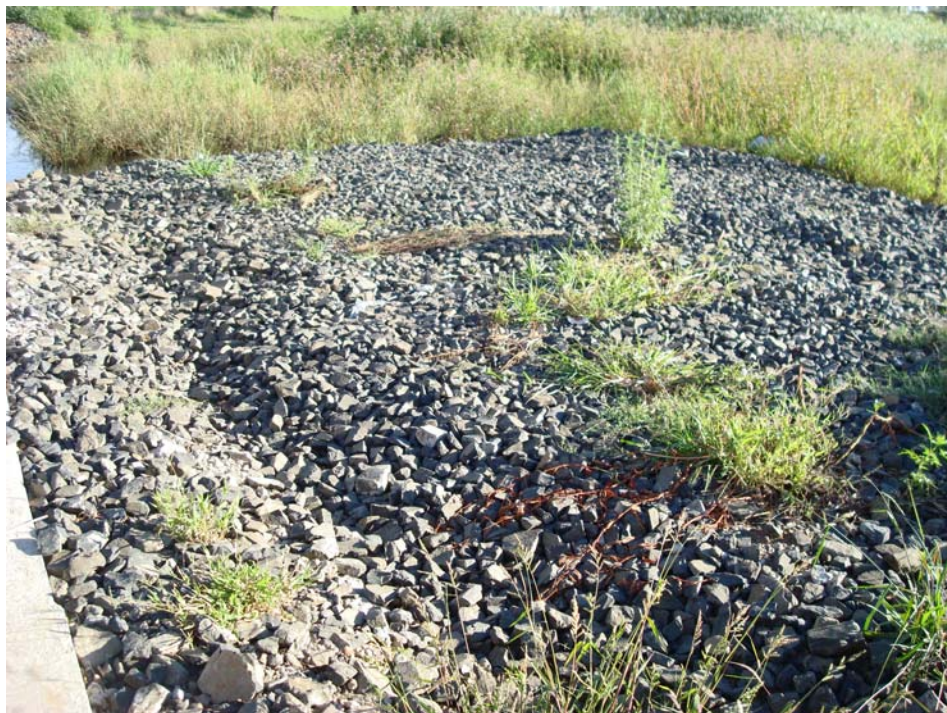
*Photograph D- 8: Old working platform*

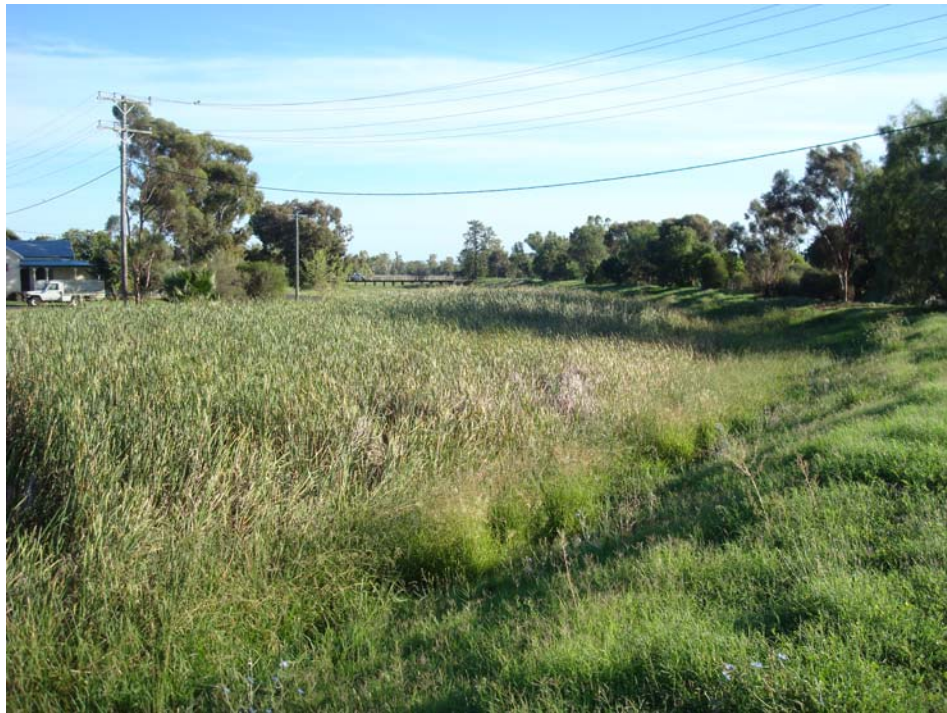
*Photograph D- 9: Blackjack Creek*

- Within Blackjack Creek: there is potential for alluvial deposits of variable composition, possibly being loose and/or compressible which may result in settlement if loaded by structures or embankments.

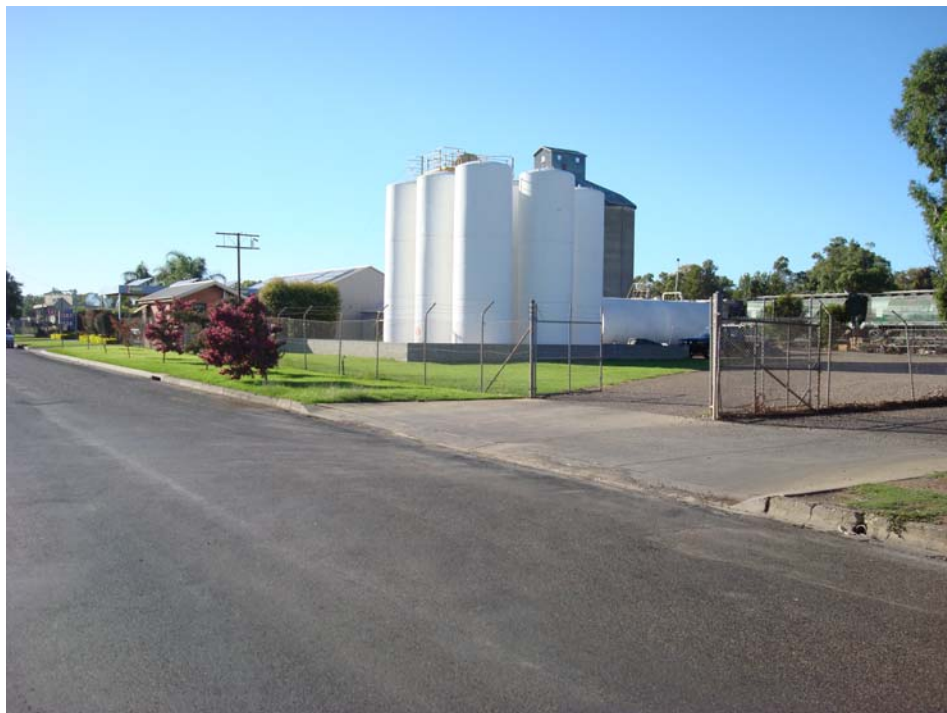
*Photograph D- 10: Hope Fuel Supplies Tank Farm*

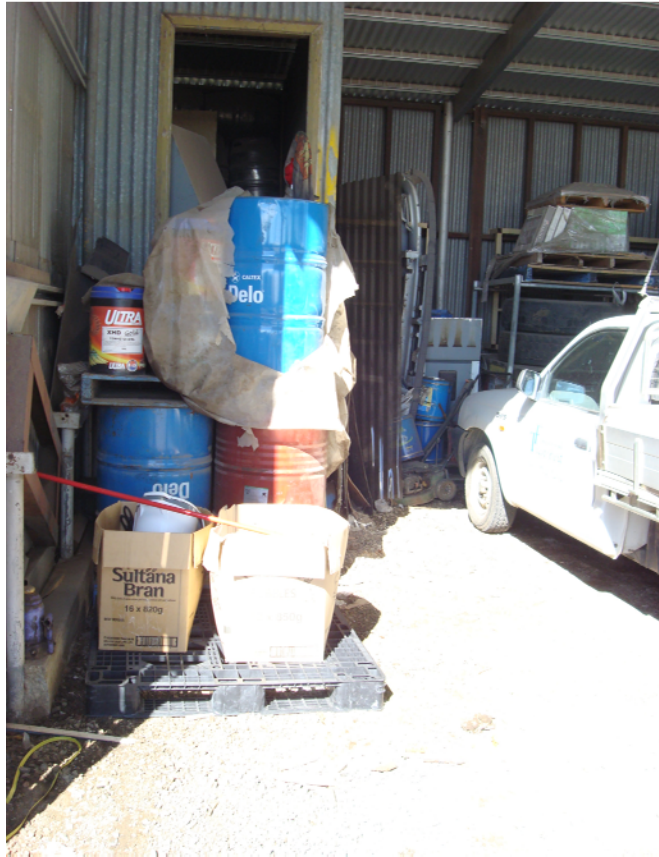
*Photograph D- 11: Fulwood Transport Fuel Compound*
