## SPORTSMANS CREEK NEW BRIDGE

# Geotechnical and Environmental Desktop Study

**Report Number.** 137622029\_001\_R\_Rev2

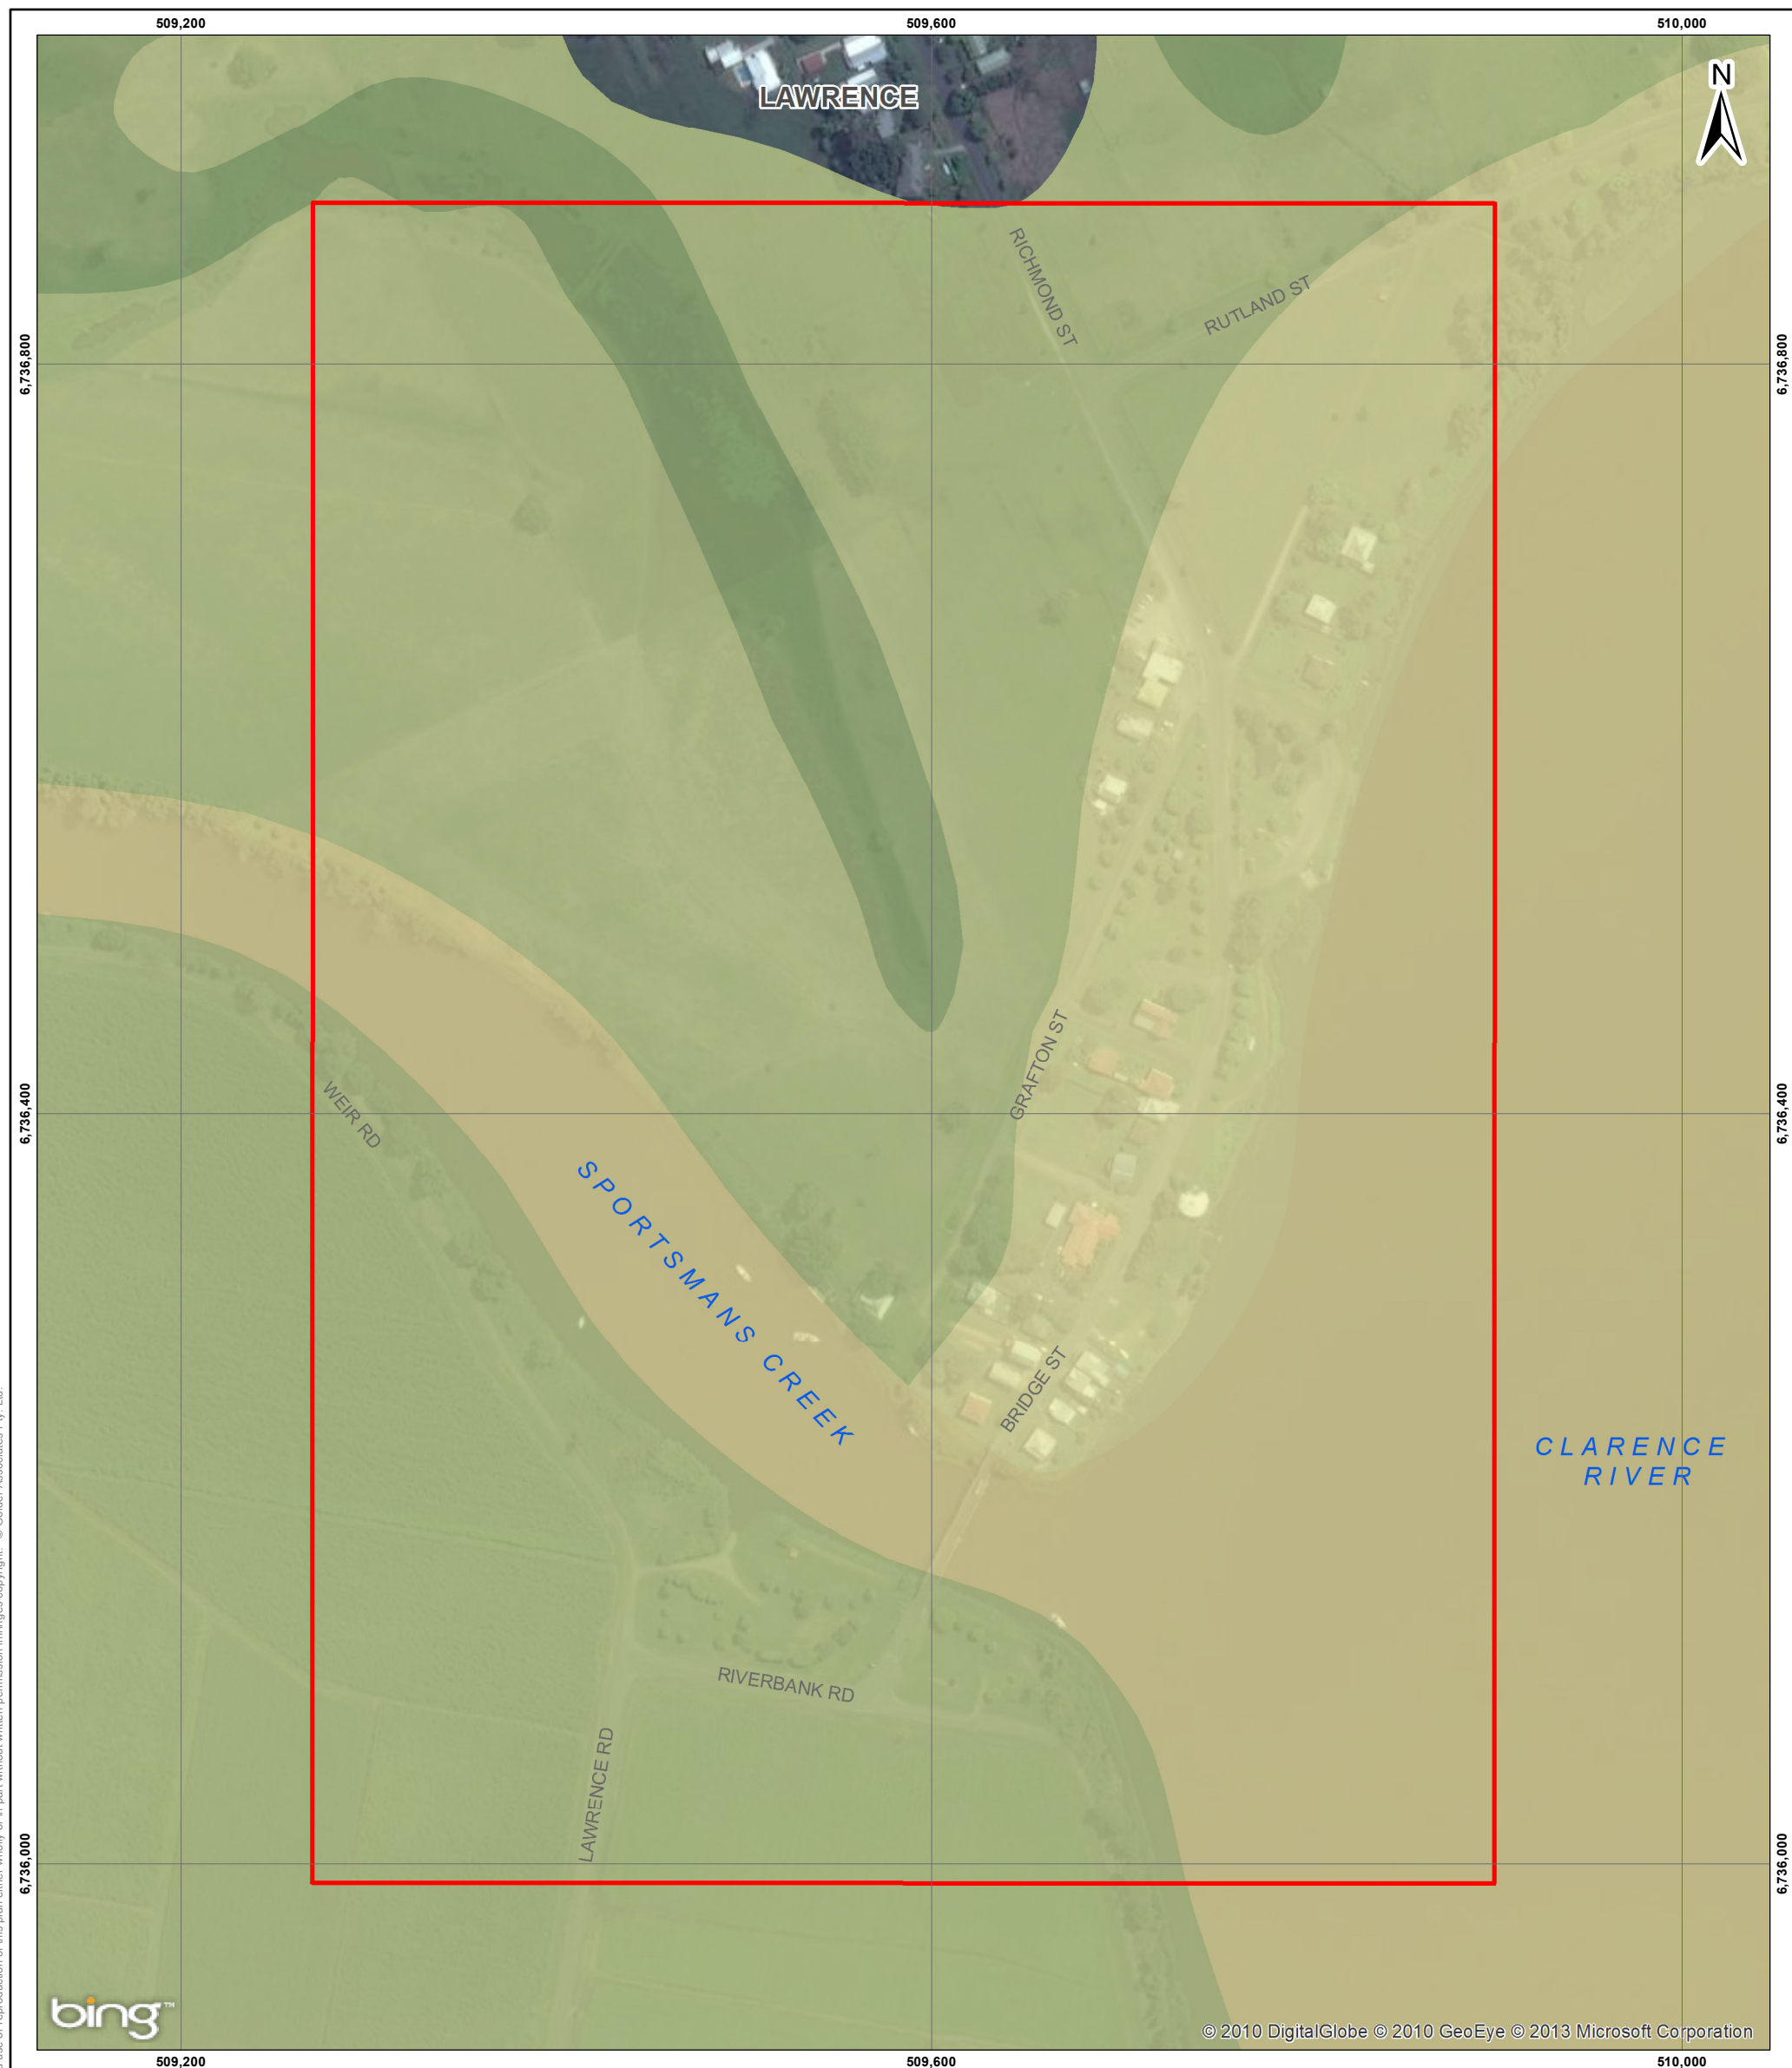
The Australian Soil Resource Information System<sup>2</sup> indicates the study area is located within an area recorded as having a high probability of the presence of acid sulfate soils (ASS). The on-line ASS map provided by Clarence Valley Council<sup>3</sup> shows the majority of the study area is located on areas mapped as either Class 2 or Class 3 ASS (Figure 3).

Sediments in Sportsmans Creek were mapped as Class 1 ASS. The Coffey site investigation (2002) indicated that samples taken from depth in the boreholes showed significant acid generating potential. A lower classification number indicates a higher relative potential for acid sulfate soils.

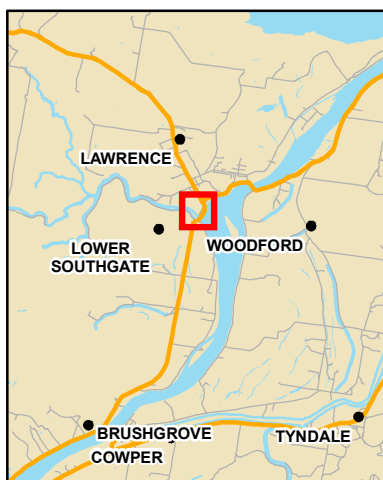
- Study Area
- High Risk 0-1m
- High Risk 1-2m
- High Risk 2-4m
- High Risk above 4m
- High Risk Bottom Sediments
- Low Risk 0-1m
- Low Risk 1-2m
- Low Risk 2-4m
- Low Risk above 4m
- Low Risk Bottom Sediments
- No Risk
- Disturbed Terrain
- Beach

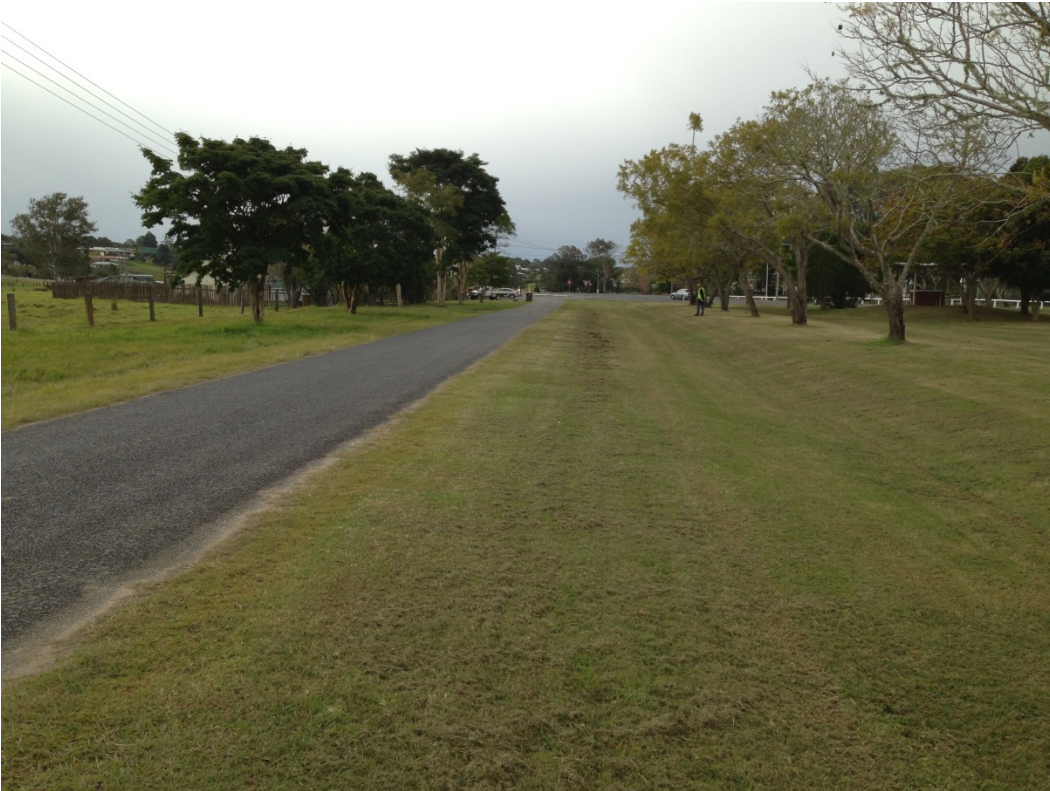
Photo 1: Looking north along Grafton Street showing light duty pavement construction.

- Poor subgrade conditions within the western portion of the study area, and to a lesser extent along Grafton and Bridge Streets, may require some ground improvement such as cement or lime stabilisation or bridging layers or installation of geo-grids and geo-fabrics . An inferred old river channel / ox-bow lake exists within the north western portion of the study area where the depth to rock is unknown, and likely to be significantly deeper than within the central and eastern portions of the study area.

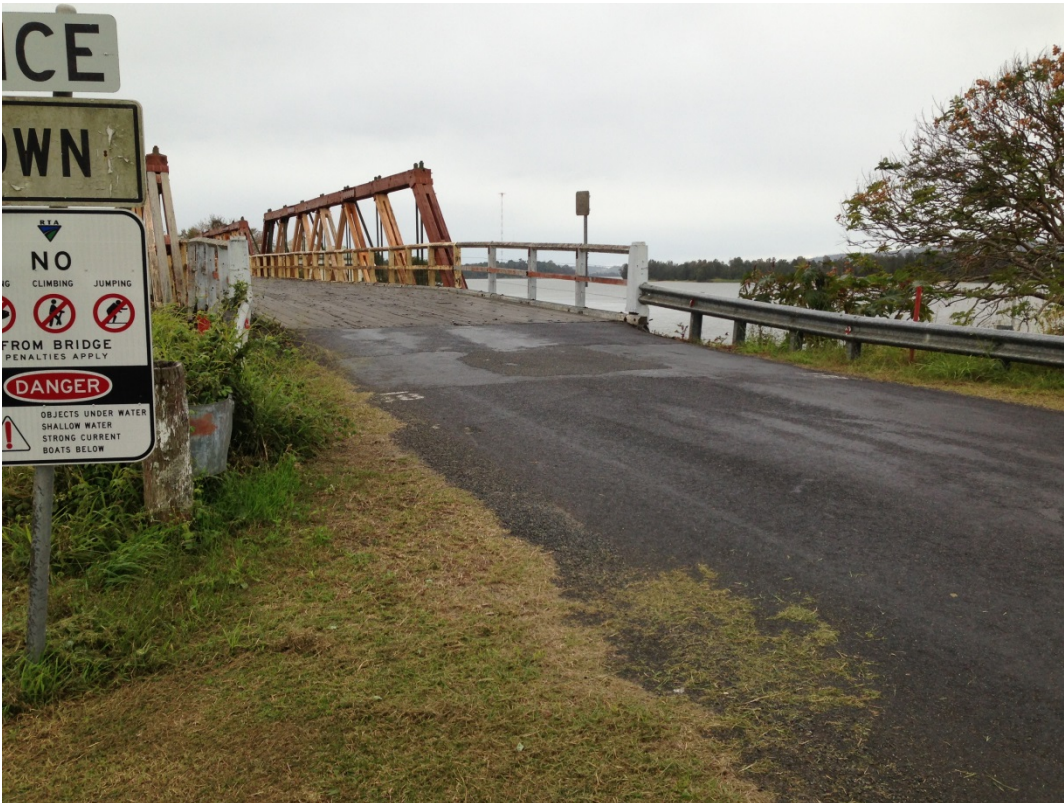
Photo 2: View at southern approach pavement/embankment showing evidence of settlement of the approach embankment.

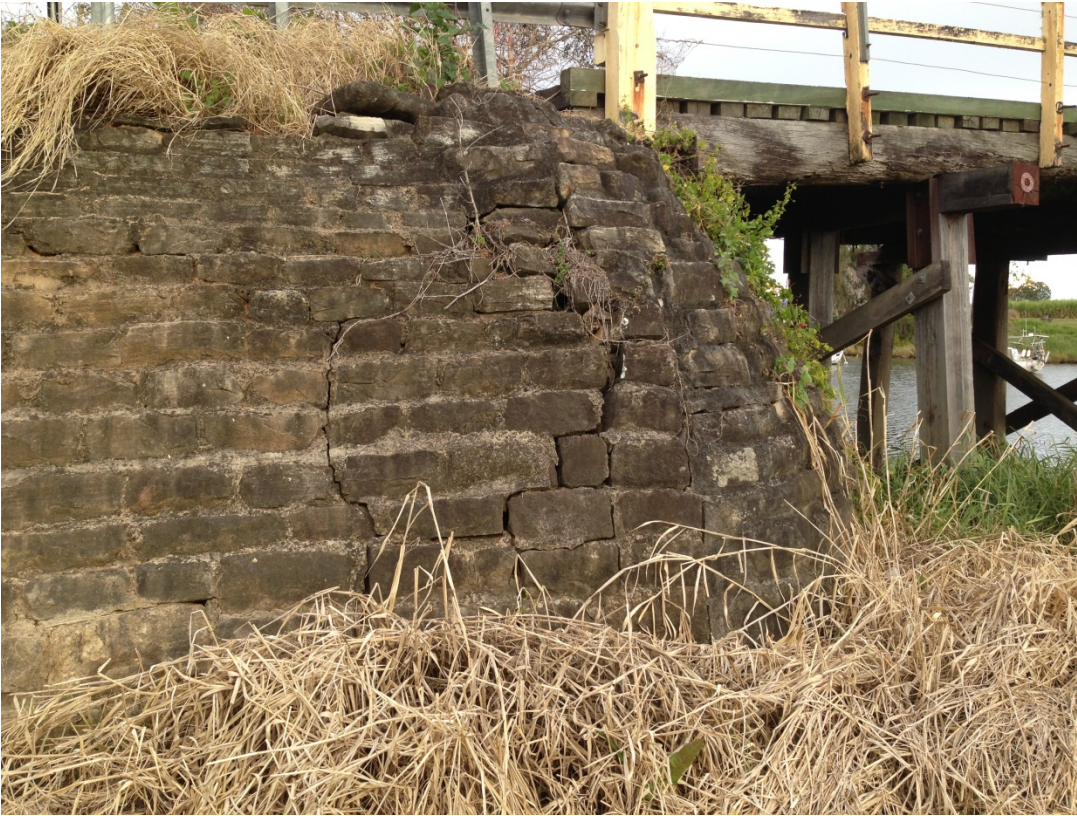
- **Dry-stone Wall Condition** – the existing dry-stone block wall supporting the northern approach embankment, based on visual observation of its external composition, appears to be in a relatively satisfactory condition, given its age. Observations on the condition of the retaining wall were only possible along the western side of Bridge Street and in and around the northern abutment. There are signs of distress, localised bulging and cracking of the retaining wall, particularly near the abutment. Possible causes include high traffic loads and differential settlement along the retaining wall footing. Refer to Photo 3 in Appendix C.

Photo 3: Dry-stone wall at northern abutment showing inferred settlement induced cracking.

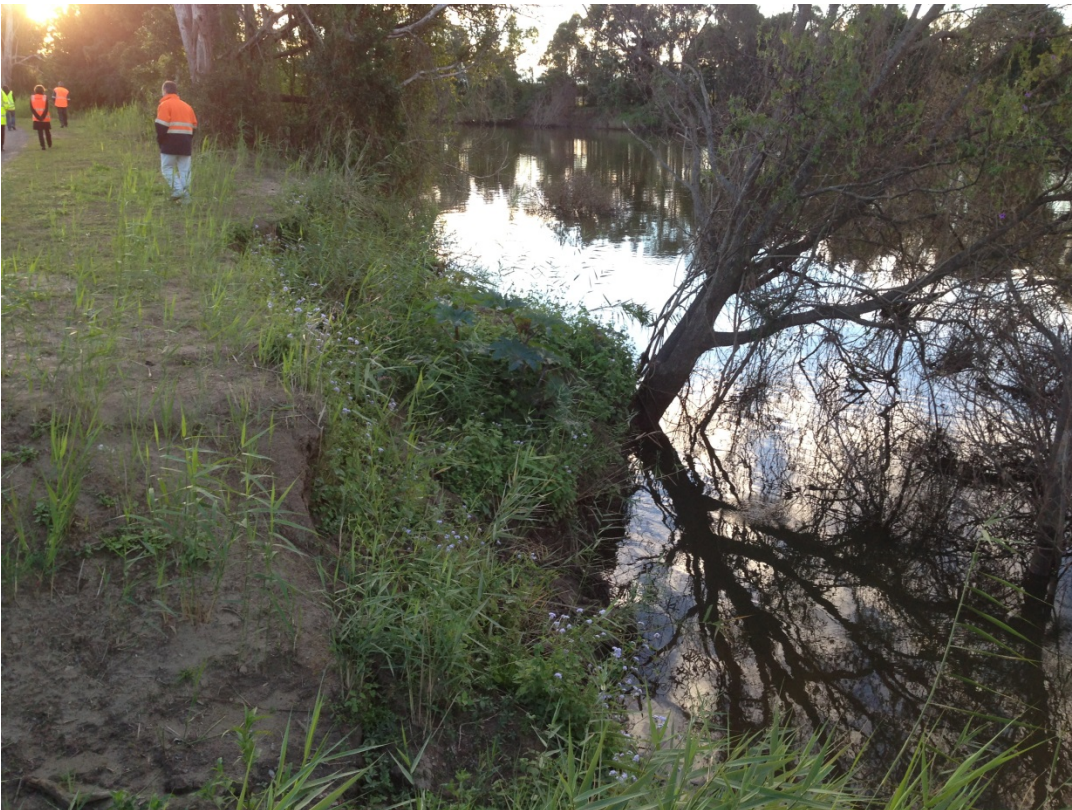
- **River Bank Stability** – observations were made on the condition of the river bank upstream of and around the existing bridge abutments. There is evidence of river bank erosion near the abutments and upstream of the bridge slumping along the river bank was observed in several locations. Refer to Photo 4 in Appendix C.

Photo 4: Upstream at existing bridge, looking north west showing recent river bank instability/erosion.

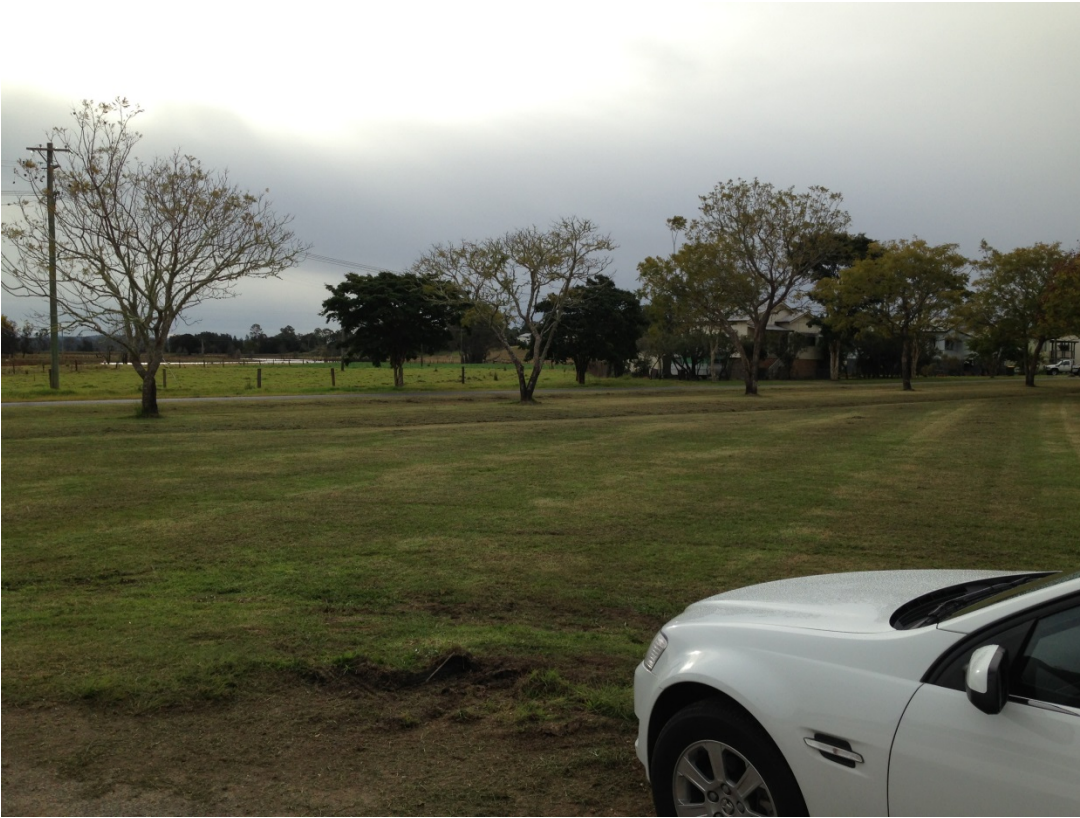
- **Standing Water** – was observed to the west of Grafton Street, in the approximate location where the western corridor would traverse the low lying areas. Refer to Photo 5 in Appendix C.

Photo 5: View to west from Bridge Street, showing standing water in background of western study area.
