Intersection Upgrade at Norwest Boulevard, Lexington Drive and Elizabeth Macarthur Drive, Bella Vista

Contaminated Site Investigation

IA227900-RP-EN-002 | 2

Project No: IA227900
 Document Title: Contaminated Site Investigation
 Document No.: IA227900-RP-EN-002
 Revision: 2
 Document Status: Final
 Date: March 18 2020
 Client Name: Transport for NSW
 Client No: 14.2166.0494.0063
 Project Manager: Steven Rusby-Perera
 Author: David Harris
 File Name: Contaminated site Investigation

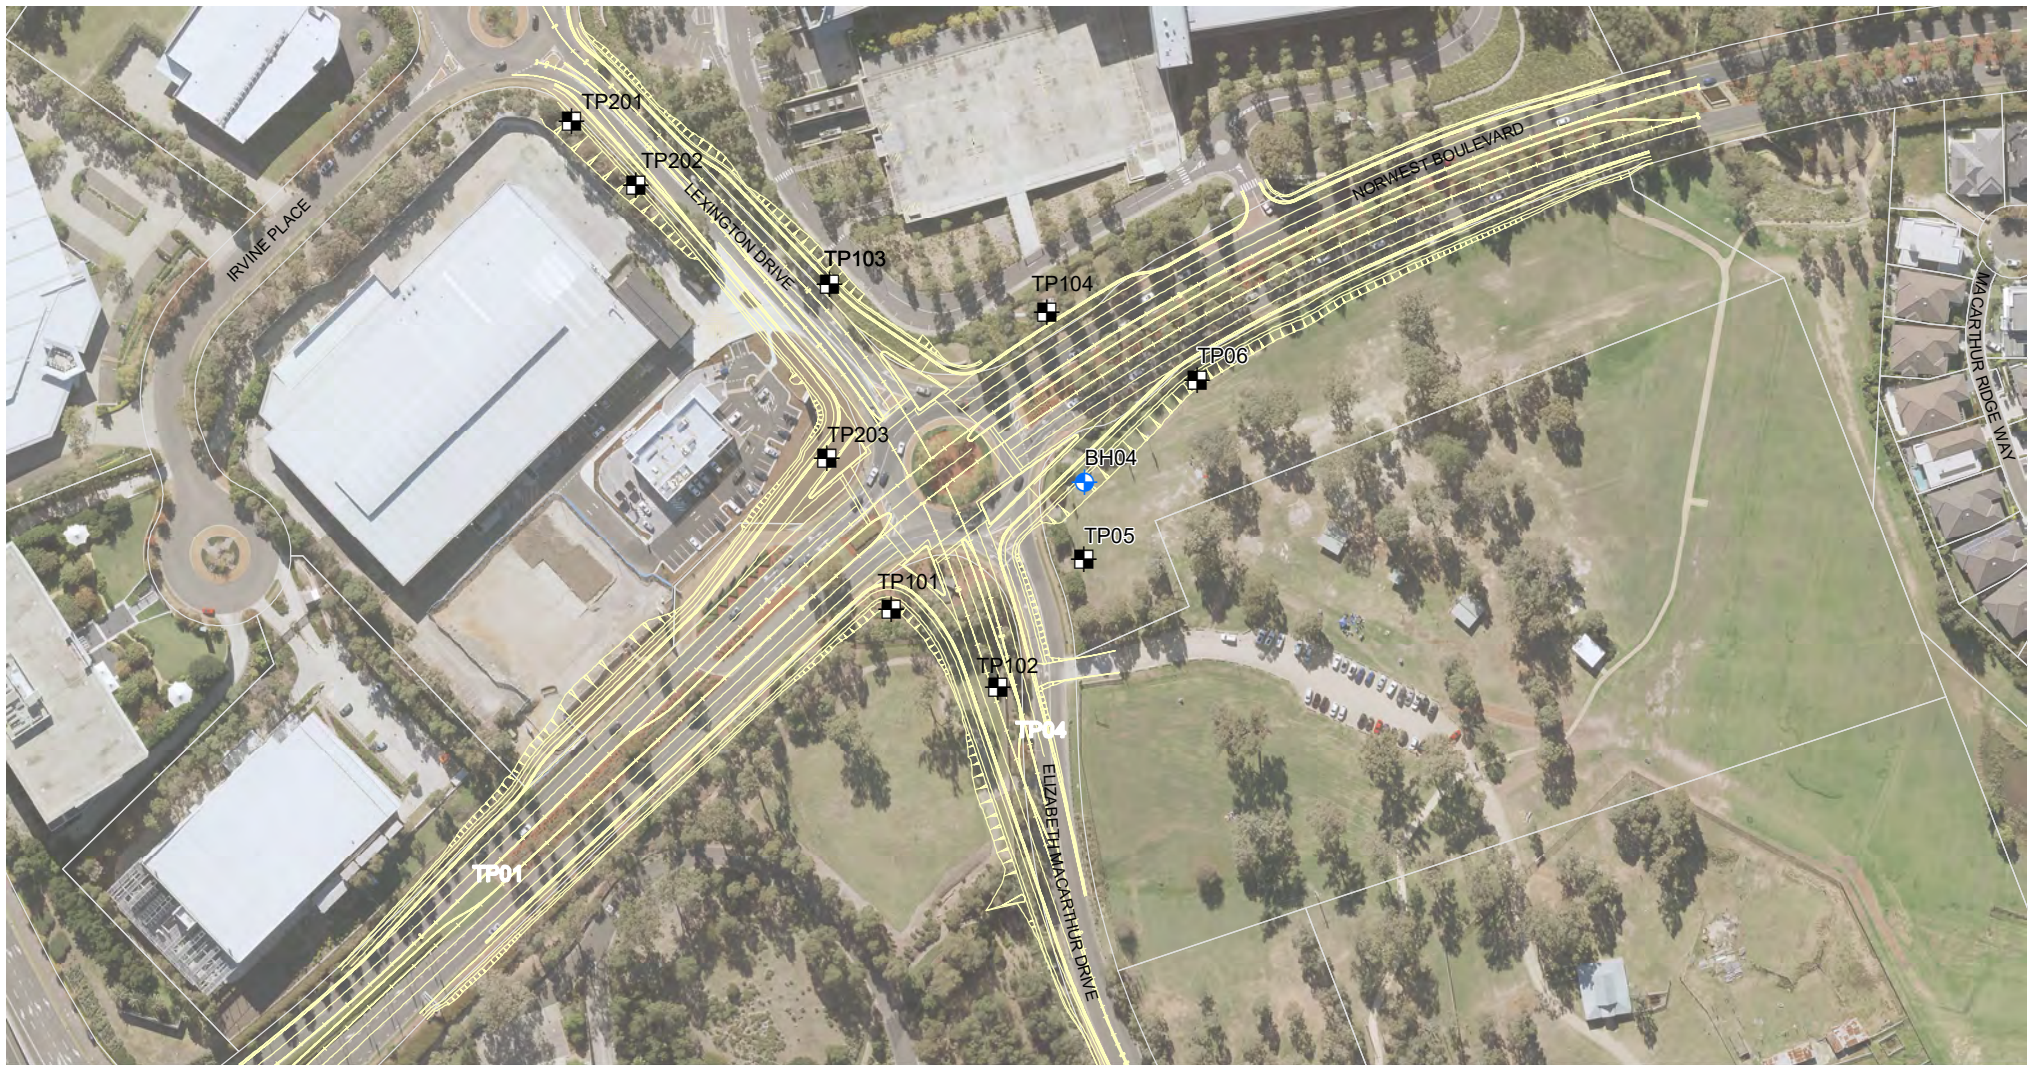
The locations of test pits and boreholes where contamination samples were collected as part of both round 1 and round 2 investigations are presented in **Figure 4-1**. Visual and olfactory observations of soil condition were also made at these sites for validation of subsequent laboratory testing results and assessment of general aesthetics in accordance with the NEPM (2013) guidelines.

- Cadastre
- Concept Design (20191022)
- + Borehole
- Test pits

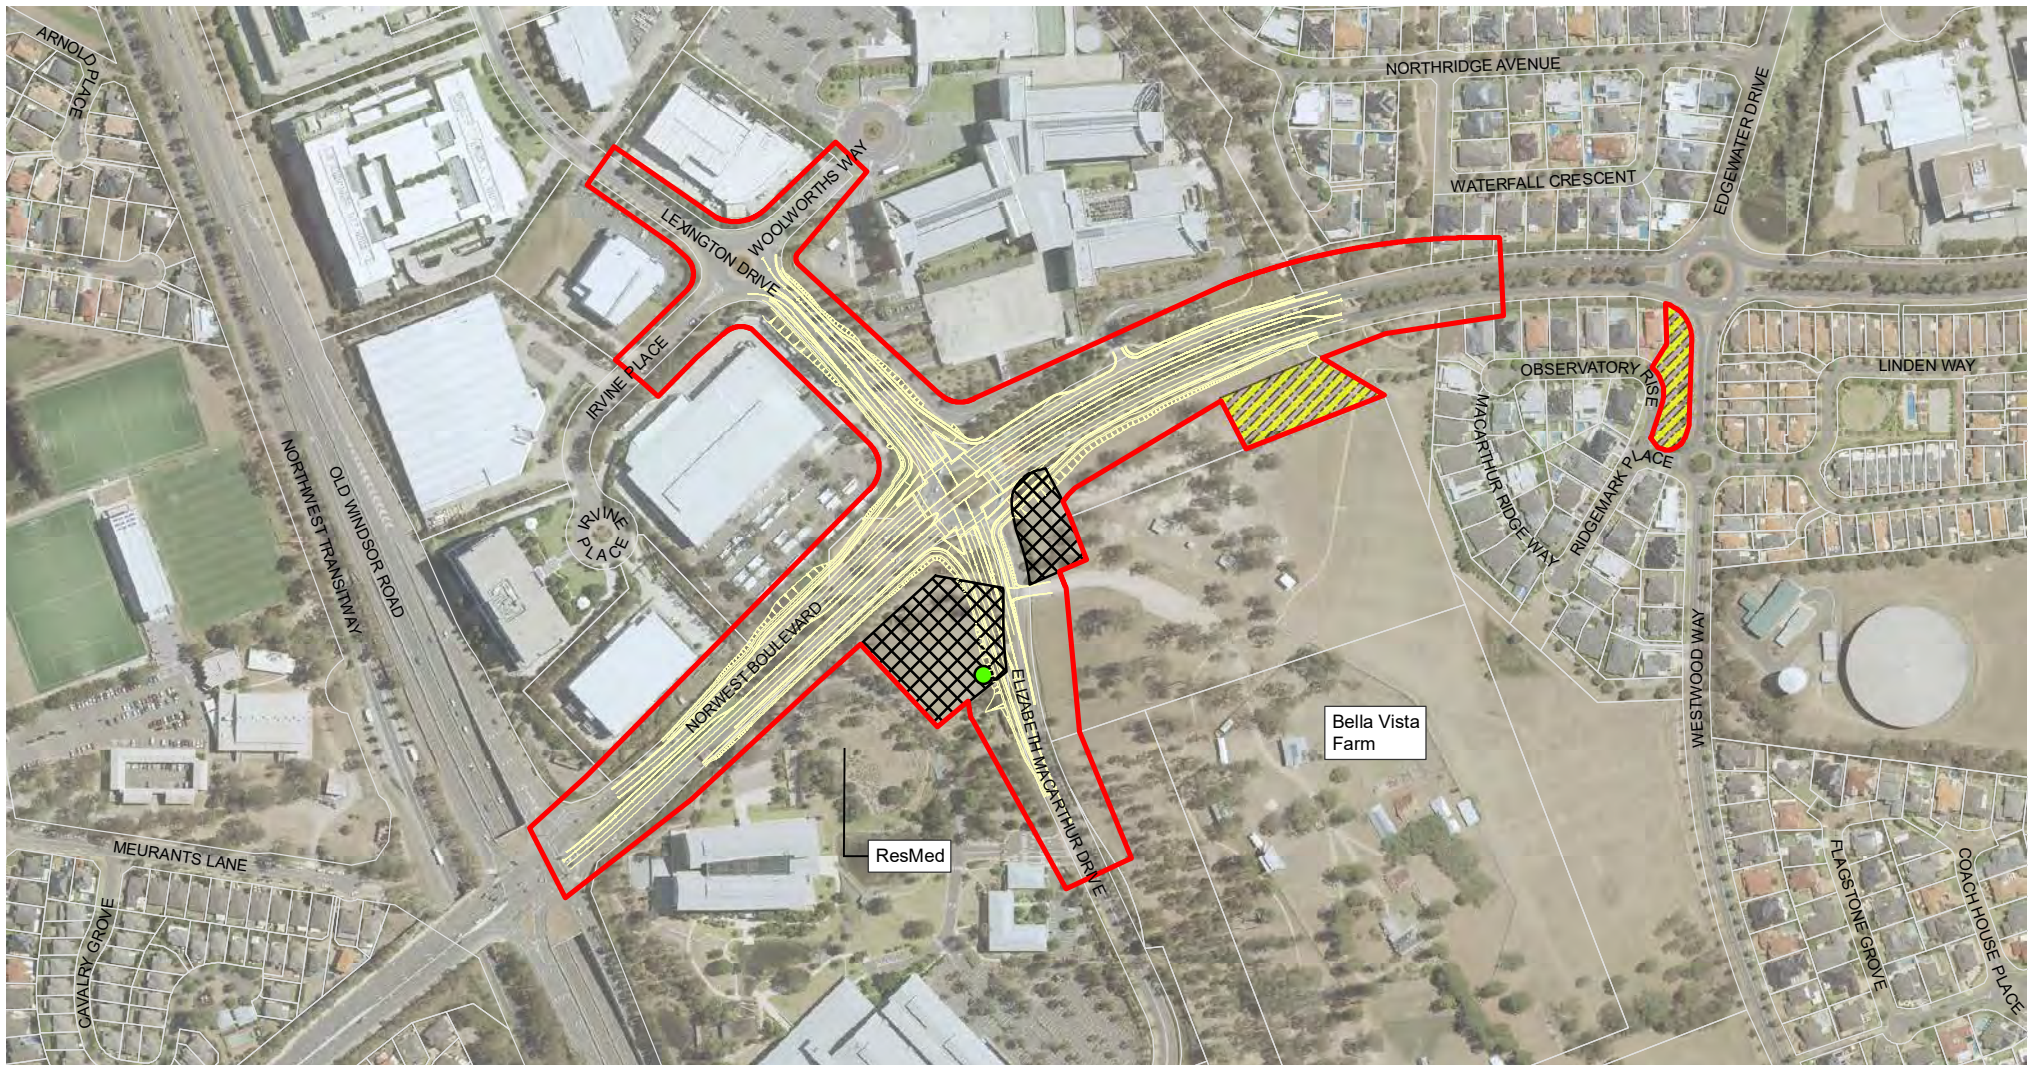
- Cadastre
- Concept Design (20191022)
- Study area
- ACM location
- High risk AEI
- Potential construction compound location - Options

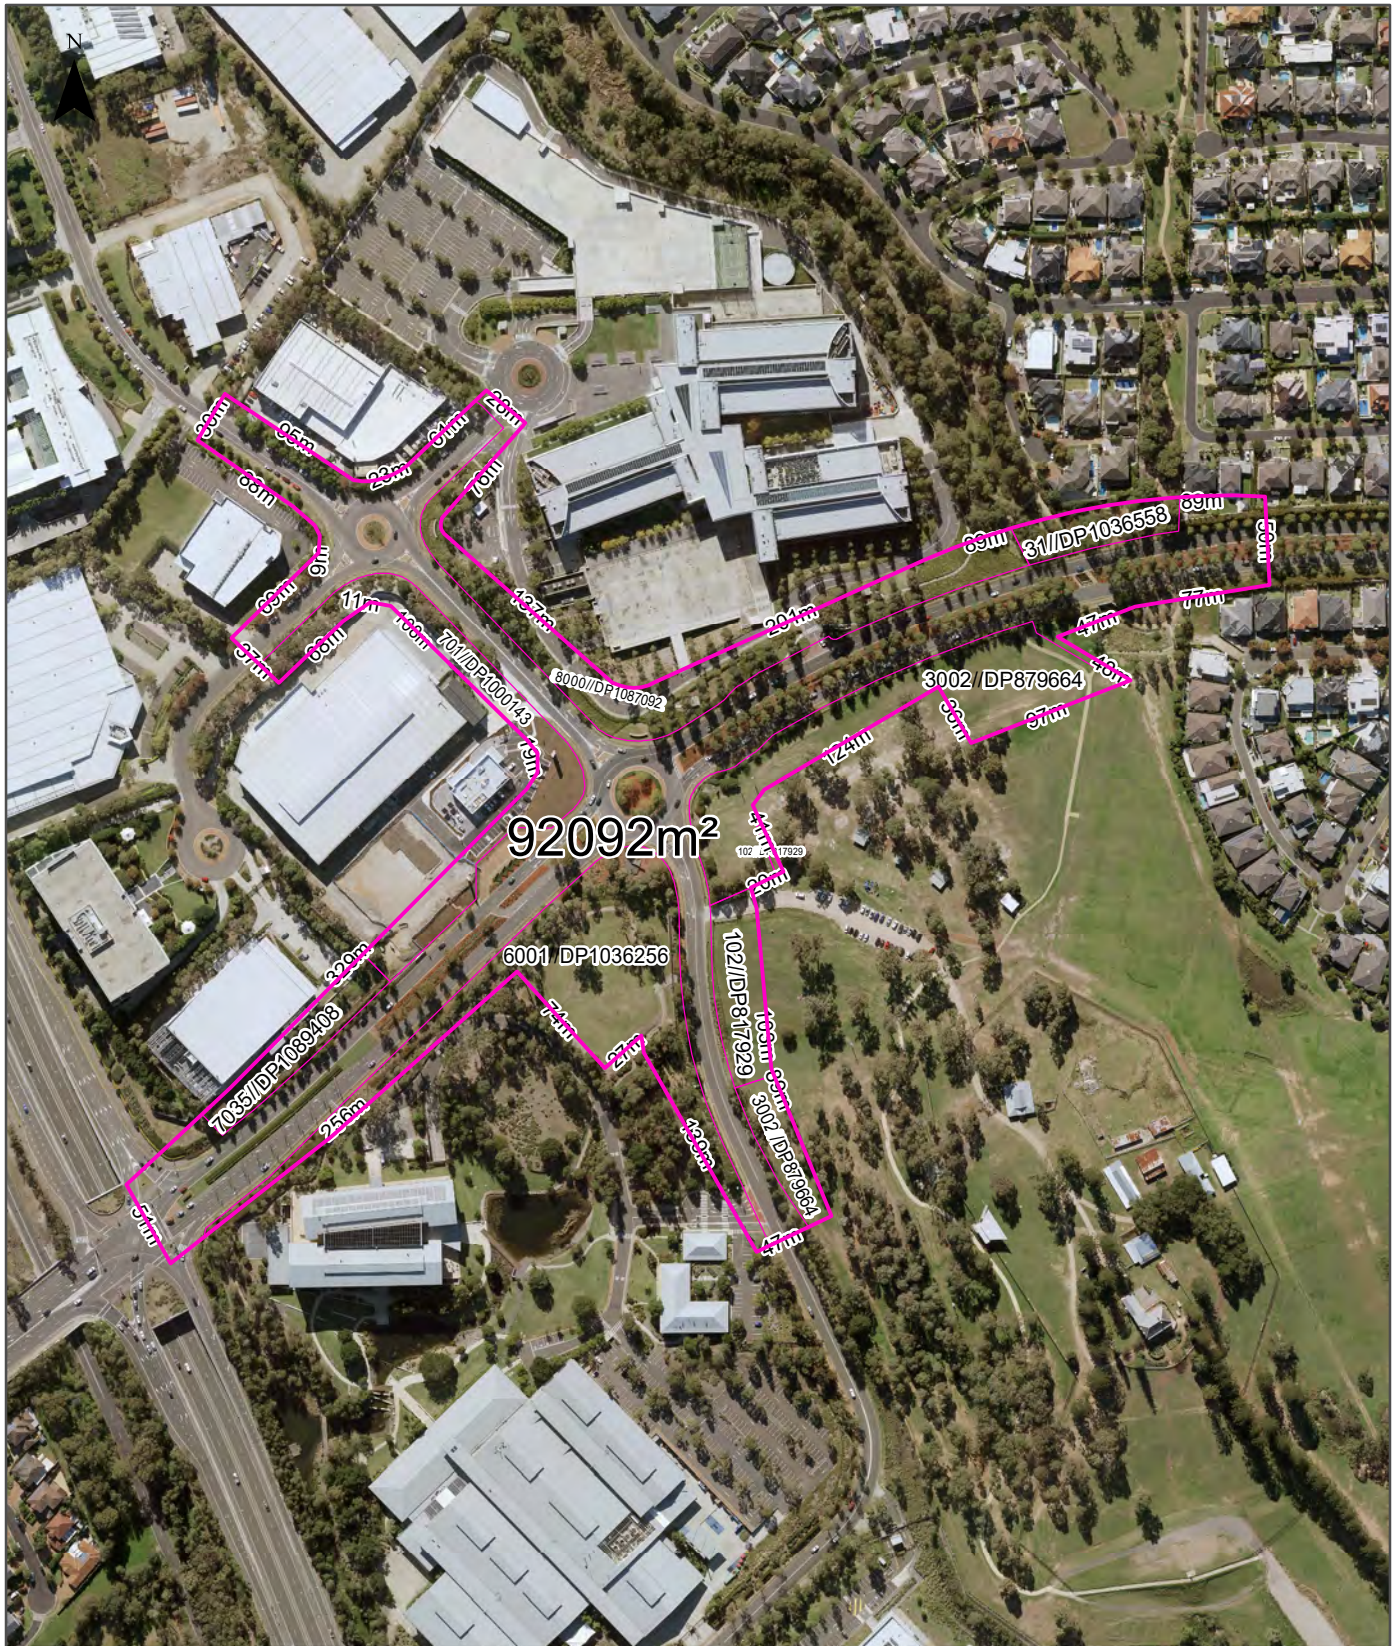
Site Diagram

Legend Site Boundary Internal Parcel Boundaries	Total Area: 92092m ² Total Perimeter: 2920m	Scale:
	Disclaimers: Measurements are approximate only and may have been simplified or smaller lengths removed for readability. Parcels that make up less than 2.0% of the total site area have not been labelled for increased legibility.	Data Sources: Aerial Imagery: © Aerometrex Pty Ltd
	Coordinate System: GDA 1994 MGA Zone 56	Date: 07 November 2019

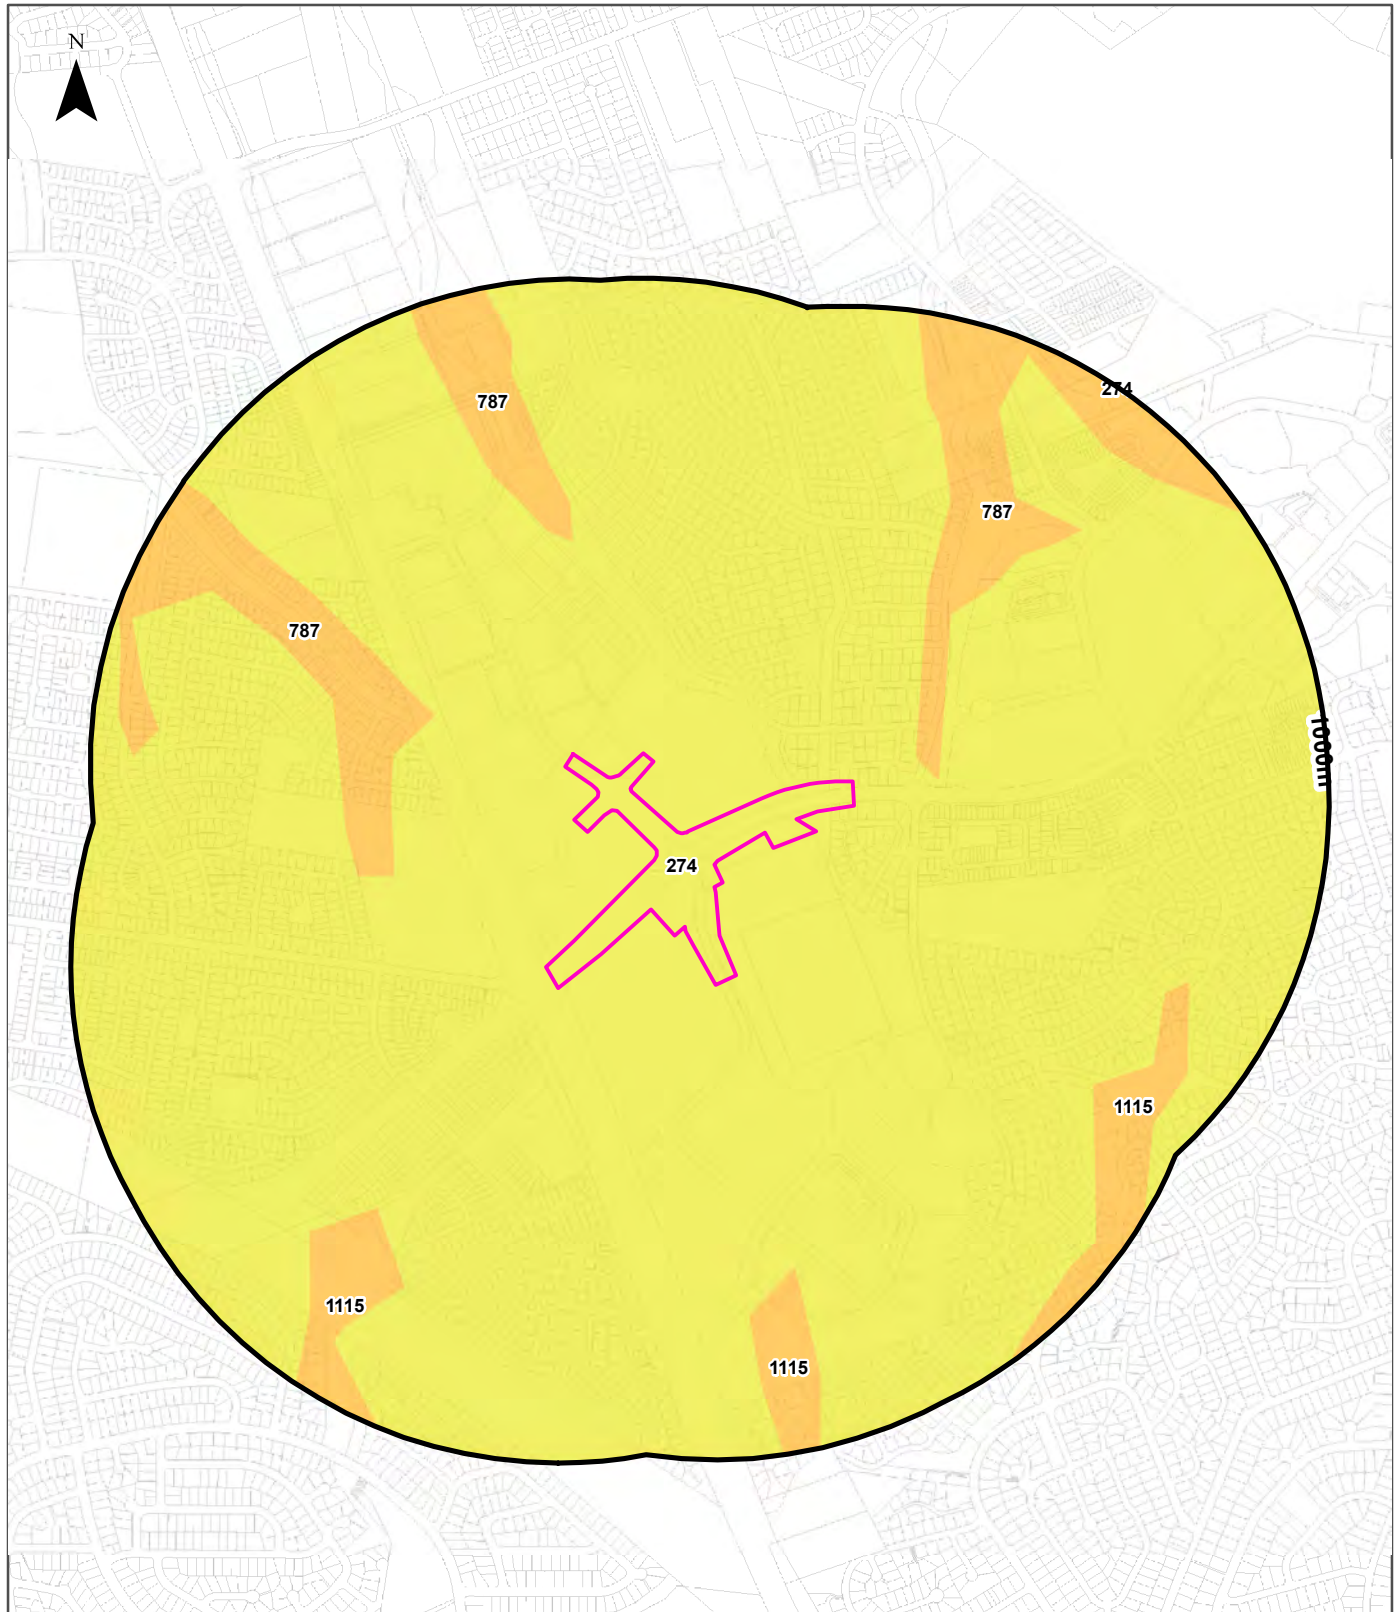
Legend	Dryland Salinity - National Assessment	Salinity Potential of Western Sydney
Site Boundary	Delineated risk area but no high hazard or risk rating for either 2000, 2020, 2050	Area of Known Salinity
Report Buffer	High hazard or risk in 2050 only	Area of High Salinity Potential
Property Boundary	High hazard or risk defined for 2050, but no assessment made for 2000 or 2020	Area of Moderate Salinity Potential
	High hazard or risk in 2020 and 2050	Area of Very Low Salinity Potential
	High hazard or risk in 2000 and 2050. 2020 not defined as high hazard	Area of Water
	High hazard or risk defined for all years: 2000, 2020, 2050

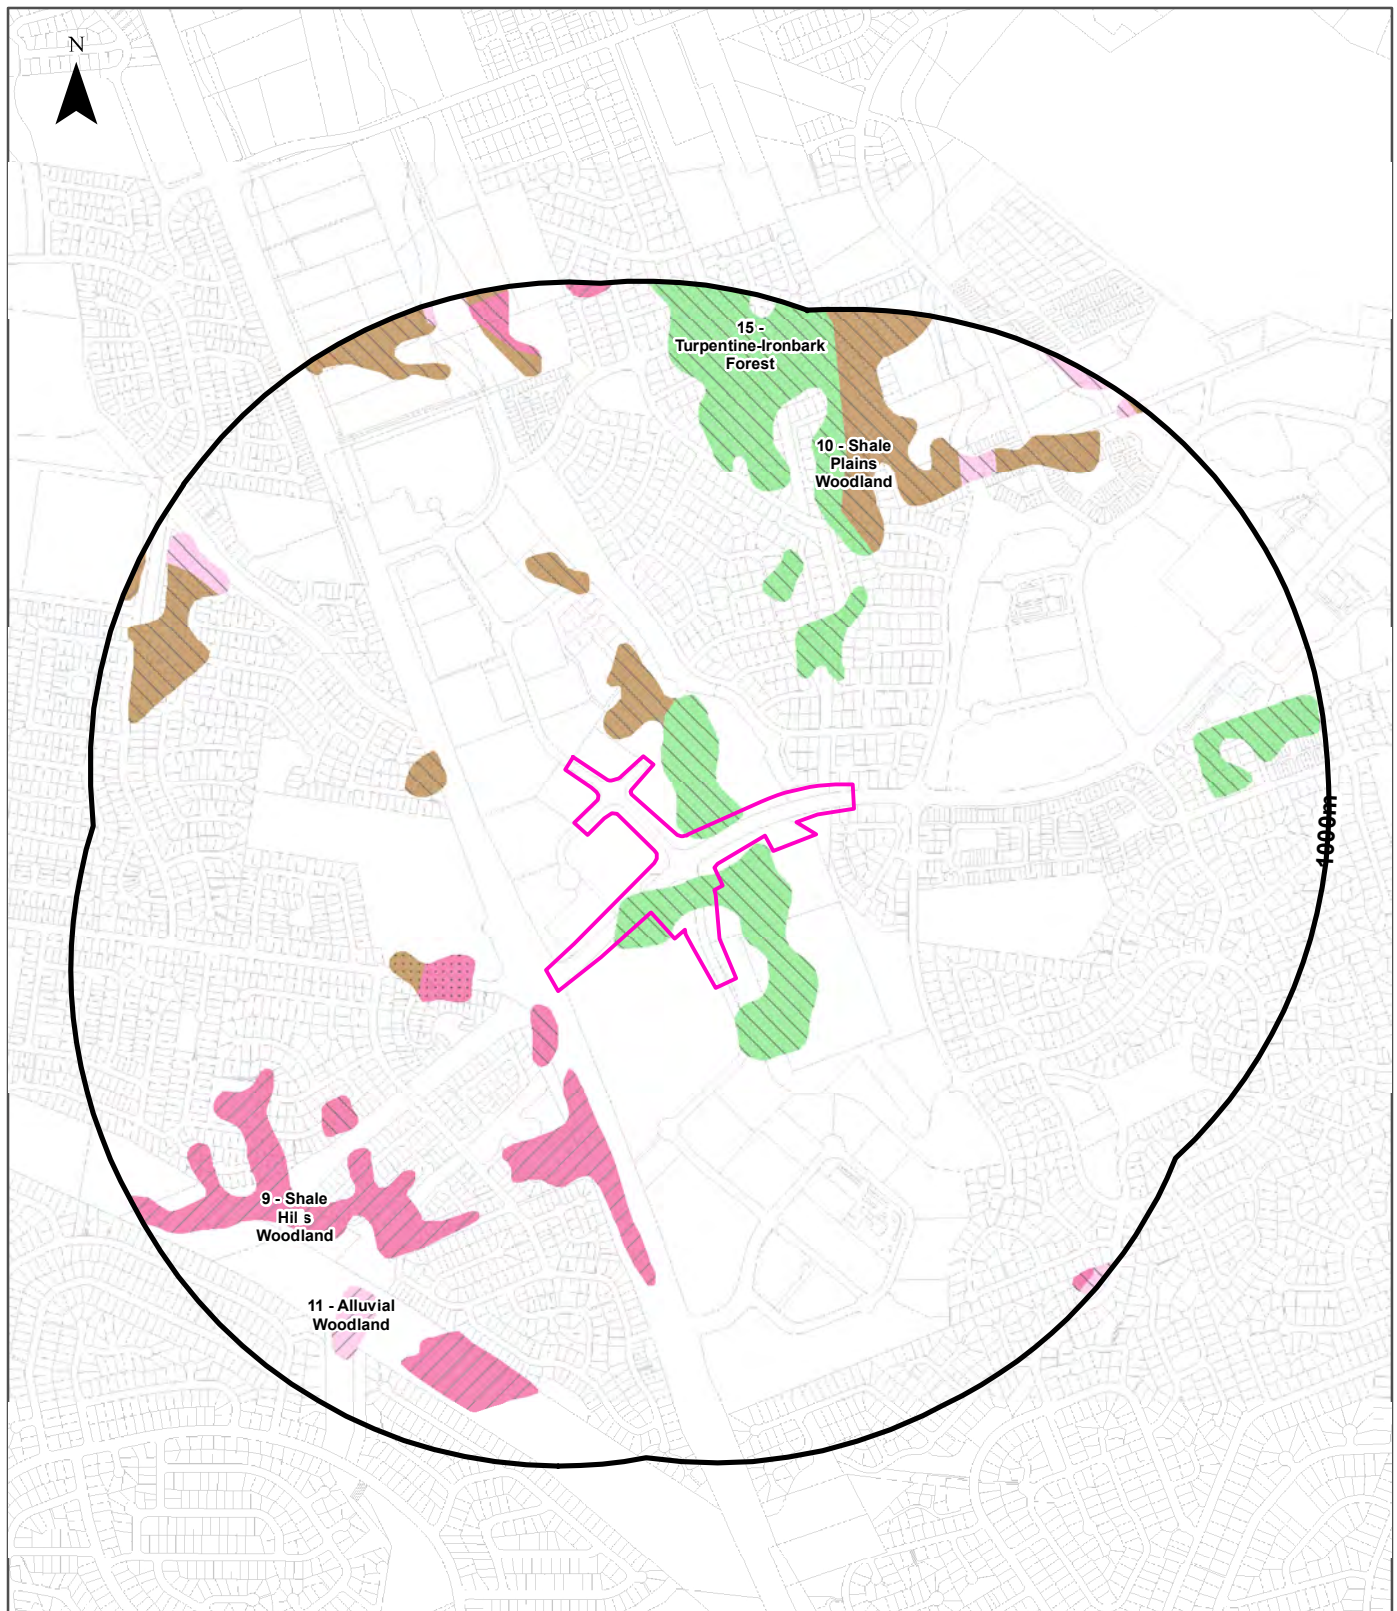
Ecological Constraints - Remnant Vegetation of the Cumberland Plain

Legend		Cumberland Plain Vegetation	
	Site Boundary		Crown cover greater than 10%
	Report Buffer		Crown cover less than 10%
	Property Boundary		Crown cover less than 10% (urban areas)
	RAMSAR Wetlands

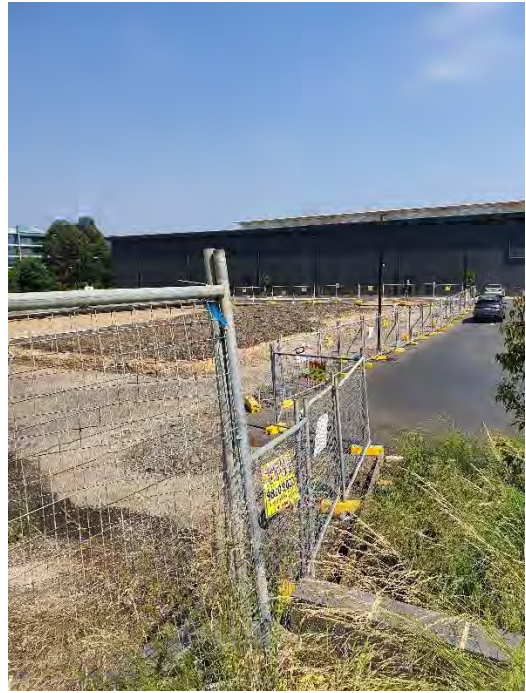
Photograph 14: Photo of existing construction site adjacent to the Lexington Drive McDonald's looking north from Norwest Boulevard (Eastings – 310330; Northings - 6265032)
