WestConnex Enabling Works Airport East Precinct.

Statement of Heritage Impact.

(Historic Heritage)

December 2014

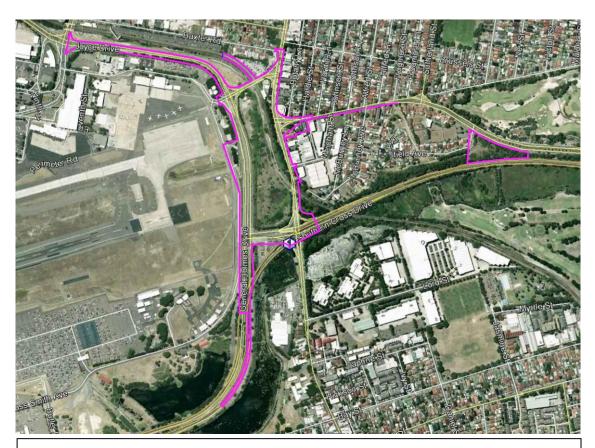
Figure 1.2. Boundaries of the study area for the WestConnex Enabling Works, Airport Precinct, Mascot, NSW. (Based on RMS Plan 2014 and Google. Updated by Stedinger).

Botany Bay, the Parish of Botany and the County of Cumberland (Figure 1.1). Situated adjacent to Kingsford Smith Airport, the study area and location of proposed works is irregular. Generally, it is bounded by General Holmes Drive, Joyce Drive, Wentworth Avenue, King Street and O'Riordan Street. It includes the following roads and land between them as shown in Figures 1.1 and 1.2:

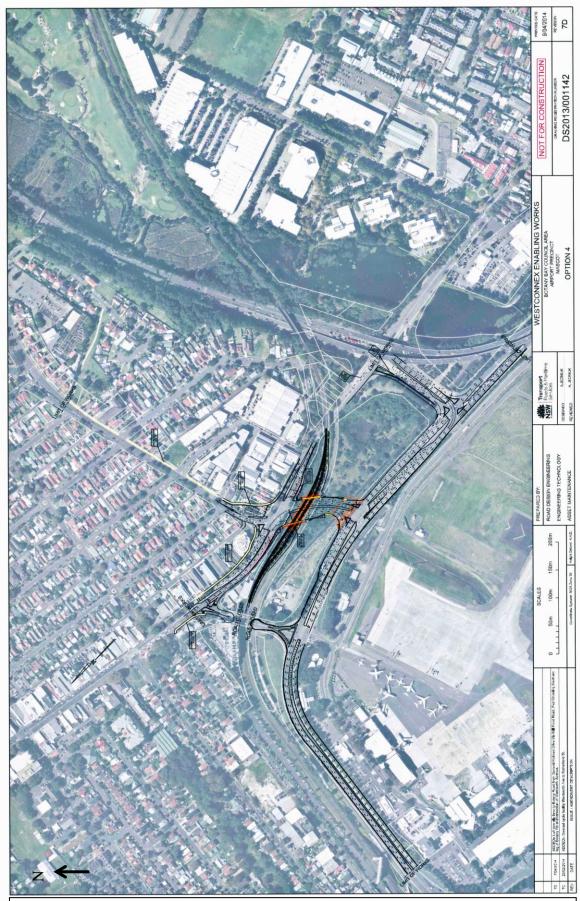
Figure 2.1. WestConnex Enabling Works. Botany Bay Council Area. Airport Precinct. Mascot. Option 4. Dated 9th April 2014. Roads and Maritime Services.

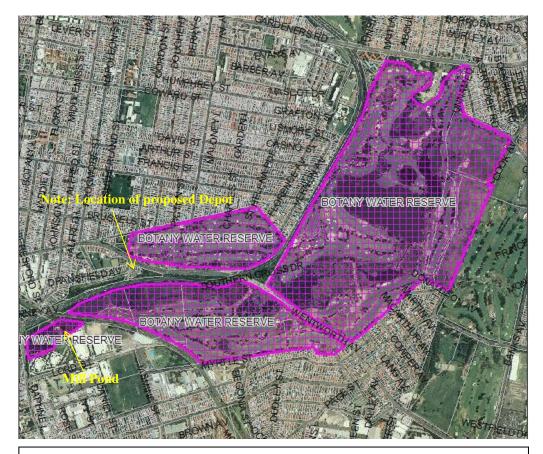
Figure 3.5. Curtilage plan of Botany Water Reserve. By Sydney Water (S170 Register).

Several Items have been recorded on the Sydney Water S170 Register. In particular, the Botany Wetlands occurs in the immediate vicinity of the proposed works. They are registered as Item No.4570025. The remaining items are located outside the study zone in the wider area and will not be impacted by the proposed works.

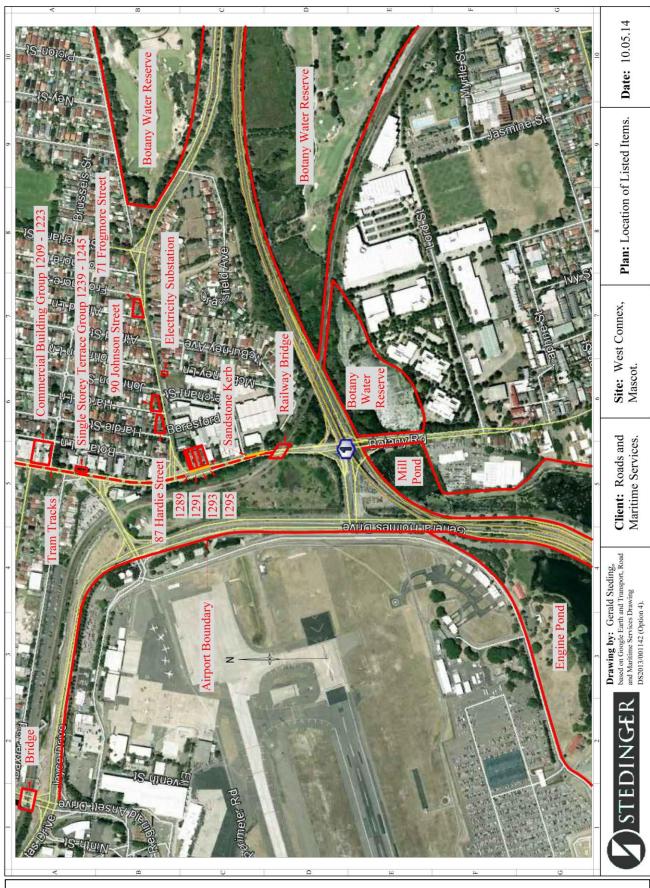
Figure 3.6. Plan showing the locations of heritage sites within and in the immediate vicinity of the study area. WestConnex, Airport East Precinct. By Stedinger Associates, 2014. Detail plans are presented in Chapter 6.

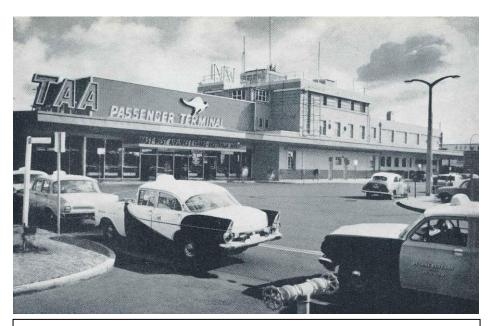
Figure 4.6. Sydney International Airport. In F.A. Larcombe (1970), *The History of Botany 1788-1970.* The Council of the Municipality of Botany. p.72.

Botany's wool and leather industries continued to grow for many years. In 1894 wool scourers, tanners and other industries were permitted to return to the wetlands area, leasing land from the government's water supply authorities until 1947. That year land from the Ascot Racecourse was resumed for an extension to Kingsford Smith Airport. Between 1947 and 1952 two thirds of the proposed east-west runway was constructed along the centre of the existing Cook's River requiring the river's diversion to the western boundary of the airport. The expansion also involved substantial filling of the Engine and Mill Ponds, the diversion of the Water Board's two main sewers, and the diversion of General Holmes Drive. The runway had a final length of 2515 metres.

The north-south runway was intended to be the main runway. However, by 1963 under new aircraft requirements, the main runway had to be longer than the east-west runway. Because the north-south runway had a length of only 1798 metres, land was reclaimed in Botany Bay for its increase to 2835 metres. The main runway was opened in 1968. It was extended to 3960 metres in 1972 to allow Concorde, DC10 and Boeing 747s to operate

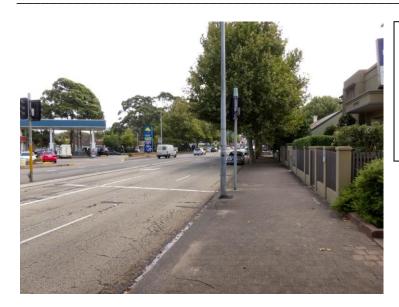
It is possible that the tram tracks continue beneath the bitumen for the length of the subject interval of Botany Road, with the exception of that area beneath Southern Cross Drive. Repaired cracks in the bitumen suggest that the tram tracks remain in situ from Banksia Street in the south to Robey Street in the north. The filled cracks for example, continued past the School of Arts at No.1361 northwards to No.1058 and the Mascot RSL Club and adjoining buildings at 1305A and 1303 Botany Road. The cracks continued northward passing Nos.1247-1251 and No.1229 Botany Road.

Image 5.17. Possible tram tracks, Plane trees and cottages beyond modern units along Botany Road (No.1247-1251). Facing north. Stedinger Associates 2012. Image 0352.

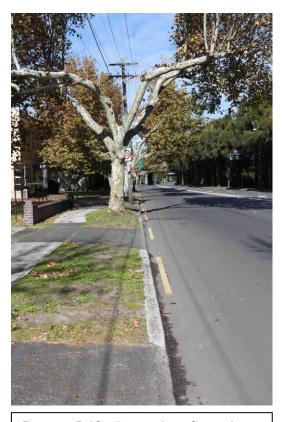
One area of sandstone kerbing occurs outside the Beckenham Memorial Church and Hall and continues up to No.1291 Botany Road near Wentworth Avenue. It survives in three intervals separated by driveways. The intervals extend, from south to north, for 5.5 metres, 5.5 metres and 3.2 metres. The sandstone blocks are in fair condition and have been faced using picks. While they are water worn, broken and weathered, they have not been displaced by vehicles. The blocks vary in size from 400mm to 1.5 metres. No alignment pins were found at of in the vicinity of the kerbing.

Image 5.18. Intervals of sandstone kerbing near Wentworth Avenue. Facing south. Stedinger Associates 2014. Image 2148.

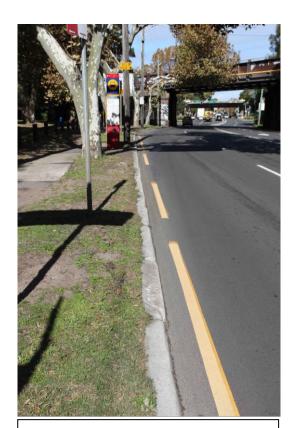
Another section of sandstone kerbing occurs to the south. It extends approximately 70 metres between Bronti Street and the Mascot (Botany Road) Underbridge. This line of kerbing is mostly continuous. The sandstone blocks are in fair condition and have been faced using picks. The blocks vary in size from 500mm to 1.5 metres. While the stones are water worn and weathered, they have not been displaced by vehicles. Although it is interrupted at McBurney Avenue earlier efforts by Roads and Maritime Services have seen the re-setting of an alignment in the centre of this roadway at Botany Road. Here, a piece of sandstone with a broad arrow survey mark has been retained. Beside it another cast iron broad arrow survey mark has been set.

Image 5.19. An extensive line of sandstone kerbing between Bronti Street and the Mascot (Botany Road) Underbridge. Facing south. Stedinger Associates 2014. Image 2153.

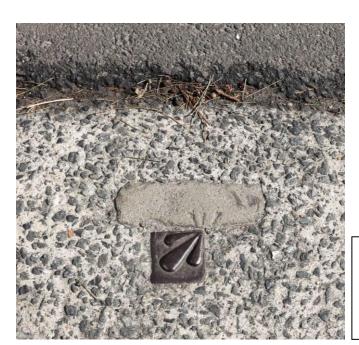
Image 5.21. Detail of the alignment pins at McBurney Avenue and Botany Road. Stedinger Facing west. Associates 2014. Image 2159.

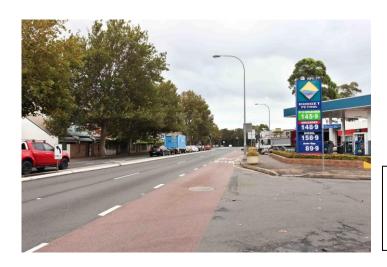
Image 5.22. Plane trees along Botany Road. View south from Bronti Street. Stedinger Associates 2012. Image 1651.

⁴⁵ after Hare, Tom. 2011. Aboricultural Assessment Botany Road, Mascot. Road clearances and kerb and gutter rehabilitation. For NSW Roads & Traffic Authority. p.8-10, 12-14, 22.

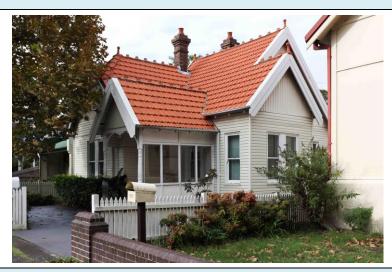
Image	Caption			
1291	Botany	Road,		
Masco	t.	Facing		
northeast				
Image	No.			
1673				
Image	Date			
2014				
Photog	grapher			
Stedin	ger Asso	ociates

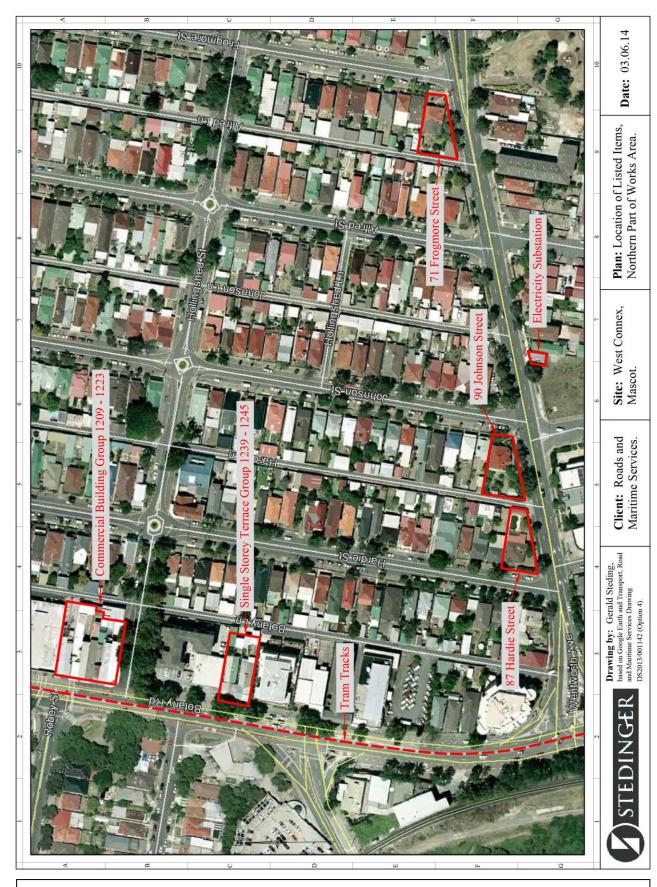
Figure 6.3. Detail plan showing the locations of heritage sites to the north within and in the immediate vicinity of the study area. WestConnex, Airport East Precinct. By Stedinger Associates, 2014.
