# A closer look at Jenolan Caves Road at Five Mile

# Steps to recovery of Jenolan Caves Road at Five Mile

# Jenolan Caves Road at Five Mile

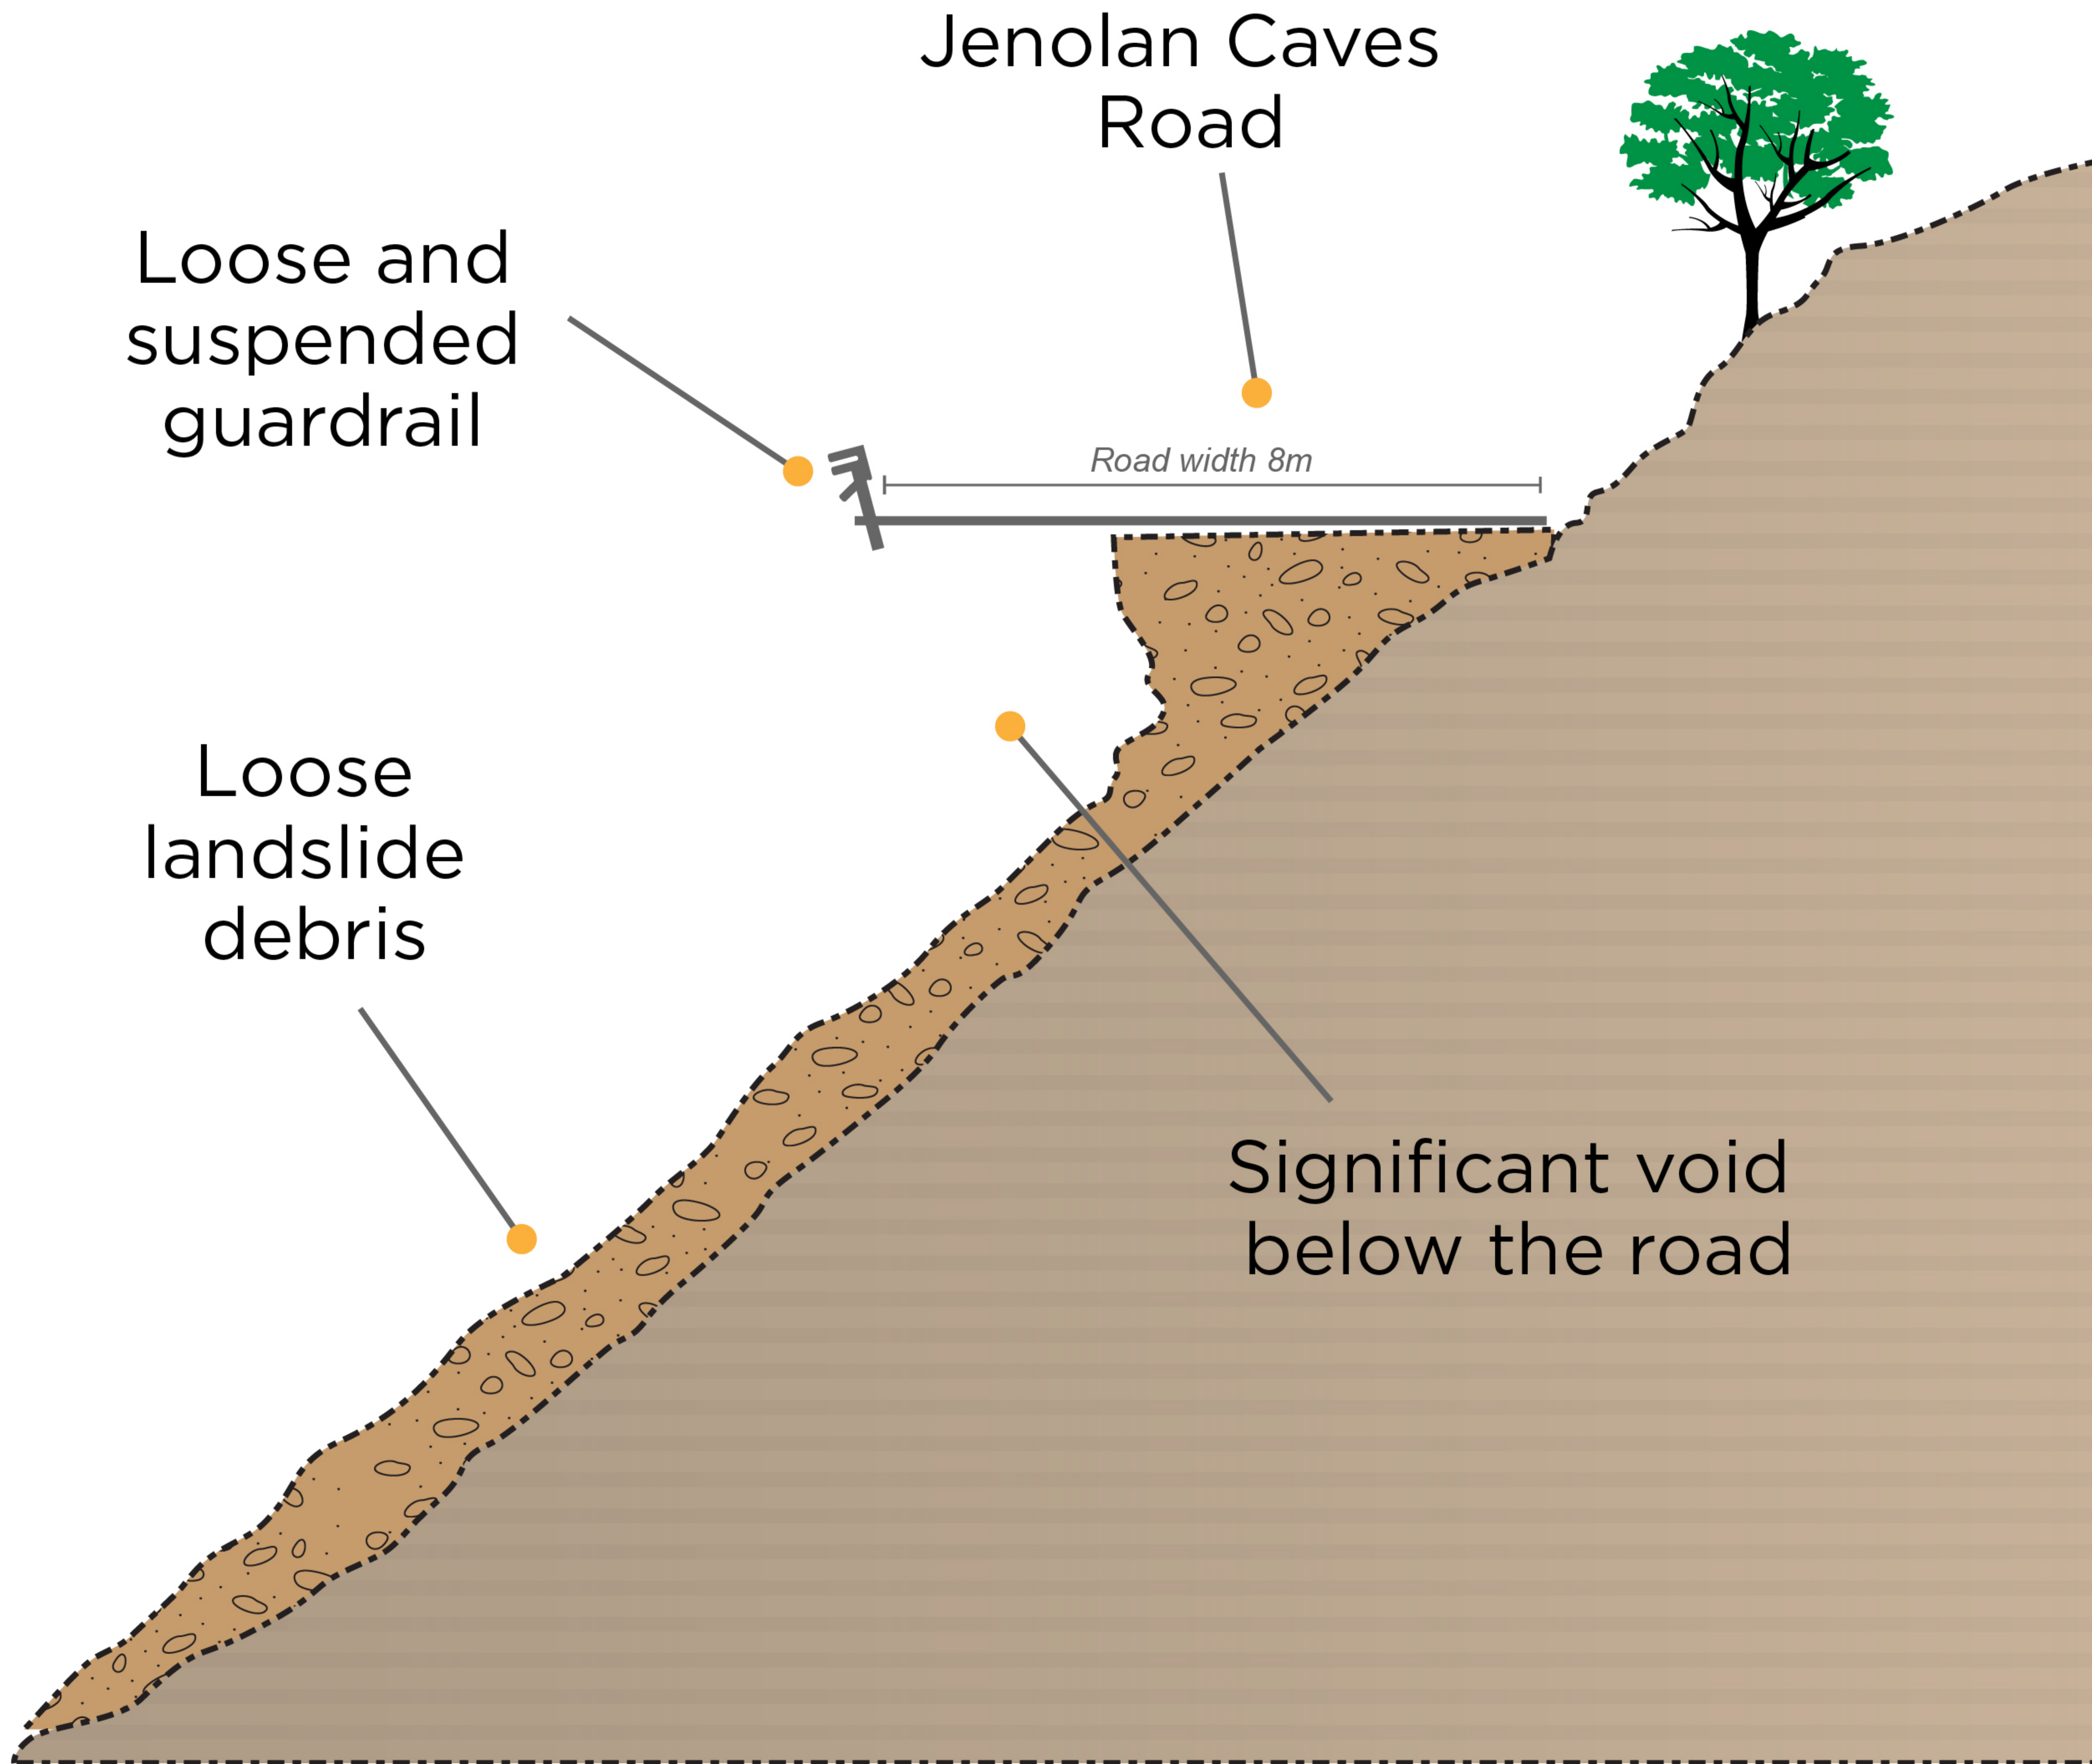
> The road is currently unsupported and the weight of traffic likely to cause further collapse

> Guardrail is suspended in mid-air, offering no restraint to errant vehicles

> There is continued erosion below the road - increasing the size of undermining and voiding (exacerbated due to wet weather)

> The ground below the road is steep and difficult to access making reinstatement very complex
