A closer look at Jenolan Caves Road at Hampton

Steps to recovery of Jenolan Caves Road at Hampton

Jenolan Caves Road at Hampton

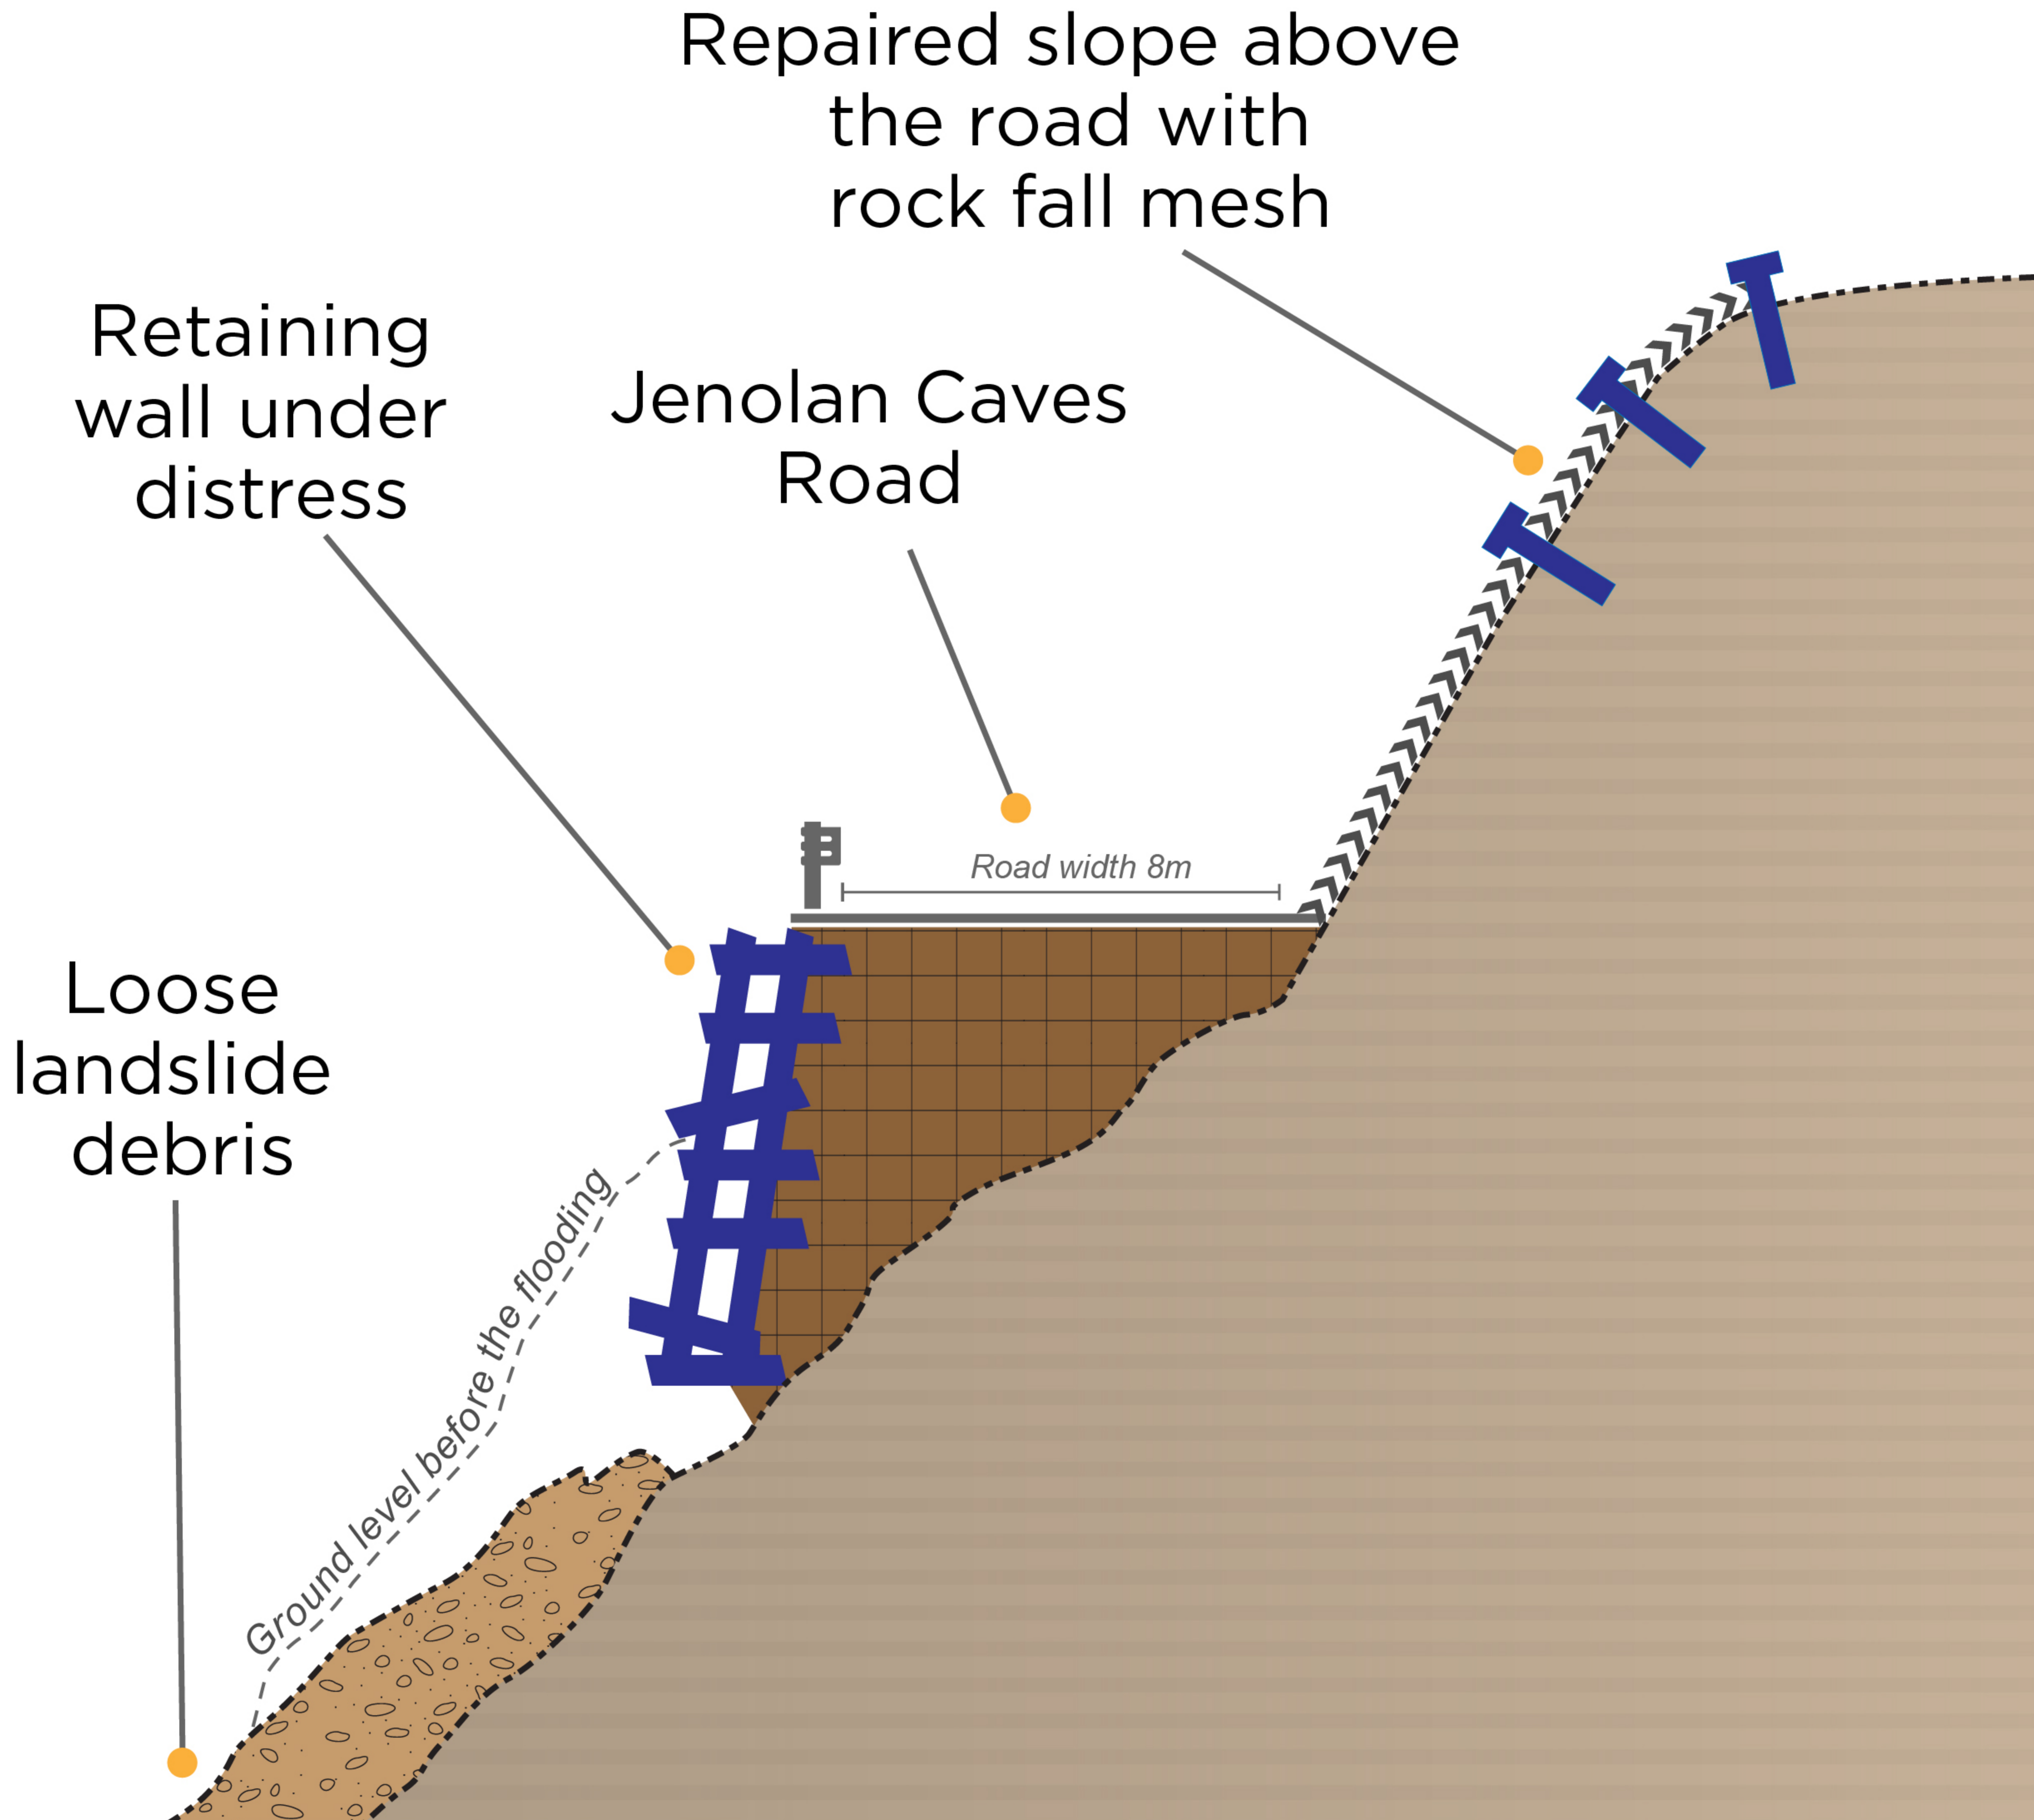
- The slope above the road has been repaired with significant scaling works to remove loose debris, install rock bolts and rock fall mesh
- On the slope below the road, some sections of retaining walls affected by erosion are exposed and hanging in mid-air offering no support to the road
- Continued erosion from wet weather below the road is increasing the size of the affected areas
- Traffic is not permitted over the affected areas to reduce the risk of road collapse
- Steep ground below the road makes repair and reinstatement very challenging
