## 7 Assessment of key issues

### 7.1 State and local historic heritage and maritime heritage

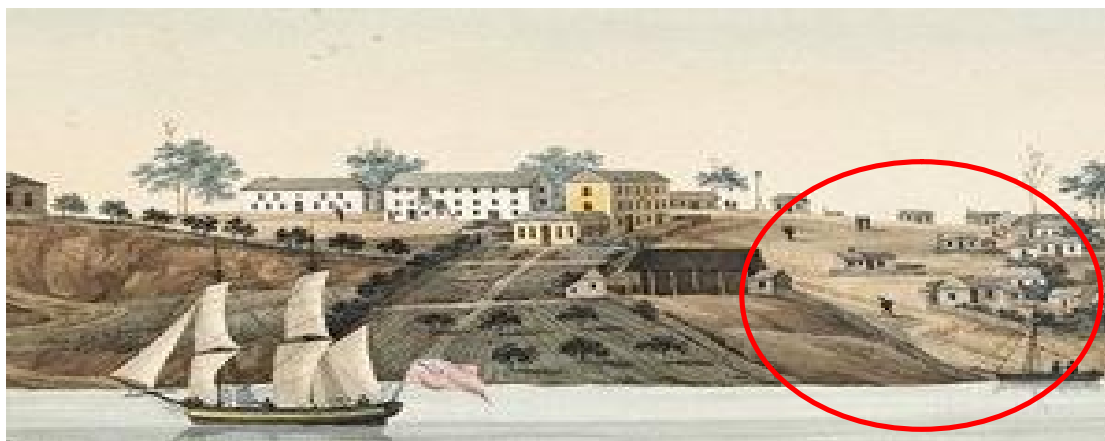
**Figure 7-1 Detail from George William Evans' 1809 watercolour showing a boat in front of what is likely to be the wharf and its associated access track (circle shows approximate location of Thompson Square)**

By the early 1800s, Thompson had acquired a farm on South Creek outside the main precinct. This became his principal home at Windsor and his lease on the square became the focus of his commercial activities, including the establishment of stores and workshops. With the river providing a direct link to Sydney, the area became a focus of commercial activity. A painting from 1809 shows clusters of buildings on the eastern and western sides of an area of open space, with a road running through the open space to what is likely to be the location of the first wharf (see **Figure 7-1**). Two of the buildings in the painting are likely to be Thompson's stores (see **Figure 7-2**).

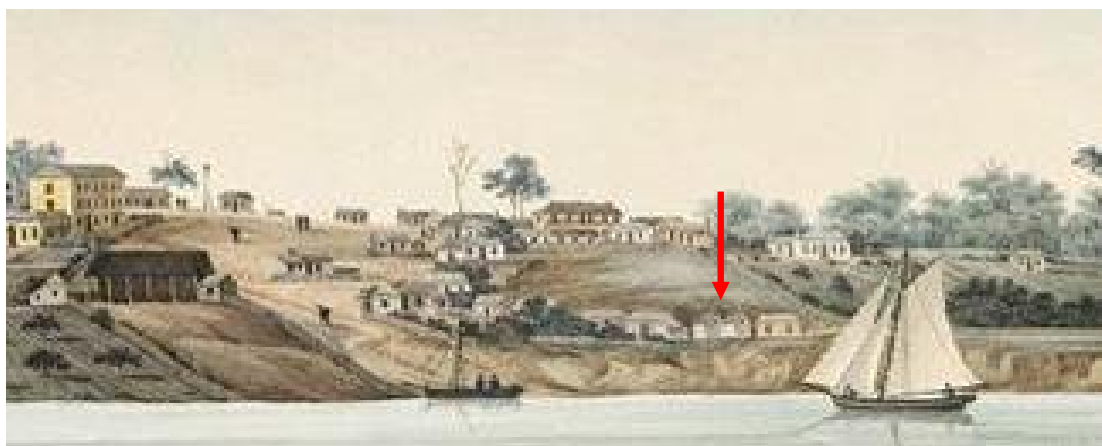
**Figure 7-2 Detail from George William Evans' 1809 watercolour showing what are likely to be two of the store buildings (indicated by red arrow)**

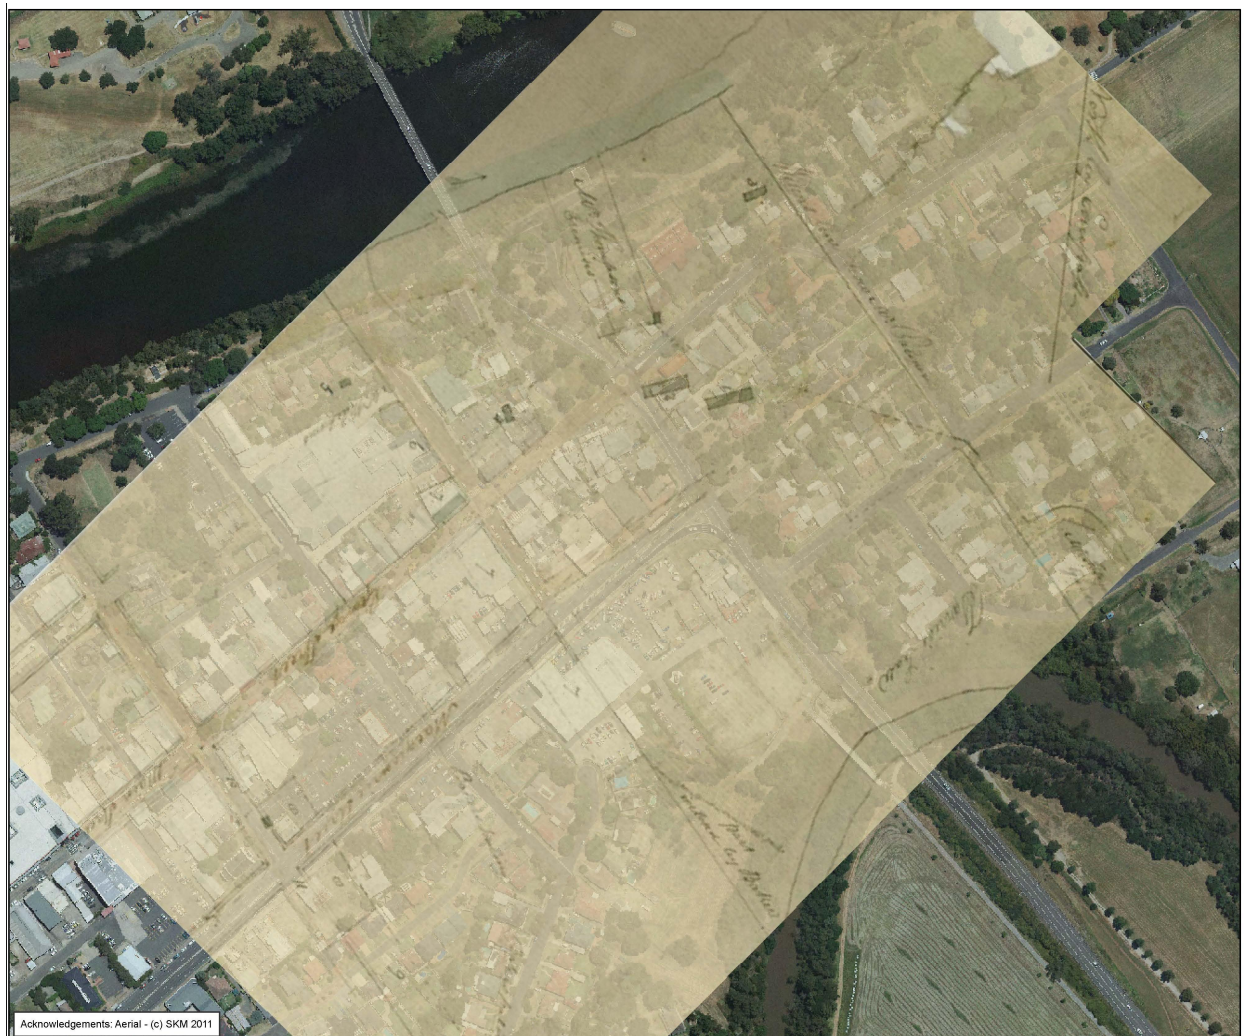
**Figure 7-3 Historical overlay of Windsor (Meehan 1812)**

Between 1812 and 1813, the newly founded Thompson Square was physically changed so that it conformed more to the standard ideal of a town square (see **Figure 7-3** and **Figure 7-4**). This included removing large numbers of buildings, leaving essentially only the most substantial buildings from the previous years of settlement, namely the stores, Government House, Thompson's store, Thompson's first small cottage, and the military barracks. New buildings were also constructed and old buildings renovated or adapted for new purposes (HRA Series 1 Volume 10; 690-1).

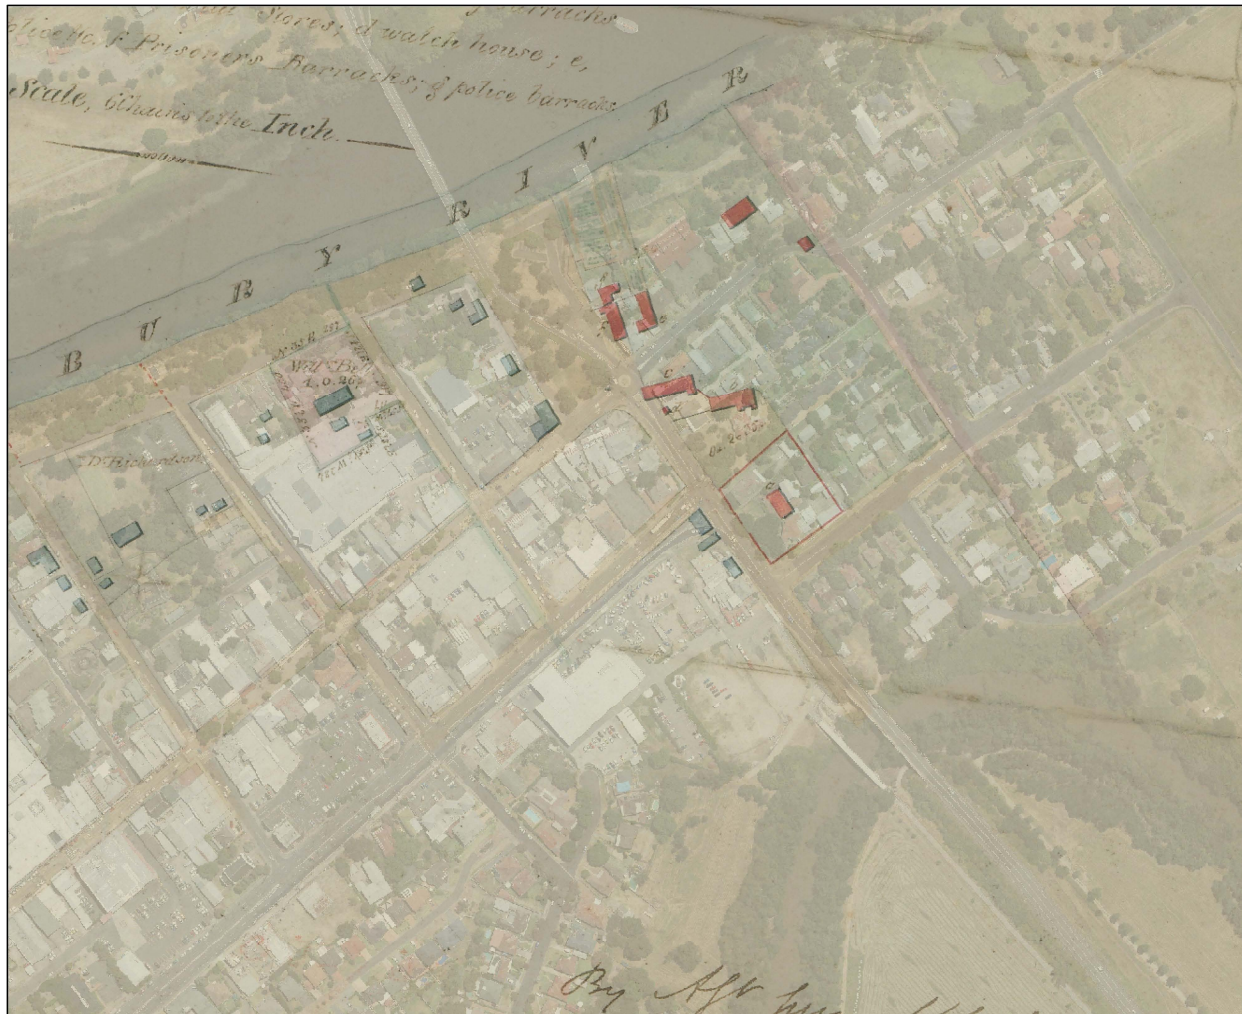
**Figure 7-4 Historical overlay of Windsor (Abbot 1831)**

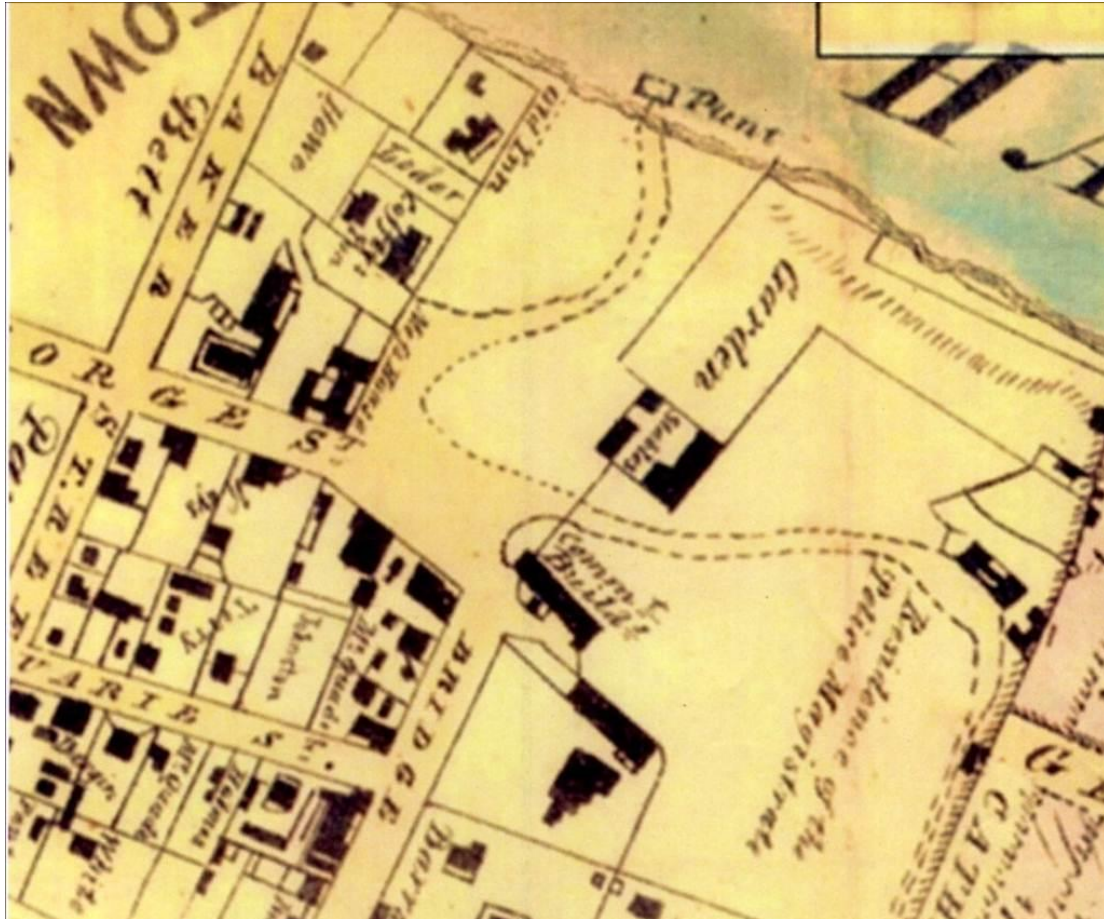
**Figure 7-5 Detail of Armstrong's plan of the town in 1842 showing the stables on the eastern side of the Square and the inns and private properties on the western side and the commercial precinct at the southern end**  
 Source: Jack (2010)

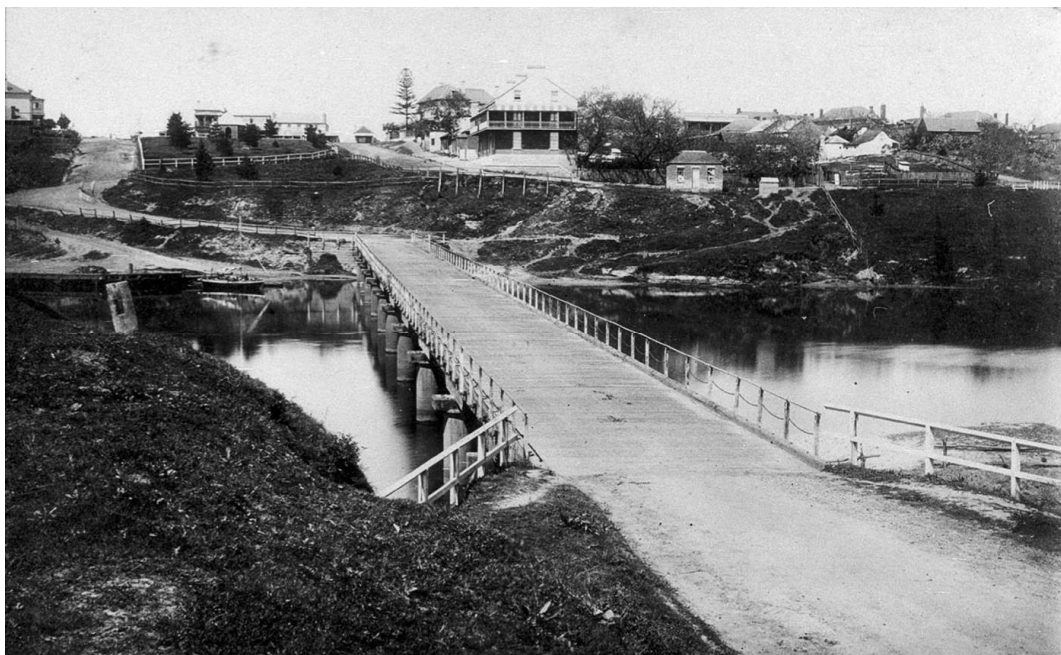
**Figure 7-6 1888 Windsor Bridge and Thompson Square**  
 Source: James Mills, ND Photograph, undated image of the square ML At Work and Play Image 04405

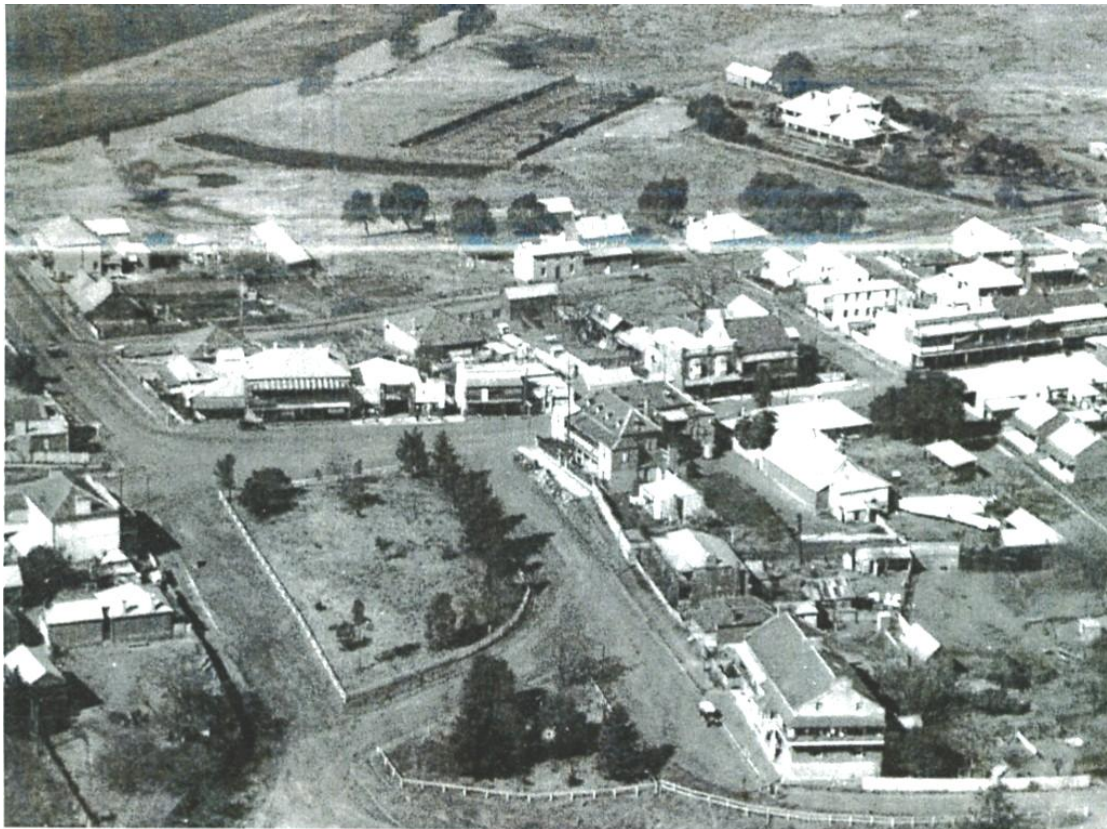
**Figure 7-7 Thompson Square in 1929 before the final changes were made to the roads (JHHS 2011 No 2: 21).**
