7.9 Flora and fauna

This section assesses the potential impacts of the project on terrestrial and aquatic flora and fauna, vegetation communities and potential fauna habitats. The full details of the study are presented in the Flora and fauna working paper (Volume 4 – Working paper 10). The assessment has been prepared to meet the relevant Director General's requirements in **Table 7-68** below as well as the relevant requirements of Schedule 2, Part 3 of the *Environmental Planning and Assessment Regulation 2000*.

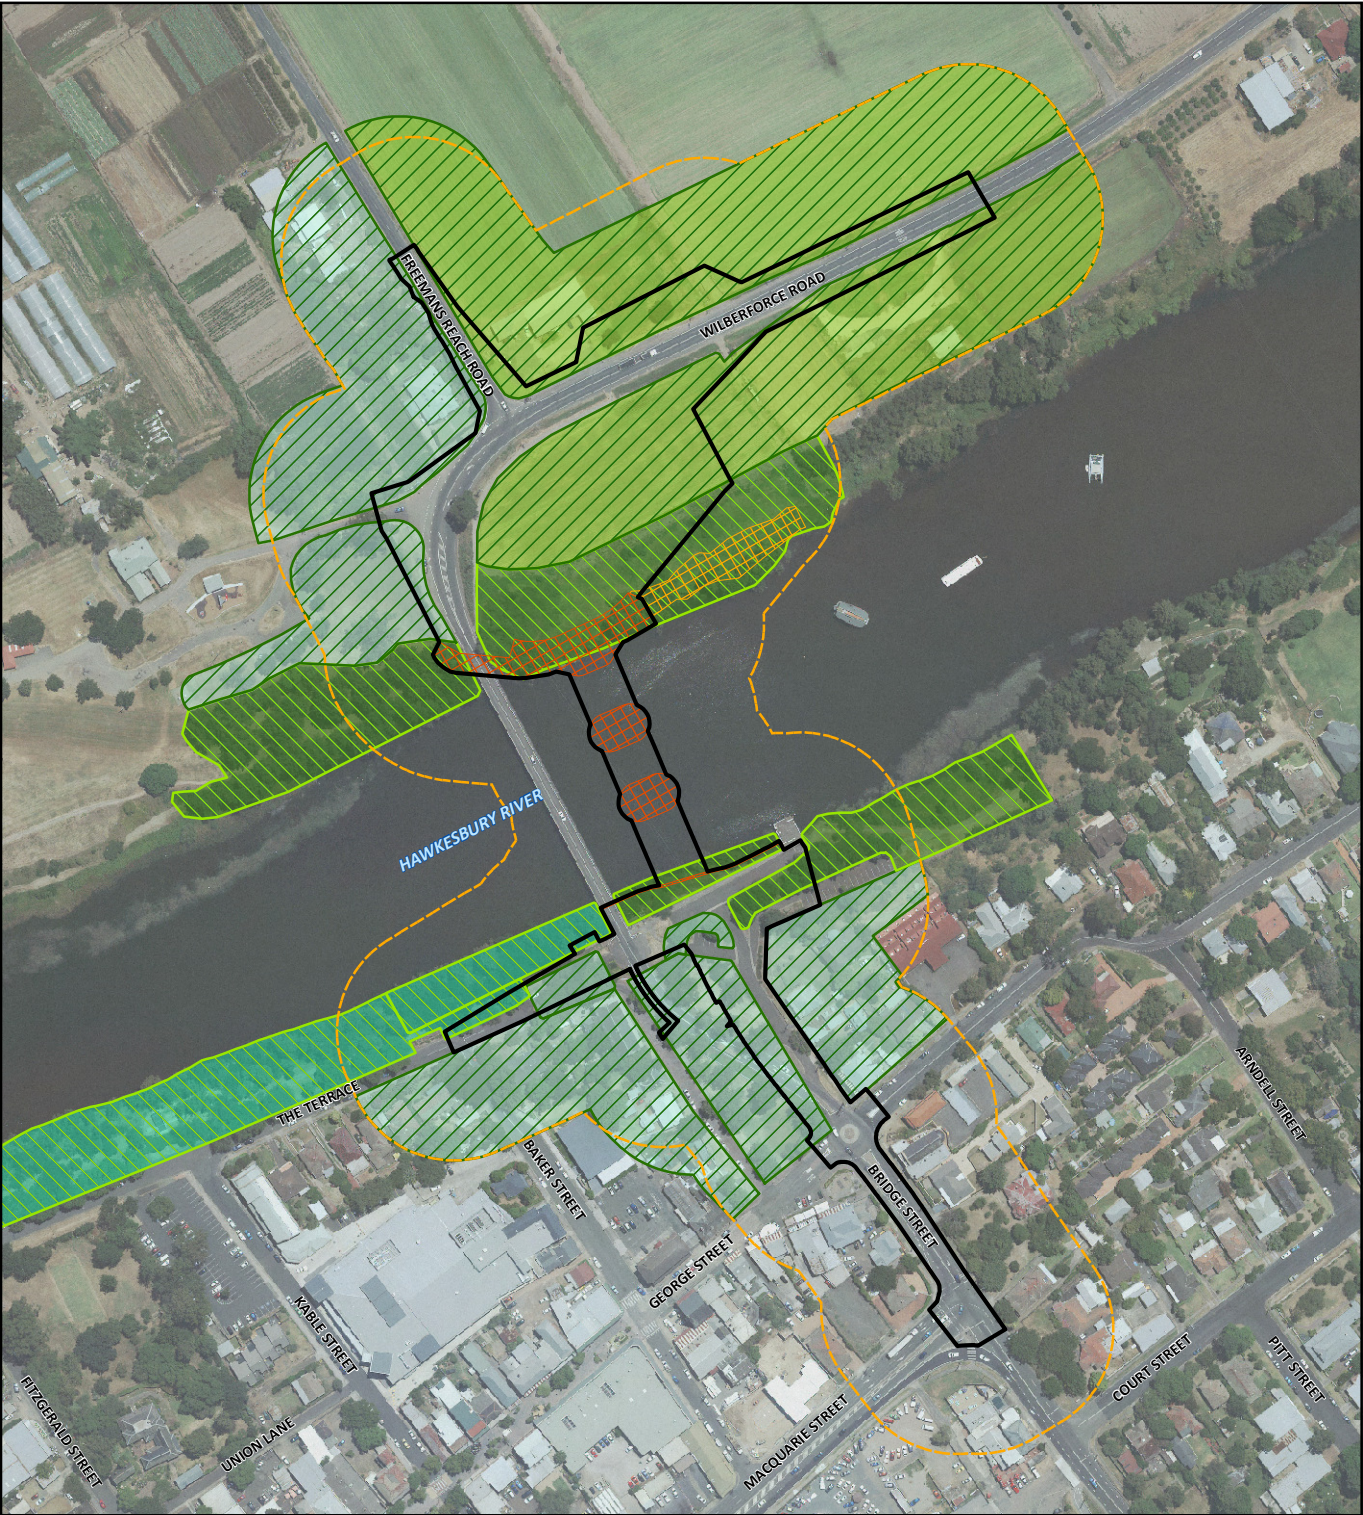
Figure 7-39 | Survey results

Four vegetation communities were identified during the field survey and have been shown on **Figure 7-39**. The attributes of these communities are outlined in **Table 7-69** and further described below. In general, the existing vegetation was found to be in poor condition and is identified as having low ecological value.

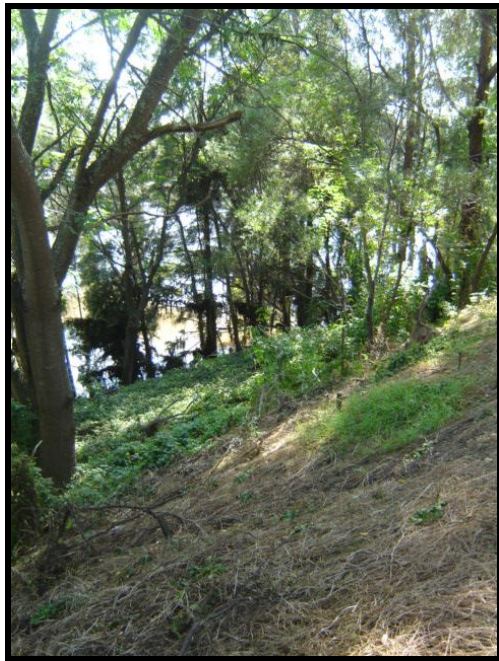
Figure 7-40 Riparian Casuarina open forest in low condition in the study area (south east of the existing bridge)

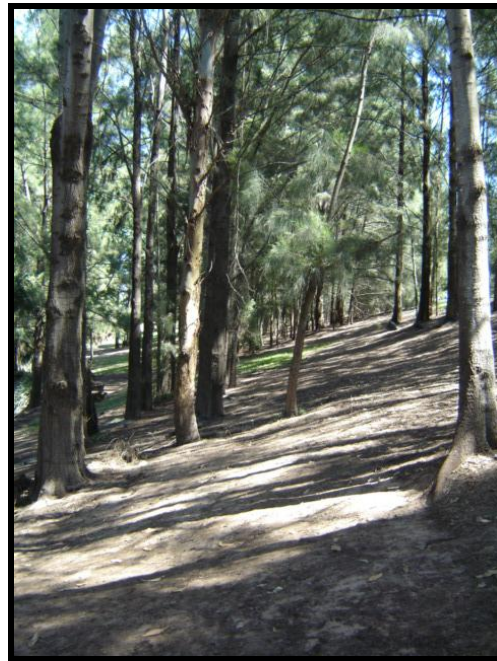
Figure 7-41 Modified riparian forest in low condition (north west of the existing bridge)

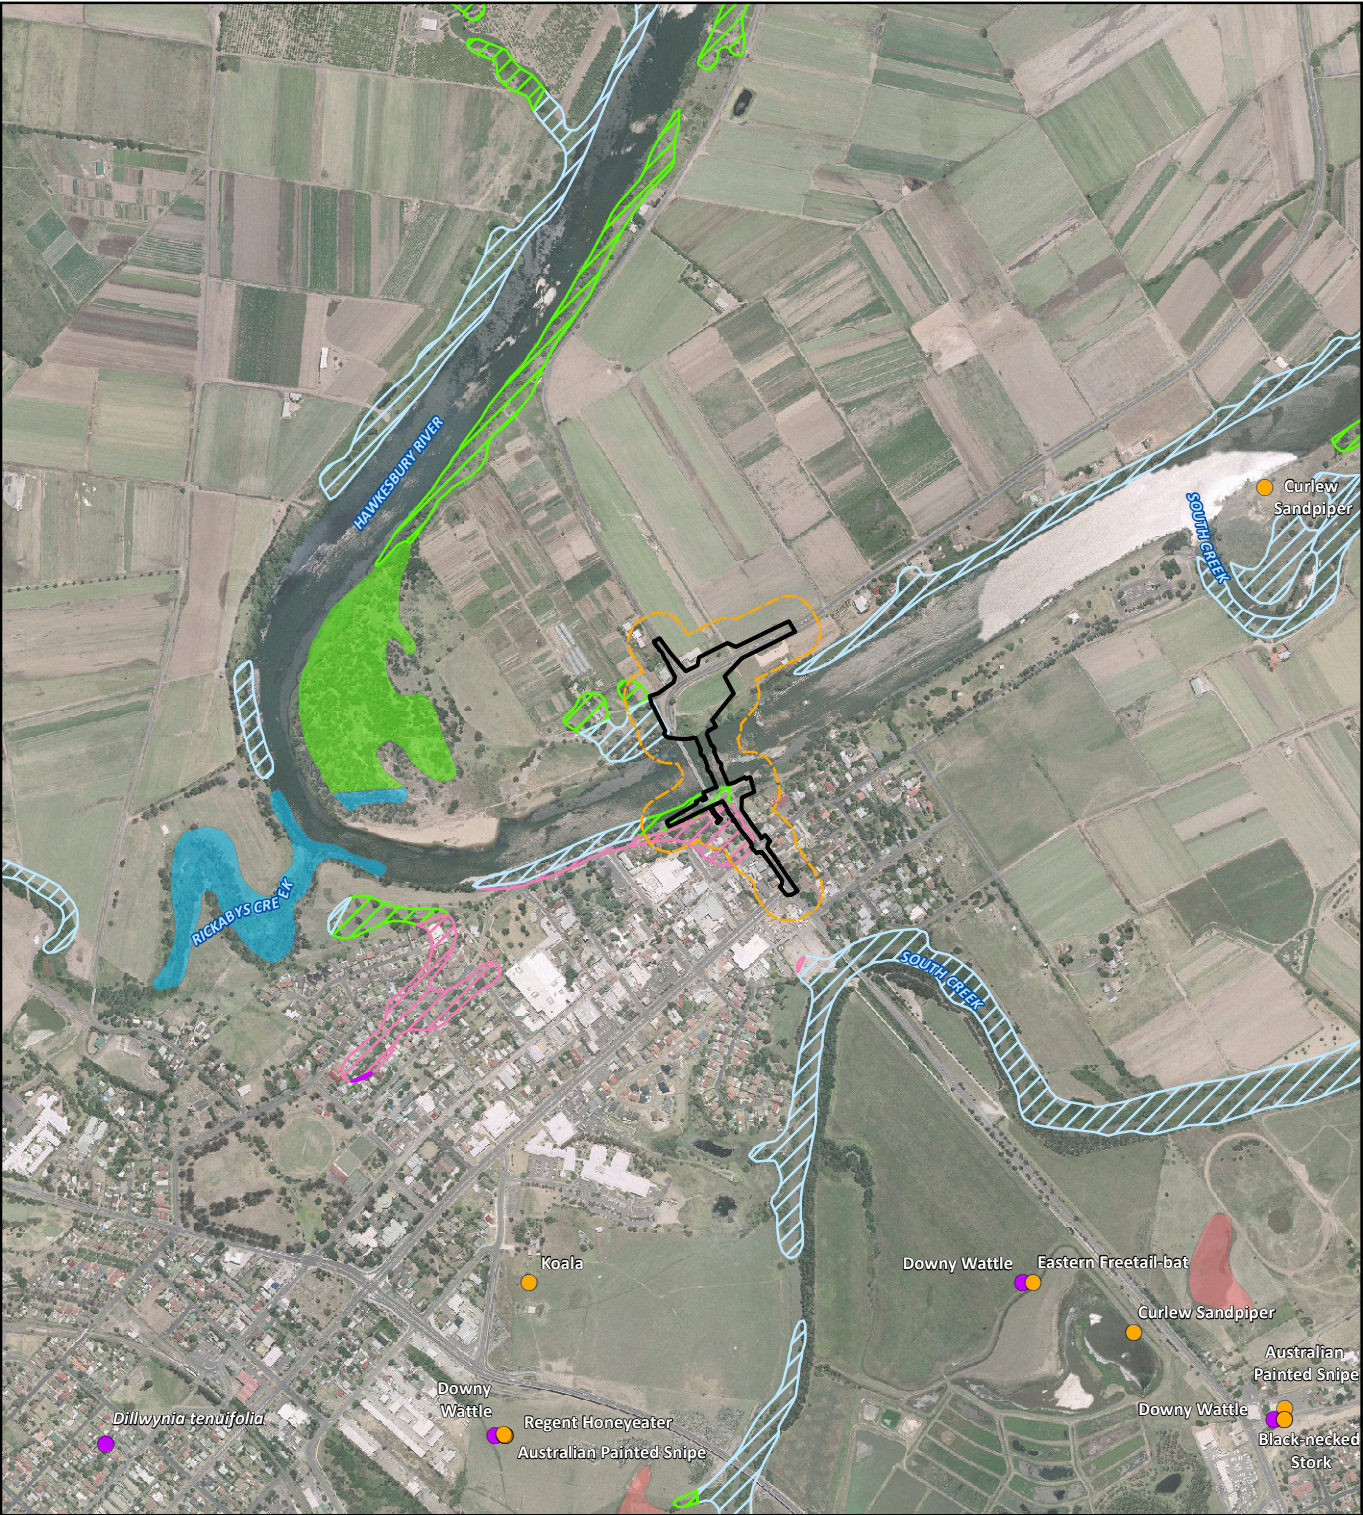
Figure 7-42 | Threatened flora and fauna records and vegetation communities

NPWS mapping of the Cumberland Plain (NPWS, 2002) suggested that two threatened ecological communities (TECs) may be present within the study area (see **Figure 7-42**). These TECs included Cumberland Plain Woodland (TSC Act/EPBC Act) and River-flat Eucalypt Forest (TSC Act). Field surveys in the study area did not record vegetation characteristics or key diagnostic species representative of the TECs identified in the NPWS vegetation mapping. Accordingly, no TECs were found during field investigations.
