### 3.6.4 River Crossing – Punt

### 3.7.1 A New Bridge

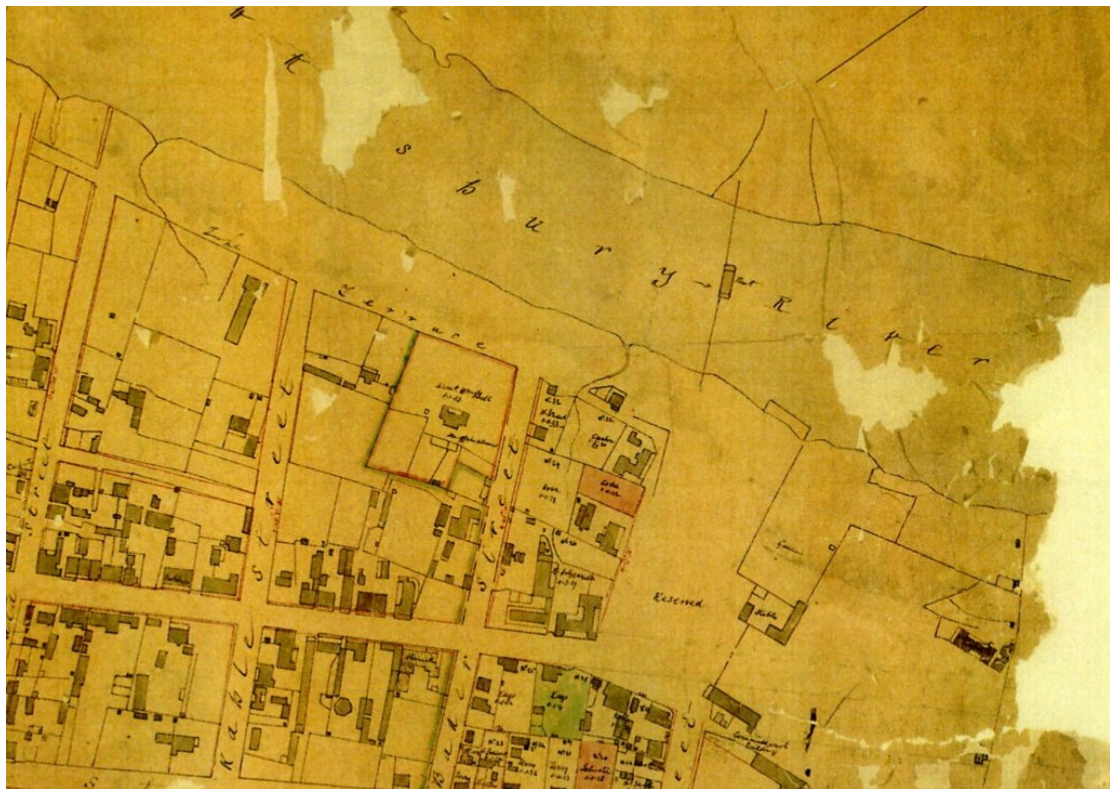
**Plate 10:** *Detail of a survey c. 1835 showing the punt and the wharf on the river's edge at the northern end of Thompson Square and a wide cutting on the northern side of the river (AO Map 5968)*

It would not be until the later part of the nineteenth century that a permanent crossing would be made across the Hawkesbury. Until then, probably from the 1820s or earlier a punt provided the only means of crossing the river. It operated from the middle of the river frontage at the bottom of Thompson Square, a position now just to the west of the present bridge. It can be seen on the 1842 survey (Figure 6) but is more clearly seen on other surveys including one provisionally dated to the mid 1830s; this also shows the position of the wharf. The management of the service was taken over by the government in 1832.

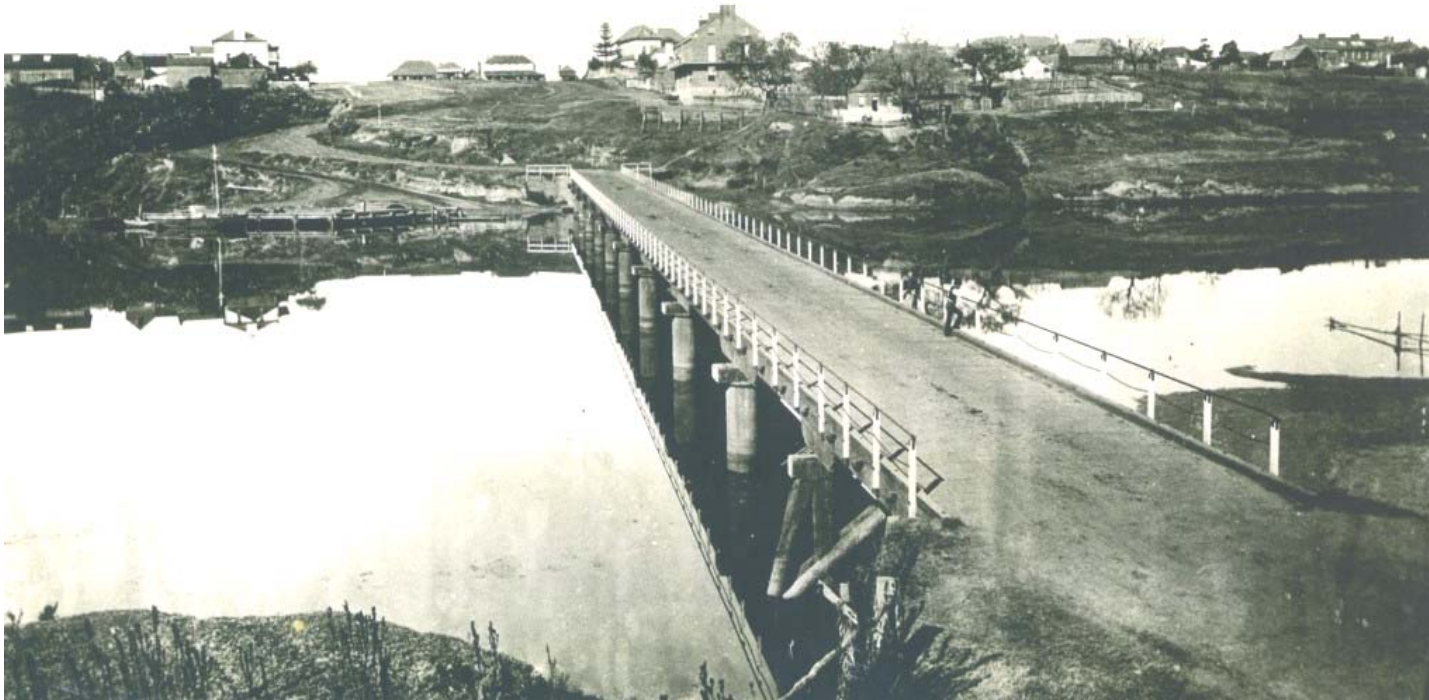
**Plate 16:** *Part of an undated panorama showing Thompson Square in the later part of the nineteenth century; it shows the residential character that had been established during the second half of the nineteenth century, the open reserves and the cuttings that had been made for the road. The photograph dates to between 1874 and 1897 as the bridge is shown at its original level (ML SPF).*

Trees were planted within the reserve between the 1870s and the 1880s. By 1888, saplings had been planted in the reserve (Plate 16 & Plate 14).

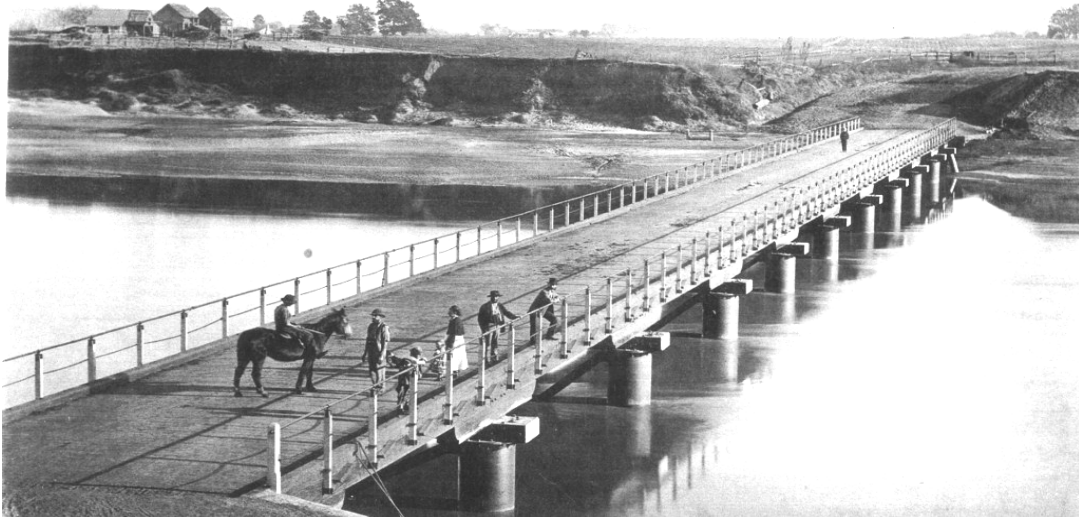
**Plate 17:** *View across the original low level bridge (1874 – 1897) to the northern side of the river showing the cutting made there for it and also illustrating the scattered occupation and open fields and pastures that characterised this side of the river. Note the scouring of the banks, presumably by floods (ML SPF Windsor NSW Bridges).*
