4.0 ABORIGINAL TEST PITS A - D: RESERVES AND THOMPSON SQUARE

5.0 TEST PITS 4-9: THE NORTHERN RIVER BANK

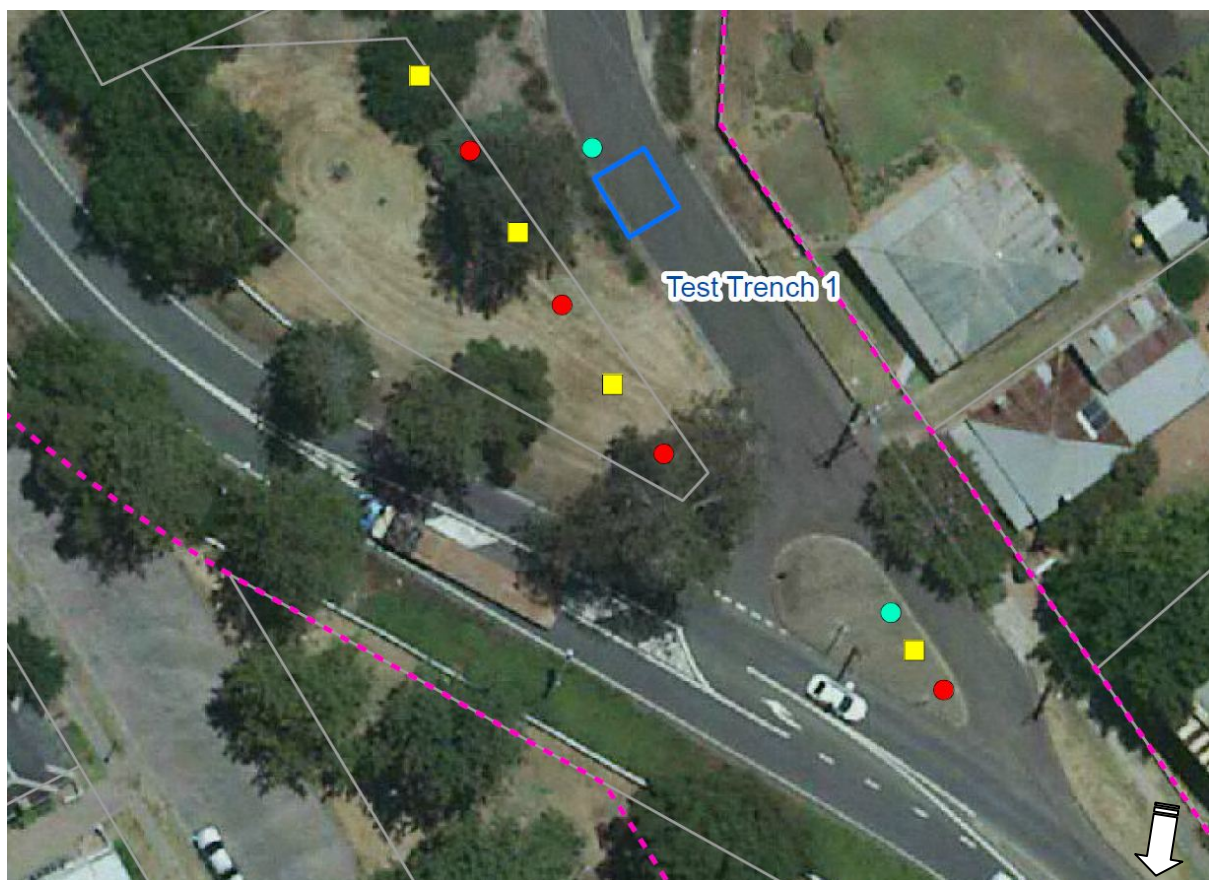
Plate 55: Location of Aboriginal archaeology test pits A-D. The yellow squares are the test pits. Refer also to Figure 1.

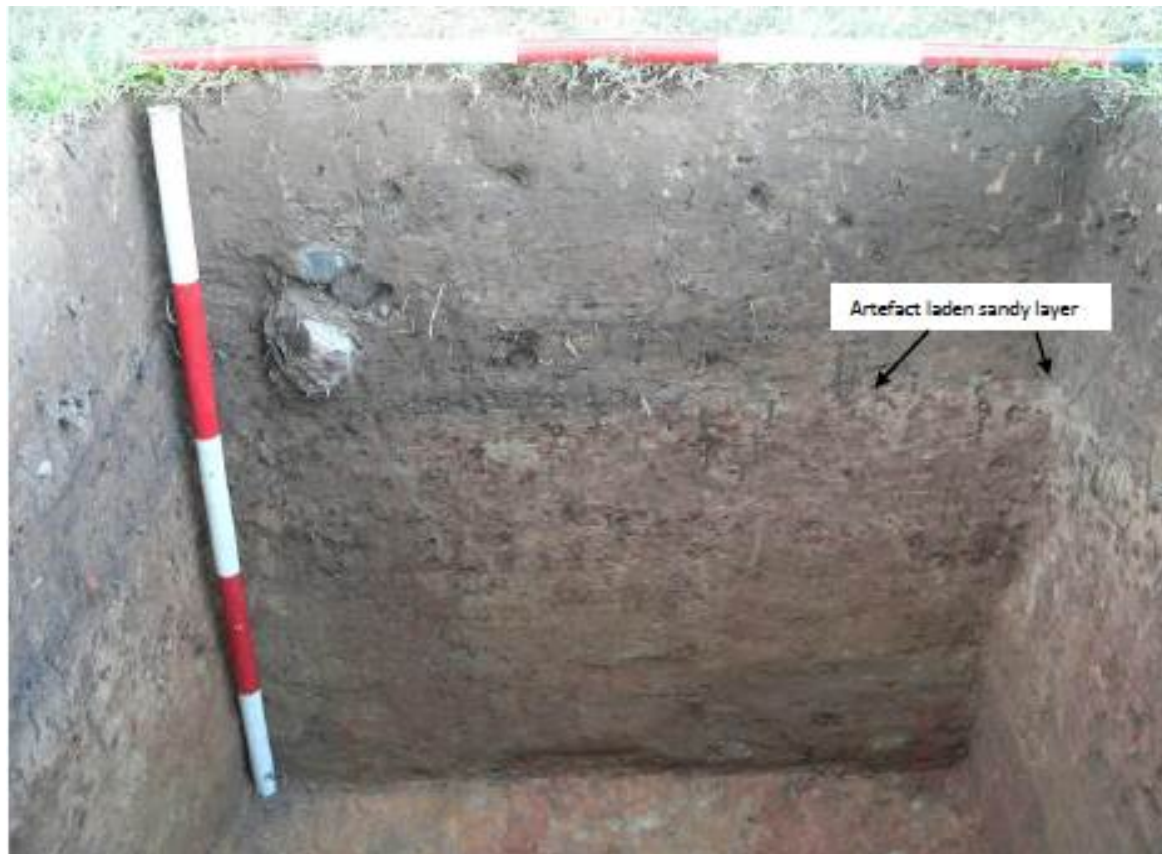
Located in the proposed area of the European Test Trench 3 within the upper parkland area and close to the corner of Bridge Street, the excavation revealed that the top 300 mm of the deposit comprised dark grey-brown humic loam considerably disturbed by tree roots and including a small sample of European artefacts with a wide chronological spread including a fragment of a later nineteenth century clay smoking pipe and c. 1950s tiles. Below this material from 300 mm downwards was the upper portion of the ancient sand dune including substantial quantities of Aboriginal artefacts (Plate 55). This is below the anticipated base of the project excavation.

Plate 56: North section of ATP A showing the small European horizon above the remnant sand dune identified in the image as the artefact laden sandy layer; scale one metre⁶

The southernmost of these pits, (ATP A) close to the corner of Bridge and George Streets in the upper parkland area, demonstrates that the land in and around the excavation has been substantially truncated, apparently in the twentieth century; the material in the fill used to level the site included artefacts from as late as the 1950s. The Windsor Town Improvement Society may have initiated some of the work in the 1930s but the later chronological spread suggests that there has been later cutting and filling at the southern end of the reserve. The deposit above the intact dune sand was homogenous and suggests that anything from the nineteenth century or earlier has been removed in this area.

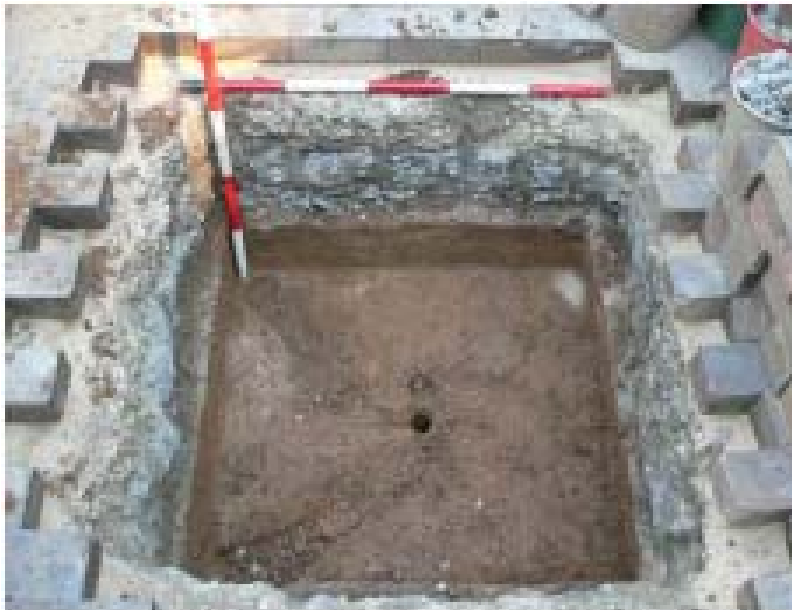
This pit was located in the traffic island between Old Bridge Street and Bridge Street. The surface was covered with paving bricks removed to reveal 80 mm of bedding sand, above 230 mm of blue metal. Below this was 250 mm of concrete. Below this was sticky red clay, likely to have been fill (Plate 57). The base of the trench is below the anticipated excavation zone for the proposed bridge.

Plate 57: Section in ATP B; scale one metre.

The second Aboriginal test pit (ATP B), in the traffic island in Bridge Street also demonstrated extensive cutting and filling during the twentieth century, here more likely from the later part of the century. Nothing from the nineteenth century was found in this pit.

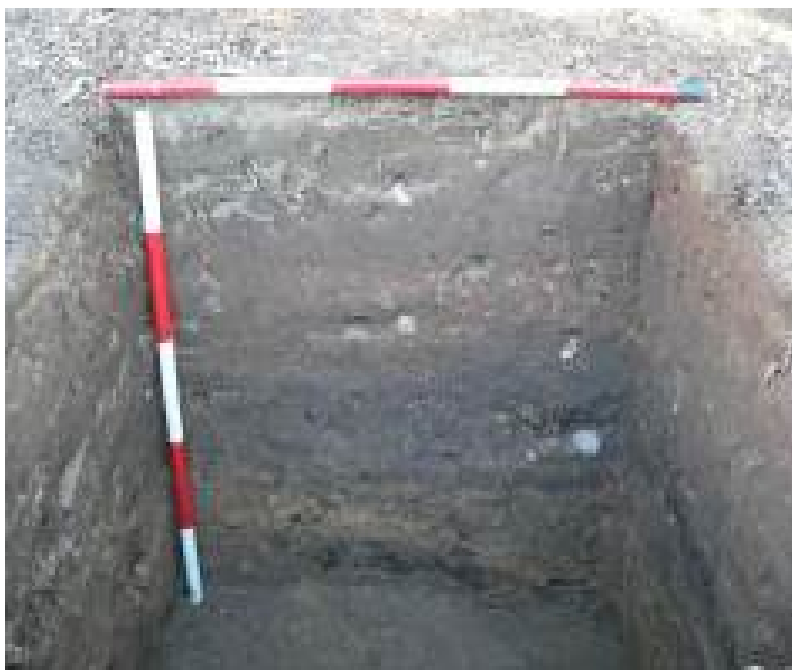
This test pit was excavated at the northern end of the northern reserve close to the car park and the site of European Test Trench 2. This test pit revealed dark brown sandy loam with numerous lenses and cuts. It included European artefacts with the same wide chronological range found in ATP A; a 1945-penny was found at the surface of the excavation and nineteenth century artefacts (clay smoking pipes) and twentieth century material (including glass and ceramics). Mixed with this European material was shell and Aboriginal artefacts assessed to have been taken at least in part from middens and brought to the site.⁷

At 600 – 700 mm the deposit changed to become yellow sandy clay loam; this was also seen in European Test Trench 2. This deposit continued to the base of the excavation, a depth of one metre; this soil contained some bottle glass and a small quantity of brick.

Plate 58: View south of section in ATP D; scale one metre⁸

The fourth test pit (ATP D) located close to the car park also demonstrated the impact of twentieth century work but here there was also evidence of nineteenth century fill and Aboriginal midden material. The small sample suggests that fill has been brought from another site and used to reshape the surface of the reserve; the presence of the 1945 coin in the fill gives an approximate mid-twentieth century date for the work. This is consistent with the artefacts found in the other test pits. The yellow sandy clay found at the base of this test pit appears to be the same as that found in the small extension made to European Test Trench 2 into the reserve. This soil was relatively free of artefacts except for a very small number of glass sherds. This is more likely to be a nineteenth century level.

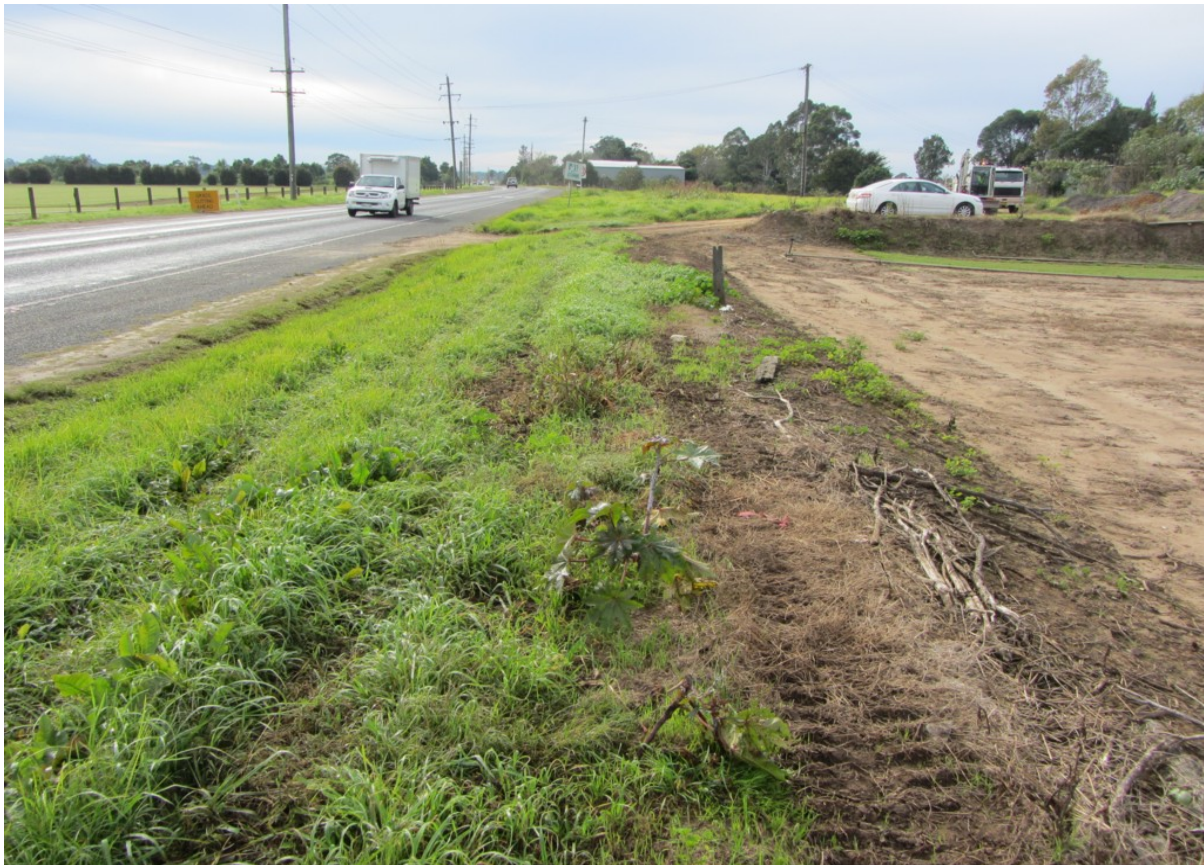
Plate 59: View east of the area of test pit 4.

This was the most easterly placed pit and was located on the southern road verge abutting the turf farm. The surface of the pit was just above the level of the road.

The surface of the pit was covered with grass [080] and immediately below this was soft, dark loam to a depth of approximately 600mm [081]. The soil included wastes such as plastic, soft drink cans and part of a car bumper. Below this soil was a thin, sandy deposit [082] in which there was part of a fence post [083]. Below the sand to the three metre depth of the excavation was dark brown, silty clay [084]. The clay in this deposit increased as the trench became deeper; there were also some orange clay inclusions and organic matter. At 1.8 metres the clay matrix became lighter in colour.

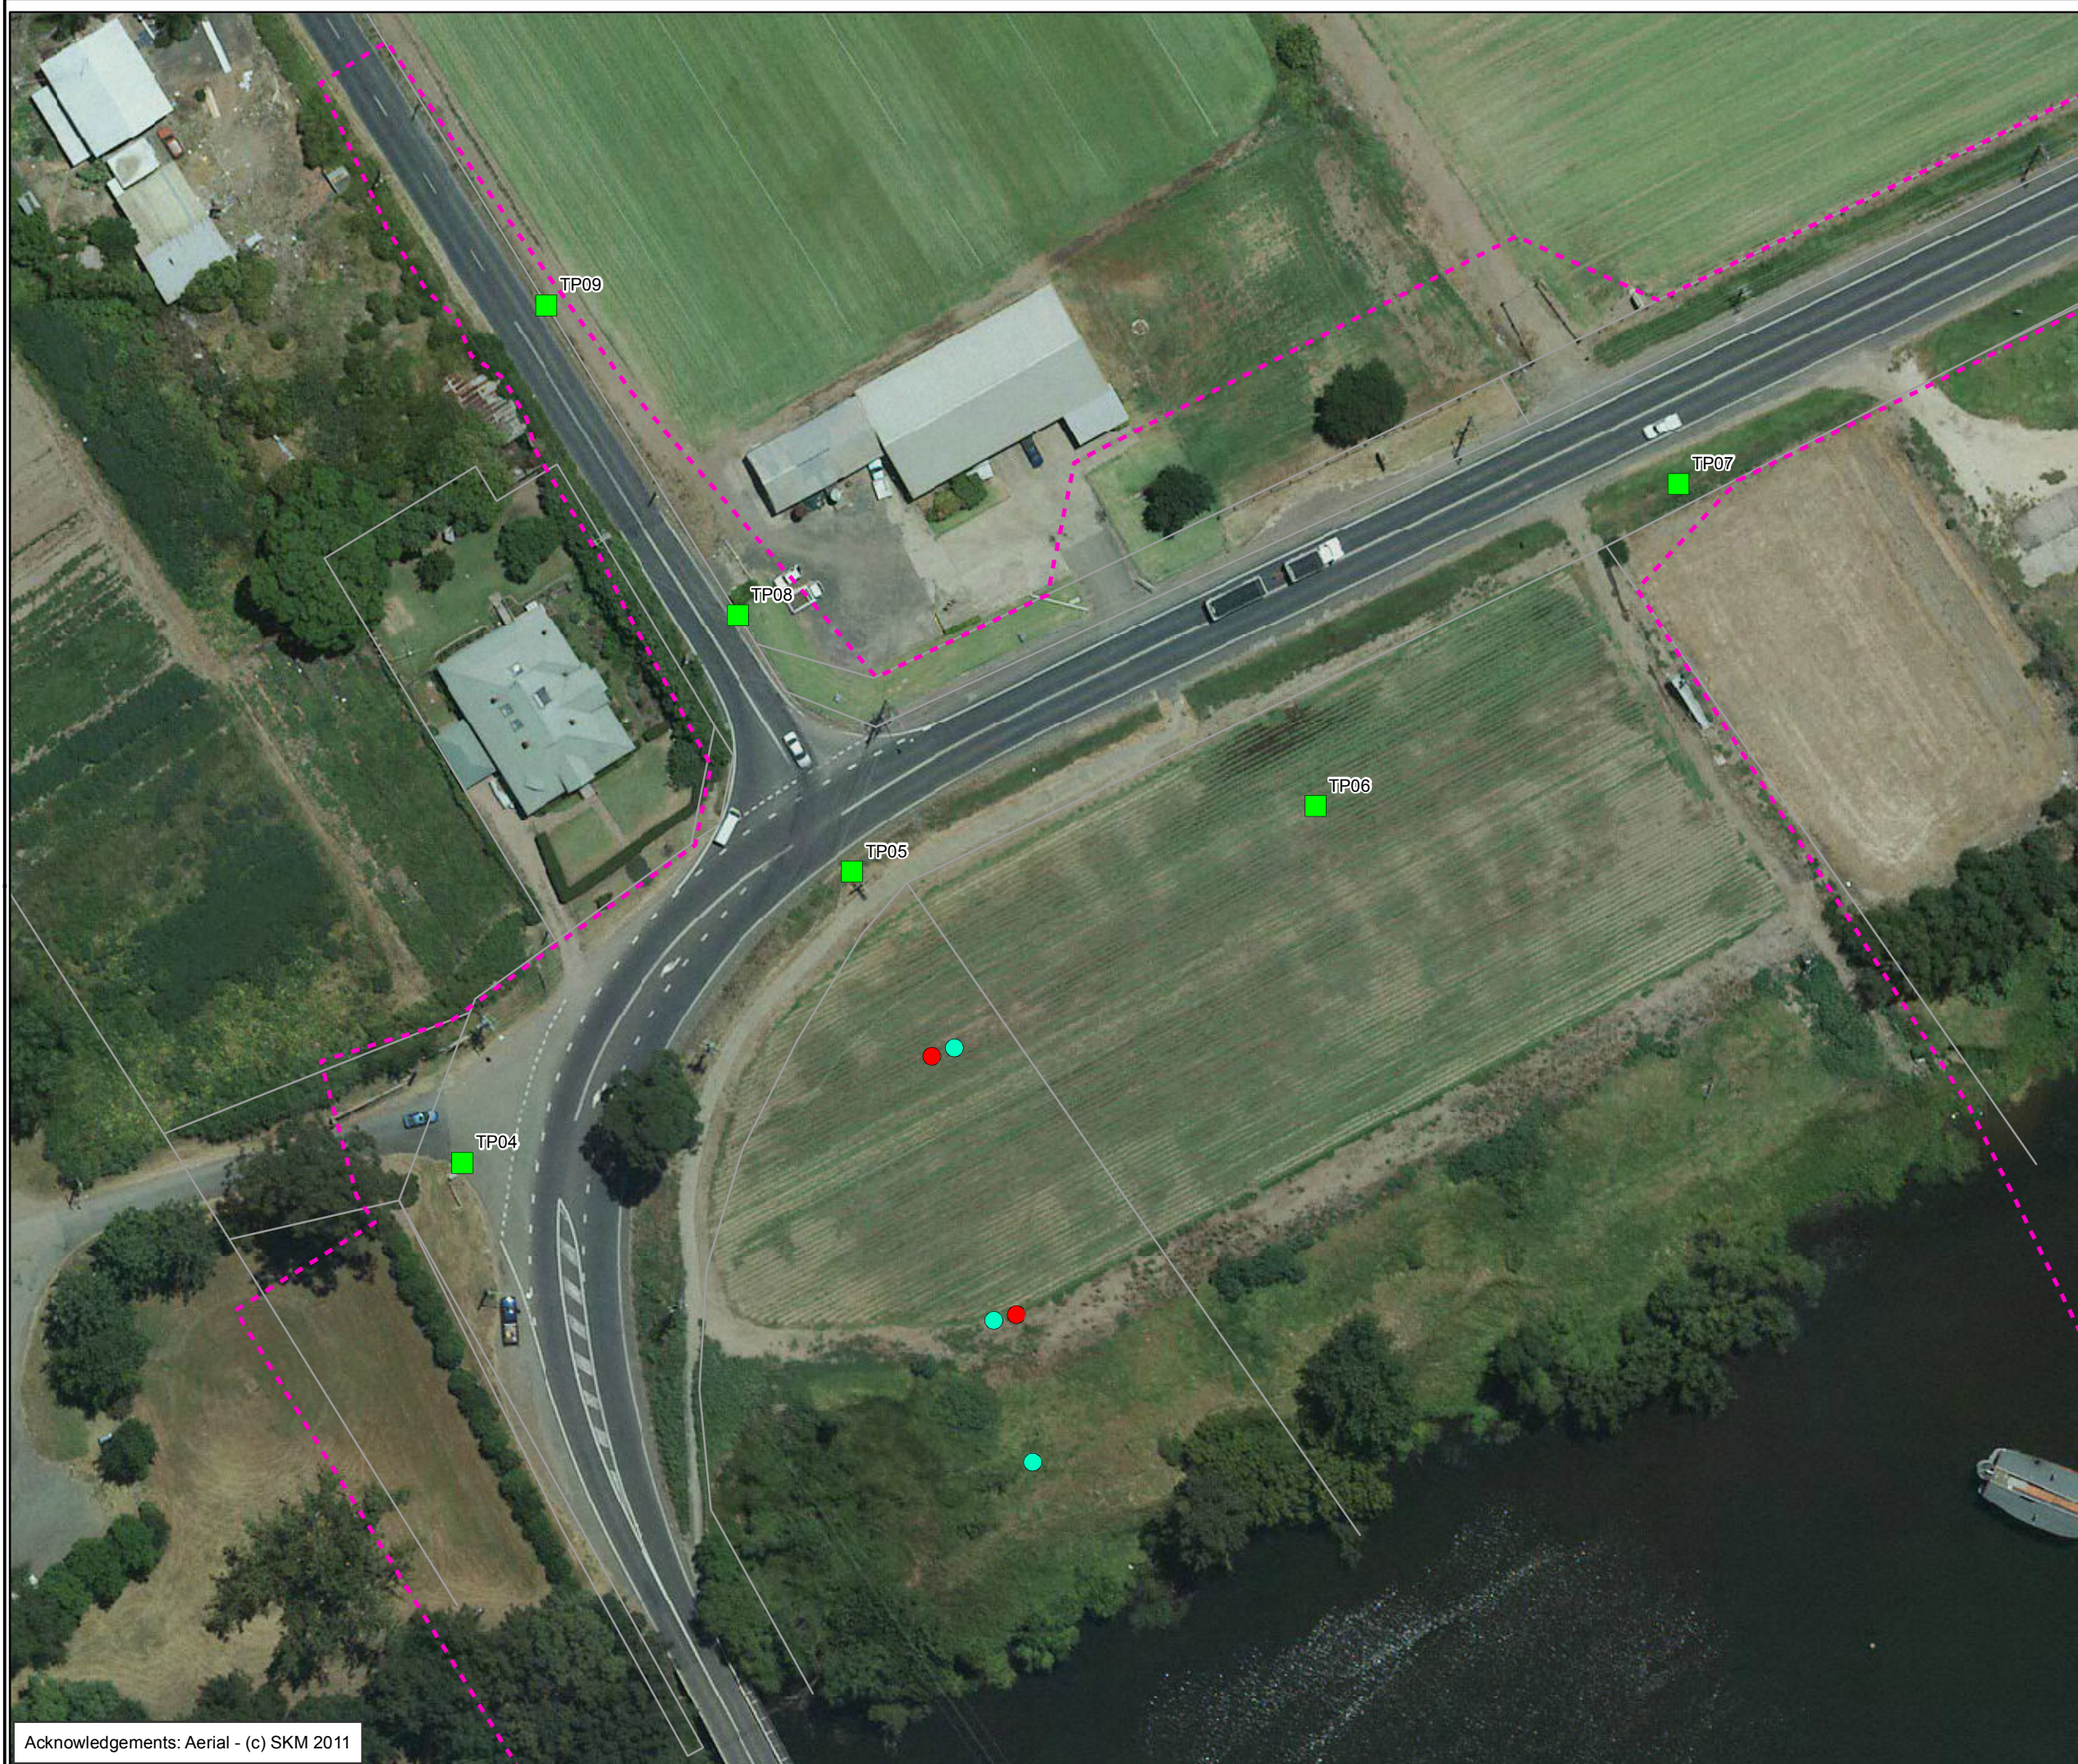
Figure 2: Location of the archaeologically monitored geotechnical test pits, Aboriginal test pits and geoarchaeological test pits (for the Aboriginal test pit program)

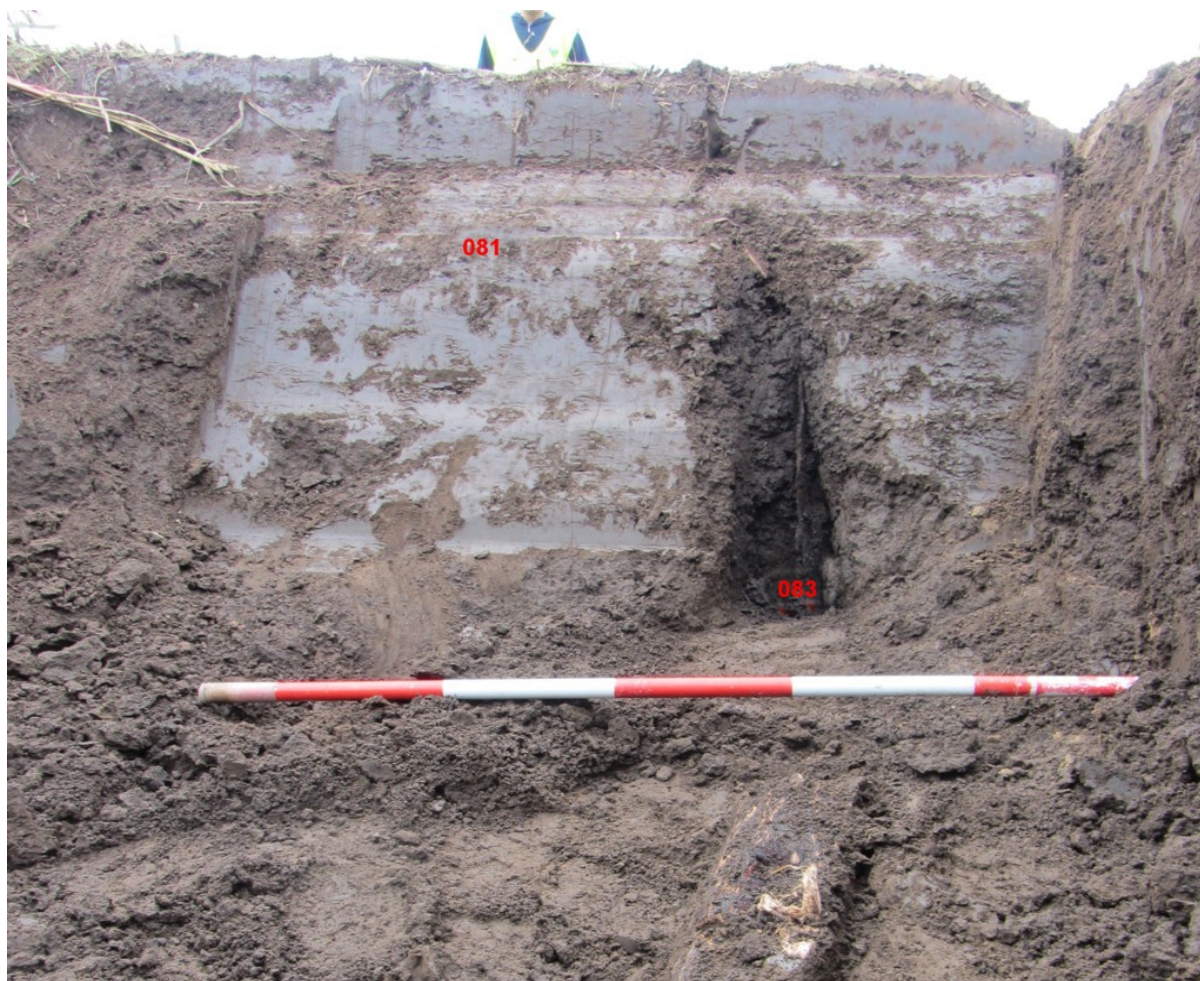
Plate 60: View west showing the position of a fence post [063] within the soil matrix [061]; scale one metre.

There were a few exceptions. Test pit 4 had a single fence post buried nearly one metre below the present ground surface; the rubbish in the soil that buried it was clearly twentieth century in origin suggesting that the post also was from the same period. It appears to have been constructed on an older twentieth century land surface. Test pit 7 revealed strap iron at 1.2 metres depth demonstrating how much soil has accumulated or been deposited within the northern part of the project area.

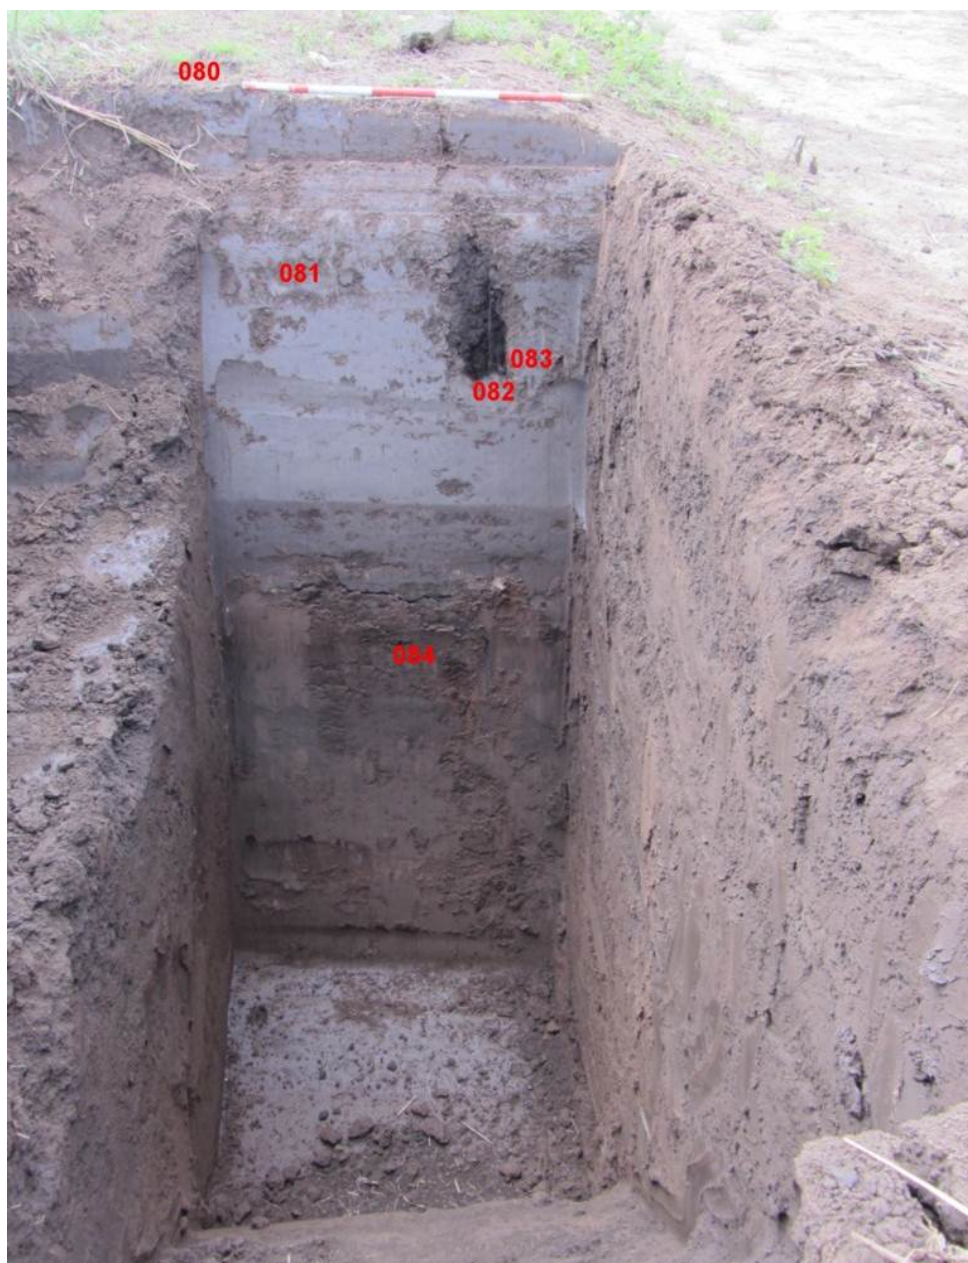
Plate 61: View east of the completed section in test pit 4; scale one metre.

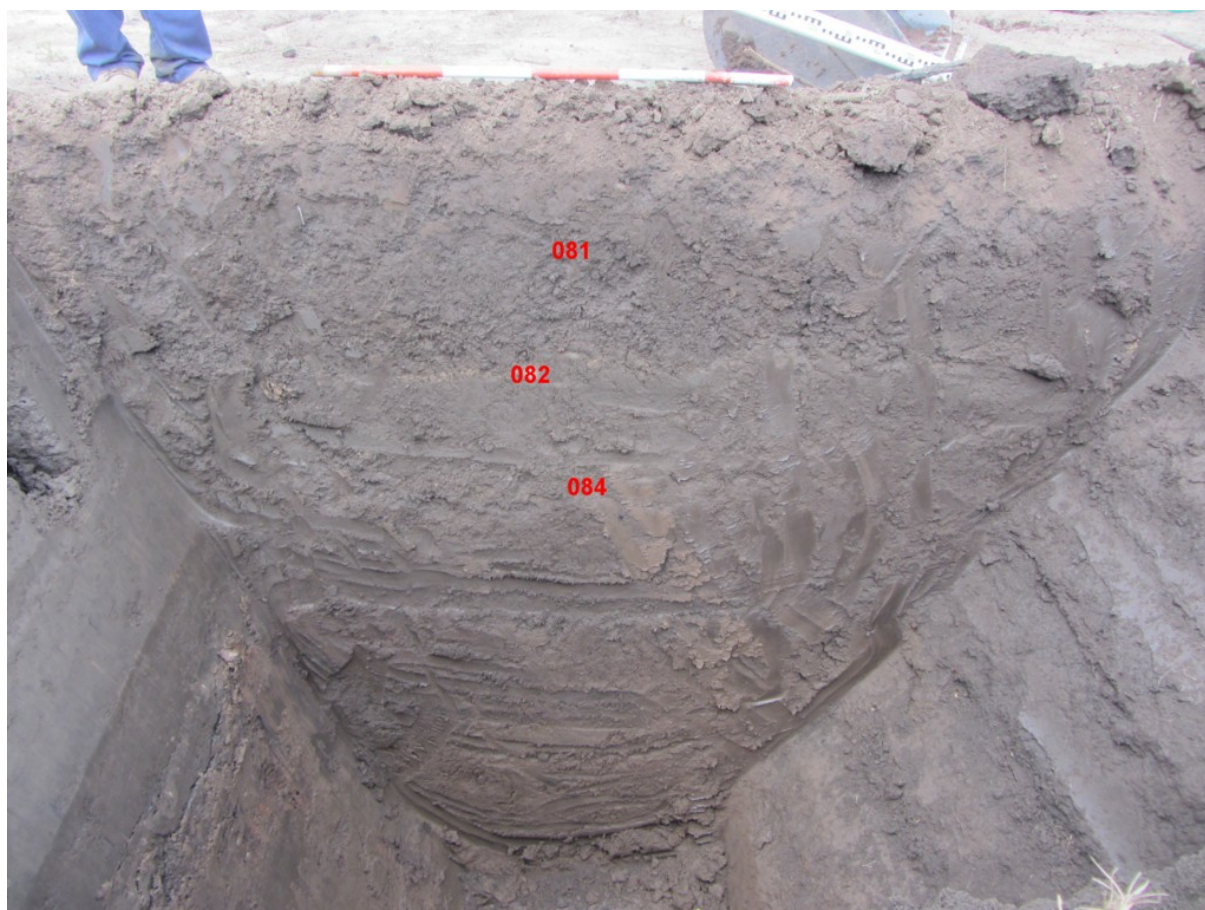
Plate 62: View of south section test pit 4, the thin sandy layer [082] is more visible here; scale one metre.

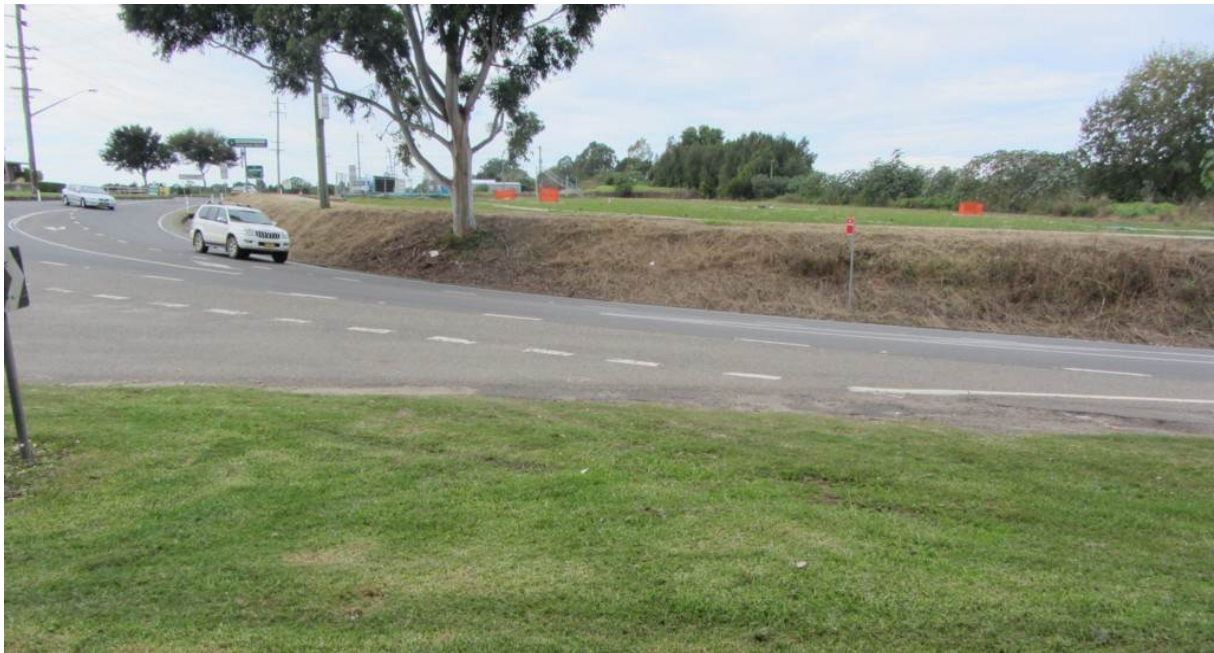
Plate 63: View east across the area, in the foreground, of Test Pit 5.

This test pit was located on Wilberforce Road where it turns south to proceed over the existing bridge. The excavation revealed that the area had many services in it that have disturbed the profile.

At the top of the profile was the grass cover [086]. Below it was dark loam with silty clay and sand mixed into the matrix as well as a small amount of blue metal [087]. This loam extended to a depth of approximately 500 mm. Below this soil was a deposit [088] of road base. It was mixed with clay and silt and the surface was uneven; it appeared to be redeposited from elsewhere. There were inclusions of broken bitumen and contemporary beer bottle glass confirming that this was introduced material. This deposit was approximately 200 mm deep.

Below this material was a thin layer of clayey sand [089] between 30-50 mm in depth. The next deposit was thin, dark clay that contained rusted fragments of nails, probably twentieth century in origin [090]. This deposit was approximately 50 mm deep. Lying under this was a sandy clay layer or lens [091] approximately 10 – 20 mm deep and a similar layer with more clay [092] under it.

At approximately one metre below the grass surface two concrete beams [096, 097], the same as those exposed in Test Trench 2 [014-020] were found in the test pit. Here the beams were not packed in gravel but were placed in dark brown silty clay [094]. They ran diagonally across the trench roughly north to south. The soil [094] contained a small number of artefacts; fragments of dark black bottle glass and light green coloured bottle glass that were later nineteenth or early nineteenth century in date. This soil was approximately 300mm deep. From here the trench was extended again to preserve the concrete beams [096, 097]. The extension was made to the west and was excavated down the side of the exposed beam. The extension was excavated stratigraphically and revealed the same deposits as the first two portions of this trench.

Test pit 5 provided the most substantial evidence of European activity in the form of two concrete beams similar to those found in Test trench 2 on the southern side of the river. There the beams were interpreted as part of the infrastructure created in 1896 to improve the roads and approaches leading to the newly raised bridge. Almost certainly the beams on the northern side of the river are part of the same work. This means that the metre of soil above them was deposited largely in the twentieth century.

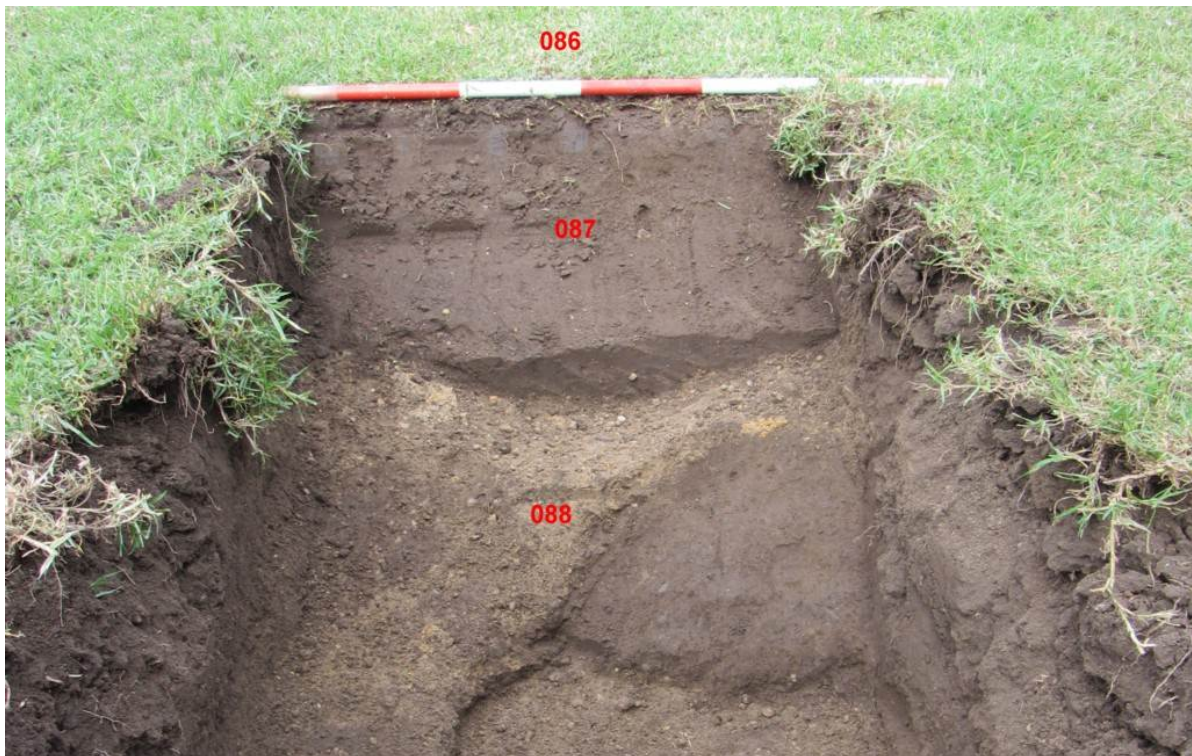
Plate 64: View east showing deposits to gravel mixed with sand [088]; scale one metre.

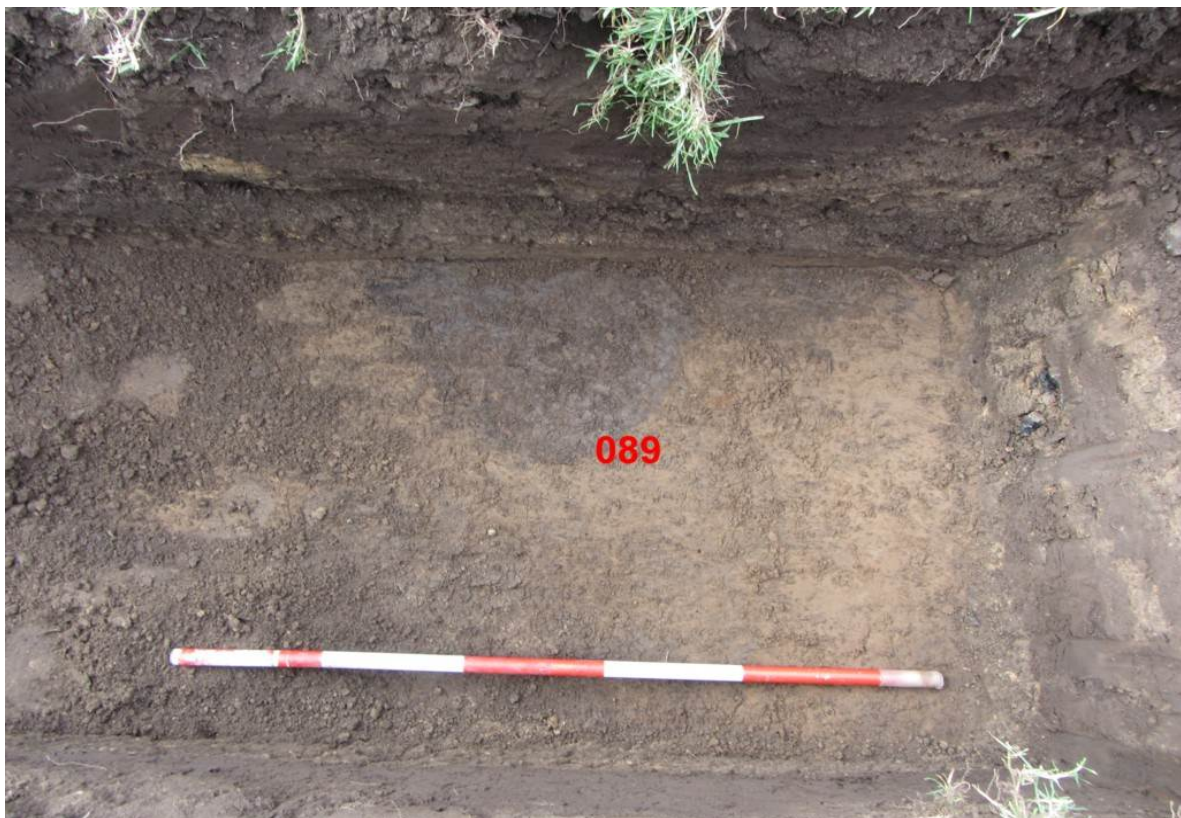
Plate 65: View east of thin, sandy deposit [089]; scale one metre.

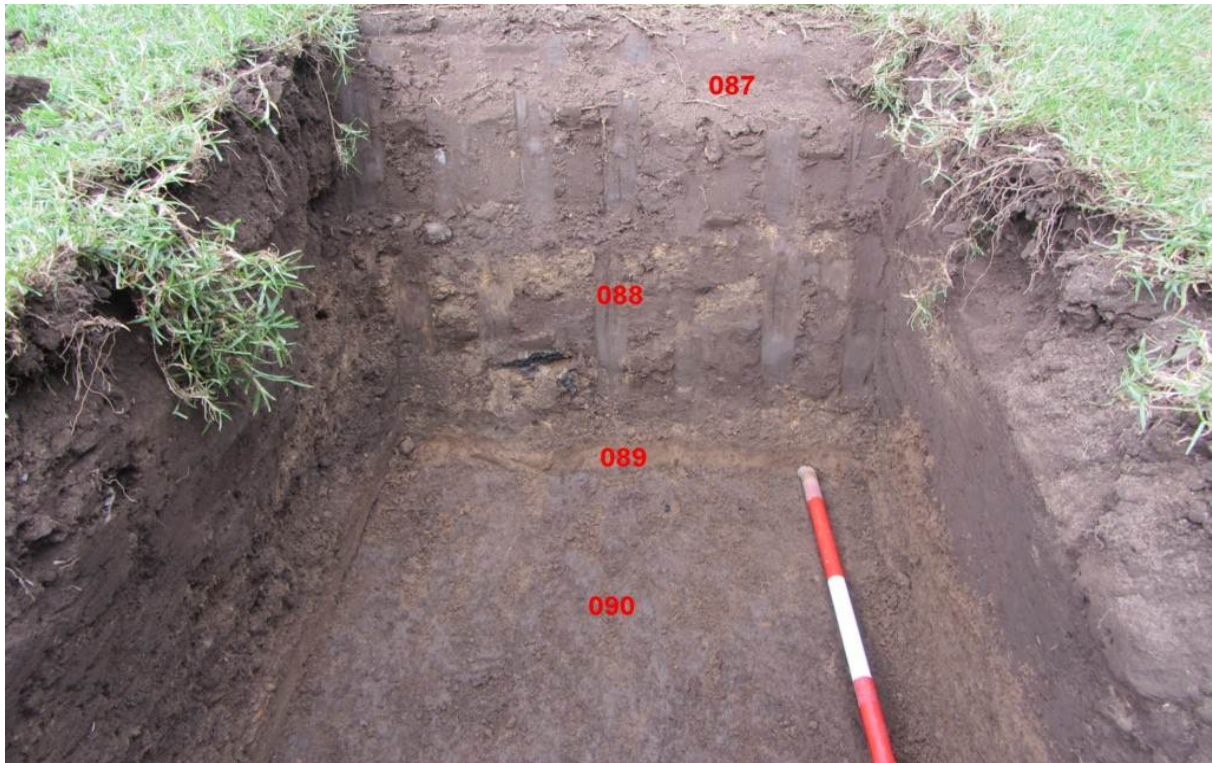
Plate 66: View south showing clay deposit with nail fragments; scale 200 millimetre increments.

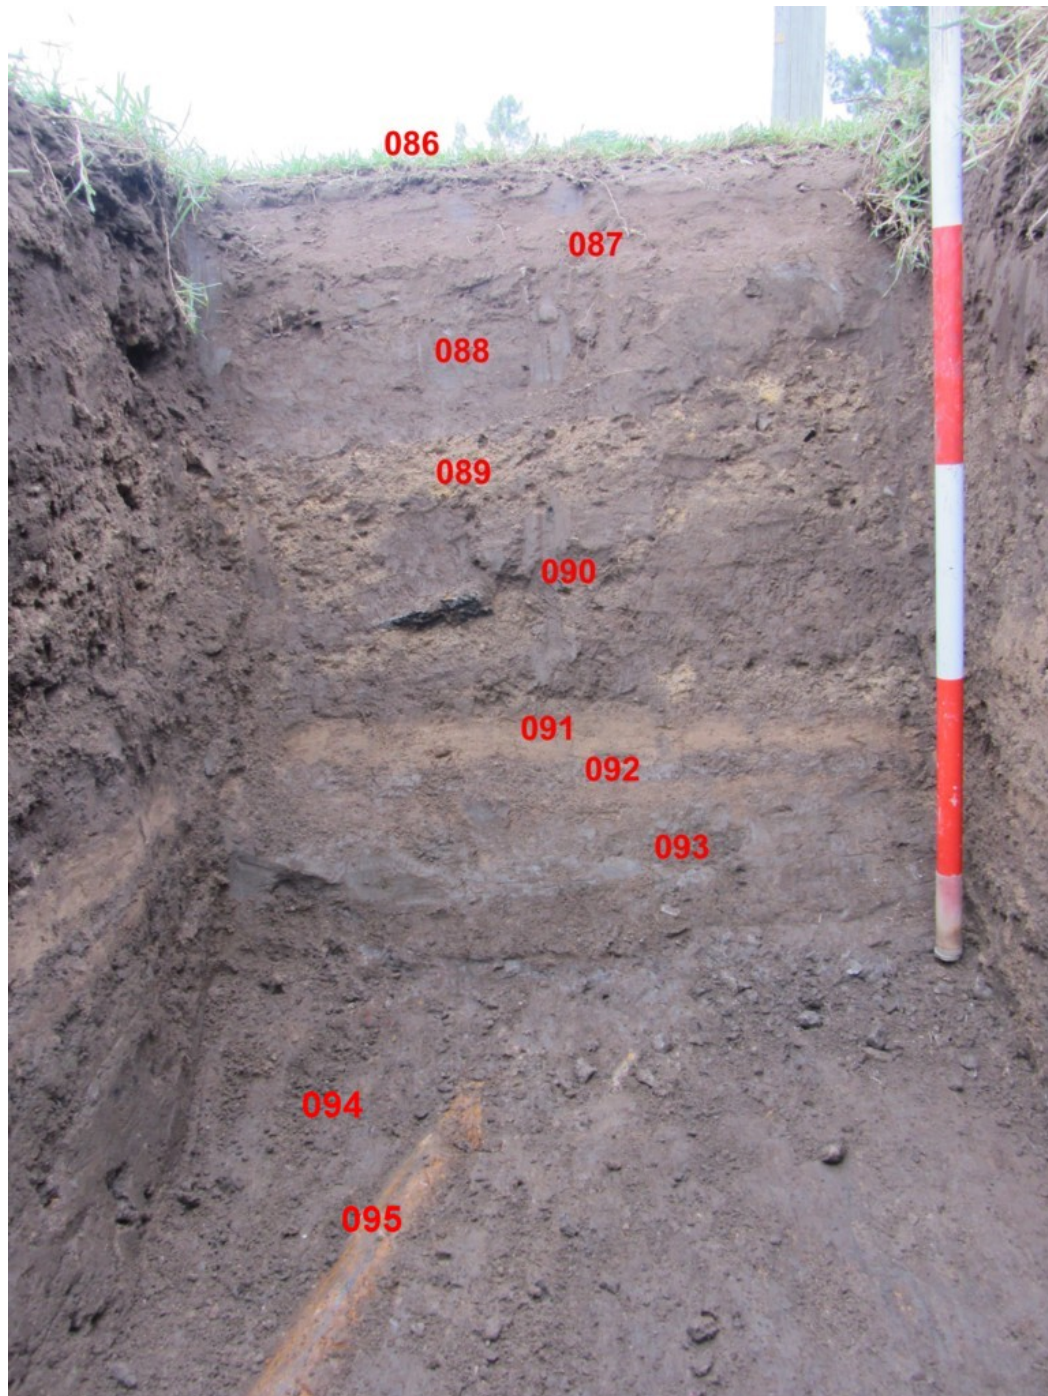
At this level, at the southern end of the test pit below the silty clay deposit [093] was a trench [094] with an iron water pipe in it [095]; the trench was packed with gravel. The presence of the pipe trench led to the test pit being extended further north to avoid the disturbance from this excavation. The extension revealed the same stratigraphy described to date. In both the original trench and its extension the pipe trench only appeared below all the levels above it [065-072]; this means that all these deposits were laid after the pipe had been excavated and the trench back-filled.

Plate 67: View east showing the iron water pipe and trench [094, 095]; scale 200 millimetre increments

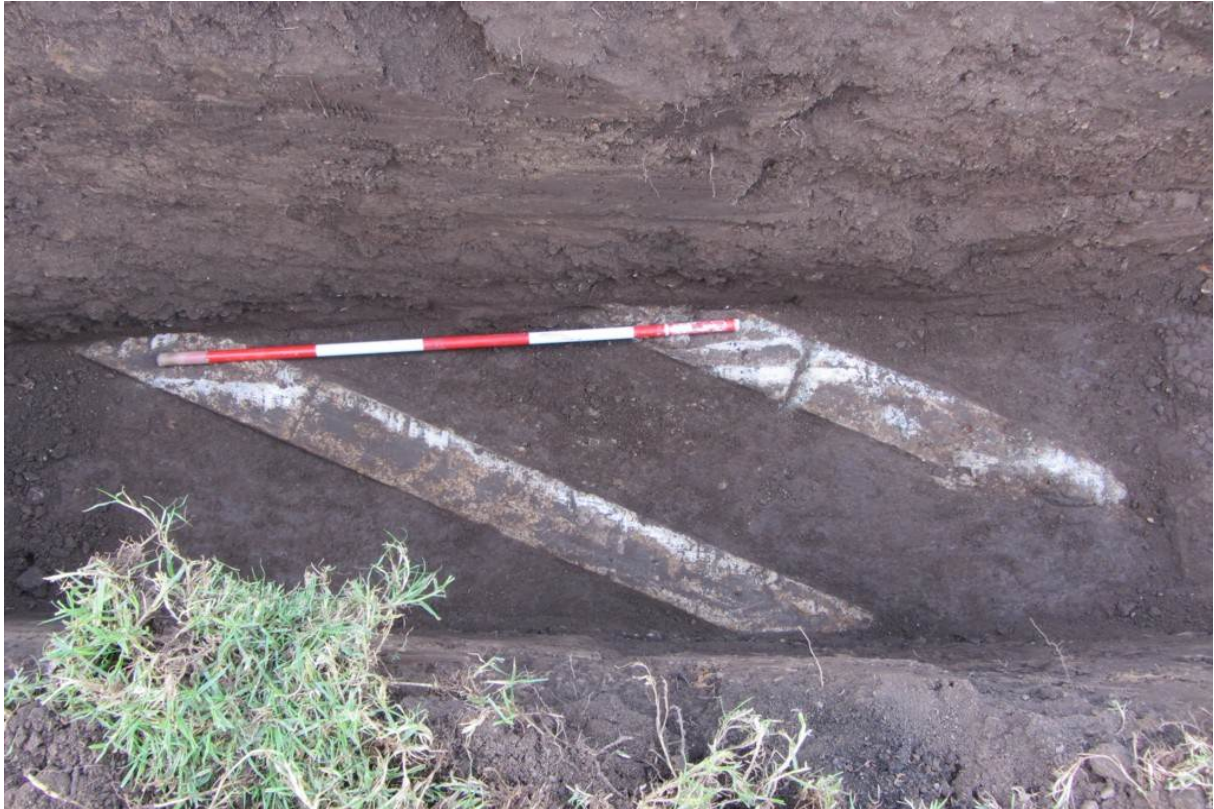
Plate 68: View east showing concrete beams [096, 097], scale 200 millimetre increments.

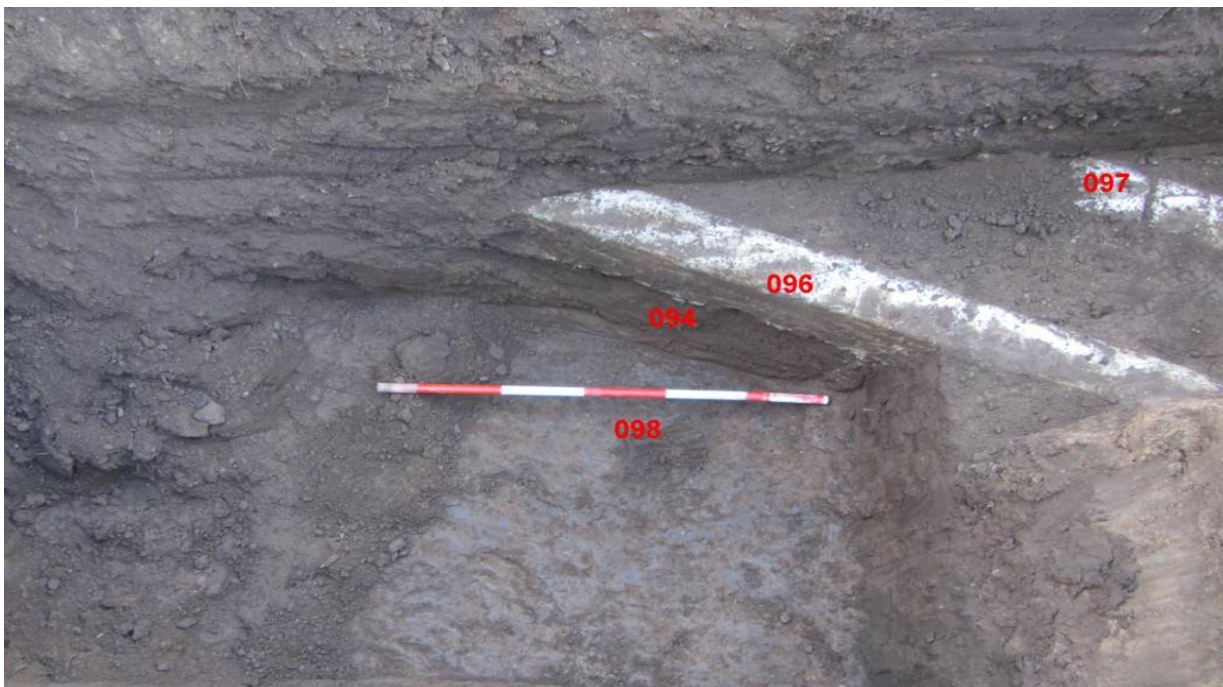
Below the silty brown soil [094] in which the beams were placed was a deposit of hard clay with some ironstone inclusions [098]; it was approximately 300 mm deep. Below this was soft light brown silty sand [099]. This was at the three-metre depth of the excavation.

Plate 69: View east showing the profile below the concrete beams; scale one metre.

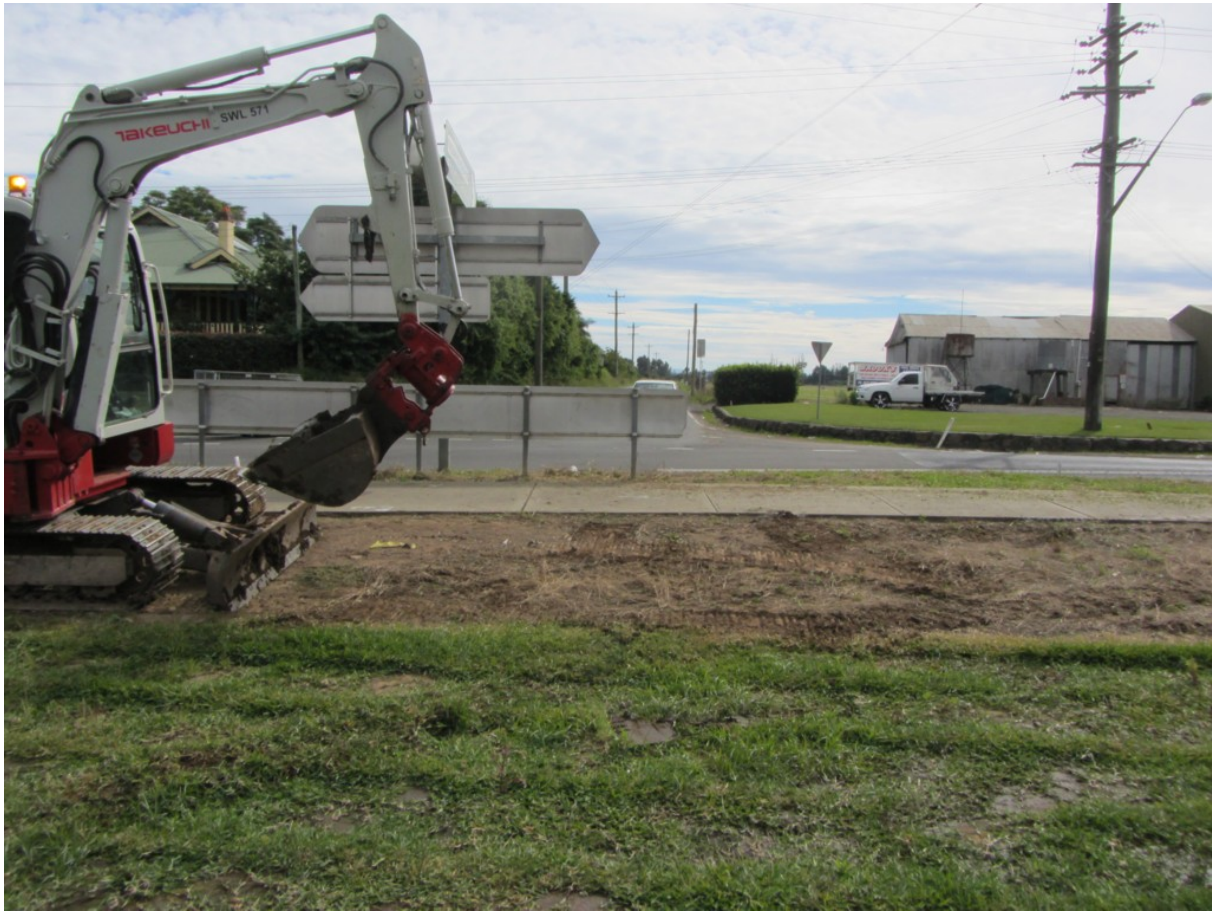
Plate 70: View north of the area of test pit 6.

This test pit was located on the southern side of Wilberforce Road on the verge opposite its intersection with Freemans Reach Road.

The top of the test pit was covered with exposed topsoil [100]; below it was dark brown silty clay [101]. It had some sand lenses and organic material within the soil but there were no artefacts within it. This reached a depth of approximately 900 mm.

At this depth the soil became lighter with more sand [102] and this greater component of sand was noticeable to a depth of 1200 mm. At this point a new deposit [103] of clay/sand became apparent and this also became lighter as it got deeper. At 2.8 metres below the surface the soil changed to very wet sandy clay [104]. This continued to the three-metre depth of the excavation. No artefacts or features were found in any part of the excavation.
