4.0 ABORIGINAL TEST PITS A - D: RESERVES AND THOMPSON SQUARE

5.0 TEST PITS 4-9: THE NORTHERN RIVER BANK

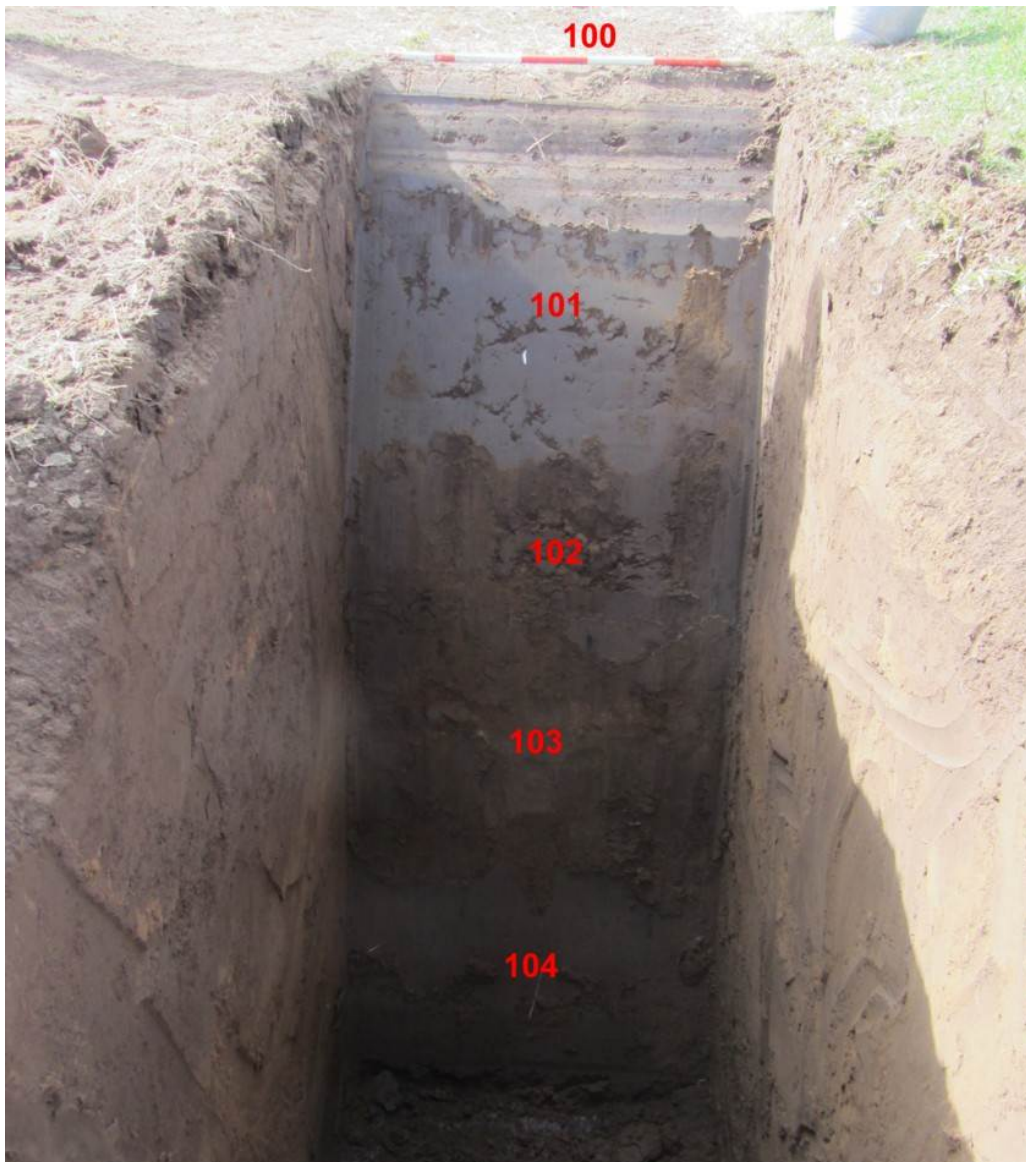
The top of the test pit was covered with exposed topsoil [100]; below it was dark brown silty clay [101]. It had some sand lenses and organic material within the soil but there were no artefacts within it. This reached a depth of approximately 900 mm.

Plate 71: The eastern section of test pit 6; scale 1 metre.

At this depth the soil became lighter with more sand [102] and this greater component of sand was noticeable to a depth of 1200 mm. At this point a new deposit [103] of clay/sand became apparent and this also became lighter as it got deeper. At 2.8 metres below the surface the soil changed to very wet sandy clay [104]. This continued to the three-metre depth of the excavation. No artefacts or features were found in any part of the excavation.

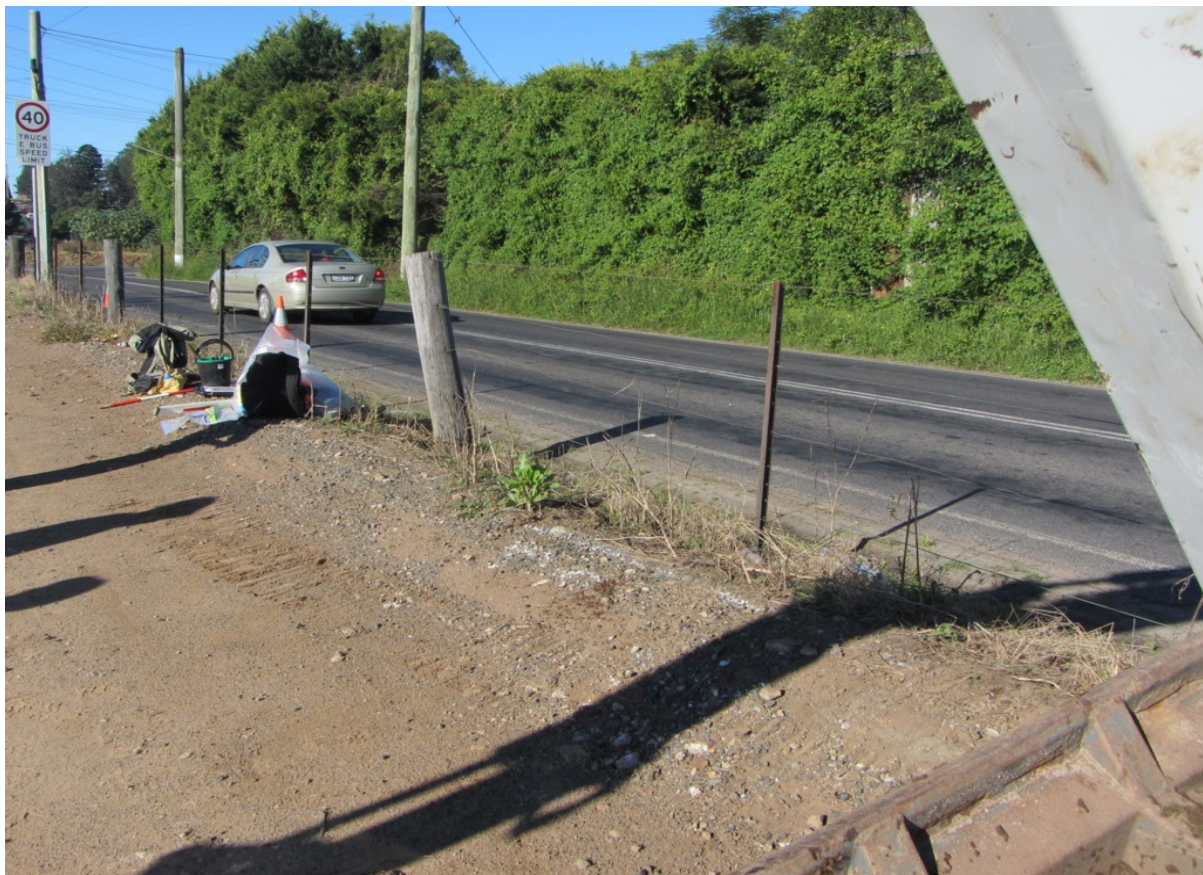
Plate 72: View south of the area of test pit 7 of Freemans Reach Road.

This was the most northerly of the test pits; it was located on the eastern road verge on Freemans Reach Road.

The area has been disturbed by excavation for a Telstra cable so the trench was placed close to the fence line to avoid the worst of this impact. The surface deposit [105] comprised a mixed deposit of loam, blue metal and gravel. This was no more than 30-50 mm in depth. Below this was dark brown silty clay with some sand lenses [106]. This same deposit extends to approximately 550 mm below the surface but as it deepens it has more clay in it. Below this is a similar soil but with much more sand [107]. This deposit continues to approximately 1200 mm below the surface. At this point the soil acquires more clay [108]. This same deposit continued to approximately two metres below the surface. At that point the excavation uncovered a twisted piece of strap metal approximately 350 mm in length [109]. At the base of the excavation from approximately 2.7 metres the sand content increased again [110].

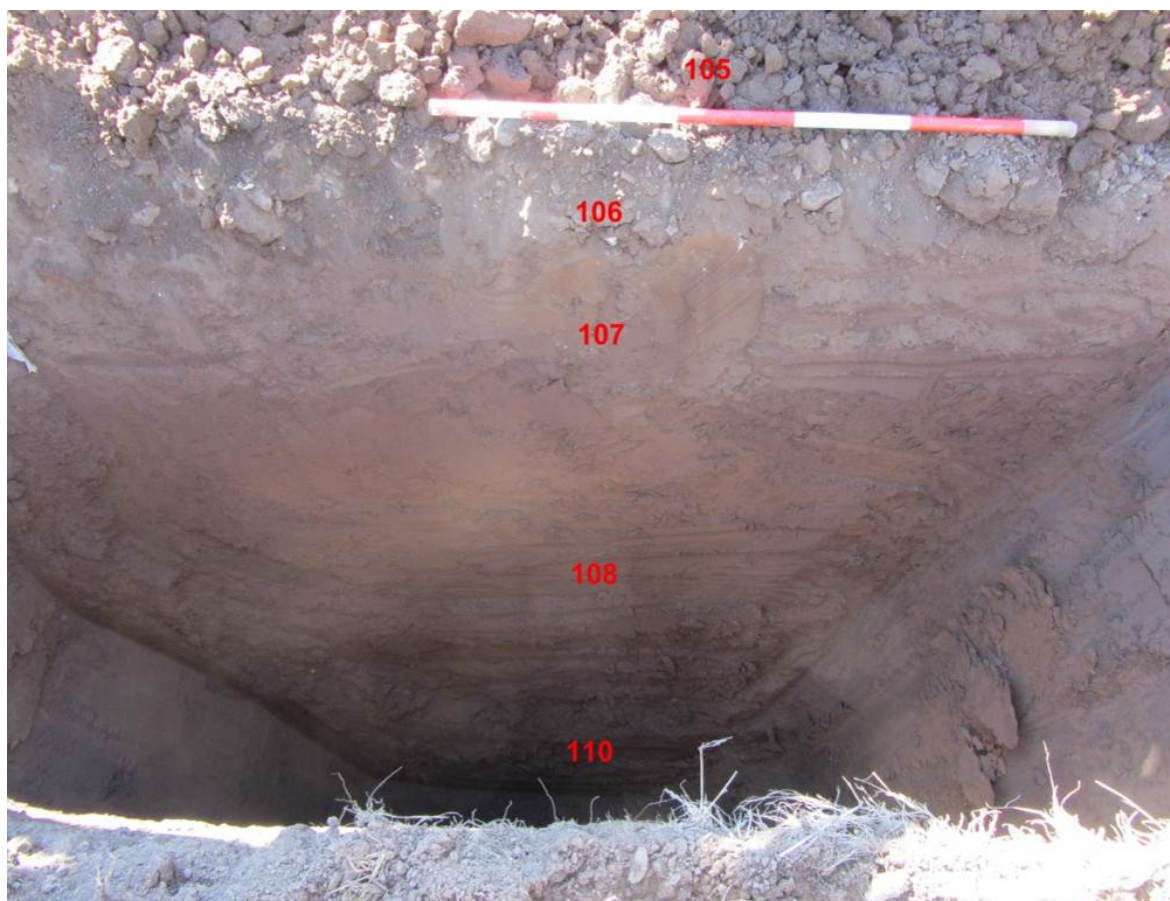
Plate 73: View east of test trench 7; scale one metre.

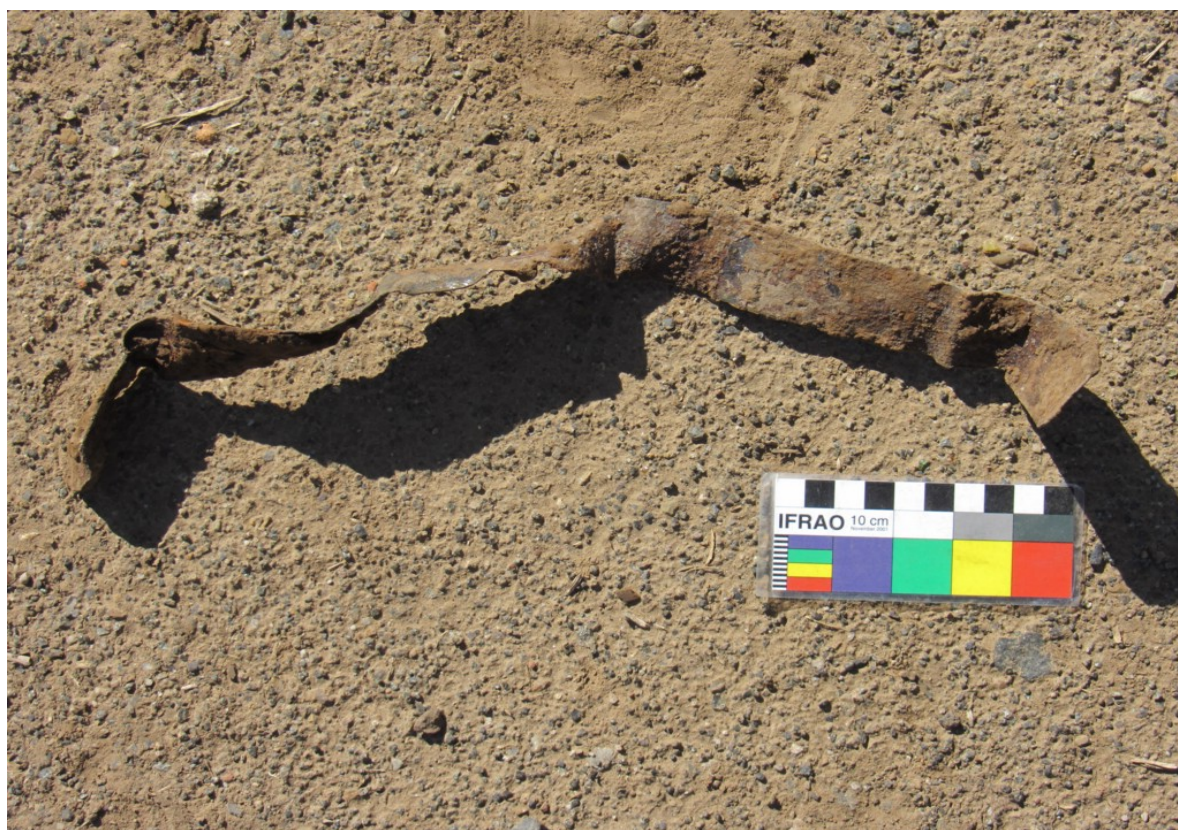
Plate 74: Strap metal [109] found at two metres depth in test trench 7

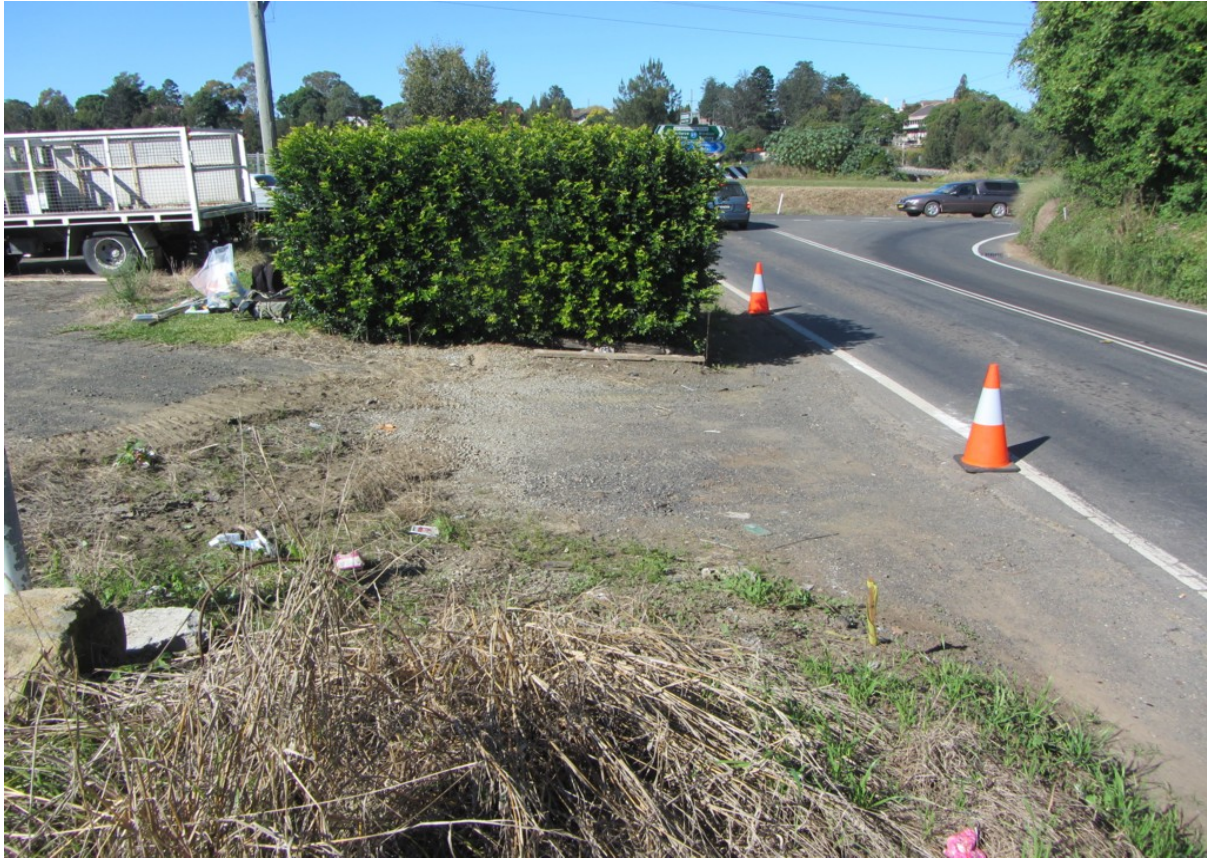
Plate 75: View south of the area of area of test trench 9

This test pit was located on the eastern side of Freemans Reach Road close to the entrance to the turf farm.

The surface of this trench was covered with gravel, blue metal, topsoil and grass [111]. Removal of this revealed more gravel road base, approximately 30 mm thick [112]. Beneath the road base was a deposit of compact silty clay [113]. It contained one fragment of a mid-later nineteenth century brick in it. The same deposit continued to approximately 2.2 metres depth. From that point the clay content increased [114]. This material continued to the base of the excavation.

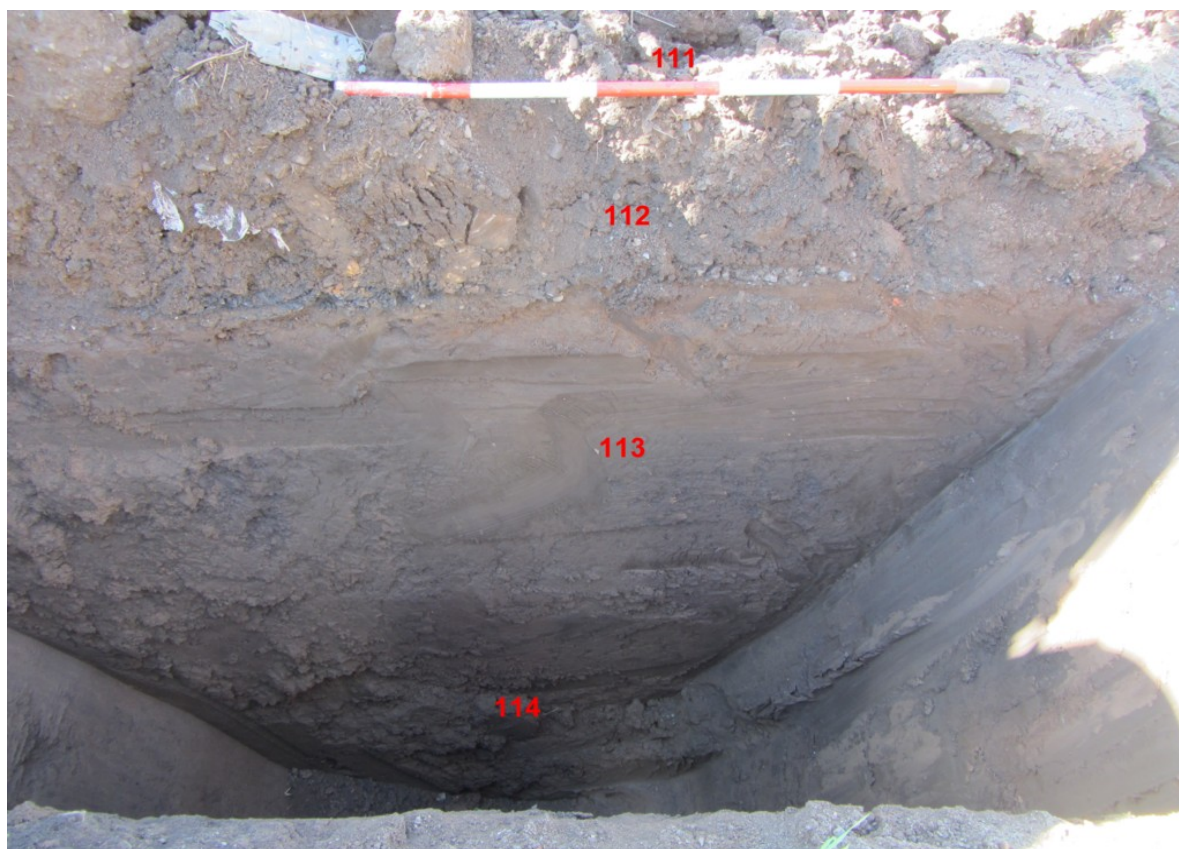
Plate 76: Eastern section of test pit 8; scale one metre.

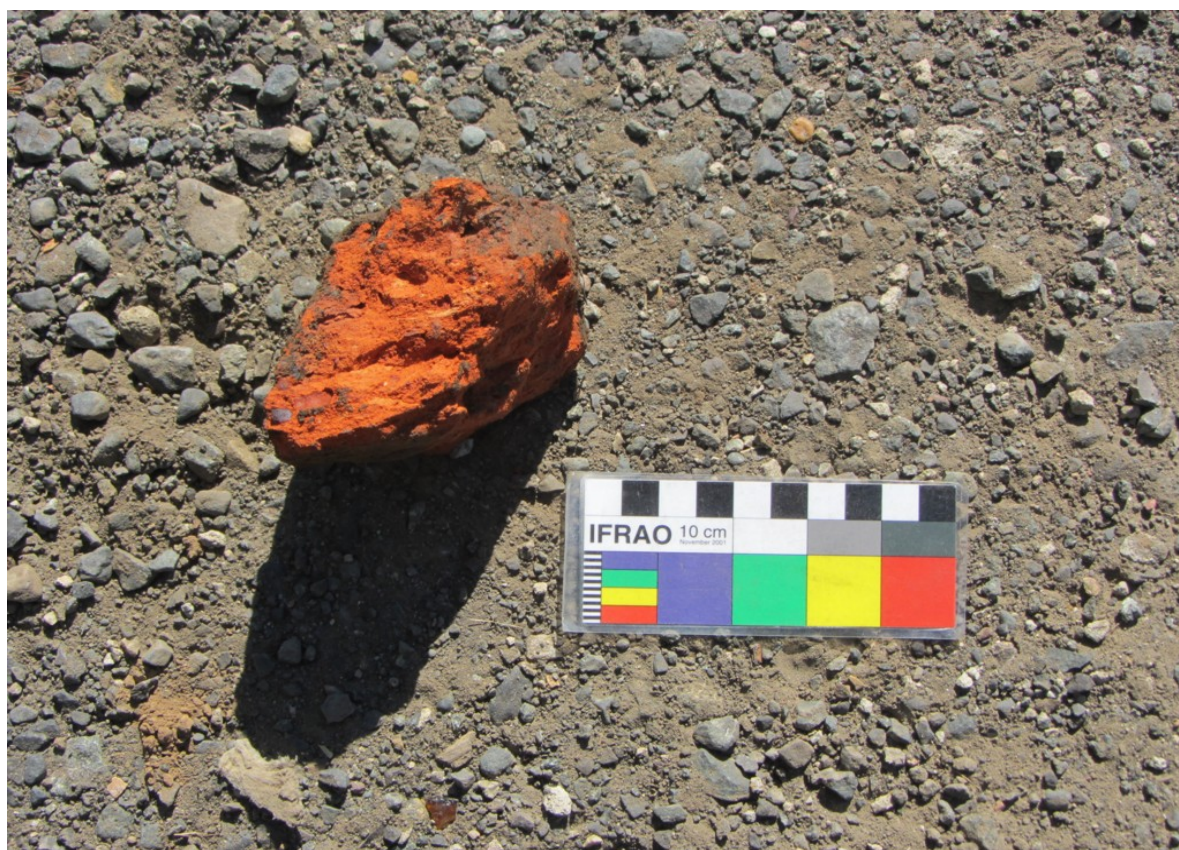
Plate 77: Small fragment of mid-nineteenth century brick found in test pit 8.

Test pit 8 provided the only nineteenth century artefact; a fragment of one mid-nineteenth century brick. The site of the nineteenth century Squatters Arms inn is likely to be in this area but one fragment is insufficient to provide a certain indication of the location of this place.

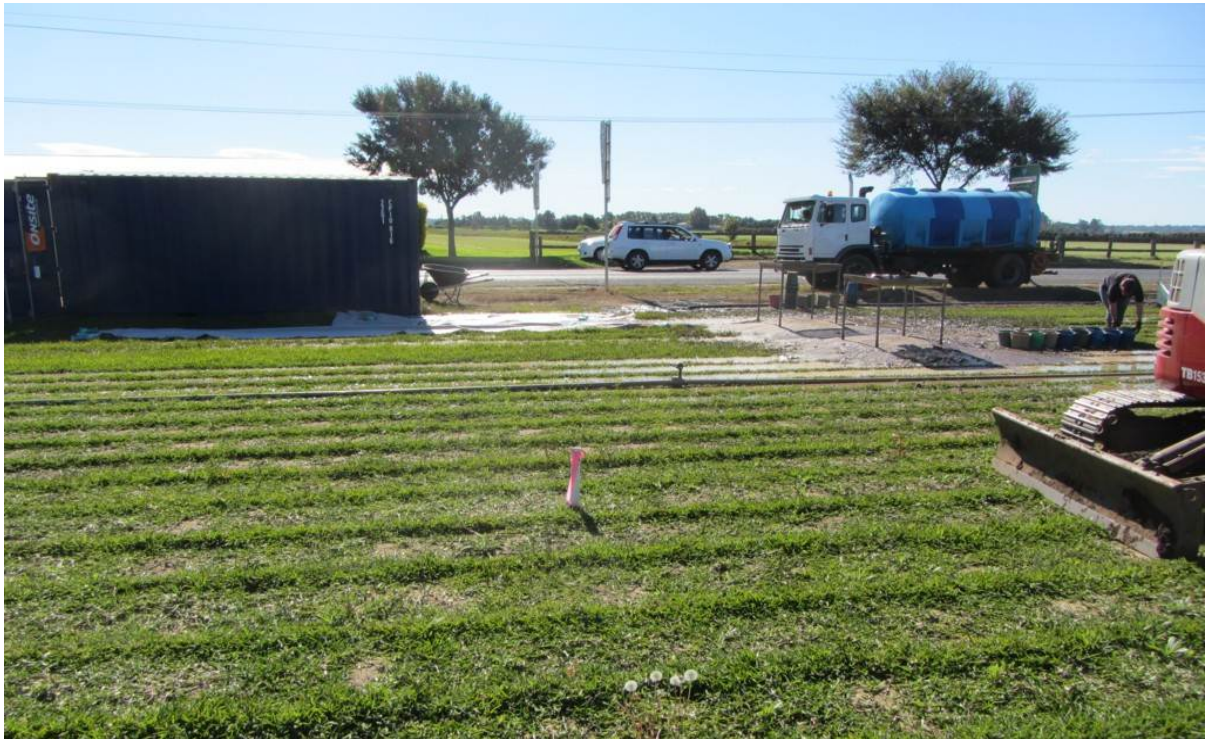
Plate 78: View north showing the location of test trench 9.

This test pit was located in one of the fields of the turf farm on the southern side of Wilberforce Road between it and the river.

The surface deposit in this test pit was the turf being grown on the farm in brown silty loam [115]. This soil continued with very little variation to a depth of 2.6 metres where the sand content increases [116]. This soil continued to the depth of the excavation.

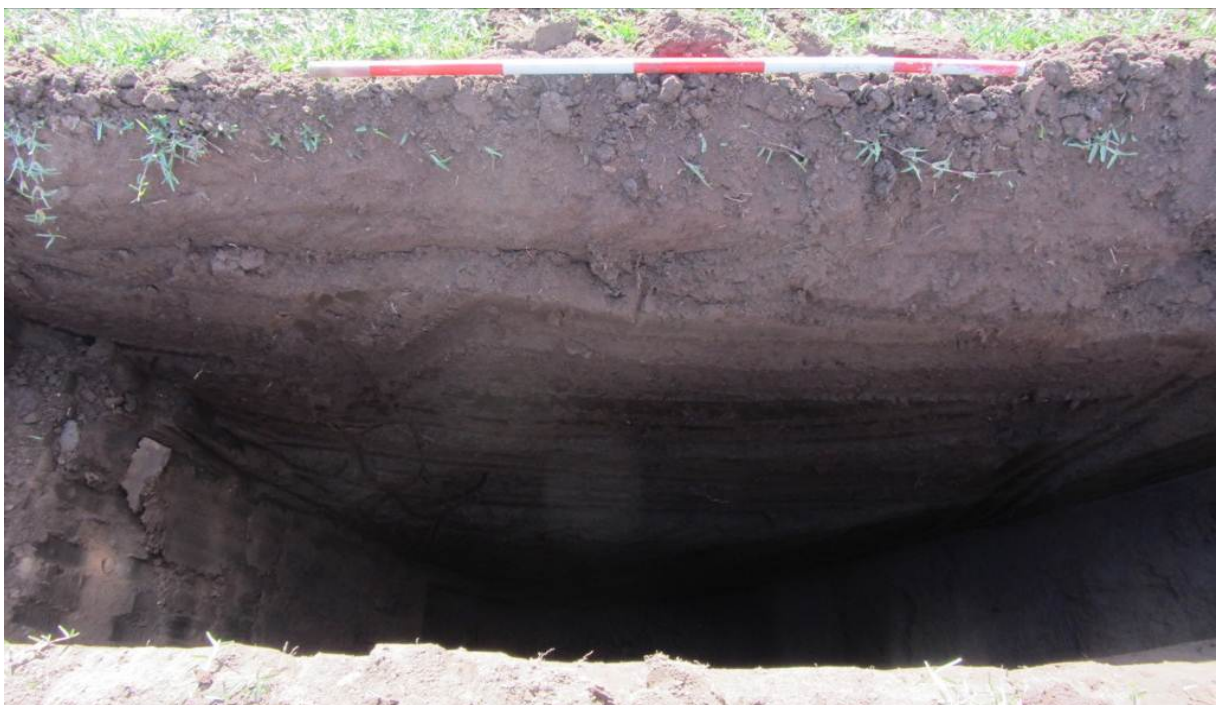
Plate 79: View north of profile in test trench 9; scale one metre.
