Windsor Bridge Replacement Project

Maritime Archaeological Testing Report And Detailed Salvage Strategy For Maritime Archaeological Excavation

Windsor,
Hawkesbury River, NSW

March 2018

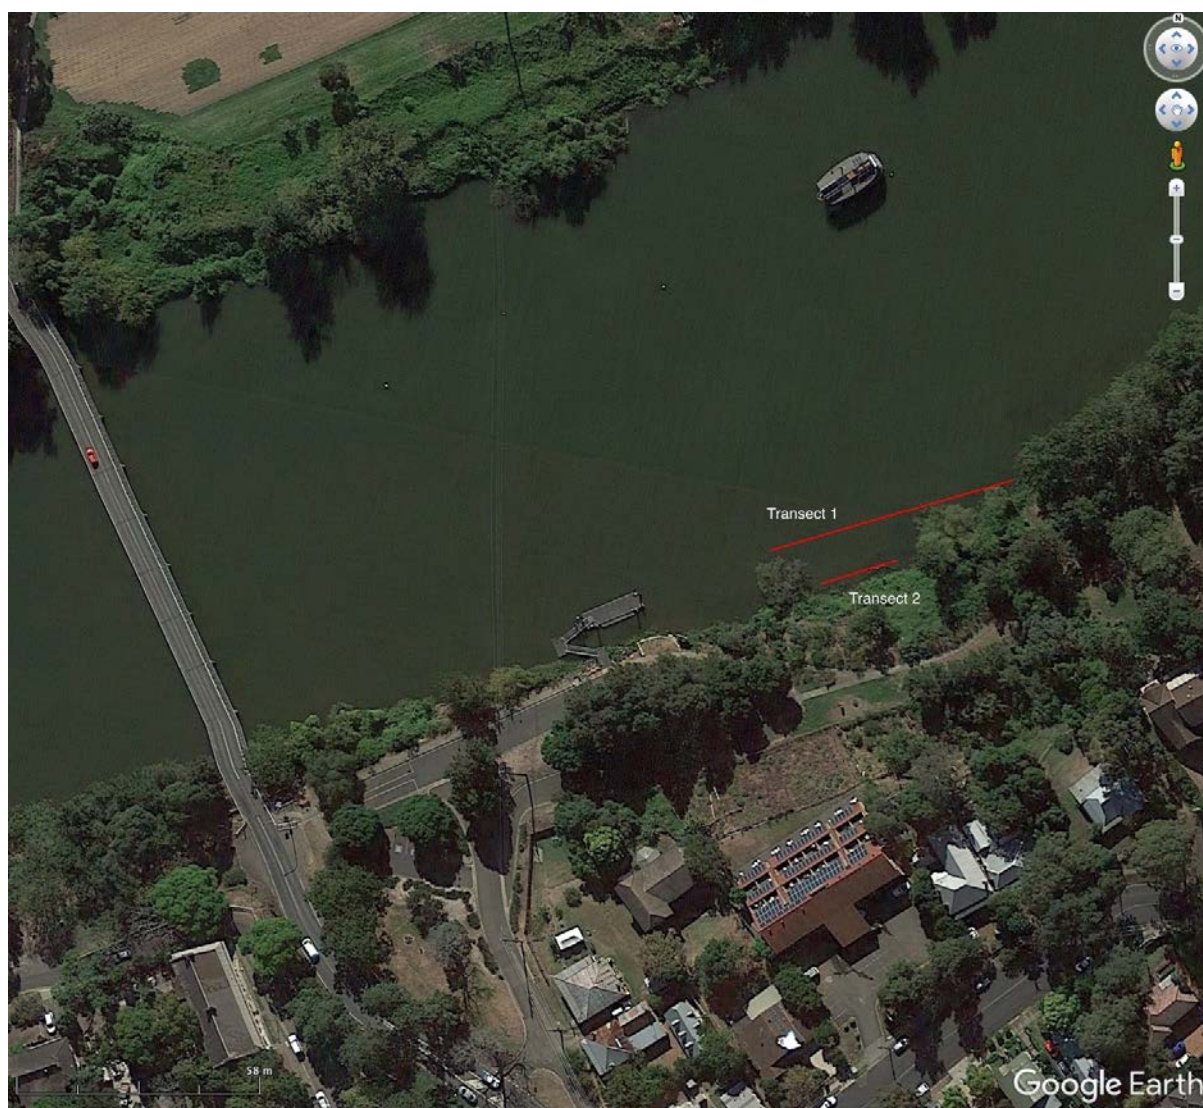
Figure 3: Location of survey transects for potential second government wharf site.

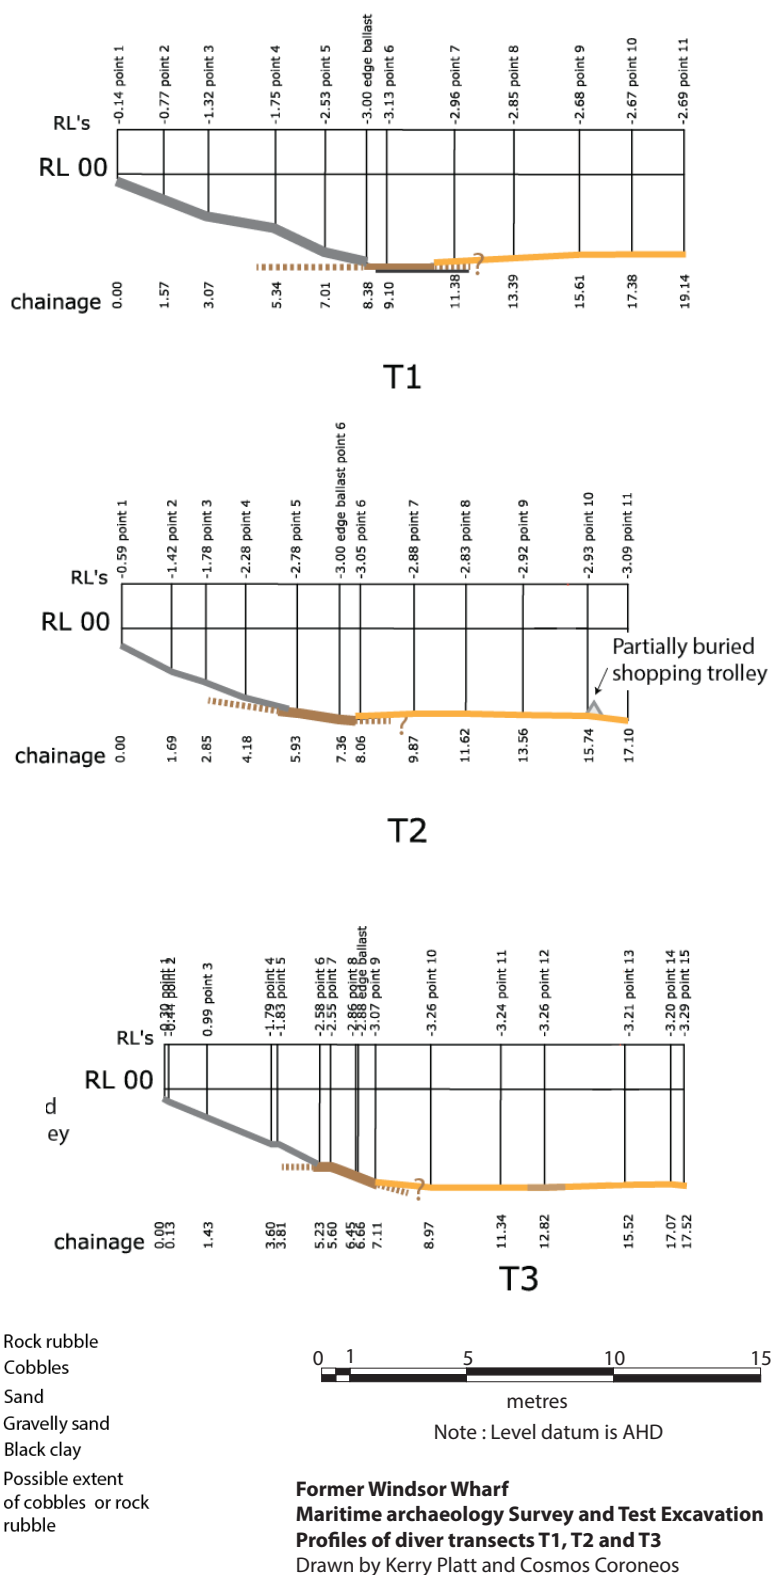
Figure 5: Diver transect profiles 1, 2 and 3 showing riverbed composition.

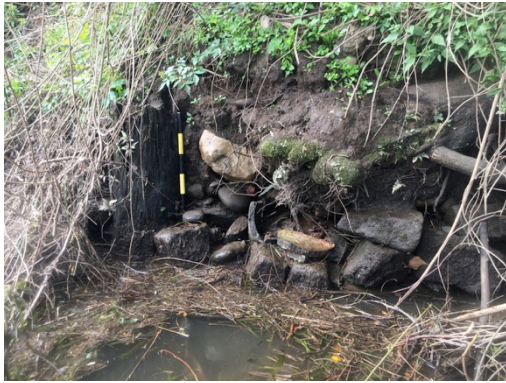
Figure 8: Feature 1 is composed of a timber pile, broken stone ware pipe and irregular coursed roughly squared stone retaining wall. Exposed at spring low tide. Scale in 50 mm increments.

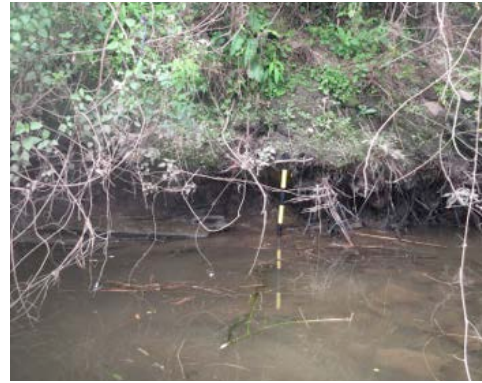
Figure 9: Timber planking (Feature 2) associated with the 20th century version of the Windsor wharf. Scale in 50 mm increments.

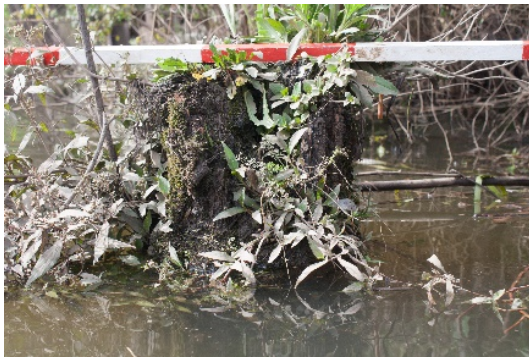
Figure 10: Timber pile (Feature 7). Scale in 200 mm increments.

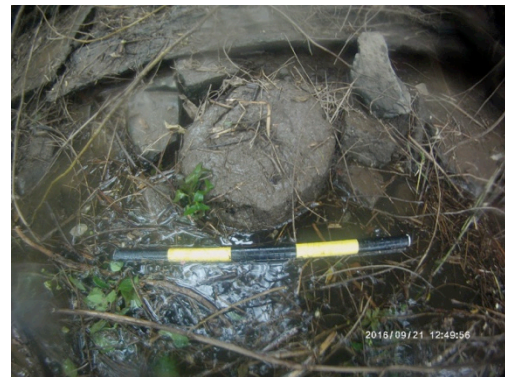
Figure 11: Timber pile (Feature 5). Scale in 50 mm increments.

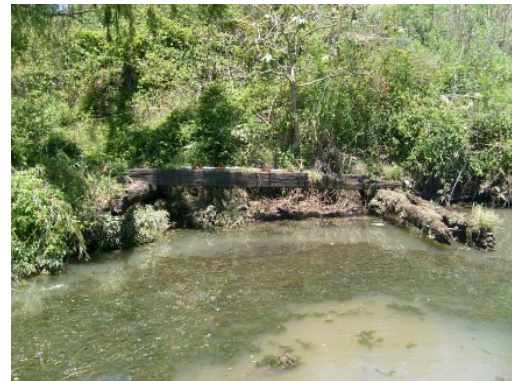
Figure 13: Wharf timbers (Feature 6). Scale in 200 mm increments.

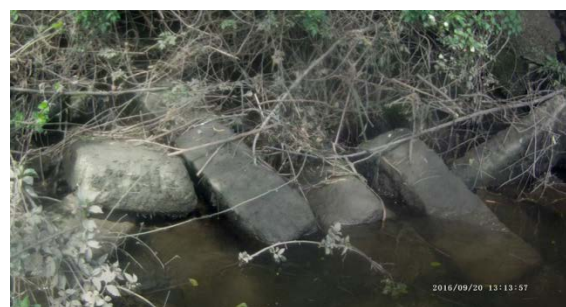
Figure 15: Sandstone kerbing (Feature 9).

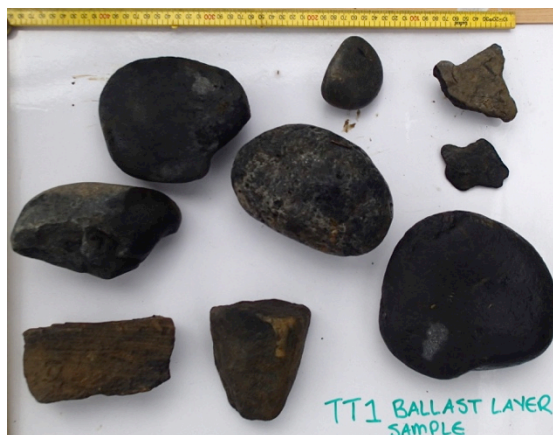
Figure 17: Sample of ballast from Unit 1. Dark staining of stones signifies anaerobic conditions.

The stones recovered from Unit 1 were mostly rounded and appeared to be types of sandstone and mudstone (Figure 17).

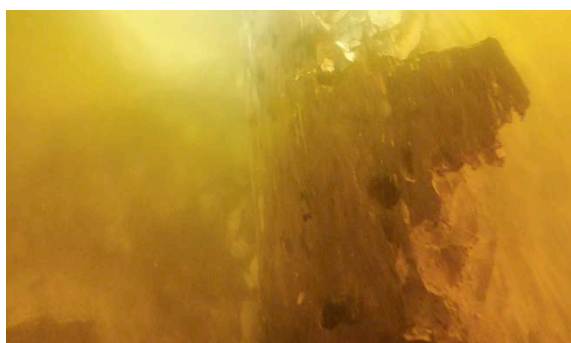
Figure 19: Video screen grab of timber log which abuts UWTT02.

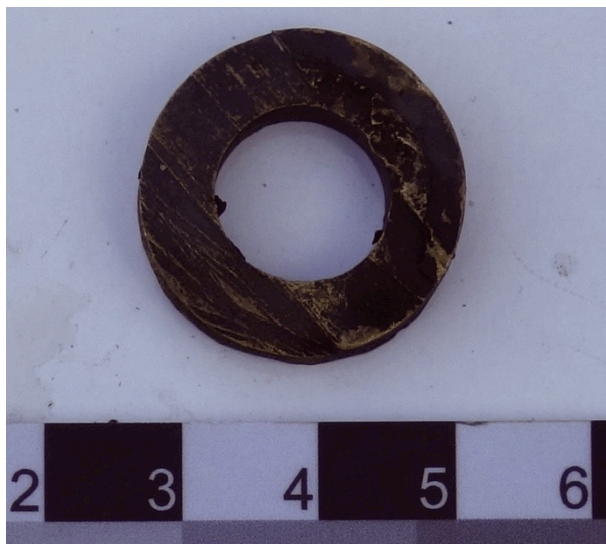
Figure 21: Copper alloy washer which may have been a clench ring.

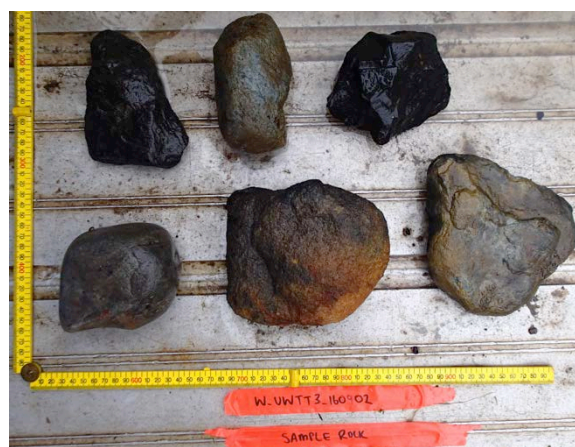
Figure 24: Sample of stone recovered from Unit 3.

The stones recovered from Unit 3 were mostly rounded, sub-angular and generally flatter rather than spherical in shape. There appeared to be types of sandstone as well as coarser grained harder rock which may be metamorphic or igneous in nature (Figure 24). One dark fragment appeared to be basalt.

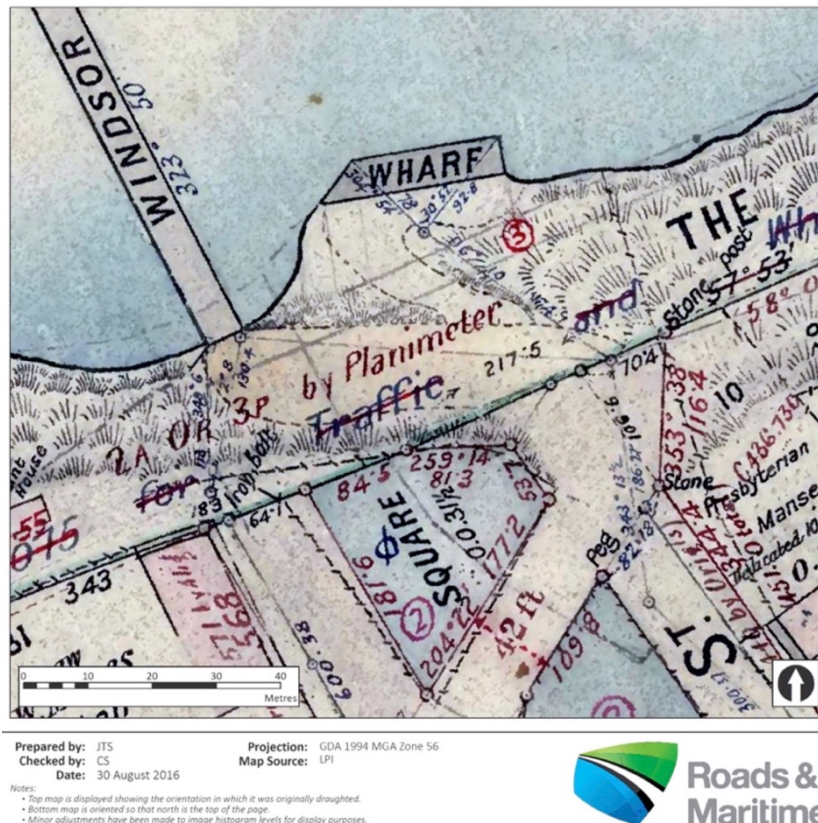
Figure 26: The wharf surveyed in 1894 (Source: C. Scrivener, plan of Thompson Square, 1894, LPI, Road Plan, R 1009.3000).¹²

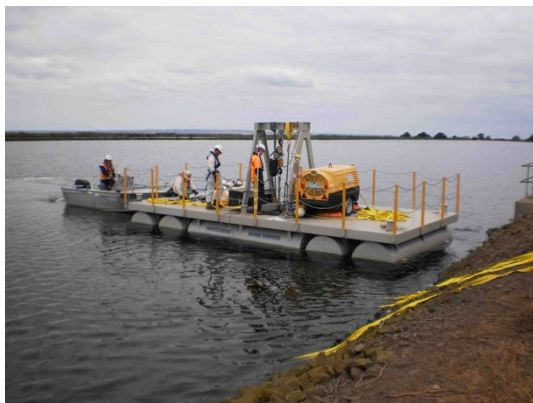
Figure 32 – Proposed barge for use as a dive and work platform.

At this stage, the working platform is expected to be a dumb barge of 9 m x 4 m with a small container from which dive operations will be conducted (Figures 32 and 33). The working platform has a collection well on board, whereby the sediments and other material can be sent to and passed through sieves on board the working platform. Artefacts can then be collected and sorted. With the sieve well in the centre of the working platform, it is possible to attach a silt screen all the way around the hull forming a skirt.
