PROPOSED WINDSOR BRIDGE REPLACEMENT WINDSOR, NSW

MARITIME ARCHAEOLOGICAL STATEMENT OF HERITAGE IMPACT

Final Working Paper Report

Proposed Windsor Bridge Replacement: Maritime Archaeological Statement of Heritage Impact Windsor, NSW

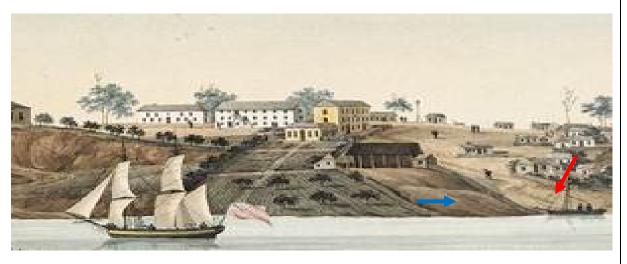
Figure 4: Detail of G.W.Evans watercolour of 1809 showing a boat obscuring the believed location of the original wharf and the track running down to it (*red arrow*). The possible outline of a former slipway is outlined by the *blue arrow* (ML PXD 388 V3 f7).

It is believed the original wharf was later destroyed by a flood in ca.1799. There is no mention from the historical record of the wharf being repaired or rebuilt at Windsor until in 1812 with the construction of what is known as the second wharf. There were several major flood events along the Hawkesbury River at Windsor after 1795, notably 1799, 1800 and 1806. It is possible that one of these events destroyed the original wharf. The earliest paintings do not show the location of the original wharf on site. An 1807 painting from the site, which cannot be reproduced due to copyright issues, does not show the original wharf. Evans' 1809 watercolour of Windsor shows a boat obscuring the believed location of the original wharf. Behind the boat is a track that leads down the hill to this location which may have served as a track leading to the first wharf (Figure 4).

of infrastructure shown in the 1807 watercolour can be seen (See Blue Arrow in Figure 4).

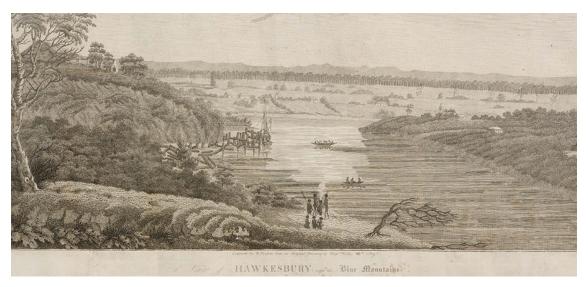
Figure 6: A View of Hawkesbury, and the Blue Mountains. / New South Wales. c. 1818. Printed beneath the image is "Engrav'd by W. Preston from an Original Drawing by Cap.t Wallis. 46th Reg.t". A watercolor drawing titled "Hawkesbury & Blue Mountains, / from Windsor".

The first images that are available of the wharf date to ca.1818 and relate to either the wharf during construction or from the damage that occurred to the wharf in 1816 (Figure 6). The engraving shown in Figure 6 is marked "W. Preston from an Original Drawing by Cap.t Wallis" and may have originally been drawn in 1816 when the wharf was damaged. This image is of interest as it appears to show the township of Windsor high up on the bank on the left, a dilapidated jetty/wharf on the same side with a vessel tied up alongside, a double ended poled vessel (the punt) with passengers crossing the River and a road on the right side stopping at the river's edge (the punt crossing). It would appear that the punt crossing on the left (south bank) is obscured by the wharf.

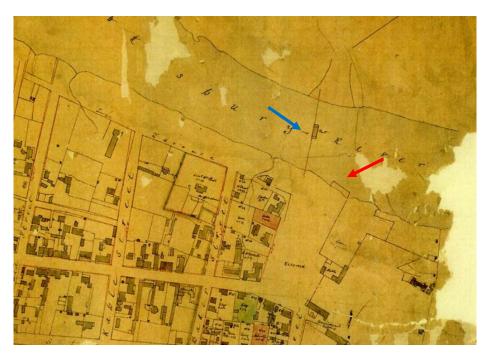
Figure 7: Detail of a survey c. 1835 showing the punt and the wharf on the river's edge at the northern end of Thompson Square and a wide cutting on the northern side of the river (AO Map 5968). The wharf is highlighted by the *red arrow*, and the punt crossing by the *blue arrow*.

The next available image of the wharf is from a detailed plan survey of 1835 plan of the township of Windsor showing the location and shape of the wharf. The plan shows the wharf located on the eastern side of the "reserved area" (Thompson Square) (Figure 7). A plan of "Buildings and Cultivation adjoining the town of Windsor" was created in 1842. The plan shows the location of buildings, allotments, roads and the boundary of the river in great detail, however, the wharf has not been included in the plan. A small rectangle is drawn in the general area of the wharf and is marked "Punt", with a road or track leading to it (Figure 8). It is likely that the plan concentrated on the detail of the arrangement of the allotments and buildings and terrestrial notaries, and that the maritime infrastructure, namely the wharf, were not added in, or added later with lesser detail.

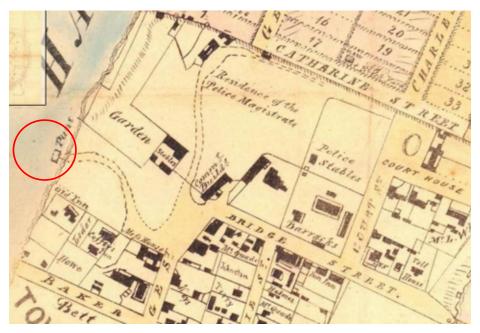
Figure 8: Detail of Laban-White's plan of the town in 1842 showing the wharf and punt crossing as one (circled in red). Source: Jack 2010.

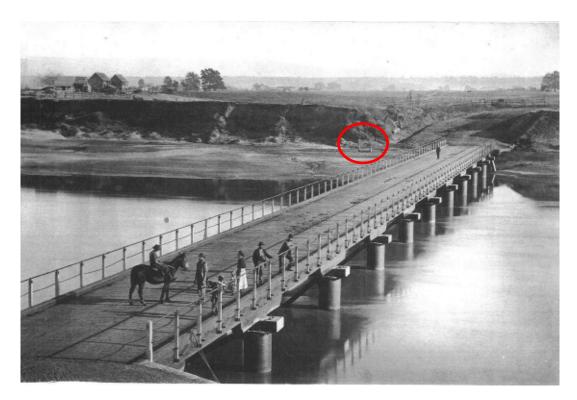
Figure 11: 1874 photograph of the first bridge across the Hawkesbury River at Windsor. The remains of the cable anchor posts of the former punt can be seen to the left of the bridge on the northern bank of the river (*circled in red*) (Source Hawkesbury City Council Library Service).

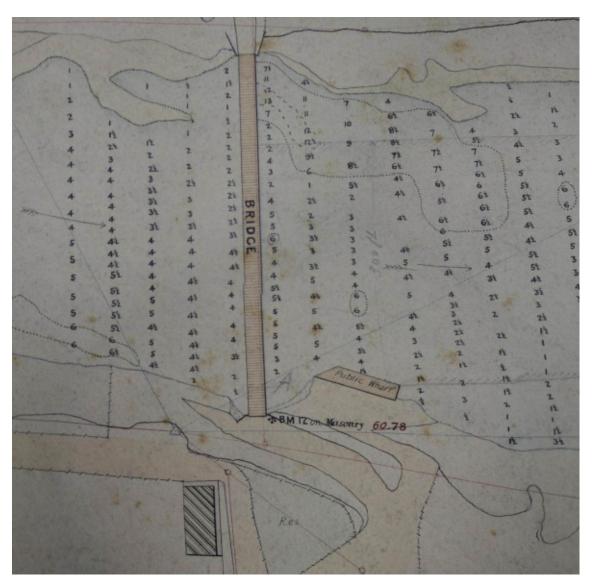
Figure 12: Plan of part of the Hawkesbury River at Windsor (1890). Soundings are shown in feet and reduced to L.W. Spring Tides. (Source State Archives of NSW X1080- 74/12).

A hydrographical survey of the Hawkesbury River in 1890 includes a detailed survey of the wharf, showing that the wharf was not rectangular in shape, but had an angled western end to the wharf that was not previously shown on the earlier plans (Figure 12). By this time the bridge across the Hawkesbury River had been constructed and the punt crossing likely ceased operation. The design reason for this angle is unclear. It is possible the wharf was extended or the western end was modified to allow for additional shallow drafted vessels to berth at the wharf.

As it faced upstream it may have served to deflect water flow around the wharf thereby reducing the risk of damage to the structure during floods. It is also possible this section was constructed to allow for shallower draft vessels, such as the punt, to berth at the wharf and leave the outer edge of the wharf that was in deeper water for larger draft vessels. The outer edge of the wharf is approximately 80 ft long, which the landward side of the wharf is approximately 90 ft. The width of the wharf is 20 ft (Figure 12). The wharf appears on a west-northwest to east-southeast orientation with a track leading down from the eastern side of Thompson Square.

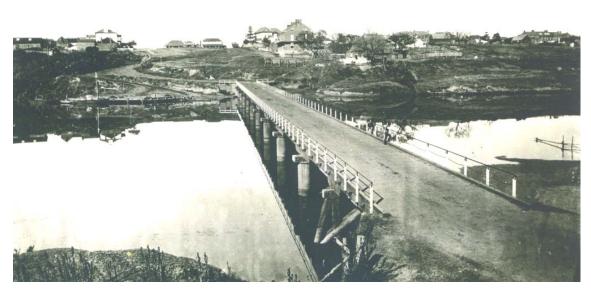
Figure 13: Part of an undated panorama showing Thompson Square in the later part of the nineteenth century. The wharf can be seen to the left of the bridge in this photograph. Remains of the cable system associated with the former crossing can be seen in the far right of the image. ML SPF after Biosis Research (March 2012).

The first photograph to show the early wharf dates between 1874 and 1897. The photograph is taken from the northern side of the river looking back at the township of Windsor and the wharf. The angled end of the wharf can clearly be seen, as well as a vessel docked at the wharf (Figure 13). From the limited information available in this photograph it appears that the wharf was of a round timber pile construction, with a flat timber deck. The angled section of the wharf appears to be level and of similar construction to the remainder of the wharf (Figure 13).

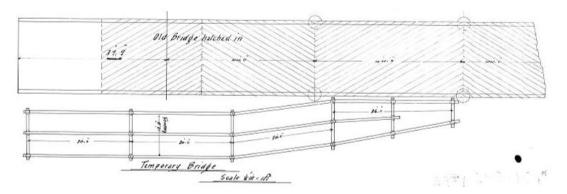
Figure 14: Proposed plan for the new (upgraded) bridge across the Hawkesbury River at Windsor showing a proposed temporary bridge located on the upstream side of the existing bridge (Source Crown Plan 80/385).

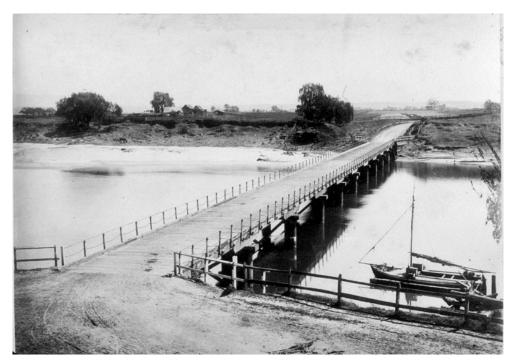
Figure 15: Photograph of the Windsor Bridge from the southern side of the Hawkesbury River dated between 1874 and 1896. Piles or mooring posts associated with the wharf can be seen

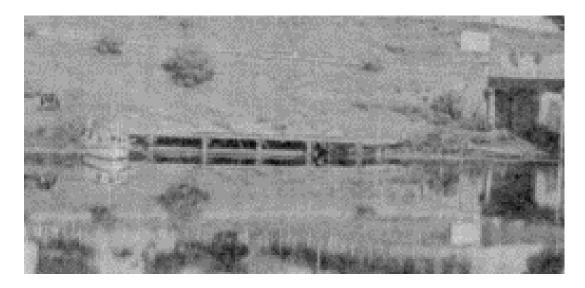
Figure 18: Zoomed image of the wharf beside the Windsor Bridge (no Date). (Source: Mitchell Library Small Picture File – Windsor).

Three later photographs dating from between ca.1890 to ca.1905 show the wharf from a closer vantage point, showing the angled section of the wharf having been removed, or degraded and collapsed, with only the rectangular section of the wharf remaining (Figure 16 and Figure 17). In both photographs the deck of the wharf appears to be in a degraded state, with sections of the decking either buckled or possibly missing in places. The third photograph was taken on the wharf looking along it (Figure 19). In the photograph the outer end of the wharf can be seen, including whaler bracing. The distance between the piles is difficult to determine from the photograph, however, from the close proximity of the whaling braces (attached between rows of piles on a wharf), the piles appear to be placed very close together.

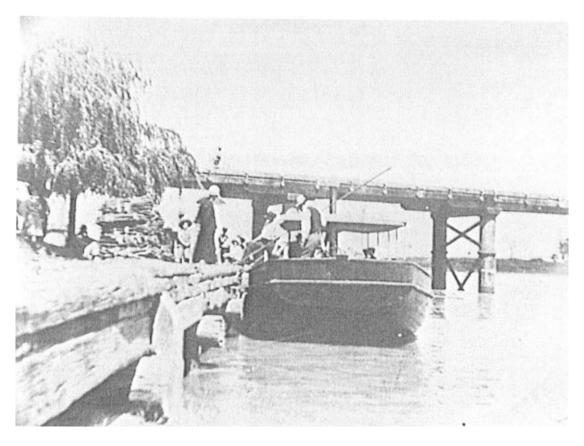
Figure 19: "Wharf at Windsor on the Hawkesbury River near Windsor Bridge" (ca.1890 to ca.1900). The photograph shows some of the below deck components of the wharf, including the closely spaced piles (Source: Hawkesbury City Council Library Service).

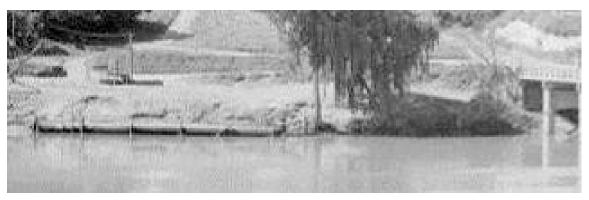
Figure 20: Zoomed section of "Bridge Across the Hawkesbury River, Windsor, New South Wales, ca. 1935." The ca.1814 wharf can be seen clearly still present on the site (Source National Library of Australia http://nla.gov.au/nla.pic-vn4655530).

The date for the removal of the wharf is not known. From documentary evidence, the wharf appears in photographs of Windsor in 1935, and possibly in the first 1947 aerial photograph of Windsor; however, the wharf does not appear in the 1955 aerial photograph (Figure 20 to Figure 22). It is thought that the wharf was left to disintegrate and may have been collapsed gradually until a flood washed loose and exposed remains of the wharf downstream.

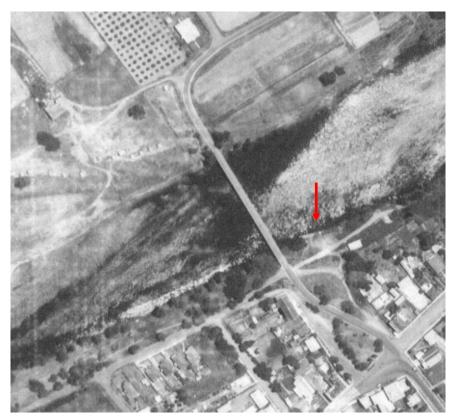
Figure 21: 1947 aerial photograph of Windsor showing the location of the second wharf (*red arrow*).

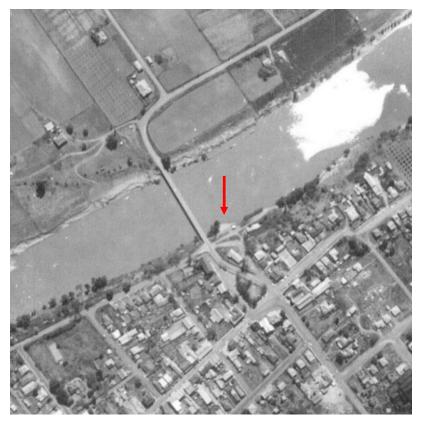
Figure 22: 1955 aerial *photograph* of Windsor showing the location of the second wharf (*red arrow*).

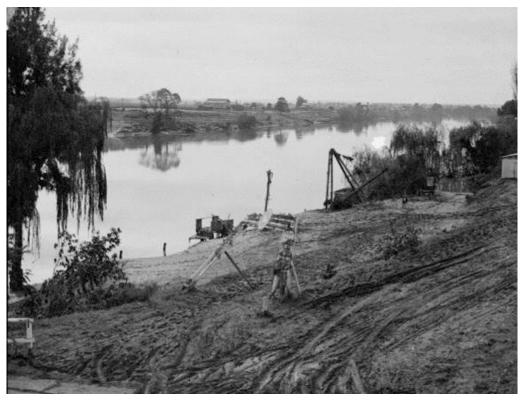
Figure 23: Flood damage after the motor boat regatta, Windsor, Hawkesbury River, NSW, 1949 (Source NLA http://nla.gov.au/nla.pic-vn4654154).
