## 4.0 Maritime Archaeological Survey Work

### 4.1 Maritime Archaeological Survey (Cosmos Archaeology 2009)

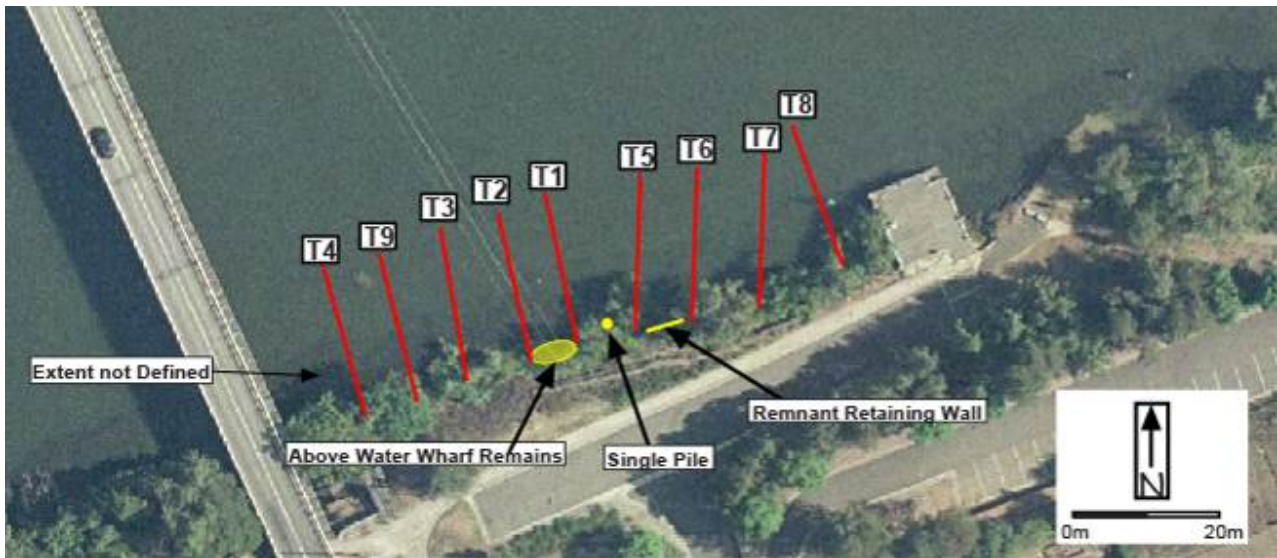
**Figure 24:** Location of the recorded above water features identified in the 2008-9 survey.

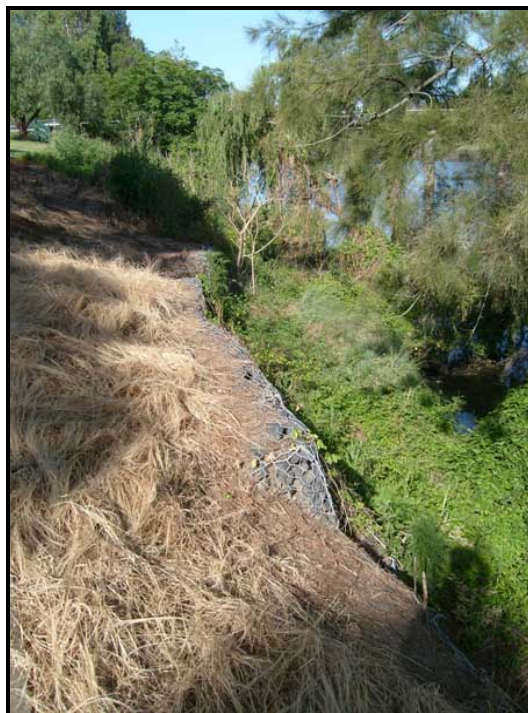
Above the low water line on the southern riverbank between the bridge and the existing wharf it was noted that it had been recently modified with the installation of a gabion wall. This has resulted in a near vertical retaining wall closer to the bridge with the gradient lessening with distance downstream to a point close to the existing wharf where the wall ceases (Figure 25). The thick vegetation on and around this wall prevented any further examination of the southern side of the riverbank.

**Figure 25:** Gabion wall recently constructed above the location of the former wharf site (Photo: Cosmos Archaeology).

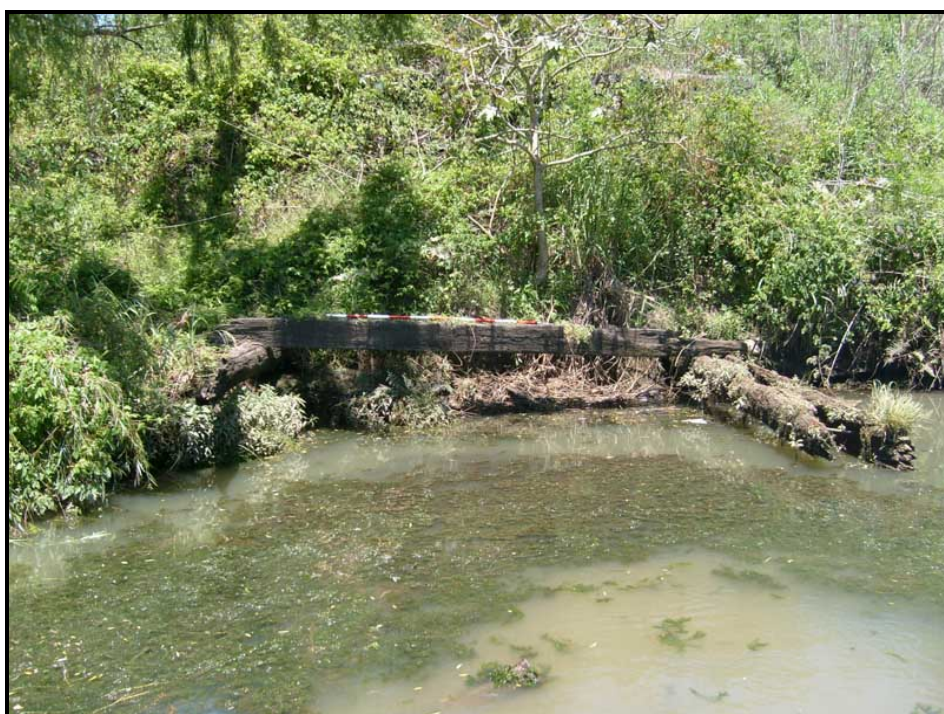
The first group, three timber beams, including a possible deck beam, are parallel to the riverbank, and rest on two walers (Figure 26).<sup>37</sup> The deck beam is 5.2 m long, 0.25 m wide and 0.20 m thick. This beam rests on top of the walers with no visible fastenings attaching them (Figure 27). There are the remains of fastening holes in the middle of the beam above where the beam intersects the two walers, implying the beam may have been fastened to another section of the wharf positioned on, or in, the riverbank.

**Figure 26:** Structural remains present of the former wharf. Scale in 200 mm increments (Photo: Cosmos Archaeology).

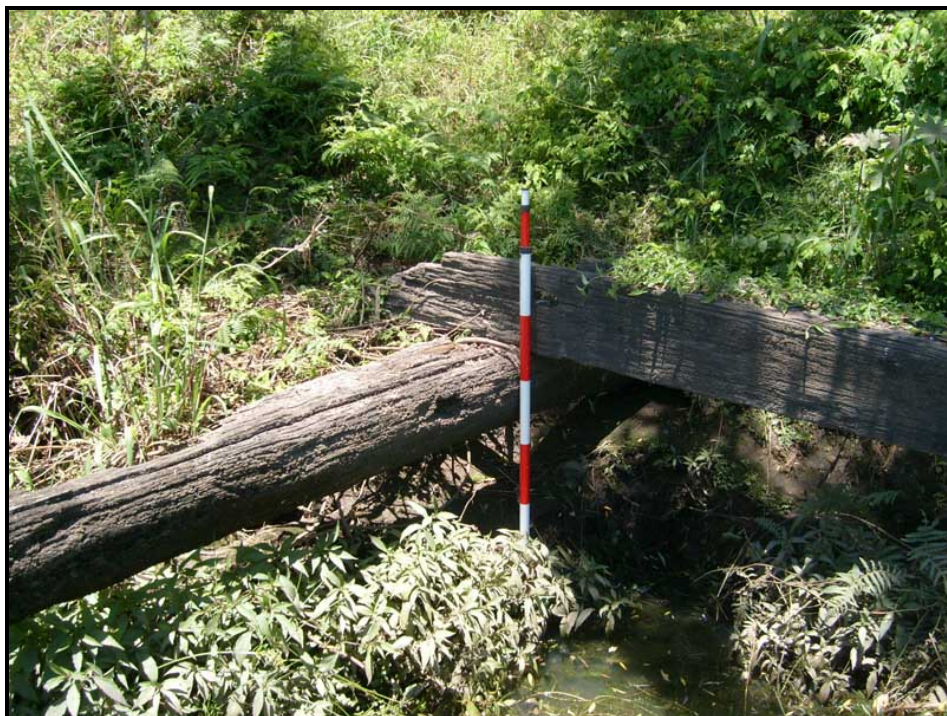
**Figure 27:** Remains of a deck beam resting on two walers. Scale in 200 mm increments (Photo Cosmos Archaeology).

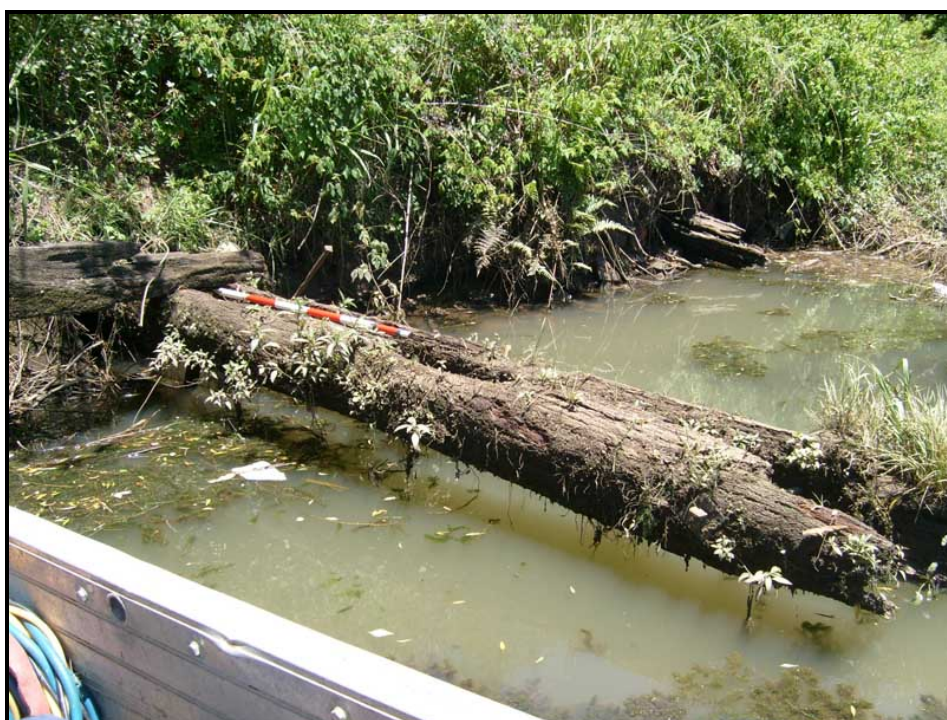
of the wharf. The two timbers on the western side of the deck beam are both 2.9 m long and 0.3 m wide, and are crescent shaped, being 0.25 m at the thickest point in the middle. Both timbers appear to be from the same rounded log that has been halved, and spaced 0.4 m apart (Figure 28 and Figure 29). There are two large iron bolts that connect each waling timber together, one approximately 0.4 m in front of the deck beam, and the other at the river end of the timbers (Figure 30). The inside sections of both waler beams have also been carved out immediately around the location of the bolts. This is likely where the beams would have been bolted through the piles. A recess has also been cut into the top of the wale beam. The recess is located approximately 1.2 m in front (river side) of the deck beam, measuring 0.35 m wide and 0.05 m deep. This may have been for the placement of another deck beam across the timbers (Figure 31).

**Figure 28:** Two waler beams on the western side of the wharf remains. Scale in 200 mm increments (Photo Cosmos Archaeology).

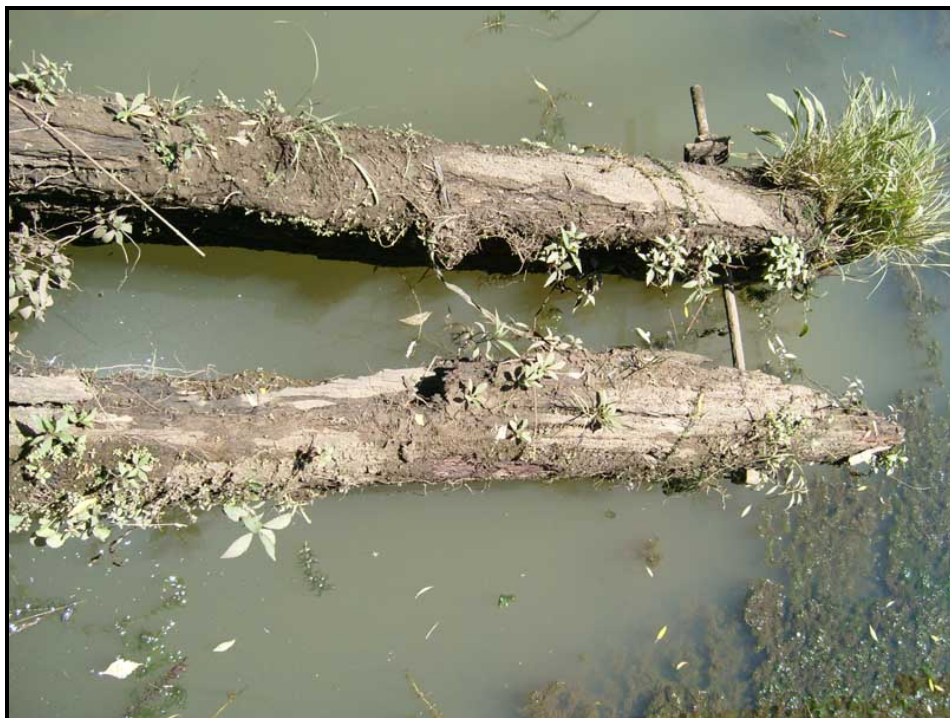
**Figure 29:** Remains of the two walers on the western side of the wharf remains (Photo Cosmos Archaeology).

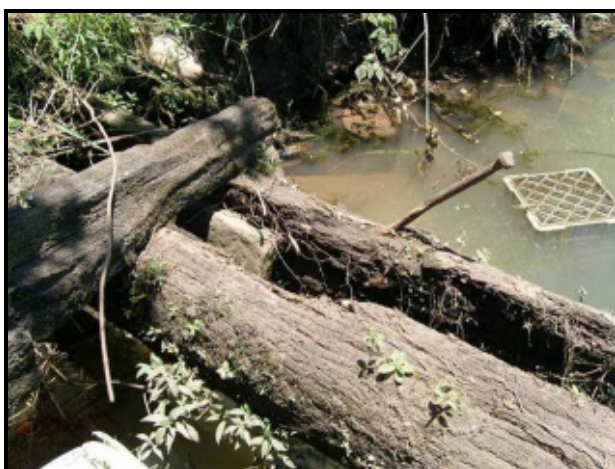
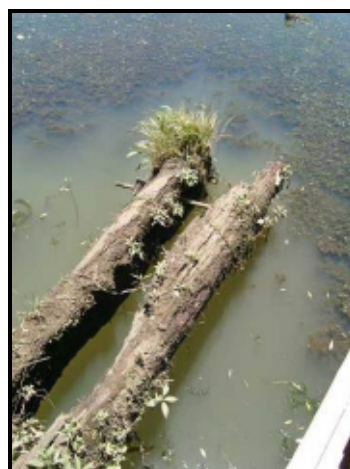
**Figure 30:** Fastening remains present on the two waler beams on the western side of the wharf remains (Photo Cosmos Archaeology).

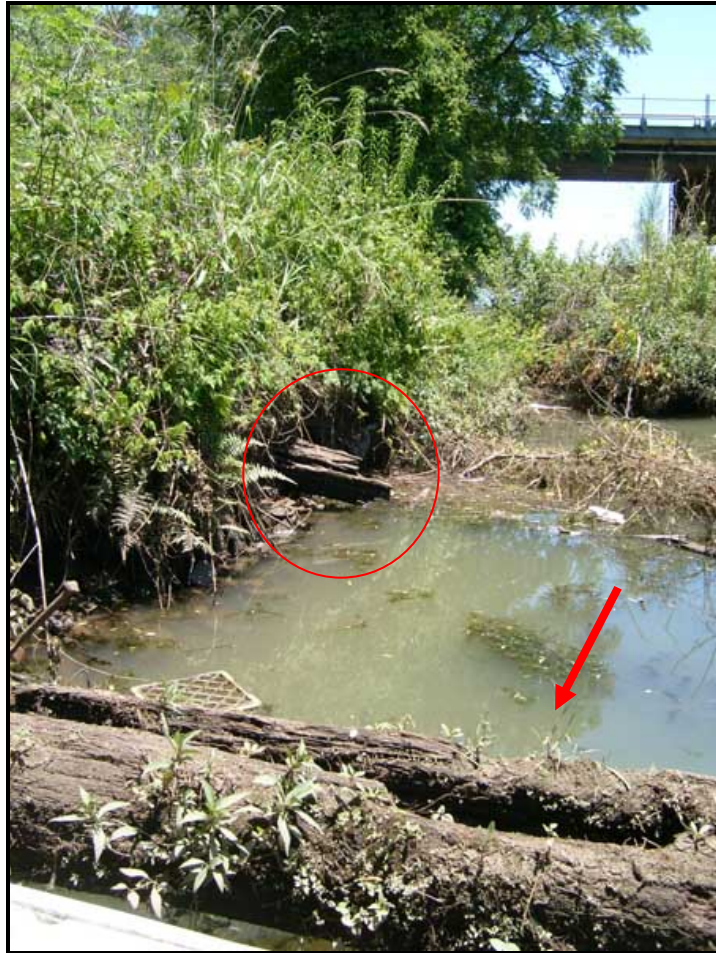
**Figure 31:** Recesses cut into the top of the walers (red arrow). Probable location of another deck beam. Note also the location of another waler in the centre of the photo (red circle) (Photograph: Cosmos Archaeology).
