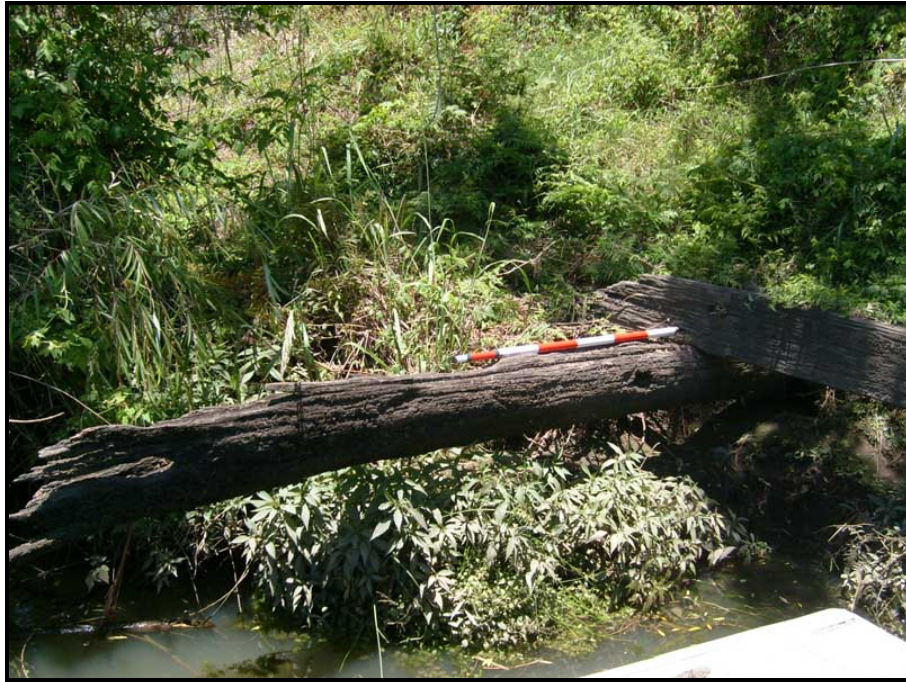
Figure 32: Remains of the singular wale on the eastern side of the wharf remains. Scale in 200 mm increments. (Photograph: Cosmos Archaeology).

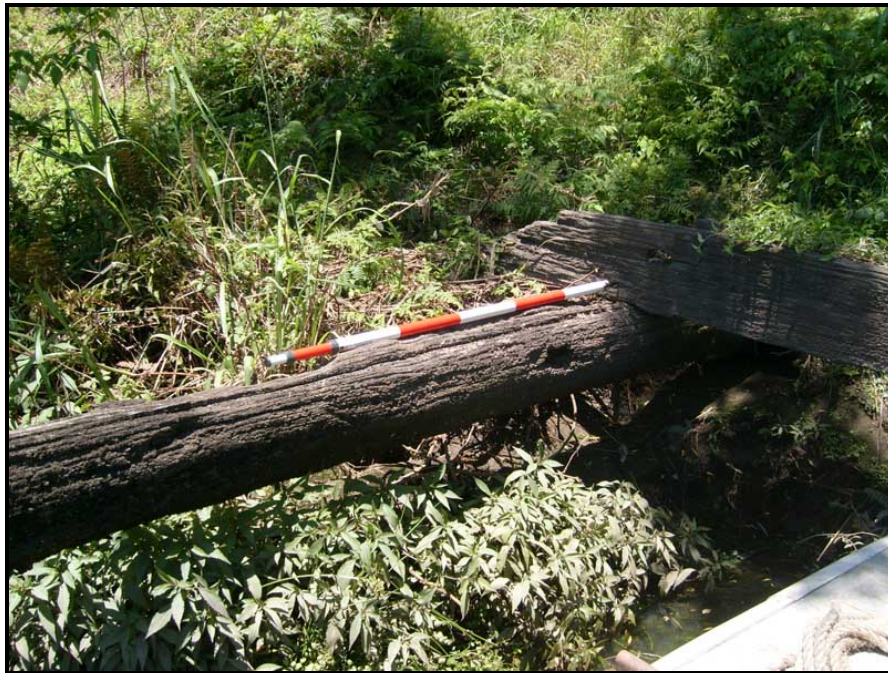
Figure 33: Location of drilled holes for the location of bolts (no longer present). Scale in 200 mm increments (Photograph: Cosmos Archaeology).

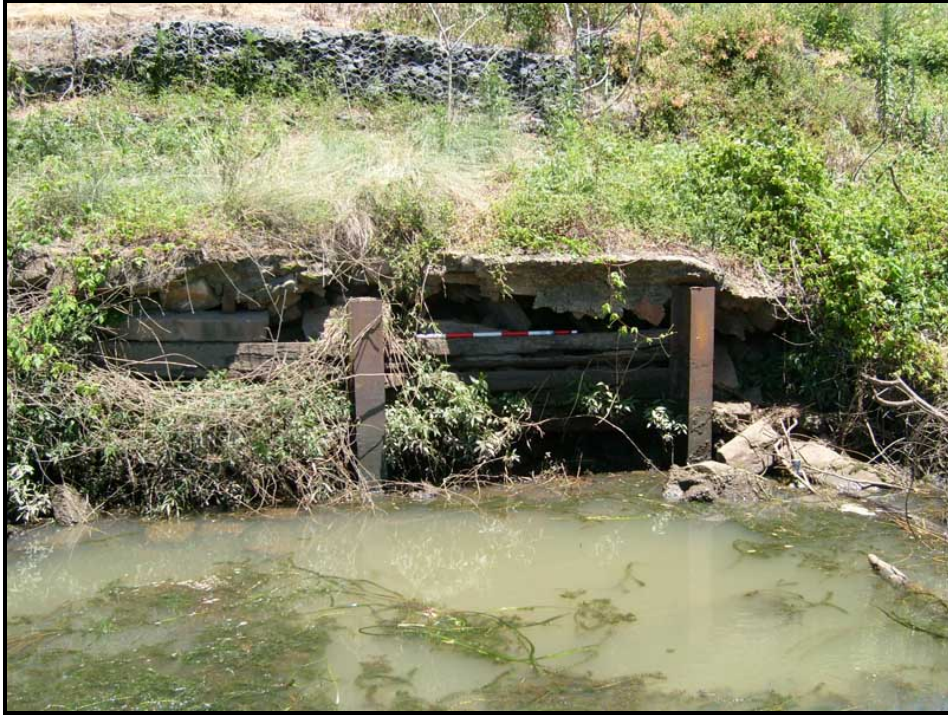
Figure 34: Remains of the retaining wall to the east of the above water wharf remains. Scale in 200 mm increments (Photograph: Cosmos Archaeology).

A section of a former retaining wall was also visible in the riverbank. The retaining wall is located approximately 20 m to the west of the existing wharf at the eastern end of the study area, and approximately 15 m to the east of the extant above water wharf remains (Figure 24). The retaining wall consisted of two iron girders 2 m apart with two timber cross pieces (Figure 34). The “I” shaped iron girders stand 1.5 m above the riverbank, and are 0.20 m wide (Figure 35). The two timber cross pieces are approximately 2.5 m long x 0.30 m wide and 0.11 m thick, and are spaced close together. Material behind the wall consists of dressed sandstone blocks, bricks and broken up concrete deposited up the riverbank. A concrete cap has been placed over the top of the fill at one stage, possibly to create a surface or to contain the backfilled material (Figure 36).

The attribution of the remnant timber and steel retaining wall on the southern bank is not certain. It most likely dates from the second half of the 20th century. It may have formed part of a river wall, which passed underneath the last upgrade of the wharf, but much more likely was constructed after the wharf fell into disrepair, using elements of the wharf in its construction and in the fill behind it.

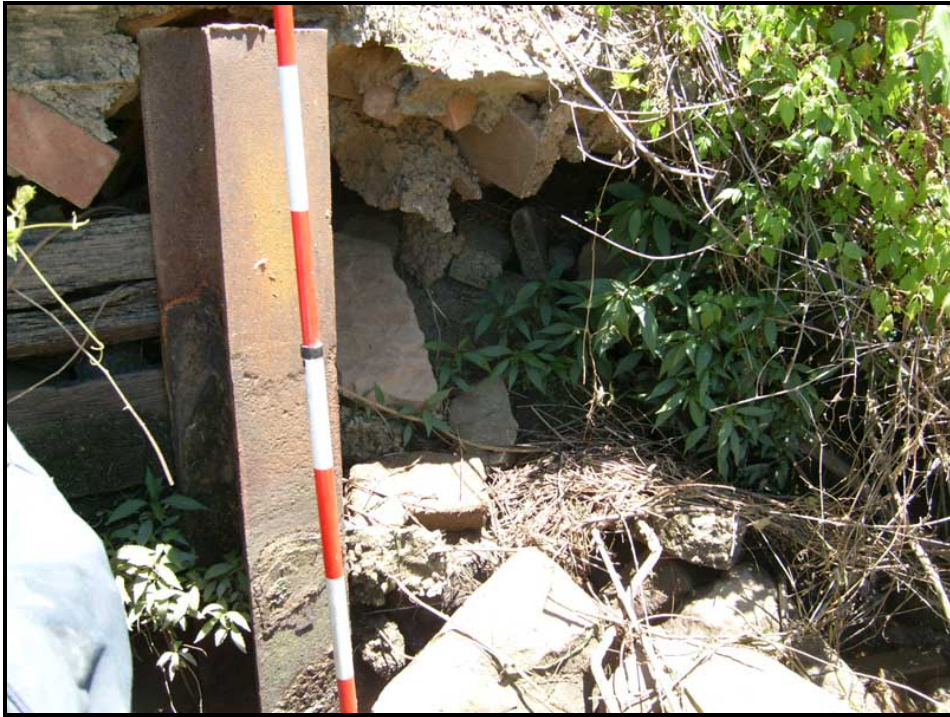
Figure 35: Iron girder that forms part of the retaining wall present on the riverbank. Scale in 200 mm increments (Photograph: Cosmos Archaeology).

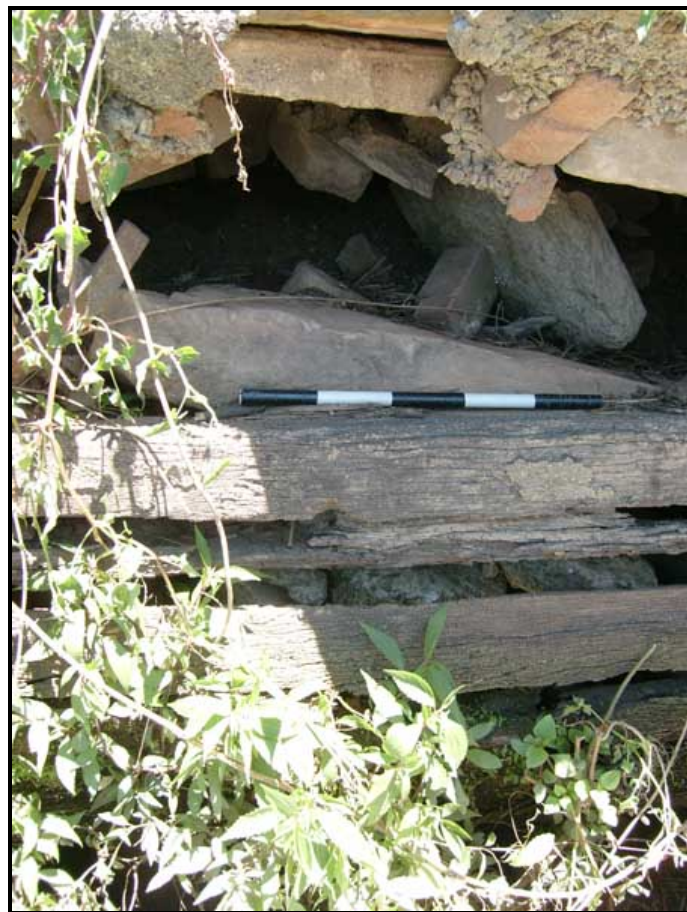
Figure 36: Example of the fill present behind the retaining wall. Scale in 200 mm increments (Photograph: Cosmos Archaeology).
