4.3 Maritime Archaeological Underwater Survey (2012)

4.3.1 Recording Process

4.3.2 Findings

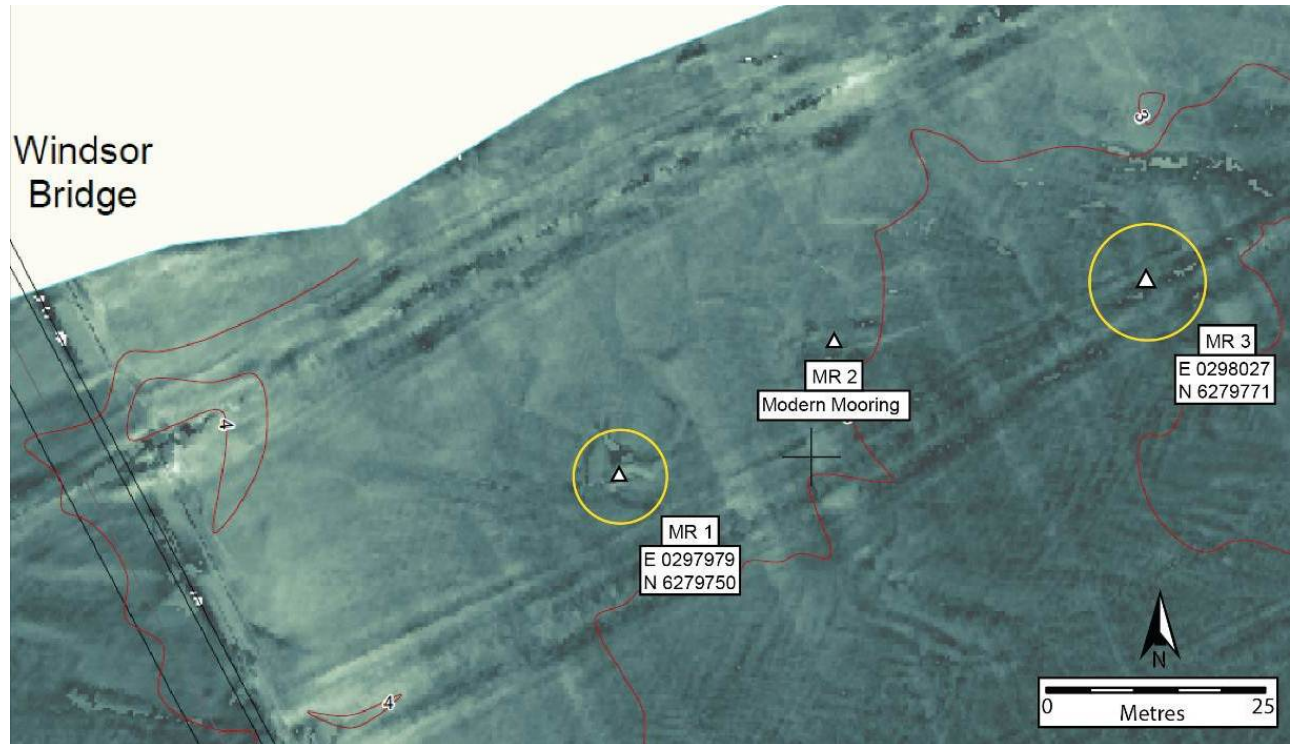
This circular search was undertaken on Middle River 1 anomaly (Figure 51). The riverbed in this location consisted of a sandy bed, and was relatively flat. The diver conducted the search starting at 2 m and heading out. No evidence of the anomaly was present, or any evidence of local scouring or other features that may attribute to the anomaly identified in the side scan sonar survey. It is possible this anomaly may have been a tree branch, or similar material, that has since moved further down river.

This circular search was undertaken on Mid River anomaly 3 (Figure 51). The location of this anomaly was on a localised sand bar within the river, with the depth of water only 2.4 m at the centre point of the survey. The river bed was very sandy and was undulating, with sand ripples present along the riverbed of a height up to 0.5 m from the peak to the trough.

The diver located localised scouring occurring around a boulder outcrop. Inspection of the boulder identified the feature to be natural, with no evidence that the boulder had previously been used as mooring or other feature. No other features or cultural material were identified during this survey.

Figure 51: Location of the anomalies Mid River 1 (MR 1), Mid River 2 (MR 2) and Mid River 3 (MR 3) circular searches (white triangles) and the area covered in each search (yellow circle).

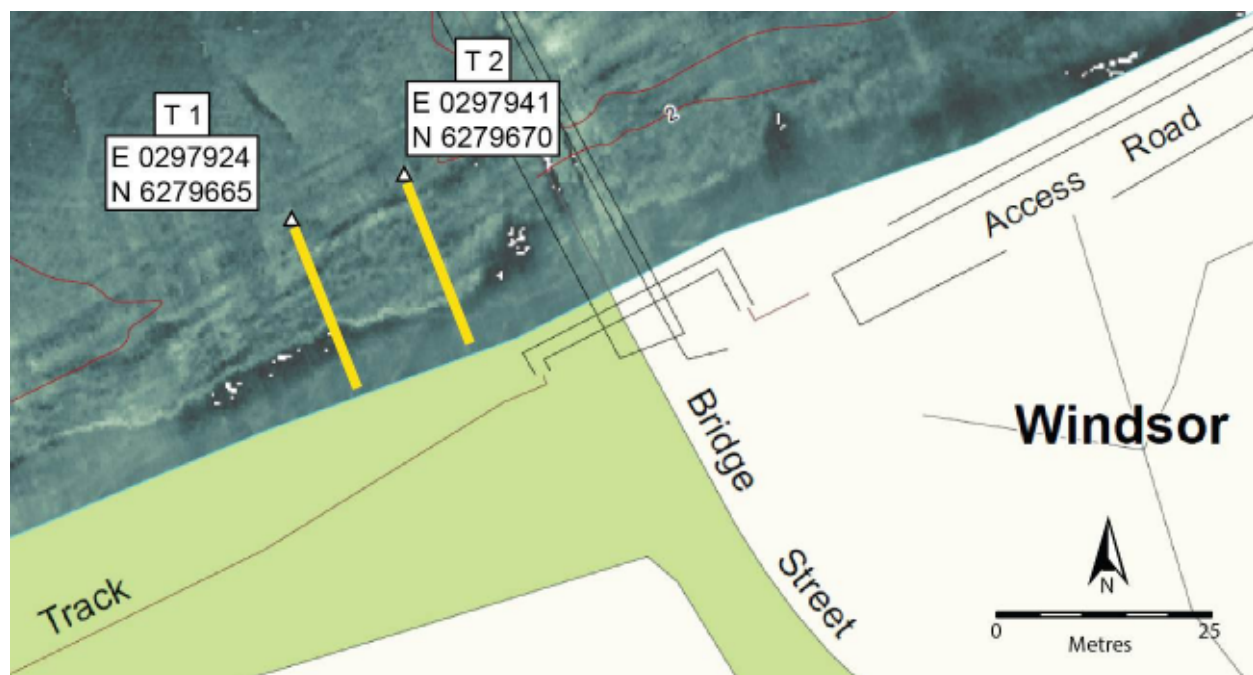
This transect was placed on the southern side of the river, to the west (upstream) of the current bridge, in the area believed to be where the southern punt landing was located (Figure 54). The side scan sonar results show a platform or ledge present in this area. The transect was

The end of a natural sandstone platform was present at a distance 15 m from the edge of the riverbank. The platform sloped slightly downwards towards the centre of the river, and extended back towards the riverbank, where it was covered by silt and vegetation debris. Another smaller section of sandstone shelving was exposed at a distance of 17 m from the riverbank. The shelving was natural and the diver noted no evidence of the shelf being worked as part of a landing. There was no evidence within the section of the sandstone platform that posts or other features had been embedded into it.

This transect was located 20 m to the east of Transect 1, approximately 20 m away from the current bridge, with the transect on an angle of 160 degrees (Figure 54). The riverbed in this section was similar to that in Transect 1; sandy riverbed with tree debris. The riverbed became siltier with more tree branches and other vegetation debris.

A deposit of cobble stones was located at approximately 12 m out from the riverbank. This was a small isolated deposit of sandstone cobbled, approximately 0.15 m to 0.25 m in diameter.

Figure 54: Location of Transect 1 and Transect 2.

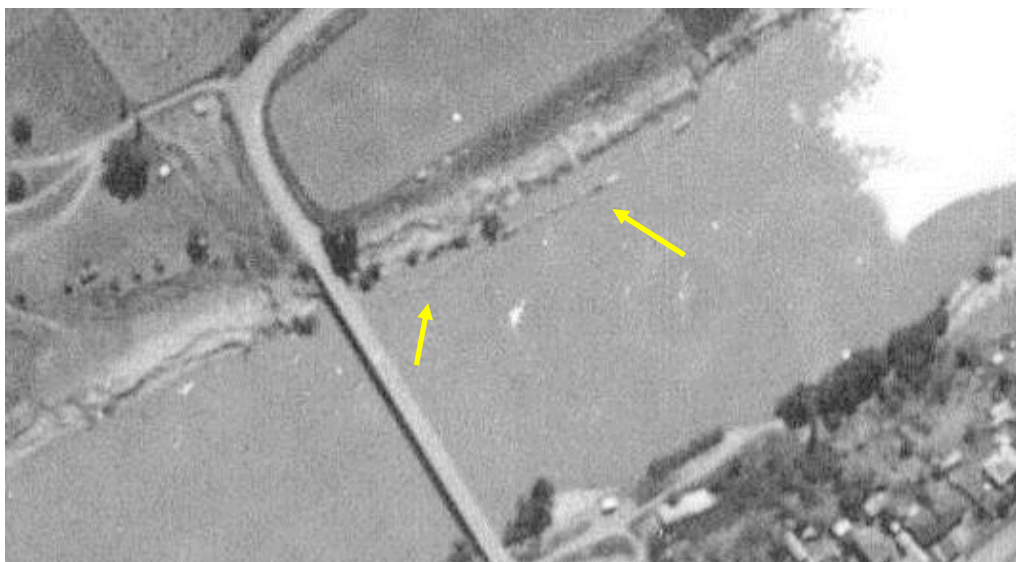
The 1955 aerial photograph shows a line of moorings, or similar structures, along the northern bank of the river in the vicinity of where the timber remains were recorded (Figure 56). No details can be seen of these possible mooring structures, whether they relate to singular mooring lines, or mooring posts in the river. It is also possible the timber remains were transported into this area from a previous flood event, and then covered with silt and other debris, creating the steep slope that was recorded by the divers in this area.

Figure 56: Section of the 1955 aerial photograph (as seen in Figure 22) showing possible moorings along the northern side of the Hawkesbury River in the vicinity.

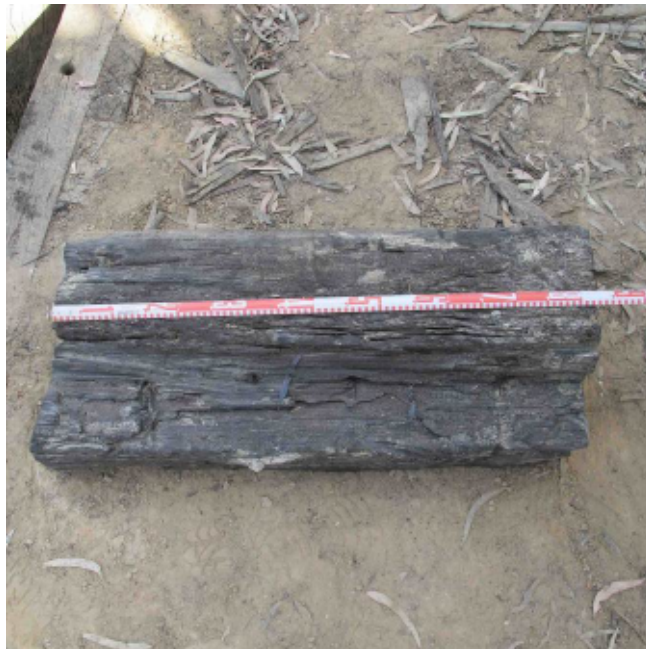
Figure 62: Timber block recovered from Spit 5 of test excavation trench NSW02
(Photograph: Cosmos Archaeology Pty. Ltd.).

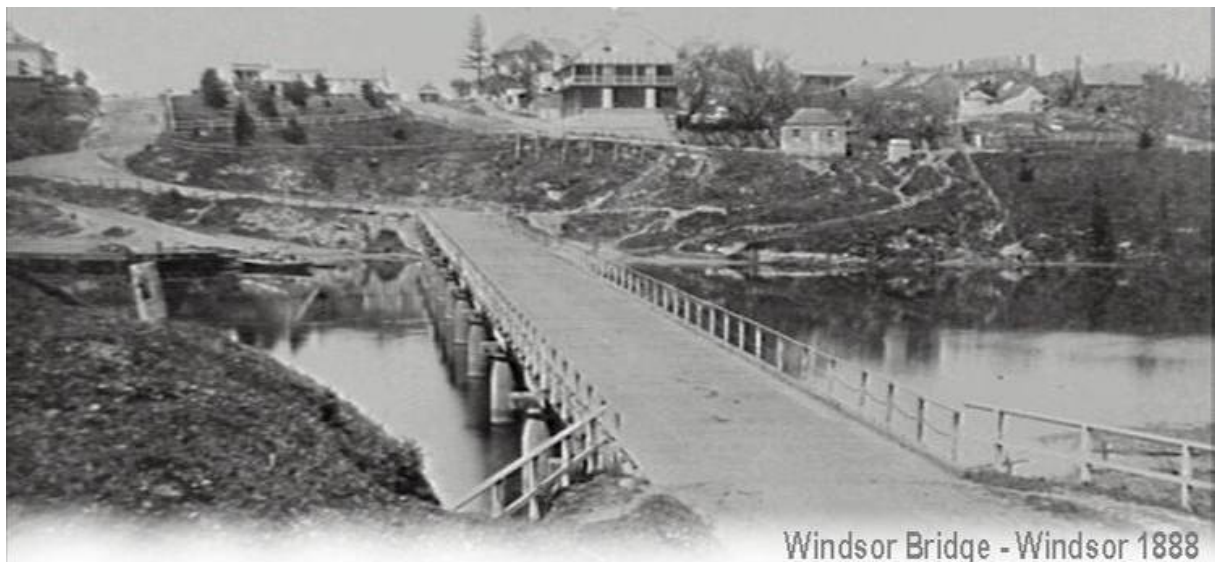
Figure 64: 1888 photograph of Windsor Bridge looking onto the south bank. The wharf is clearly shown on the left. To the right of the bridge a separate road can be made out immediately adjacent to it that leads to a beach area, believed to be the southern landing of the former punt (www.council.hawkesbury.nsw.gov.au/gwsSpatial/gws/gwsspatial.htm).
