Windsor Bridge replacement project

SOIL, SEDIMENTS, WATER AND WASTE WORKING PAPER – WORKING PAPER 7

NOVEMBER 2012

Prepared by Sinclair Knight Merz for Roads and Maritime Services

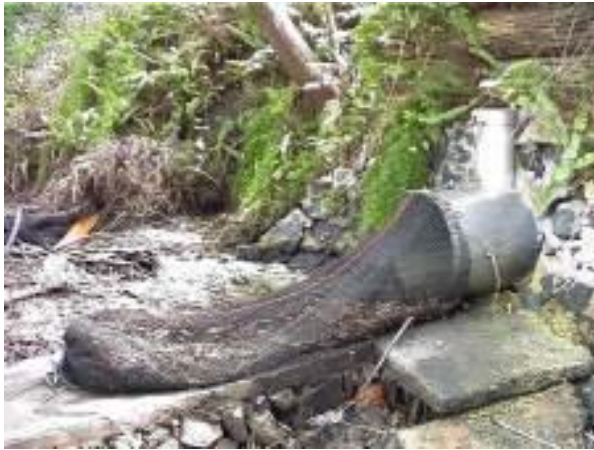
Figure 5-2 Photograph of an example end of line net type GPT

Due to space restrictions an end of pipe net type gross pollutant trap connected to the stormwater outlet will be provided. A photograph of an example in operation is provided in **Figure 5-2**. The net will collect gross pollutants (litter) contained in stormwater runoff, preventing them from entering the river and causing a decline in the river's visual amenity and water quality. The net would be emptied on a regular basis by RMS or HCC to ensure it continues functioning as intended.
