Windsor Bridge over the Hawkesbury River

Punt and wharf sites, maritime
archaeological inspection

Punt and Wharf Sites, Maritime Archaeological Inspection

Prepared February 2009 by Cosmos Coroneos and Chris Lewczak

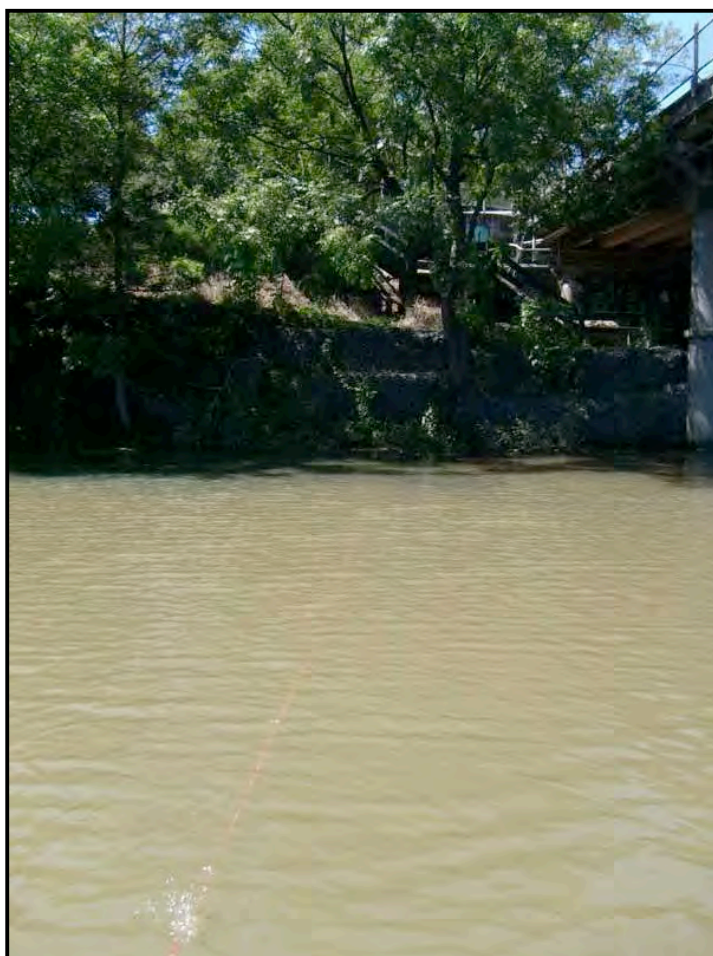
The two work components were achieved through the use of transects. A transect was formed by attaching a 20 m weighted line from a nominated location on the edge of the river bank. The line was reeled out on the riverbed its full distance (Figure 2). The diver swam along the line noting artefacts observed/felt on the surface as well as riverbed composition.

Figure 2: Setting up a survey line used for each transect (Photo Cosmos Archaeology).

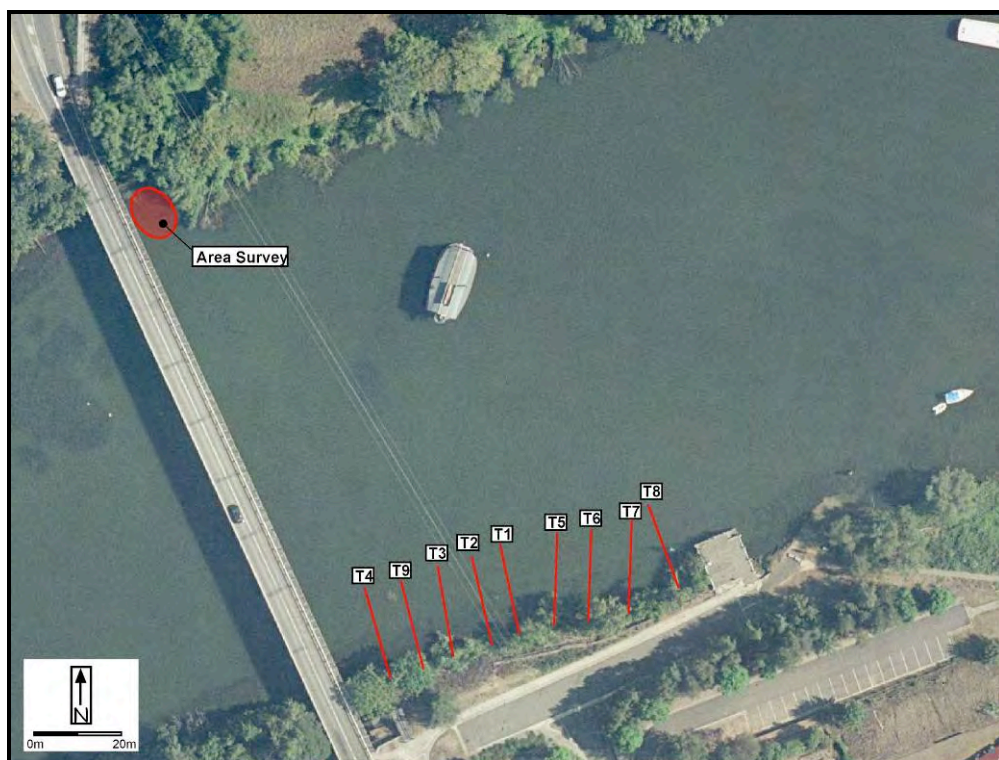
Nine 20 m transects were recorded during the inspection between the bridge and the existing and functioning wharf (Figure 4). They were evenly spaced so as to ensure that this area was sufficiently examined for the below water remains of the wharf.

Figure 4: Location of surveyed areas. (Map Source; Google Earth)

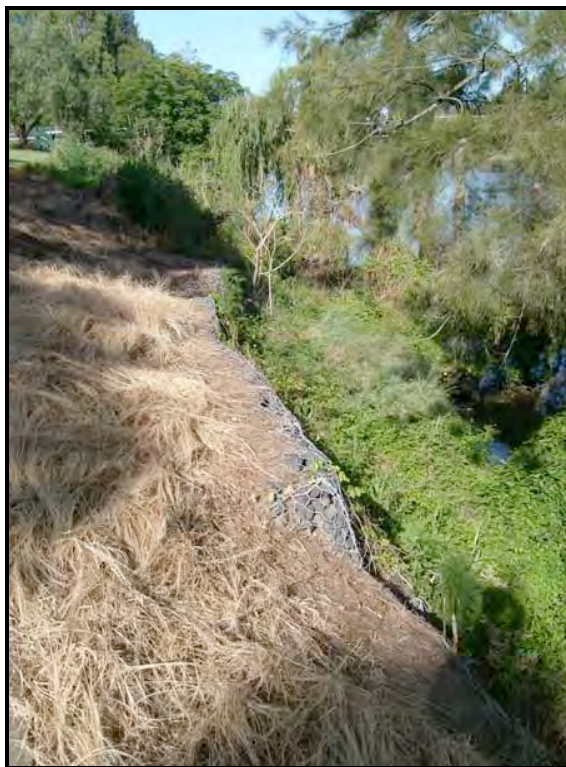
The present southern riverbank between the bridge and the existing wharf has been recently modified with the installation of a Gabion wall. This has resulted in a near vertical retaining wall closer to the bridge with the gradient lessening with distance downstream to a point close to the existing wharf where the wall ceases (Figure 5). The thick vegetation on and around this wall prevented any further examination of the southern side of the riverbank.

Figure 5: Gabion wall recently constructed above the location of the former wharf site (Photo: Cosmos Archaeology)

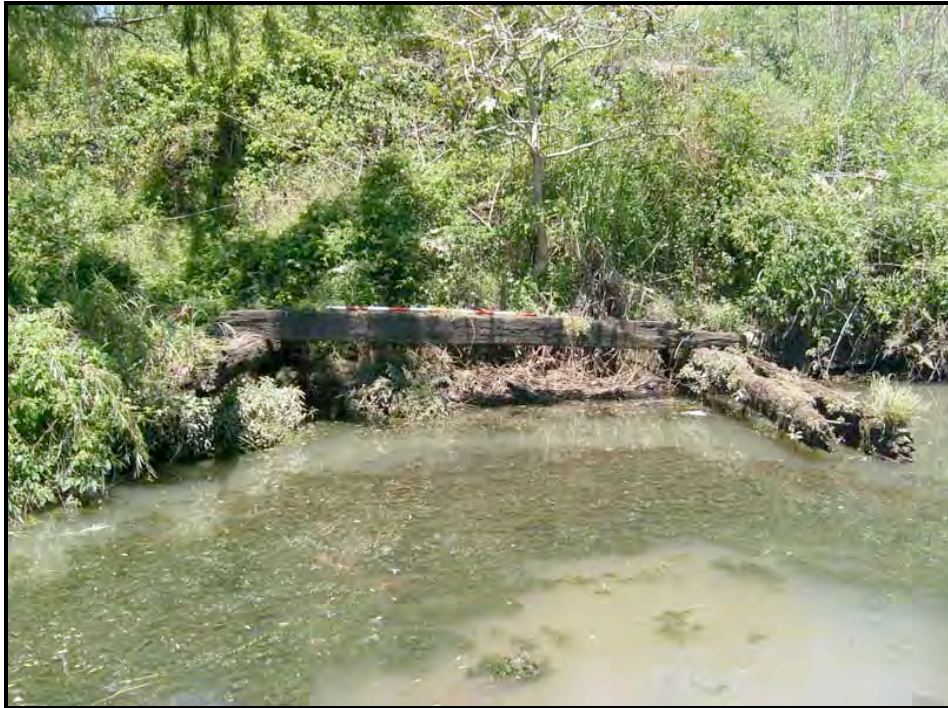
The first group consists of three timber beams, including a possible deck beam, parallel to the riverbank, resting on two walers (Figure 7).³ The deck beam is 5.2 m long x 0.25 wide x 0.20 thick. This beam rests on top of the walers with no visible fastenings attaching them (Figure 8). There are the remains of fastening holes in the middle of the beam above where the beam intersects the two walers, implying the beam may have been fastened to another section of the wharf positioned on, or in, the riverbank.

Figure 7: Structural remains present of the former wharf (Photo: Cosmos Archaeology)

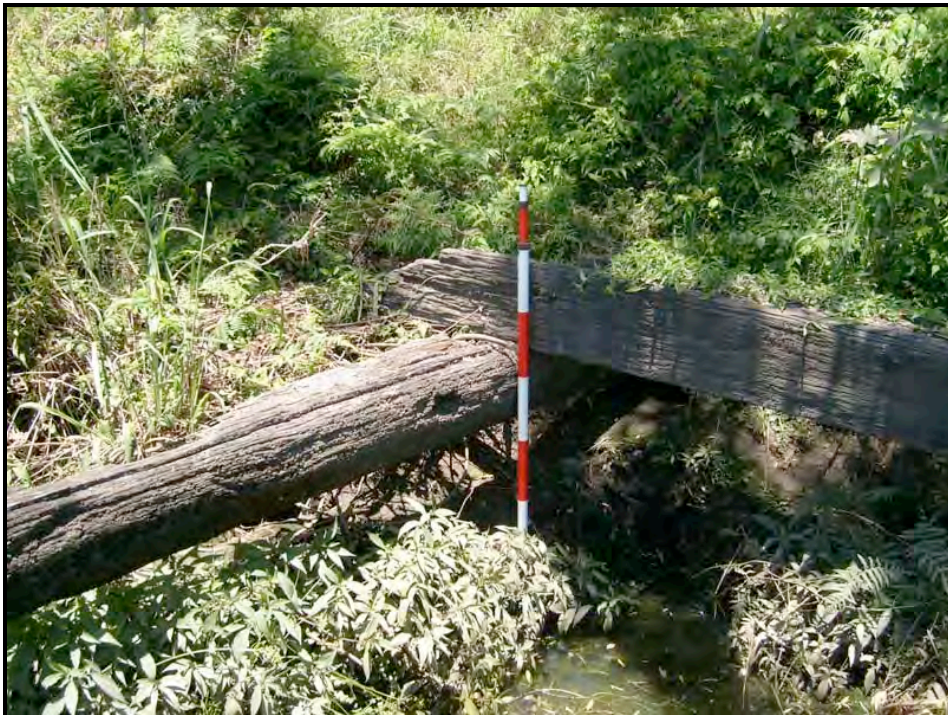
At either end of the deck beam are walers. On the eastern side of the deck beam there is only one timber waler remaining, while on the western side there are two. The timbers on both sides run back into the riverbank, possibly attached to a buried portion of the wharf. The two timbers on the western side of the deck beam are both 2.9 m long and 0.3m wide, and are crescent shaped, being 0.25 m at its thickest point at the middle. Both timbers appear to be from the same rounded log that has been halved, and spaced 0.4 m apart (Figure 9 & Figure 10). There are two large iron bolts that connect each waling timber together, one approximately 0.4 m in front of the deck beam, and the other at the river end of the timbers (Figure 11). The inside sections of both waler beams have also been carved out around immediately around the location of the bolts. This is likely where the beams would have been bolted through the piles. A recess has also been cut into the top of the wale beam. The recess is located approximately 1.2 m in front (river side) of the deck beam, measuring 0.35 m wide and 0.05 m deep. This may have been for the placement of another deck beam across the timbers (Figure 12).

Figure 8: Remains of a deck beam resting on two walers (Photo: Cosmos Archaeology)

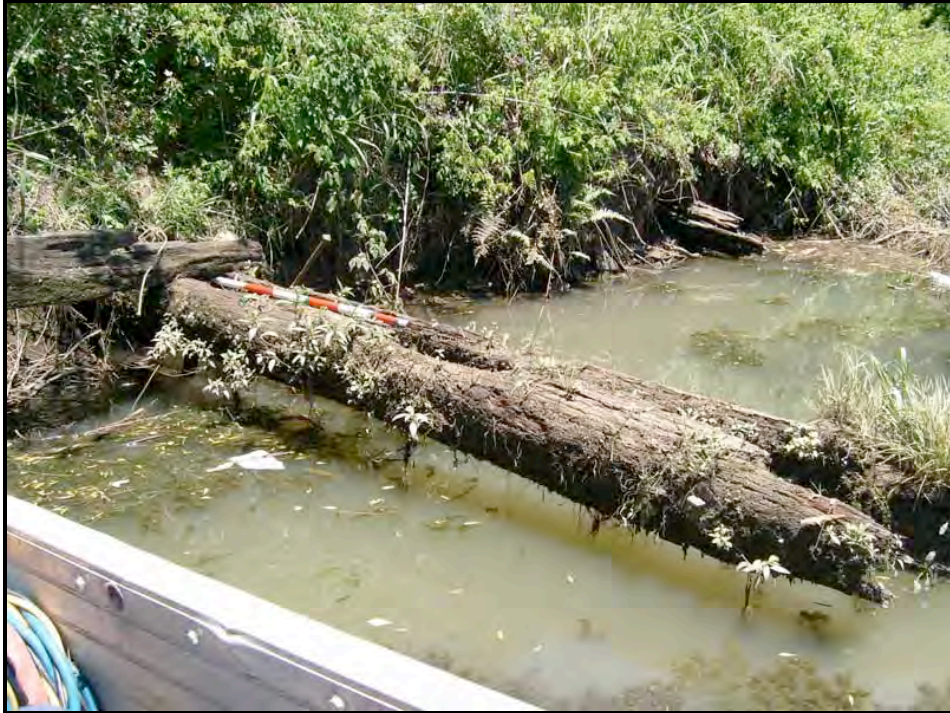
Figure 9: Two water beams on the western side of the wharf remains (Photo Cosmos Archaeology).

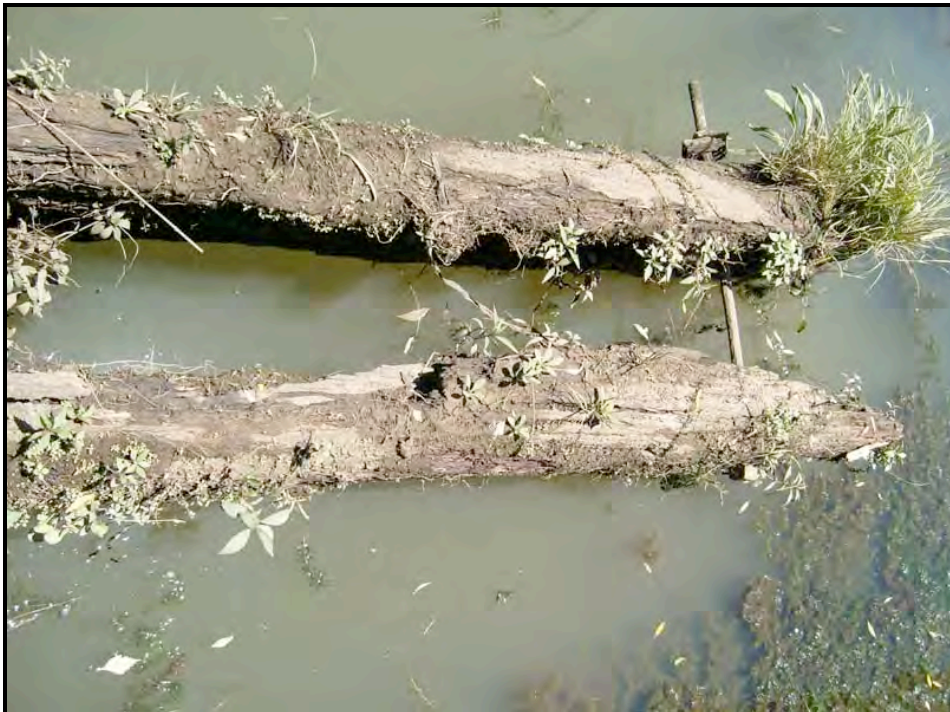
Figure 10: Remains of the two walers on the western side of the wharf remains (Photo Cosmos Archaeology)

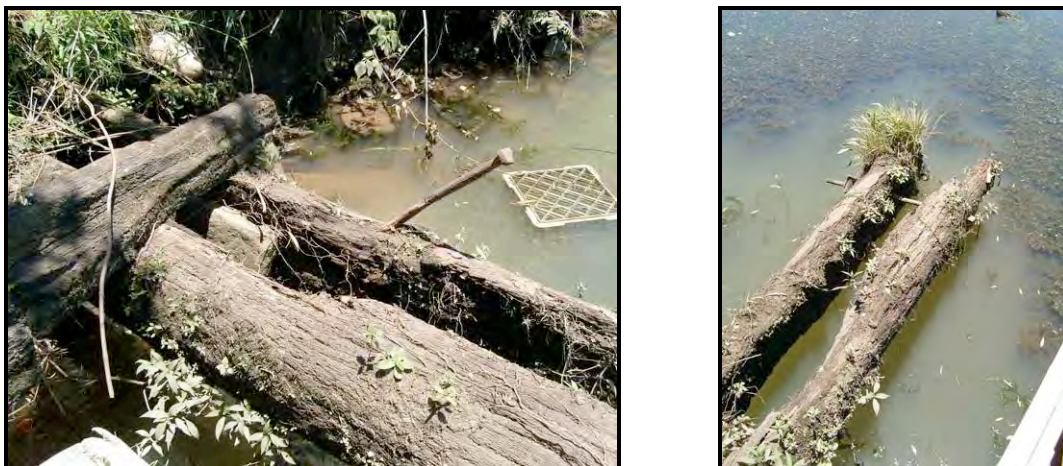
Figure 11: Fastening remains present on the two waler beams on the western side of the wharf remains (Photo Cosmos Archaeology).

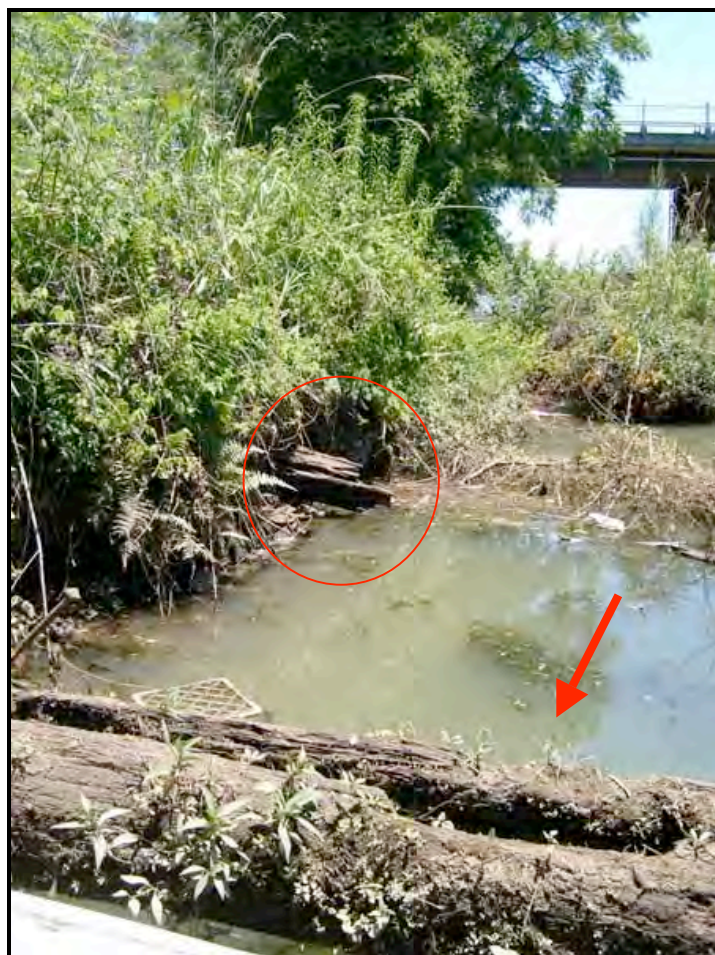
Figure 12: Recesses cut into the top of the walers (Red Arrow). Probable location of another deck beam. Note also the location of another waler in the centre of the photo (Red Circle) (Photo Cosmos Archaeology).

Approximately 5 m to the east of the of these structural remains another singular wale beam protruding from the riverbank (see Figure 12). Only a small section of this timber still remains with no other timbers located around it.

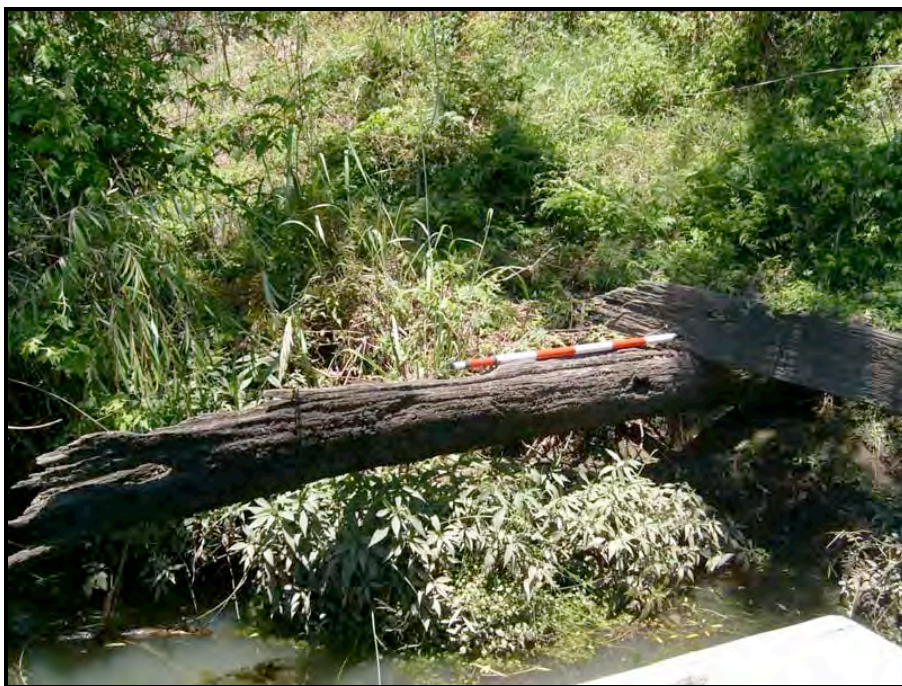
The timber on the eastern side is also crescent shaped, being 2.5 m long x 0.35 m wide, and is approximately 0.20 m thick at the middle of the beam. There are two fastening holes drilled into the side similar to those opposite, the first 0.4 m in front of deck beam, and the other at the other end of the timber remains (Figure 13 & Figure 14). There is also a less defined recess cut into the top of this waler, approximately 1 m in front of the deck beam.

Figure 13: Remains of the singular waler on the eastern side of the wharf remains (Photo Cosmos Archaeology).

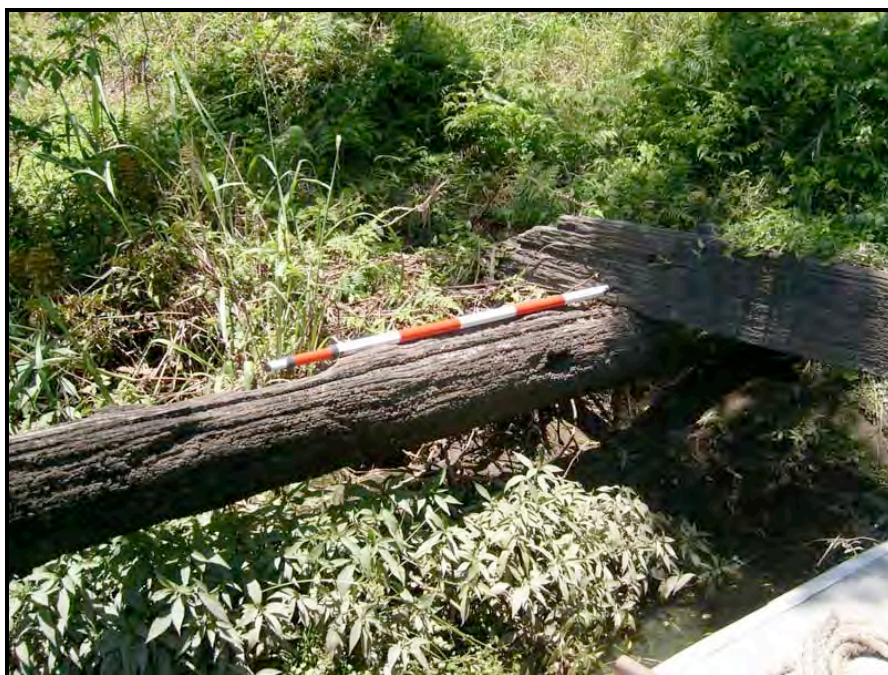
Figure 14: Location of drilled holes for the location of bolts (no longer present) (Photo Cosmos Archaeology)

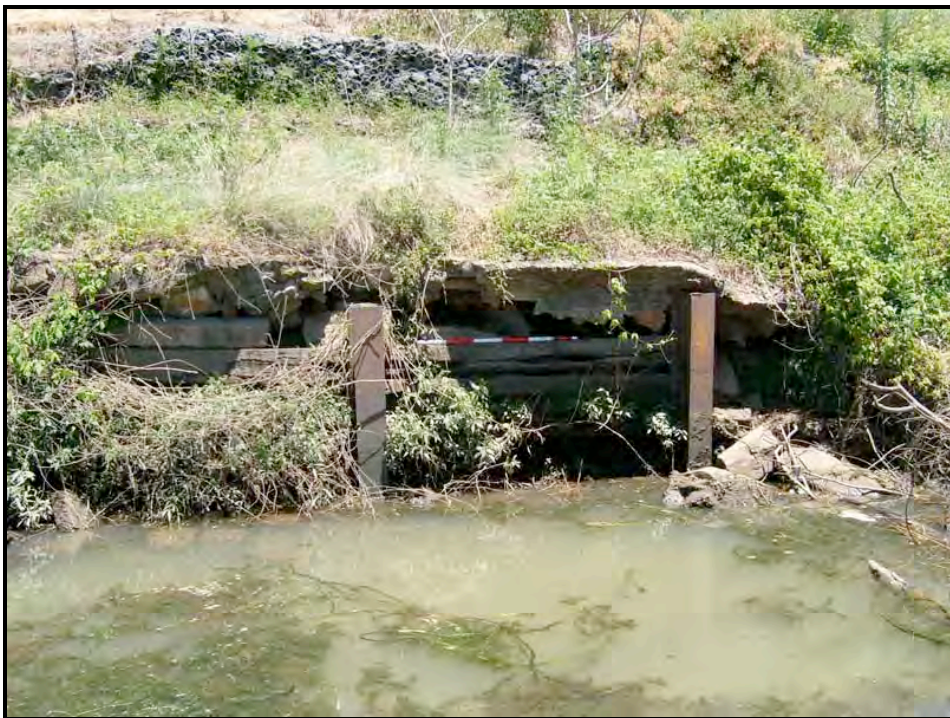
A section of a former retaining wall was also visible in the riverbank. The retaining wall is located approximately 20 m to the west of the existing wharf at the eastern end of the study area, and approximately 15 m to the east of the extant above water wharf remains (Figure 6). The retaining wall consisted of two iron girders 2 m apart with two timber cross pieces (Figure 15). The iron girders are square in shape and stand 1.5 m above the riverbank, and are 0.20 m wide (Figure 16). The two timber cross pieces are approximately 2.5 m long x 0.30 m wide and 0.11m thick, and are spaced close together. Material behind the wall consists of dressed sandstone blocks, bricks and broken up concrete deposited onto up the riverbank. A concrete cap has been placed over the top of the fill at one stage, possibly to create a surface or to contain the backfilled material (Figure 17).

Figure 15: Remains of the retaining wall to the east of the above water wharf remains (Photo Cosmos Archaeology).

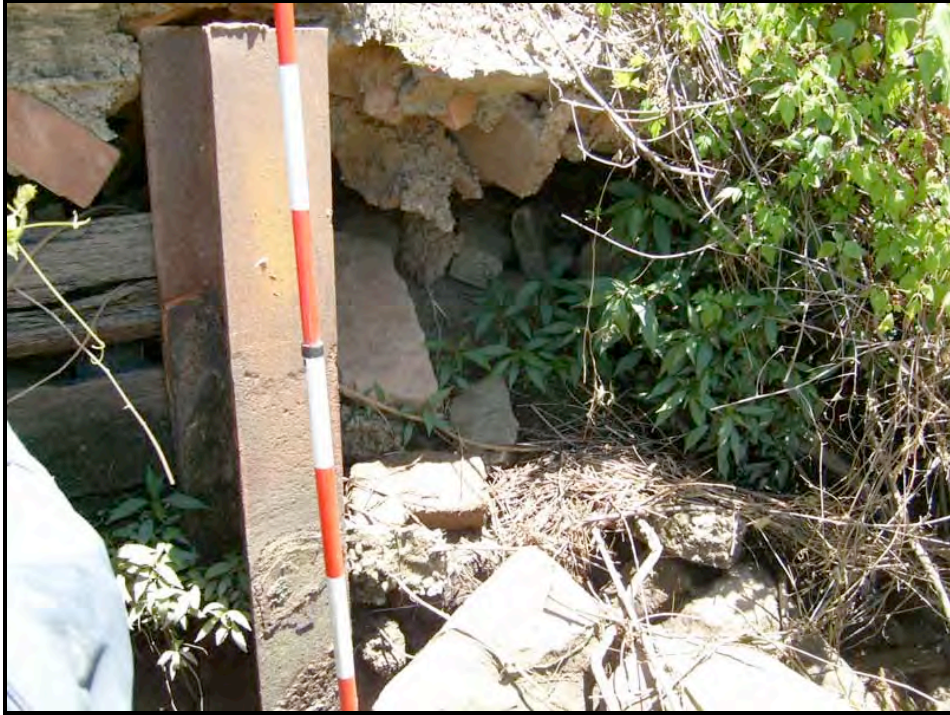
Figure 16: Iron Girder that forms part of the retaining wall present on the riverbank.

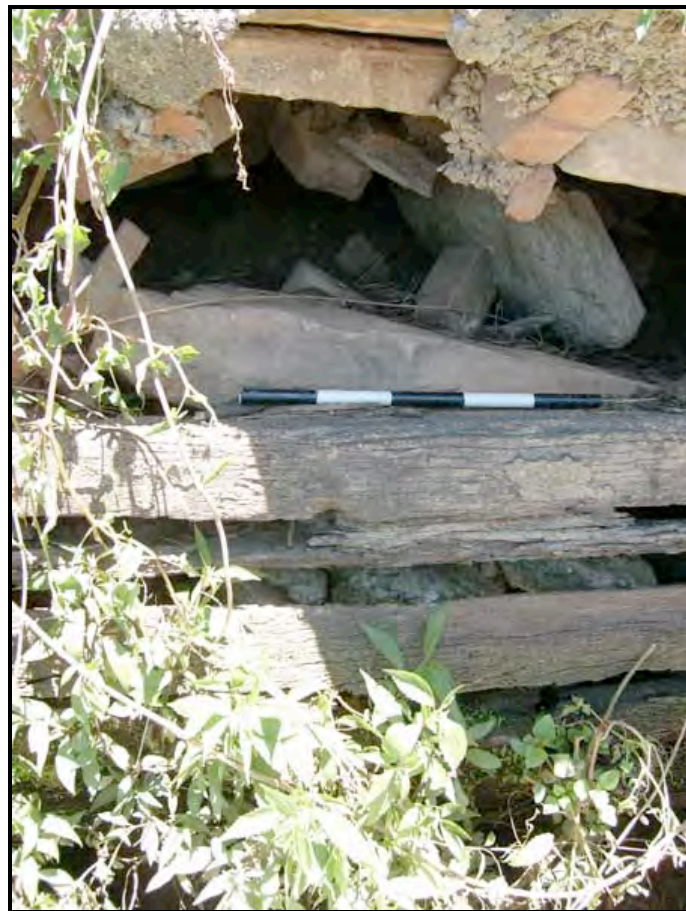
Figure 17: Example of the fill present behind the retaining wall (Photo Cosmos Archaeology).

The attribution of the remnant timber and steel retaining wall on the southern bank is not certain. It most likely dates from the 20th century, probably the 2nd half. It may have formed part of a river wall which passed underneath the last upgrade of the wharf, but much more likely was constructed after the wharf fell into disrepair, using elements of the wharf in its construction and in the fill behind it.

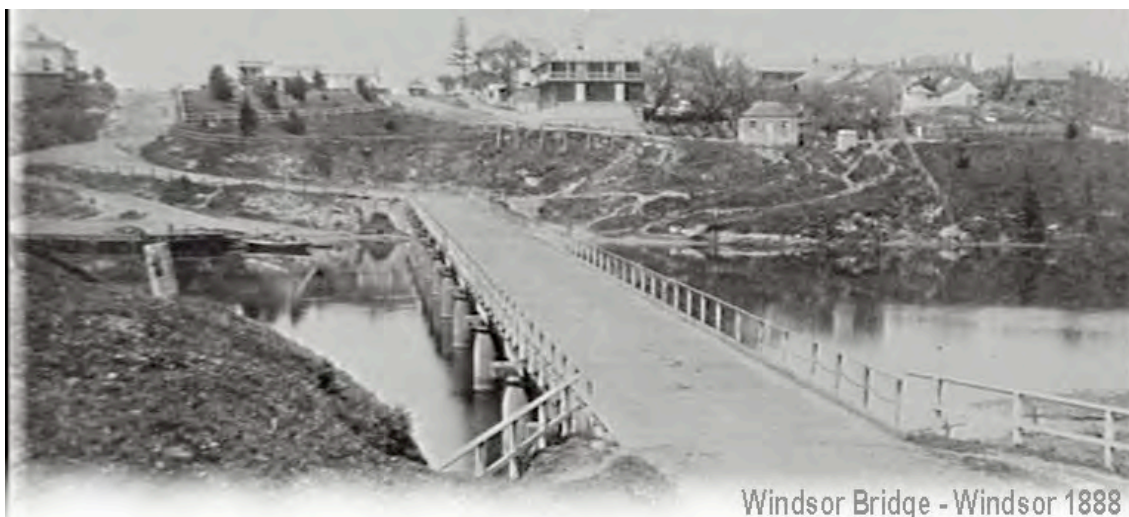
Figure 28: 1888 photograph of Windsor Bridge looking onto the south bank. The wharf is clearly shown on the left. A road leads down a reasonable gradient to the wharf and branches down to the water between the bridge and the wharf. This is the likely location of the south bank punt landing. It may also have been utilised and expanded during the construction of the bridge. Of interest is the southern approach to the bridge, which appears to be on a different alignment than today. (www.council.hawkesbury.nsw.gov.au/gwsSpatial/gws/gwsspatial.htm)
