# **WINDSOR BRIDGE REPLACEMENT PROJECT**

## **TEST EXCAVATION TO INFORM TRAFFIC SIGNALS AND CABLE TRENCHES INCLUDING EVIDENCE FROM GEOTECHNICAL CORES**

**March 2013**

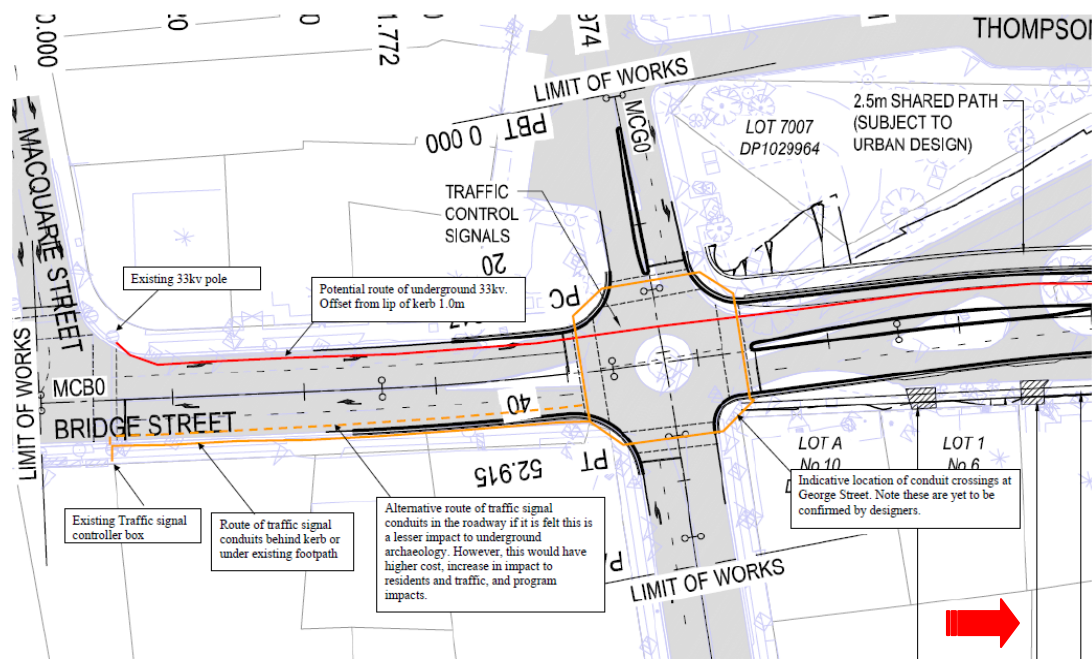
Plate 1: The proposed position of conduits and trenches. Source: RMS

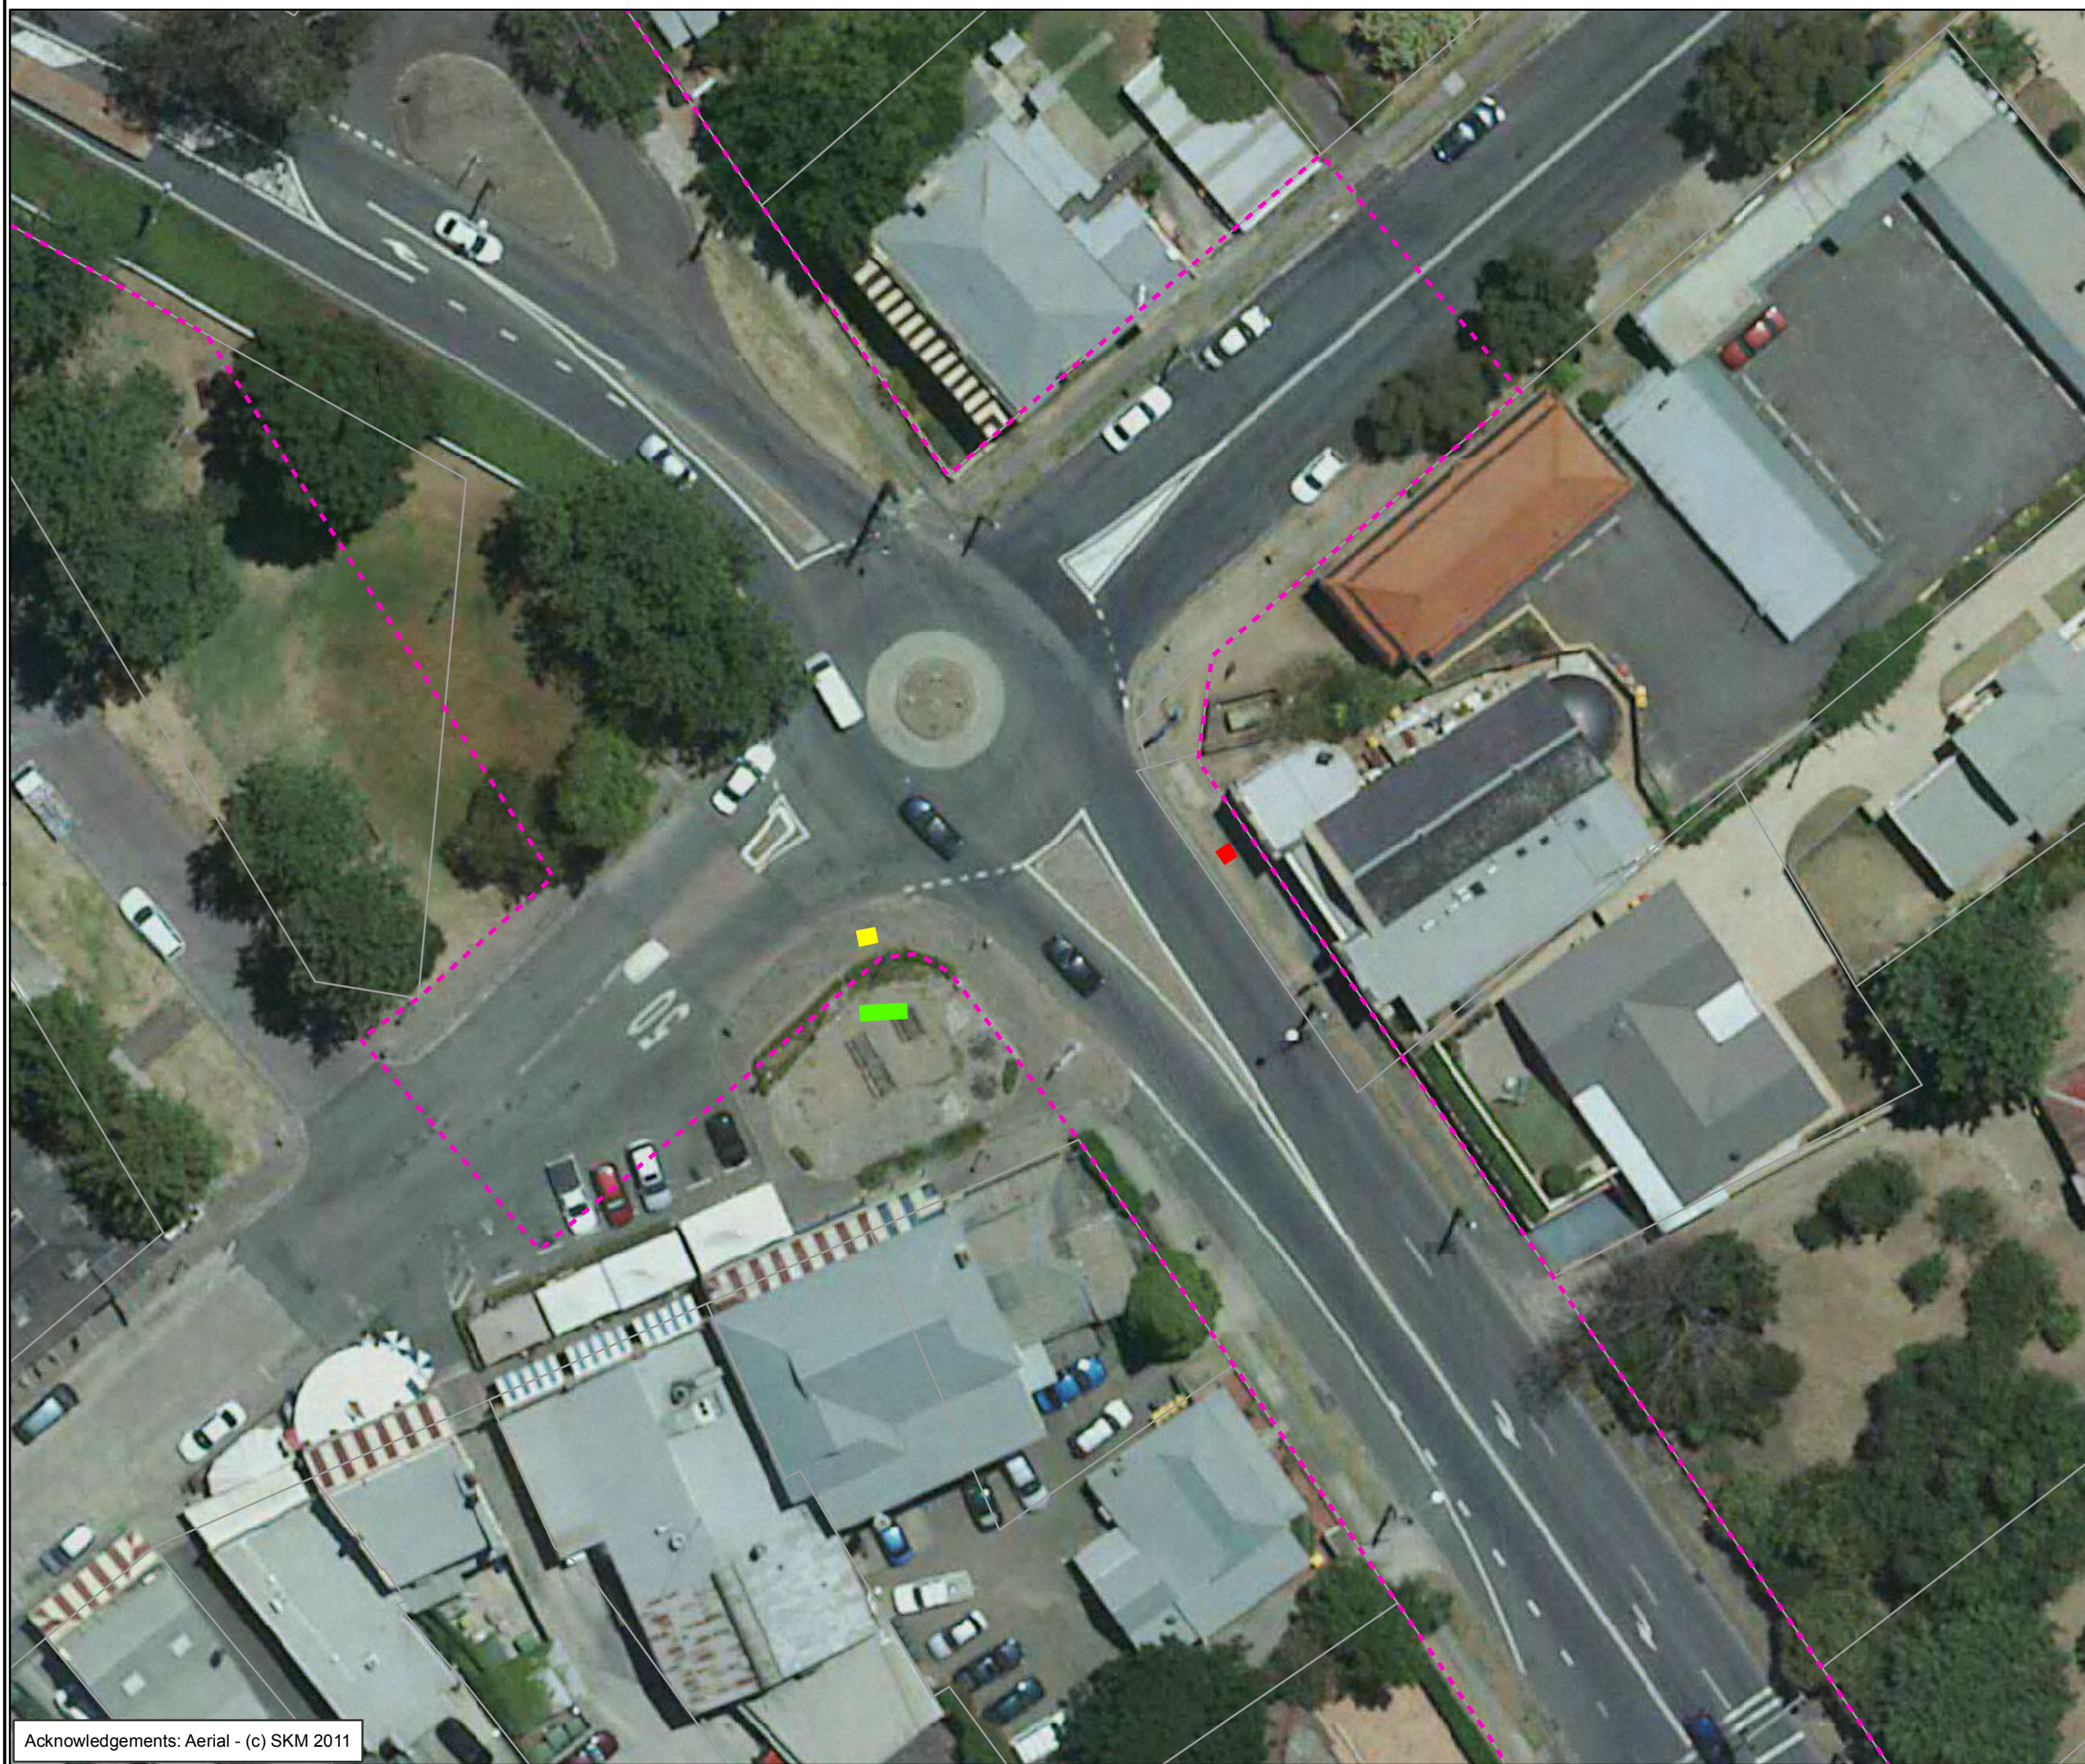
**Figure 2: Location of test trenches during the current archaeological program**

- Test Trench 10 - 1m x 1m
- Test Trench 11 - 1m x 1.2m
- Test Trench 12 - 1m x 3m
- Construction Work Zone

It was known before work commenced that there were services within those footpaths that further narrowed the areas for investigation. The services identified prior to the work commencing are shown on the accompanying diagram. Figure 2 is a plan showing the location of the trenches.

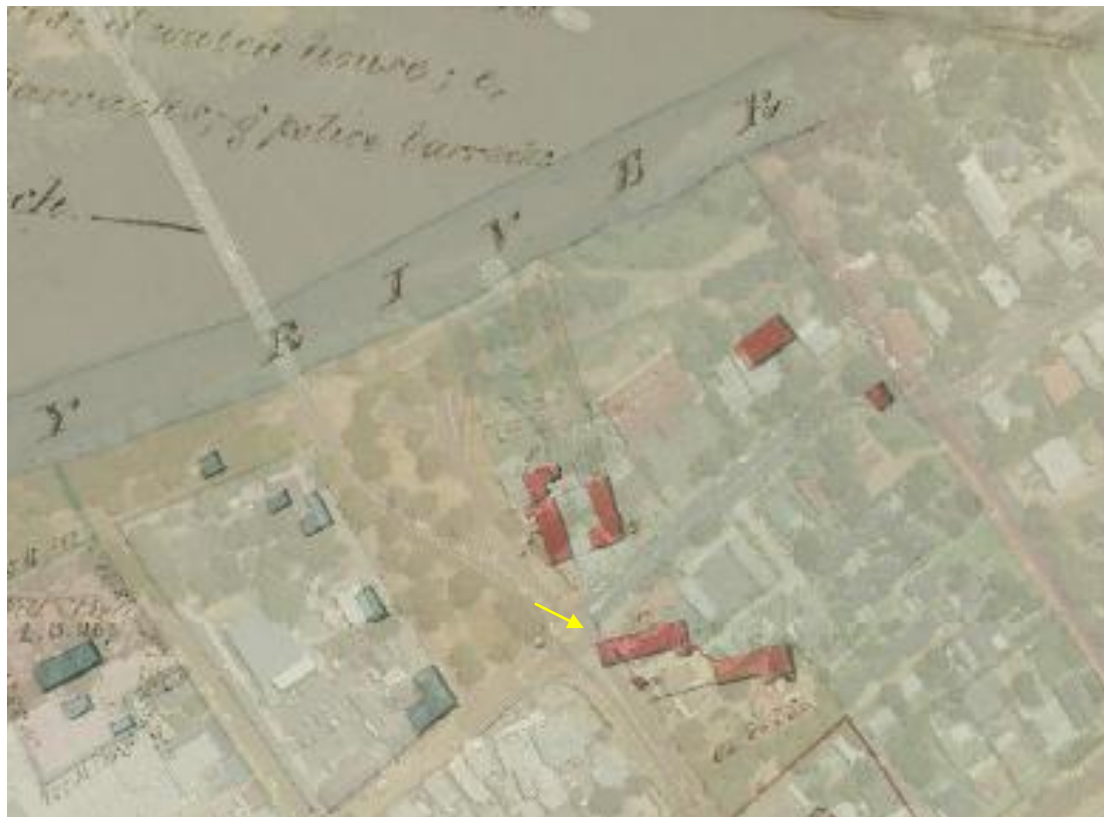
Plate 3: Overlay of 1831 survey onto contemporary aerial image showing the relationship of the Commissariat Store of 1803 to the present School of Arts building and Bridge Street

Overlays of historic period surveys from the first half of the nineteenth century in relation to the present roads and buildings demonstrate that the site of the former Commissariat building of 1803 is likely to lie under the School of Arts building. The older building appears to have projected beyond the western façade of the School of Arts into the present footpath and Bridge Street.

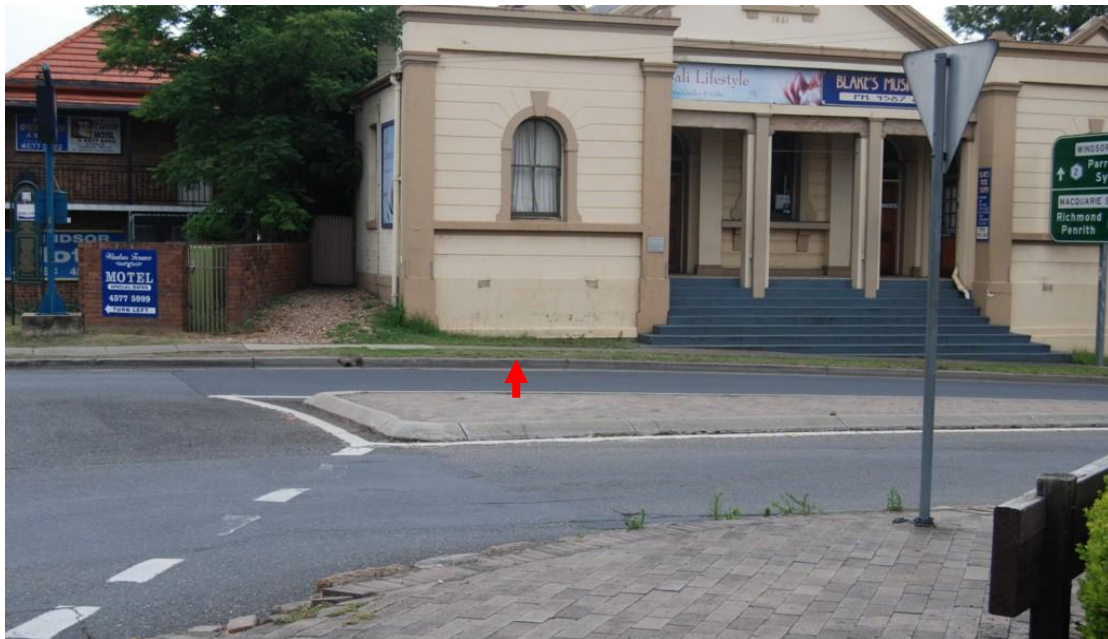
*Plate 4: View east showing Bridge Street and the School of Arts building; the position of the test trench is indicated by the arrow*

The proposed trench in the research design was intended, in a three-metre length to include the site of the northern wall of the 1803 building and a sample of the internal space. The southern wall was in an area of services and the western wall was in the road. The reduction of the trench size due to the need to avoid live services meant that the trench was likely to sample only the internal space of the building or, perhaps, allowing for a degree of variation in the 1831 survey and modern townscape, a foundation trench for that wall as well as evidence of the construction associated with the building or its demolition in the form of debris.

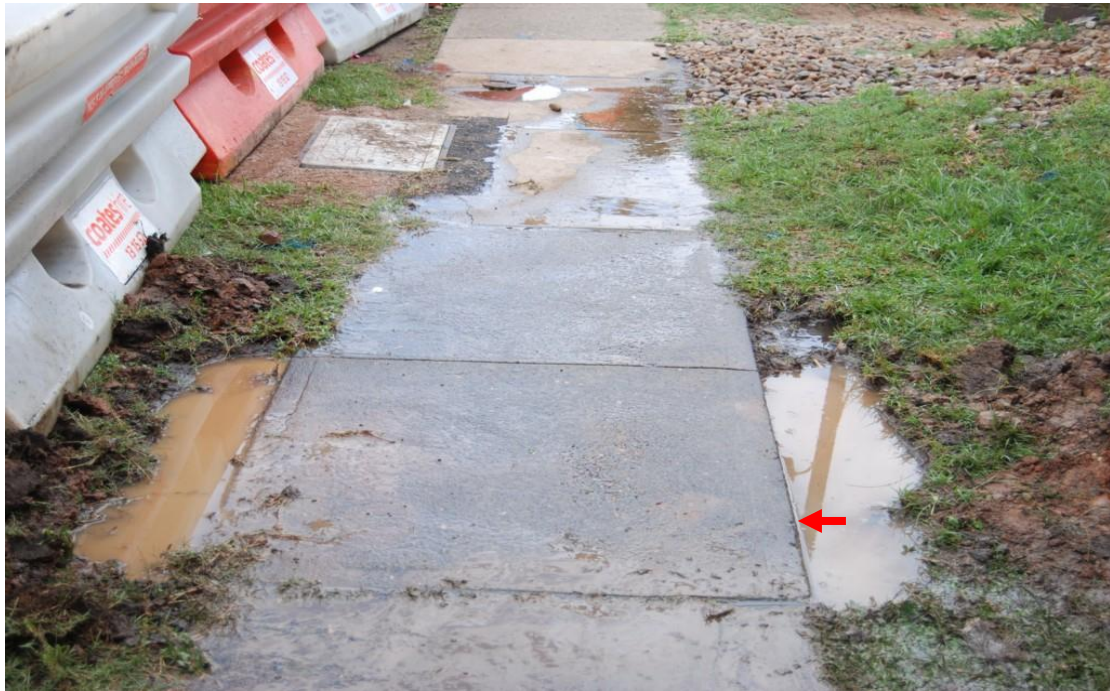
Plate 5: View north showing the slab to be removed (indicated by the arrow) for the test trench with the recent disturbance just to the north of this site caused by enlarging a service pit also visible

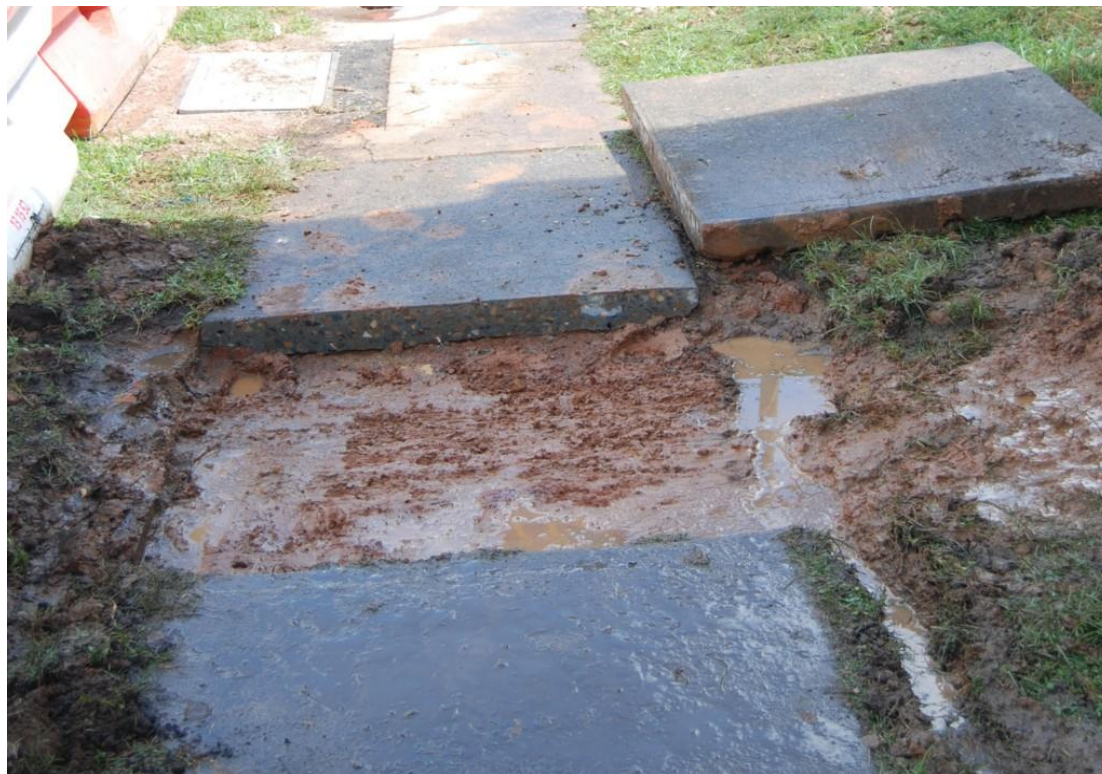
*Plate 6: View north showing the footpath slab [001] removed from the trench revealing the surface of the underlying deposit [002]*

The surface slab from the footpath **[001]** was lifted in one piece. It is made from cement with bluestone inclusions poured into formwork. It is approximately 60 mm thick and was laid directly over the underlying deposit of clay **[002]**.

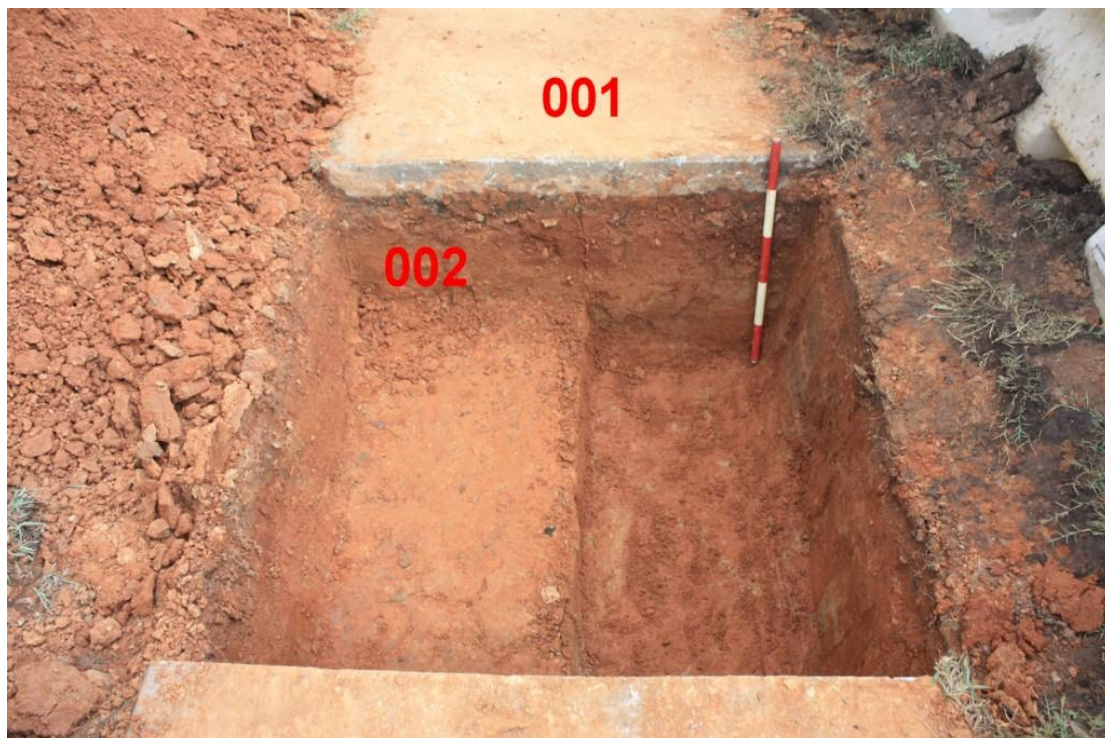
Plate 7: View south of Trench 10 showing the clay with sand lenses underlying the footpath on the eastern side of Bridge Street; scale 500mm

The deposit **[002]** below the footpath comprised red clay with minor lenses of sandy soil and some lighter coloured clay distributed unevenly throughout the matrix. The top 100-200 mm was more disturbed and less regular in composition than the lower portion but it was a consistent matrix for the full depth. The mixed red clay **[002]** was excavated to its full depth of 400 mm. This deposit filled the entire trench and extended beyond it.

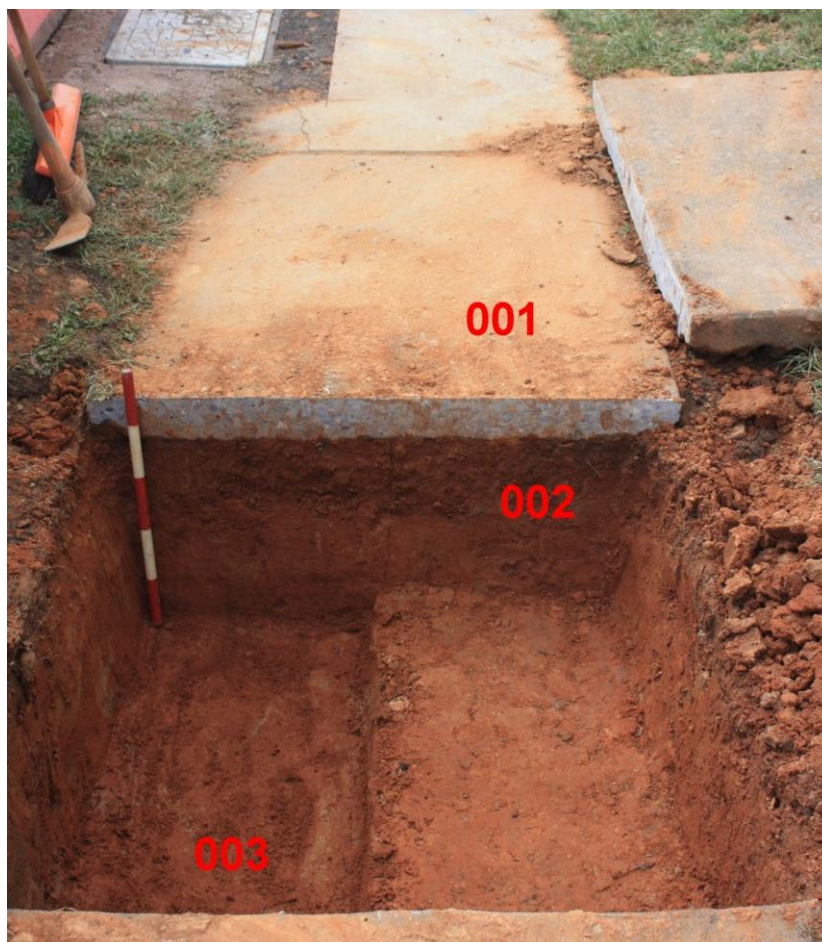
Plate 8: View north of Trench 10 showing sandstone bedrock at the base of the trench and its immediate relationship to the clay above it. This image also highlights the more disturbed nature of the upper part of the clay visible here in the shadow as a darker and slightly more textured material; scale 500 mm

Immediately below the red clay was the upper surface of naturally occurring sandstone bedrock **[003]**. There were no deposits between the two and no evidence of change to the bedrock.

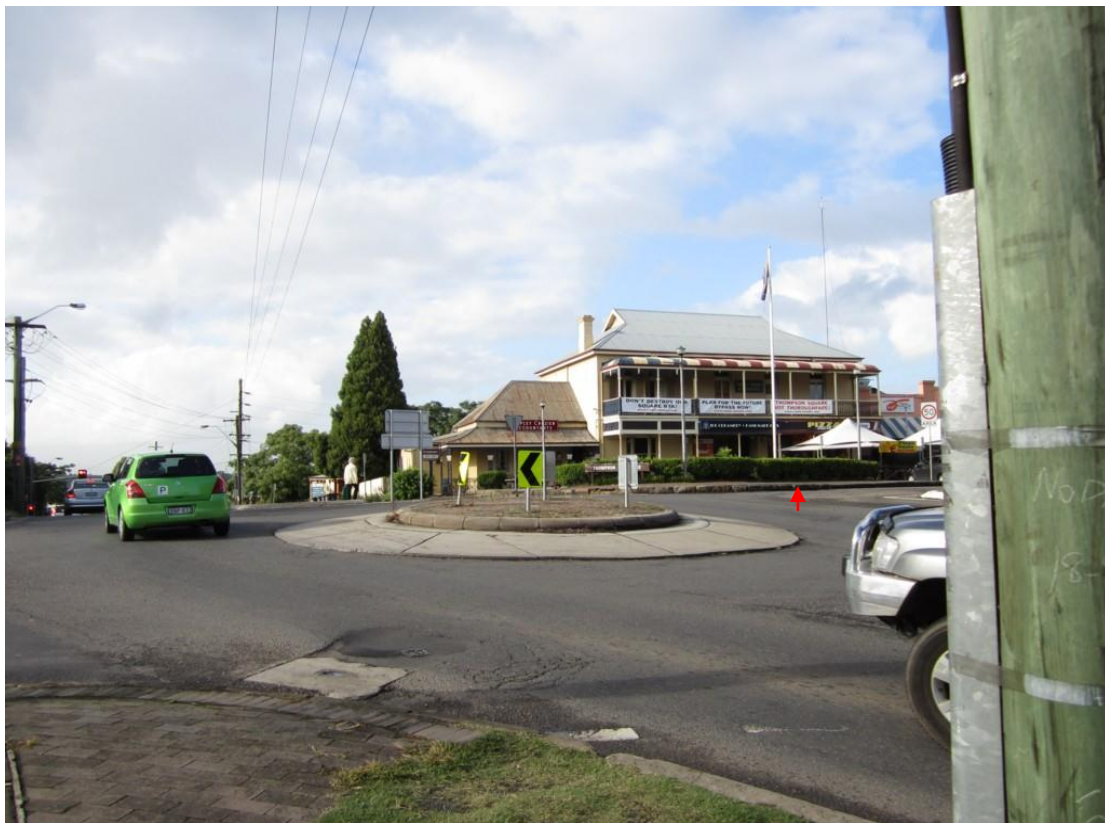
*Plate 9: View south at the intersection of George and Bridge Streets showing the investigation area along George Street indicated by the arrow*

The location of this test trench on George Street has been discussed in Section 2.6.1; it was the only viable location free of services, which could accommodate the width of the excavator bucket between the safety barrier and the garden bed, very close to the proposed test trench site and with the same archaeological potential in the project area. The sample provided from this area was expected to provide evidence of road development and possibly accumulated deposits that would characterise the use of this area as a public thoroughfare from early in the nineteenth century. The excavated trench measured 1000 x 1200 mm.
