## TRENCH 11

#### Location and Dimensions

### Excavation Evidence

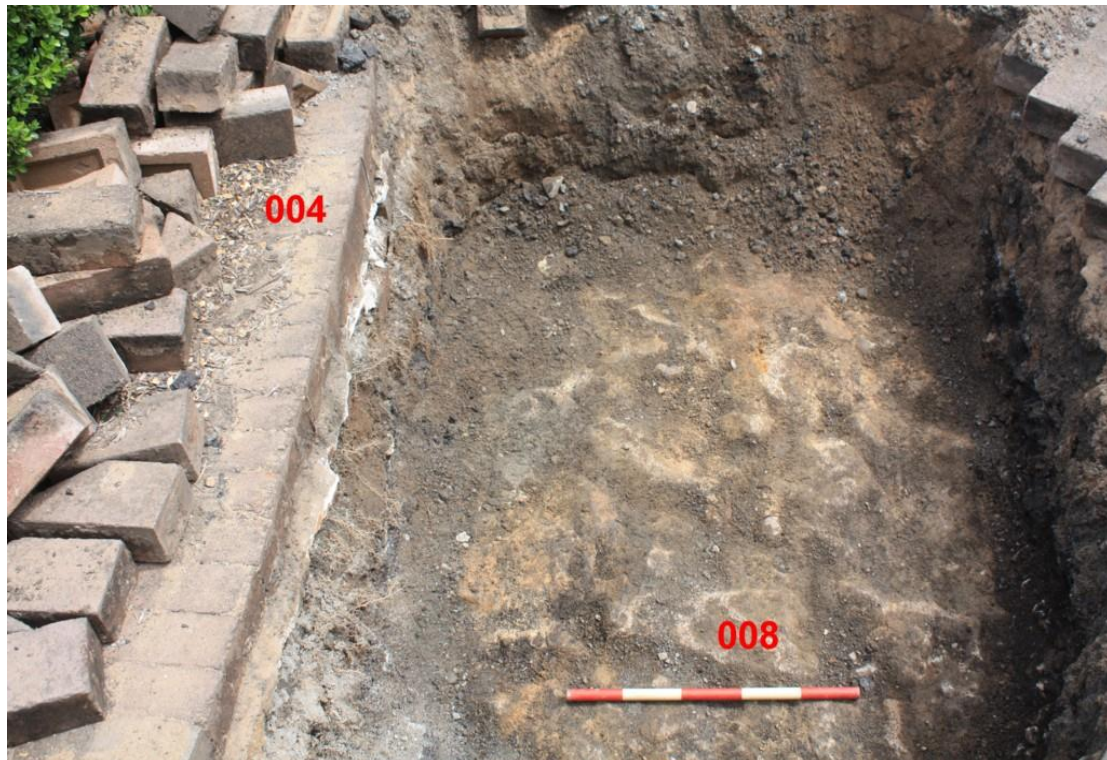
Plate 13: View west showing the surface of the sandstone feature exposed; on the left is the band of paving that provides an edge to the garden at the side of the path; scale 500 mm

This earlier feature [008] was made using irregularly shaped sandstone rubble and some shaped pieces, packed together without bonding to form a hard and impervious surface. It was approximately 250 mm in depth. It extended beyond the area of the test trench.

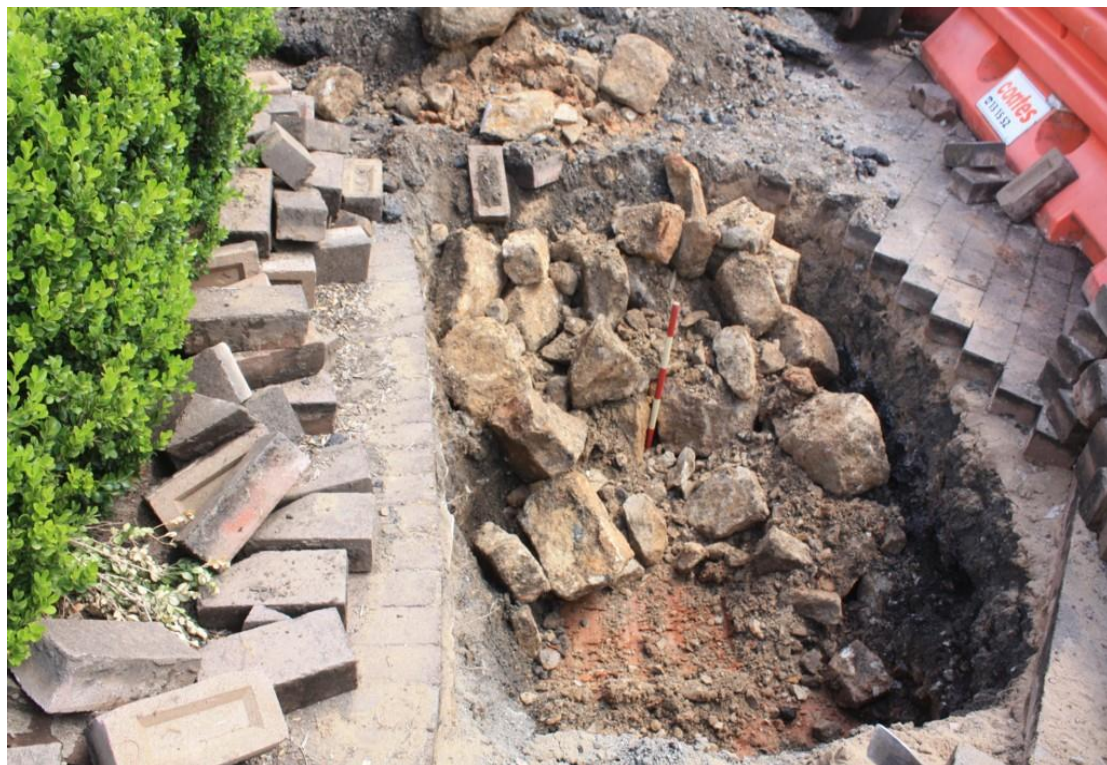
Plate 14: View west during the removal of the sandstone feature showing the variation in the cobbles; scale 500 mm

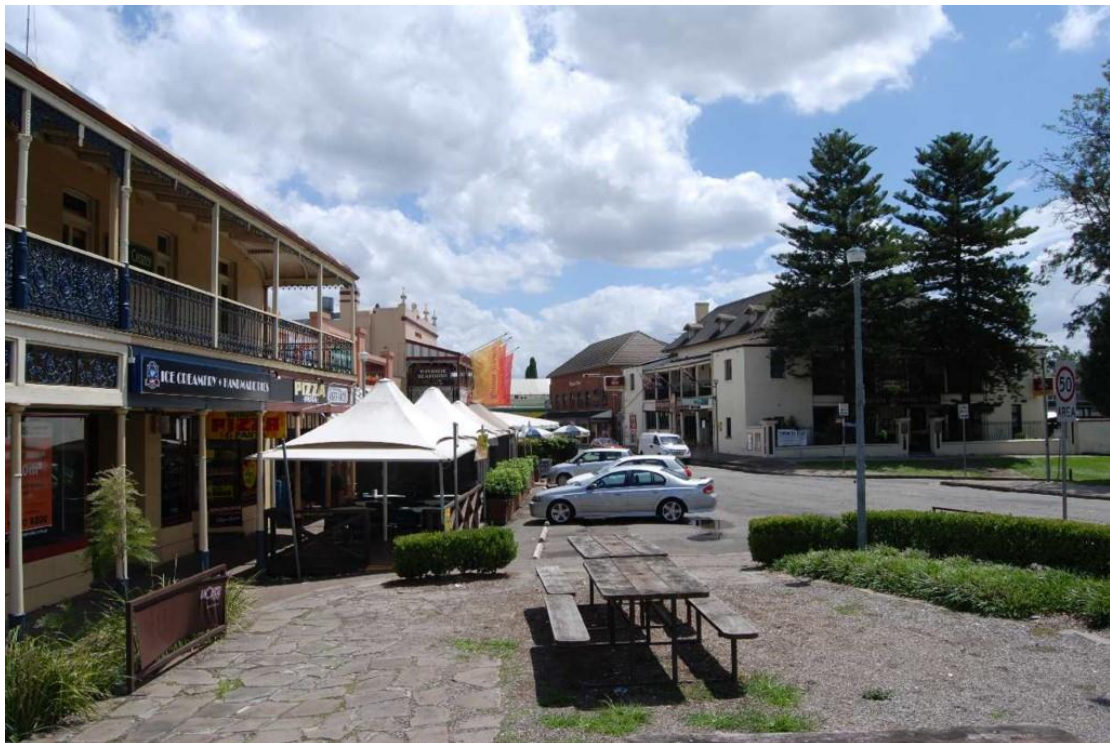
*Plate 18: View west of the area on the southern side of the hedge; the trench location is on the right just outside the image field*

This trench was commenced on the southern side of the hedge abutting the pedestrian footpath; the circumstances of its location are discussed in Section 2.6.1. This area is privately leased and when this was discovered the excavation immediately ceased, the trench back filled and mulch used to make good the appearance of the area.

The trench opened was 3000 x 1000 mm with the long length running from east to west. The site was selected as being close to the proposed test trench site, in an area clear of services and with the potential for a similar generic archaeological profile for the ridge top but with a larger unimpeded sample size possible.

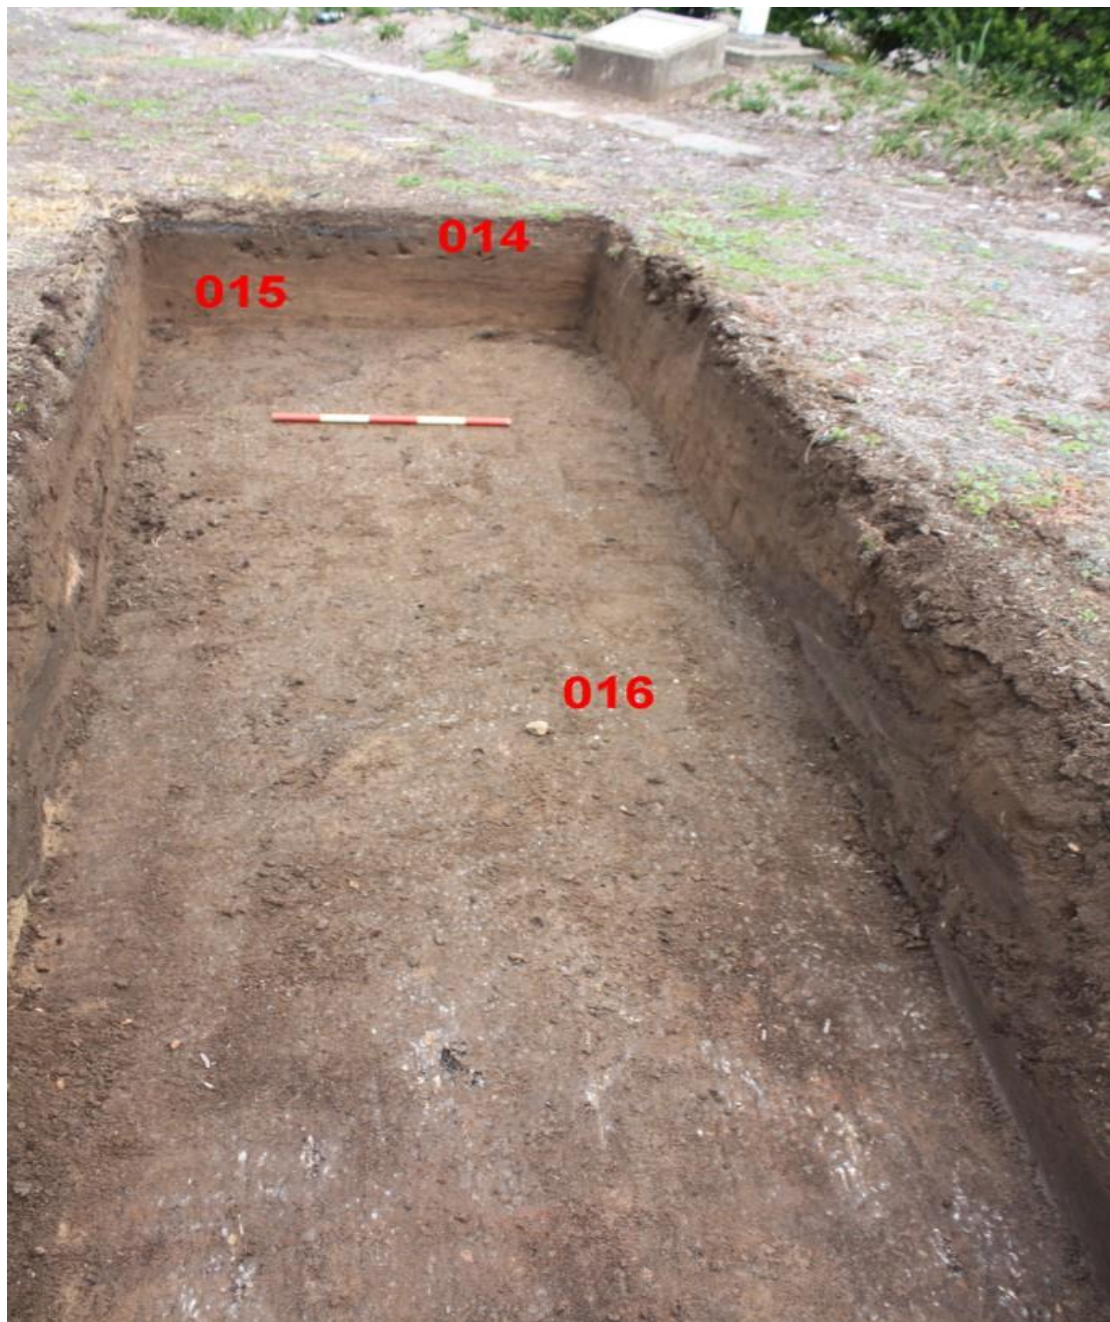
Plate 19: View west showing the topsoil [014, 015] above the bitumen surface [016]; scale 500 mm.

The surface of the trench was covered with compacted introduced sterile topsoil [014] to a maximum depth of 100 mm. Below this was 400 mm of sterile introduced topsoil [015]. Immediately below this soil was a hard compacted surface of bitumen and blue metal to a maximum depth of 20 mm [016]. Under this was a bedding deposit for the surface comprised of larger blue metal gravel and clay [017]. This deposit was not removed; the trench was backfilled with the soil removed from it. There were no artefacts recovered from this trench.

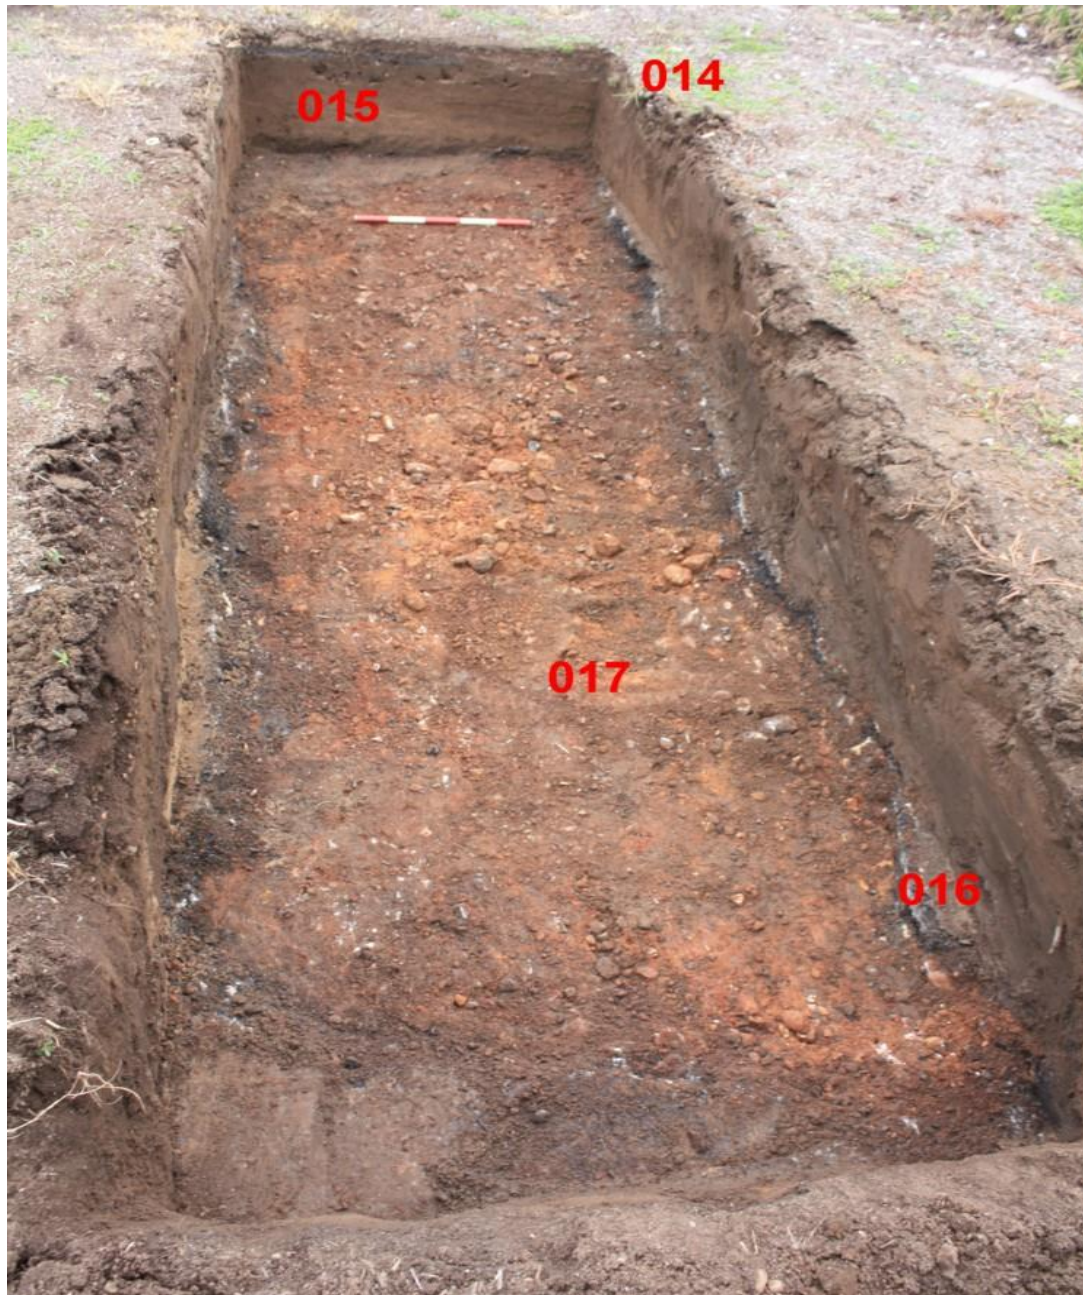
Plate 21: View west showing the bitumen surface [016] removed to reveal the bedding deposit [017] below it.

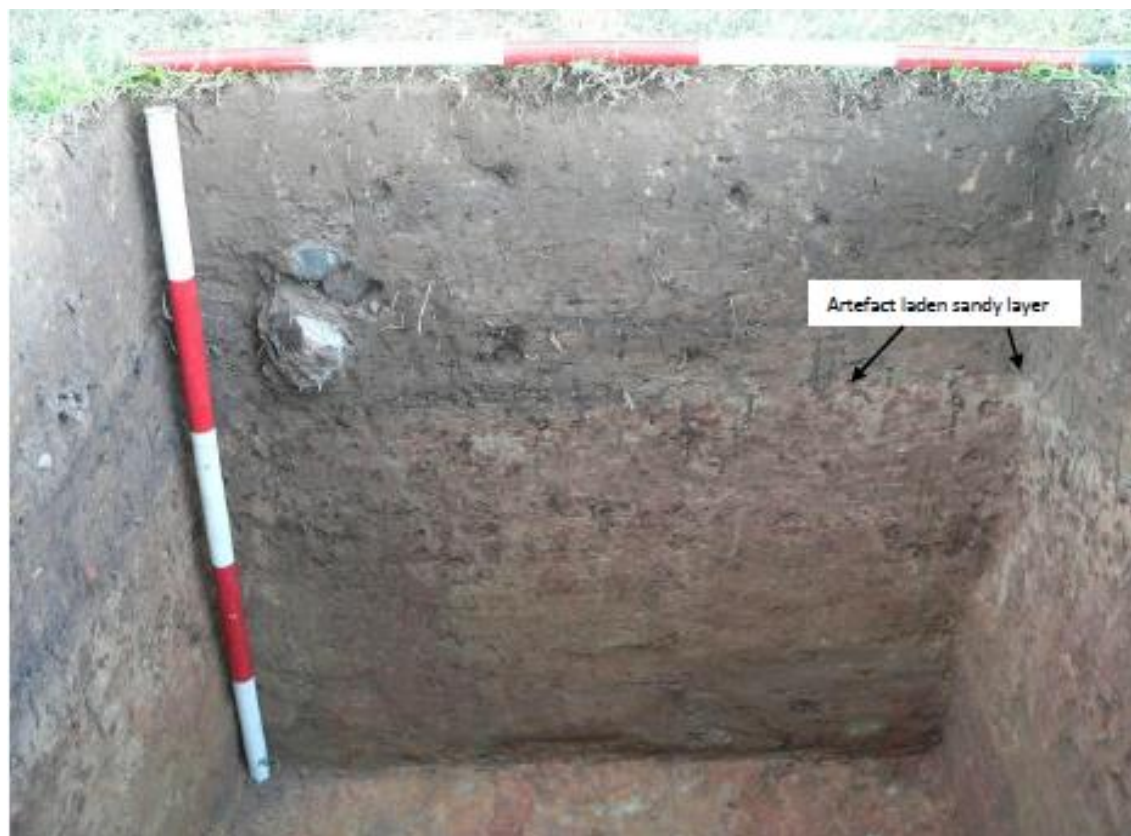
*Plate 23: North section of ATP A showing the small European horizon above the remnant sand dune; the top of the red clay is at the base of the pit (scale one metre)<sup>1</sup>.*

This test excavation revealed that the top 300 mm of the deposit in the parkland is comprised of dark grey-brown humic loam considerably disturbed by tree roots and including a small sample of European artefacts. The latter have a wide chronological spread including a fragment of a later nineteenth century clay smoking pipe and c. 1950s tiles. Below this material from 300 mm downwards was the upper portion of an ancient sand body including substantial quantities of Aboriginal artefacts. The pit was excavated to a depth of one metre; at this point naturally occurring red clay was exposed.

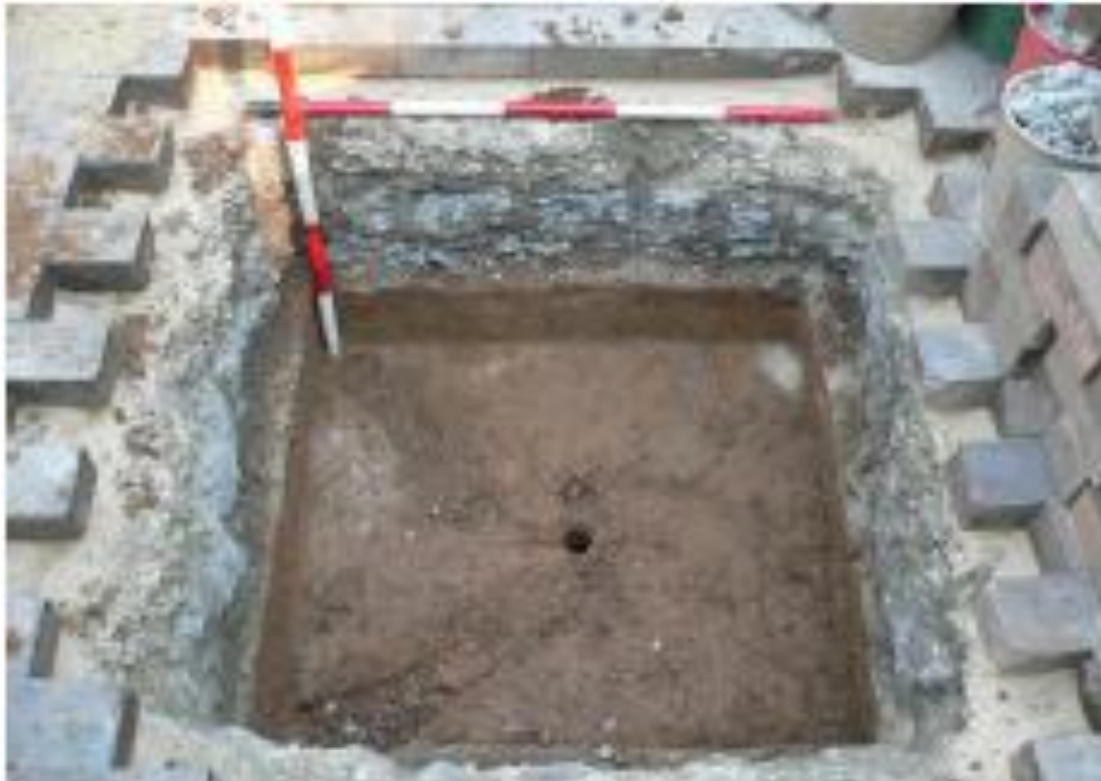
*Plate 24: Section in ATP B; scale 1 metre*

This pit was located in the traffic island between Old Bridge Street and Bridge Street. The surface was covered with paving bricks to reveal 80mm of bedding sand, above 230mm of blue metal. Below this was 250mm of concrete and at the base of the excavation was sticky red clay.
