7.0 GEO-TECHNICAL CORES

7.1 Core Locations

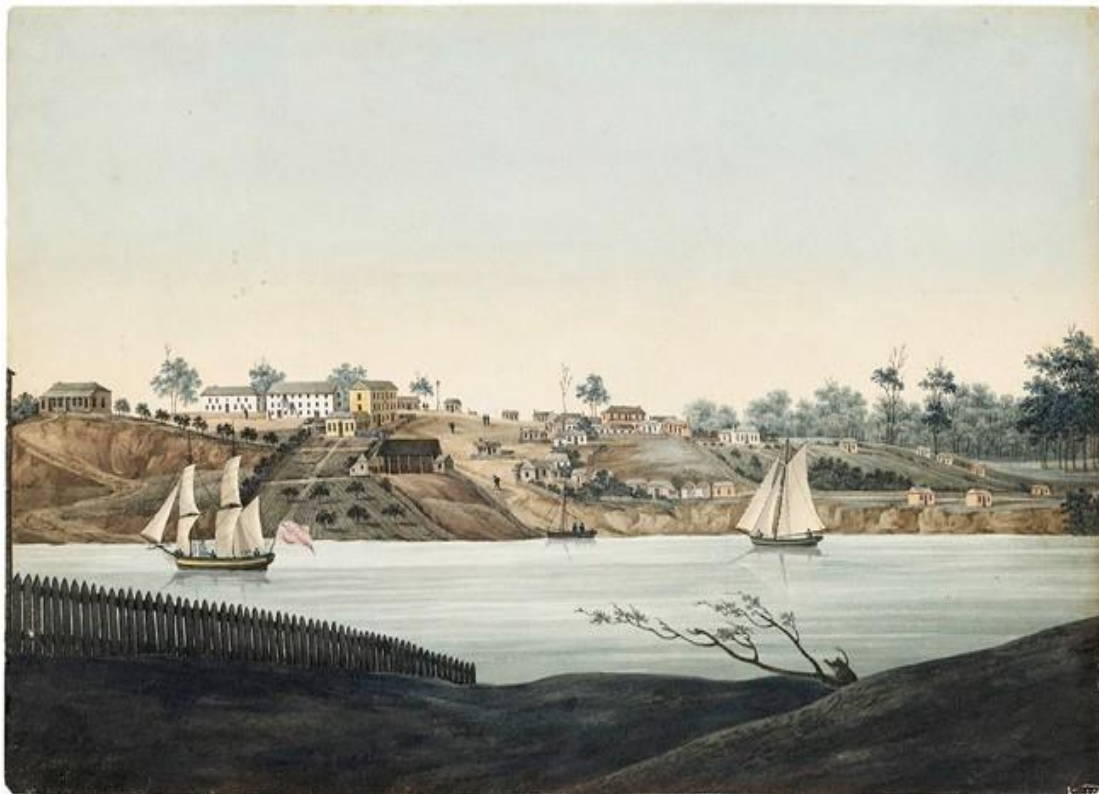
Plate 26: View of the Green Hills settlement in 1809 by William George Evans showing the steep topography from the ridge line (ML PXD 388 V3 Folio 7).

The results confirm the accuracy of the earliest European images of this area from c.1810 that shows a high exposed ridgeline that drops steeply down to the river. The results from the excavations in this area suggest that it might have been a narrow ridge line before it commenced that steep drop; there is sandstone bedrock on the southern side of George Street at a depth of 500 mm [003, 010] but it is not encountered in a core just to the north only a few metres away (core 3).

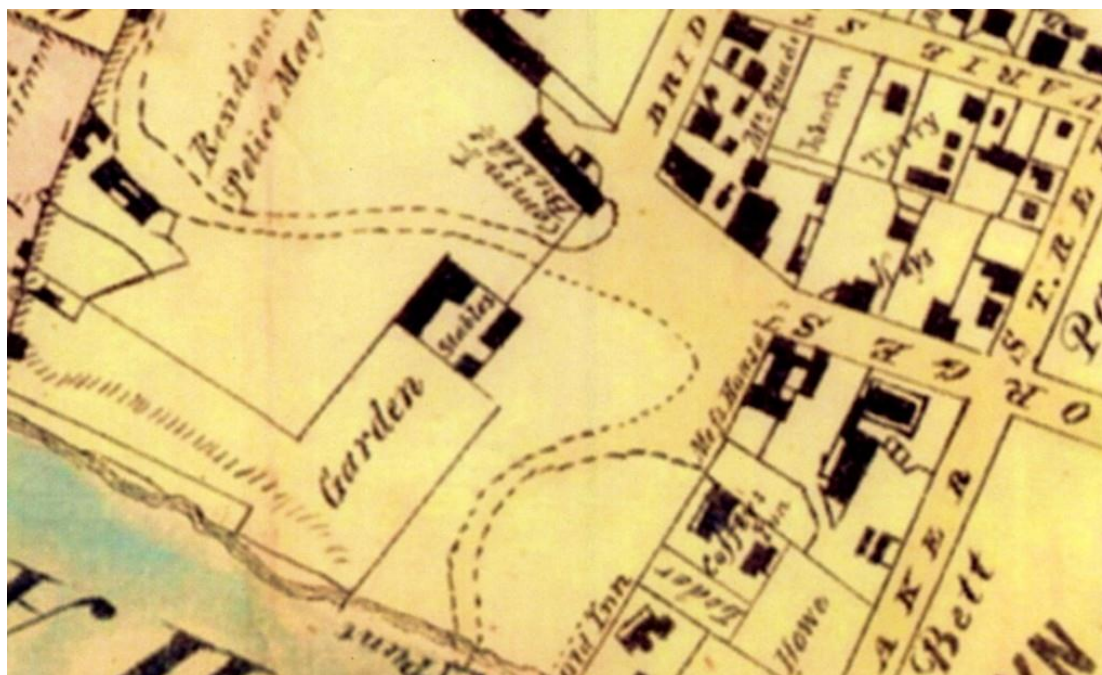
Plate 28: Detail of Armstrong's plan of the town in 1842 showing the large open area on the ridge top with the Commissariat building providing a visual curtailment to the end of George Street. The distinct played corner at the Bridge Street intersection is also recorded here detail of Peninsula Farm Auction 5 February 1842, plan prepared by Surveyor Armstrong: source nla map f187 on line).

There is very little specific evidence for the development of George or Bridge Streets in the nineteenth century. The archaeological evidence from the current program of investigation suggests that George Street may have been no more than the exposed and possibly shaped ridge-top bedrock in the earliest period of settlement. Certainly the narrow street that existed at the southern end of what is now Thompson Square was widened during Governor Macquarie's regime to match the breadth of his new planned road. There appear to have been further alterations to the configuration in the 1830s or 1840s; the discussion of the archival evidence for these conclusions is contained in the historical analysis made for this project. The configuration of the road is best seen on an 1842 town survey.

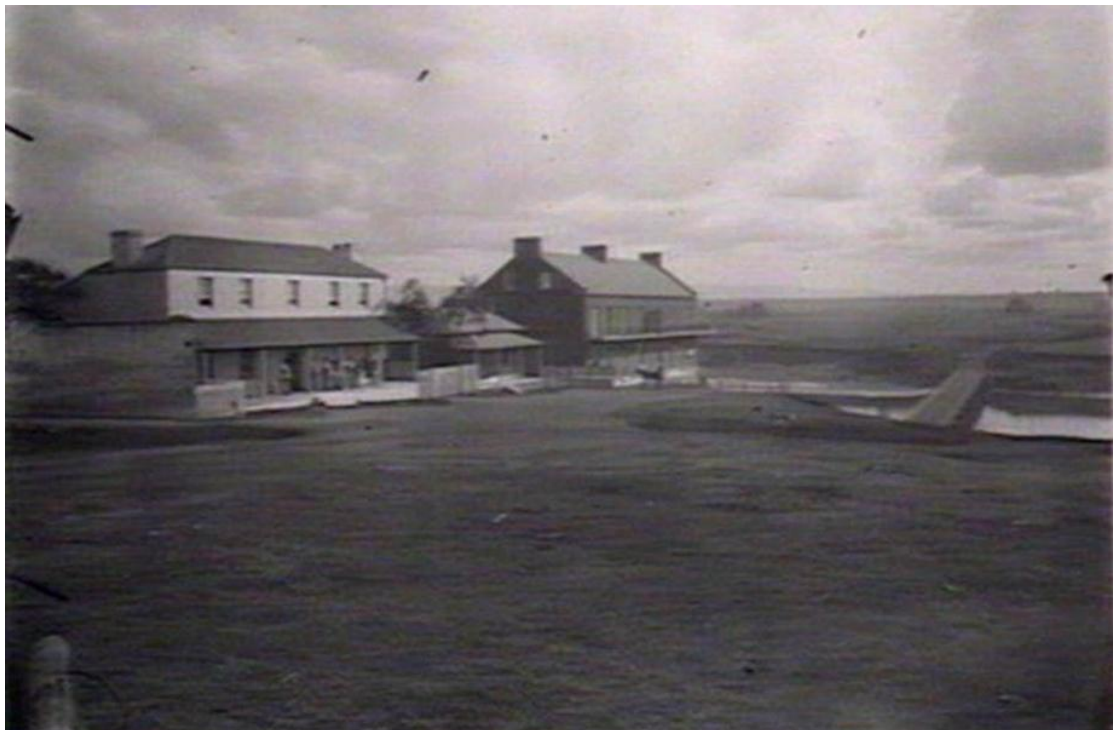
Plate 30: View of the southern end of Thompson Square after 1874 showing the Macquarie Arms Inn and the area of George Street in the foreground (source ML d1-06257)

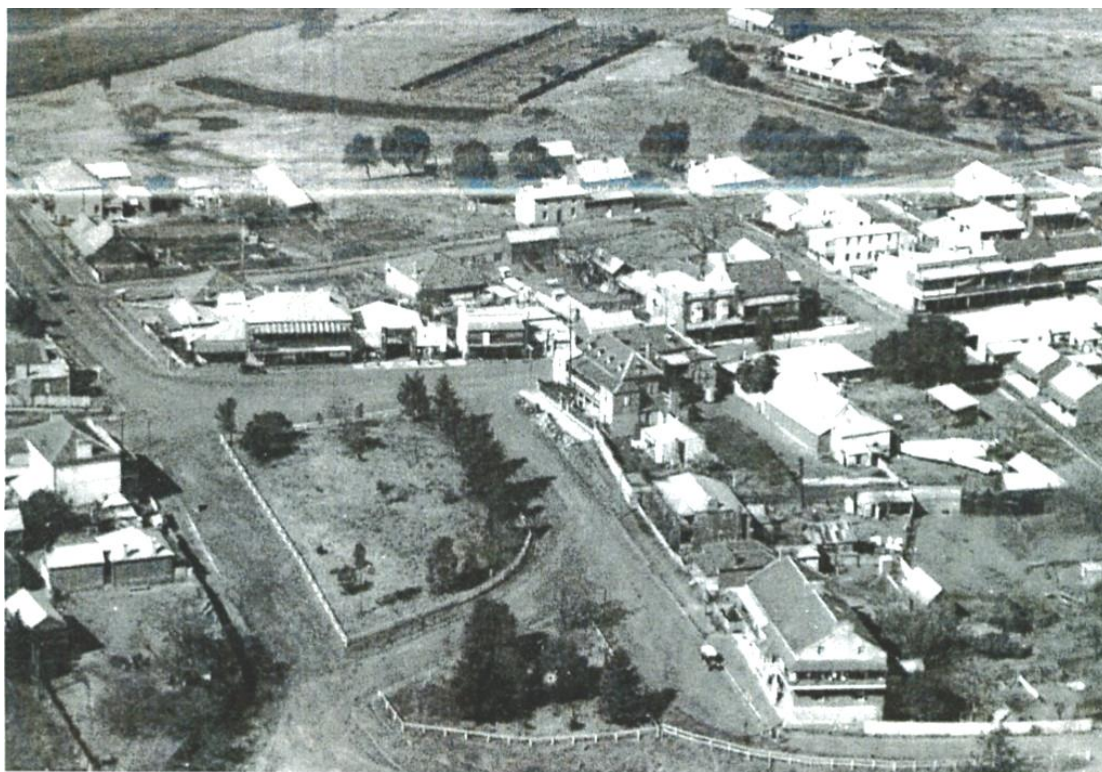
Plate 31: Thompson Square in 1929 showing what appears to be a compacted soil surface along George Street (JHHS 2011 No 2: 21).

It raises the question of how long this possible surface may have remained in use. It certainly does not appear to have been evident in the later 1920s. There is an aerial view of Thompson Square in 1929 and George Street in that image appears to be earth-covered. This could coincide with the deposit of silty soil [007] found in Test Trench 11 lying directly over the stone-built feature.

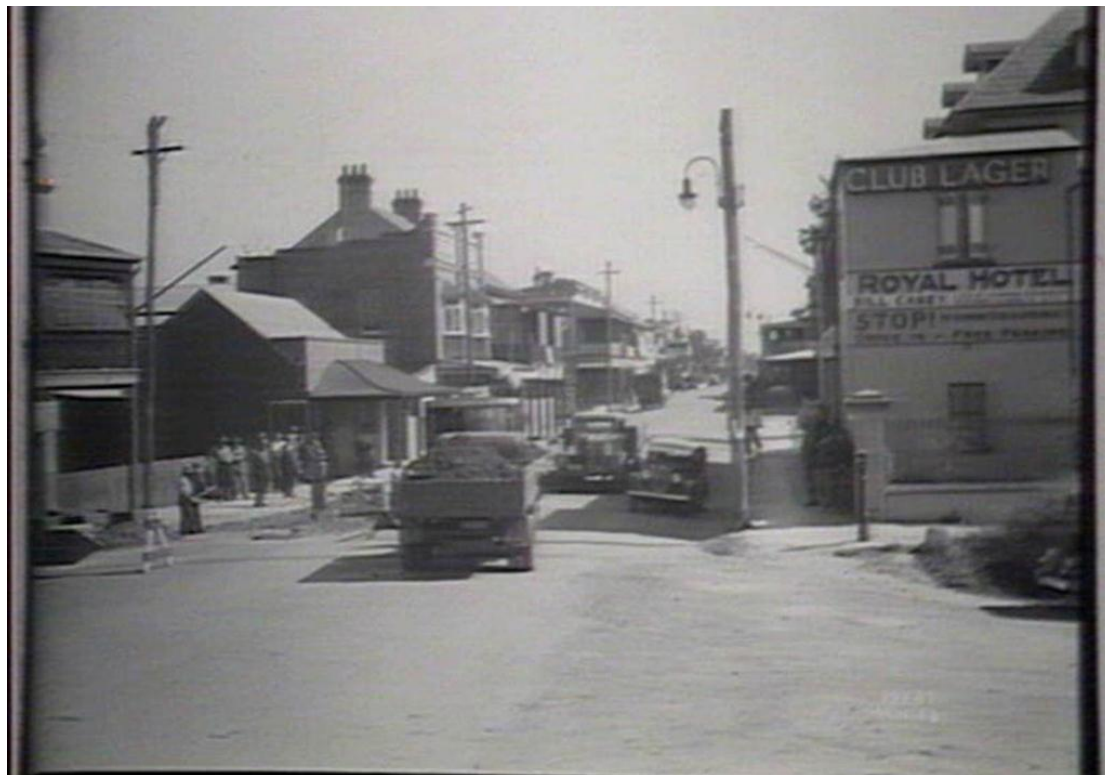
Plate 32: View of street works in 1938 looking west down George Street from the Bridge Street intersection (ML GPO 1-32538).

The 1938 image on the preceding page shows what appears to be a cement paved footpath along the southern side of George Street. It is very similar in appearance to the pavement that presently exists on the eastern side of Bridge Street. This was the slab moved aside at the top of trench 10 **[001]**. The footpath on Bridge Street could date to that time or be a later replacement.

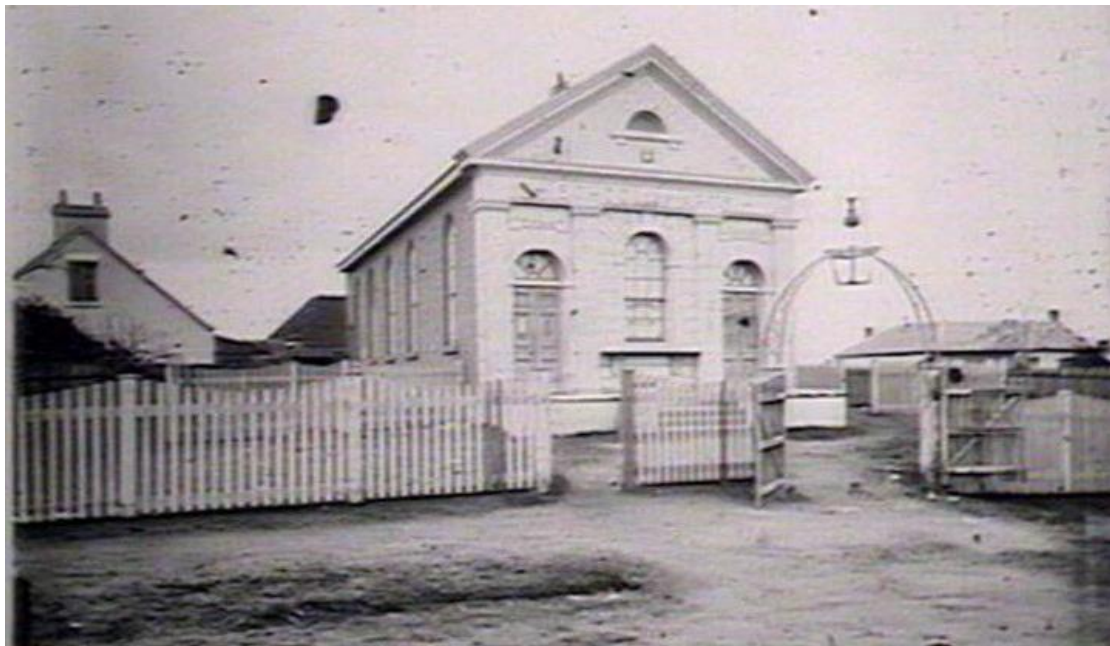
Plate 33: View of the School of Arts in c. 1870 showing the wider property boundary; test trench 10 would lie on the other side of the picket fence within the boundaries of the School (source ML GPO 1-06260.).

The land on the eastern side of Bridge Street encompassing Test Trench 10 was originally included within the School of Arts site, demonstrated by the c. 1870 image of the site. The test trench would lie behind the picket fence; Bridge Street has been widened. If the red clay found in Test Trench 10 **[002]** or part of it may be shown to have been used as the clay in Test Trench 11 **[009]** as part of a road works program then it would infer that the formation of this footpath would in its initial stages, have been in the later years of the nineteenth century. If that was the case there is no evidence within

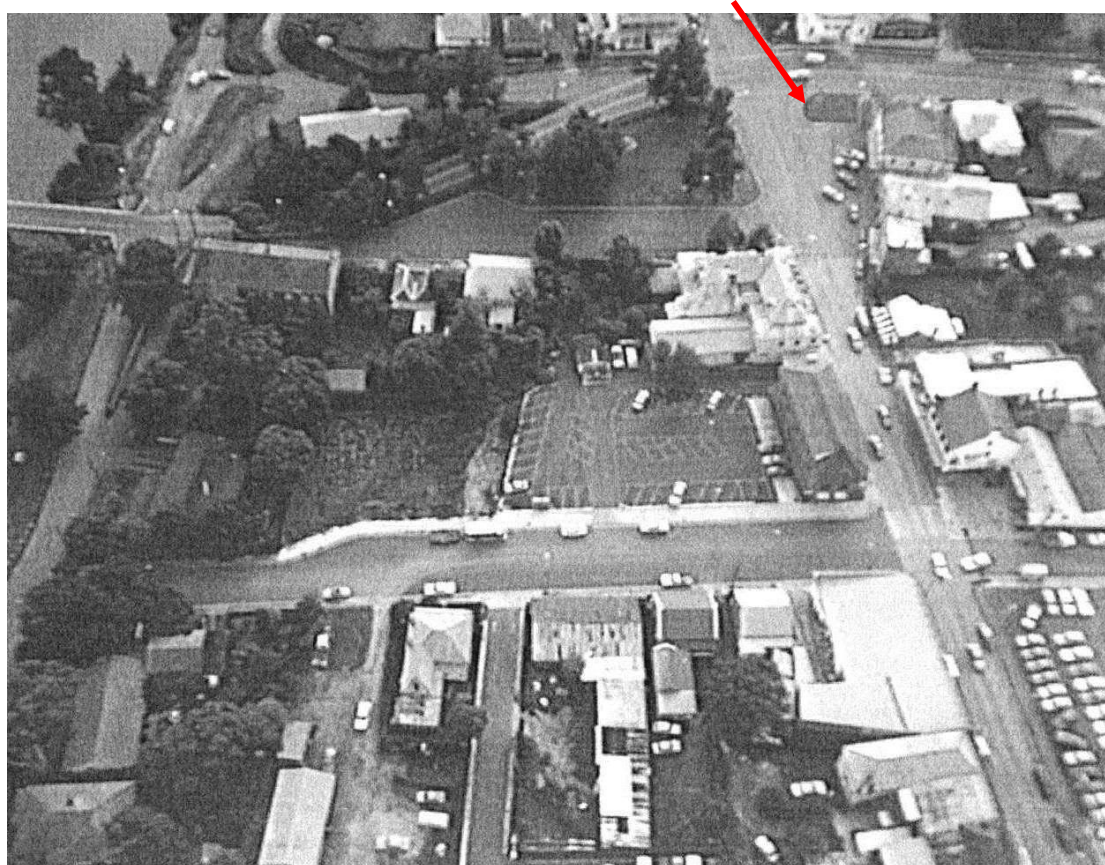
Plate 34: Oblique aerial view of Thompson Square. What appears to be a grassy area in front of the former Hawkesbury Stores is indicated by the red arrow. Source: Hawkesbury Images Local Studies Library Photographic Collection "Aerial view of North Richmond Bridge during floods, March 1978 [sic]. This is clearly an aerial photograph of Windsor with Thompson Square visible at the top of the image.

The 400 mm of topsoil at the surface of test trench 12 **[014, 015]** extends beyond the area of the grass strip recorded in the images of 1978 and 1981. It has been introduced as part of the present configuration of this corner created in the last twenty years.
