Windsor Bridge Replacement Project: Archaeological Options Paper

Prepared for Roads and Maritime Services

20 March 2013

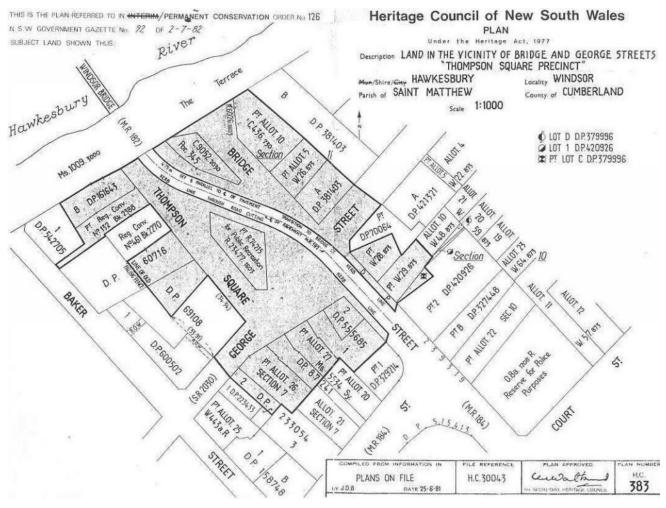
Plate 1: The SHR plan of the "Thompson Square Precinct".

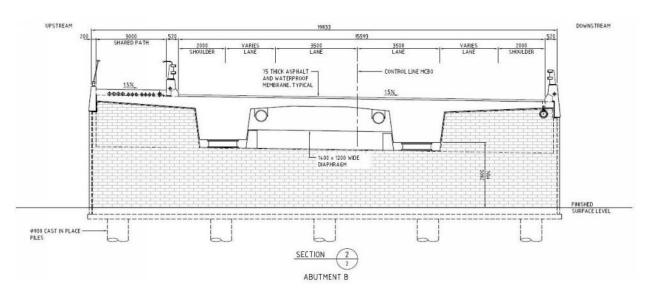
Plate 2: Cross section of the replacement bridge in Thompson Square with the Land Bridge Option showing the piles across the structure. An additional 6 piles on each long side also formed part of this particular design. Source: SKM Plan DS2012/000155 Sheet 3.

- 1. A land bridge comprising seventeen piles at 8 metre centres inserted into the ground around the perimeter to support the side walls and abutment; then from that, building a bridge structure over the void;
- 2. A concrete abutment comprising of two "L-shaped" walls and abutment wall facing inwards founded on rock, then infilling with material upon which the road is built.

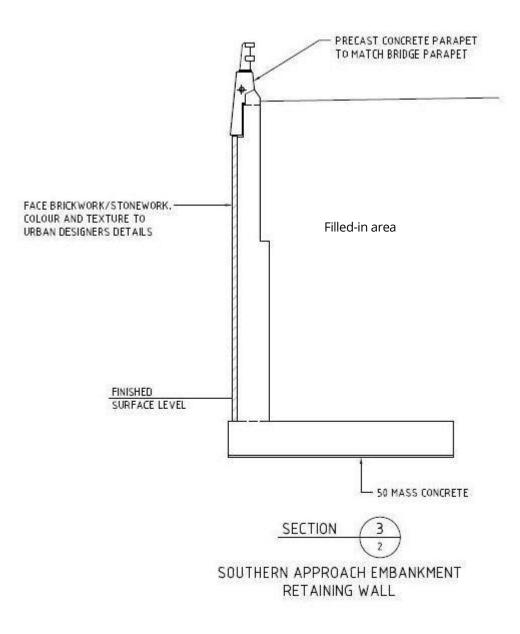
Plate 3: Diagram of one side of the L-shaped retaining walls proposed for the bridge abutment in Thompson Square. Source: SKM Plan DS2012/000155 Sheet 3.

The L-Shaped Retaining wall design option includes two L-shaped walls facing each other, with a spread footing at the abutment all founded on bedrock with the space between filled-in. The retaining wall option for the southern abutment would need to be built to support the approach road onto the bridge deck.

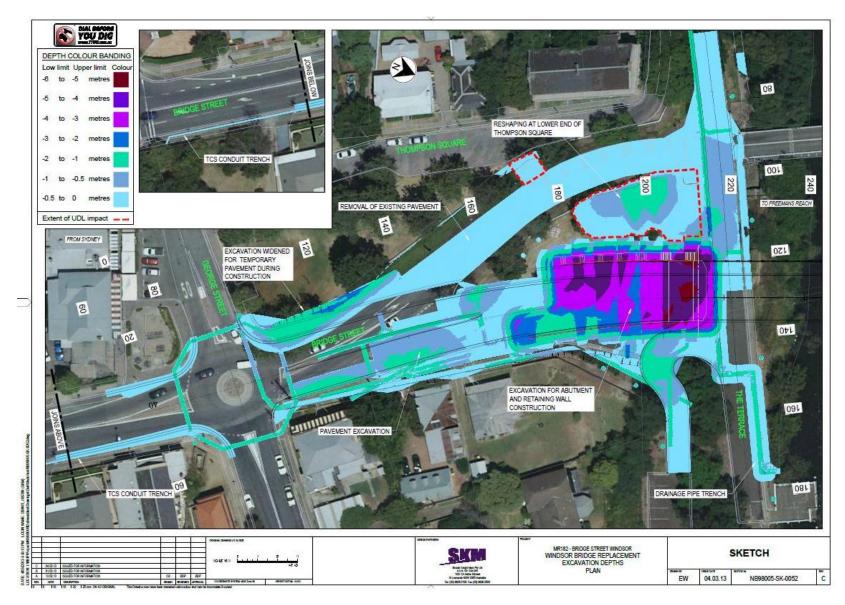
Plate 4: Diagram showing the depth of excavation in Thompson Square associated with the construction program. (Source SKM)

Refer to the sections and 12D model (Plate 7) and cut and fill diagrams (Plate 4, Plate 5 and Plate 6).

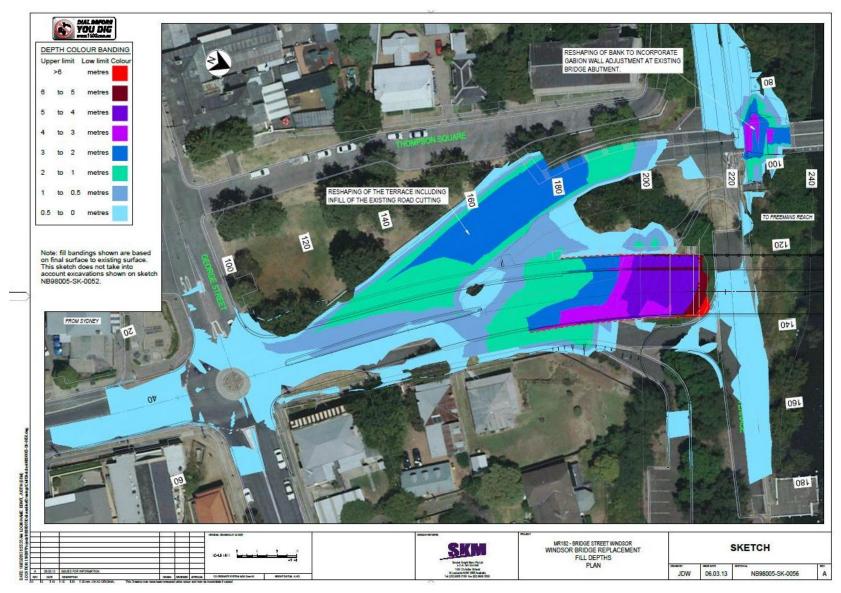
Plate 5: Diagram showing the depth of fill in Thompson Square associated with the construction program. (Source SKM)

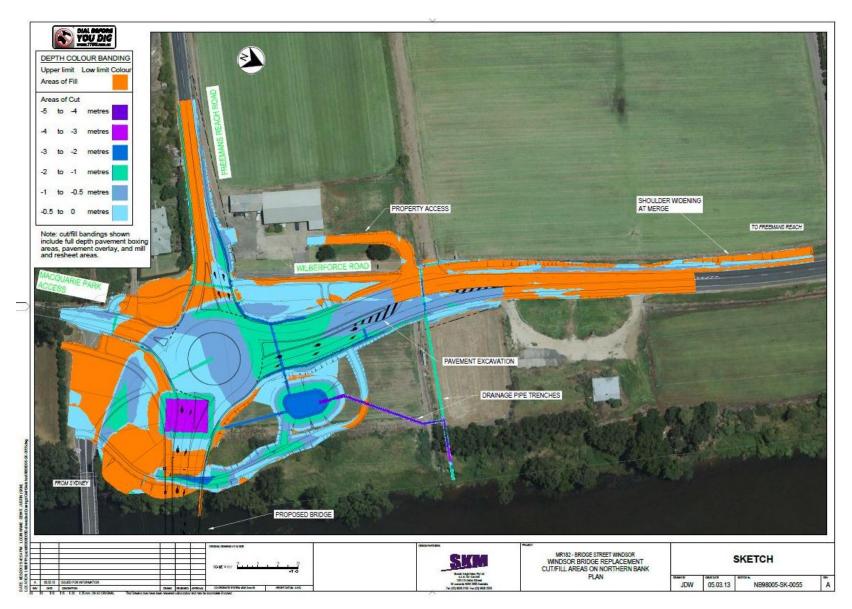
Plate 6: Diagram showing the depths of cut and fill on the north bank in Freemans Reach

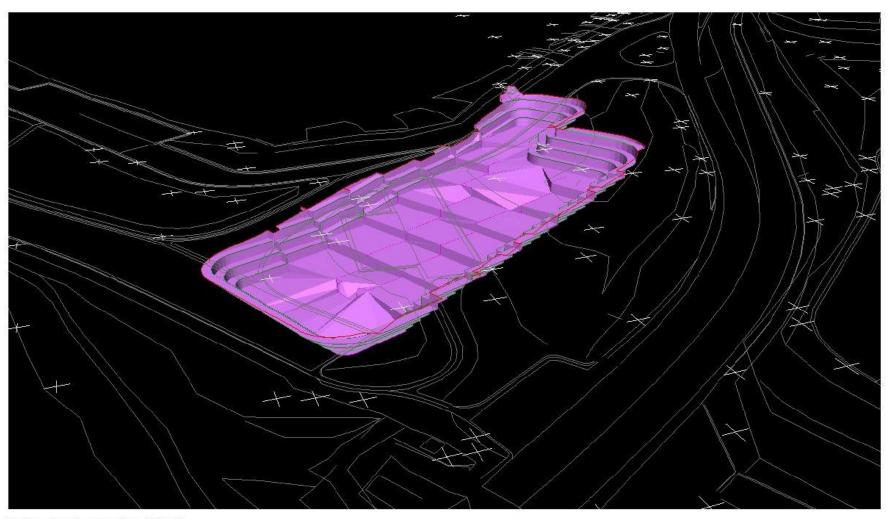
Volume of main excavation = 3645m^a

Plate 7: 12D model showing construction impacts
