ABORIGINAL AND NON-ABORIGINAL HERITAGE ASSESSMENT

Regional Rail Maintenance Facility

Dubbo, NSW

July 2018

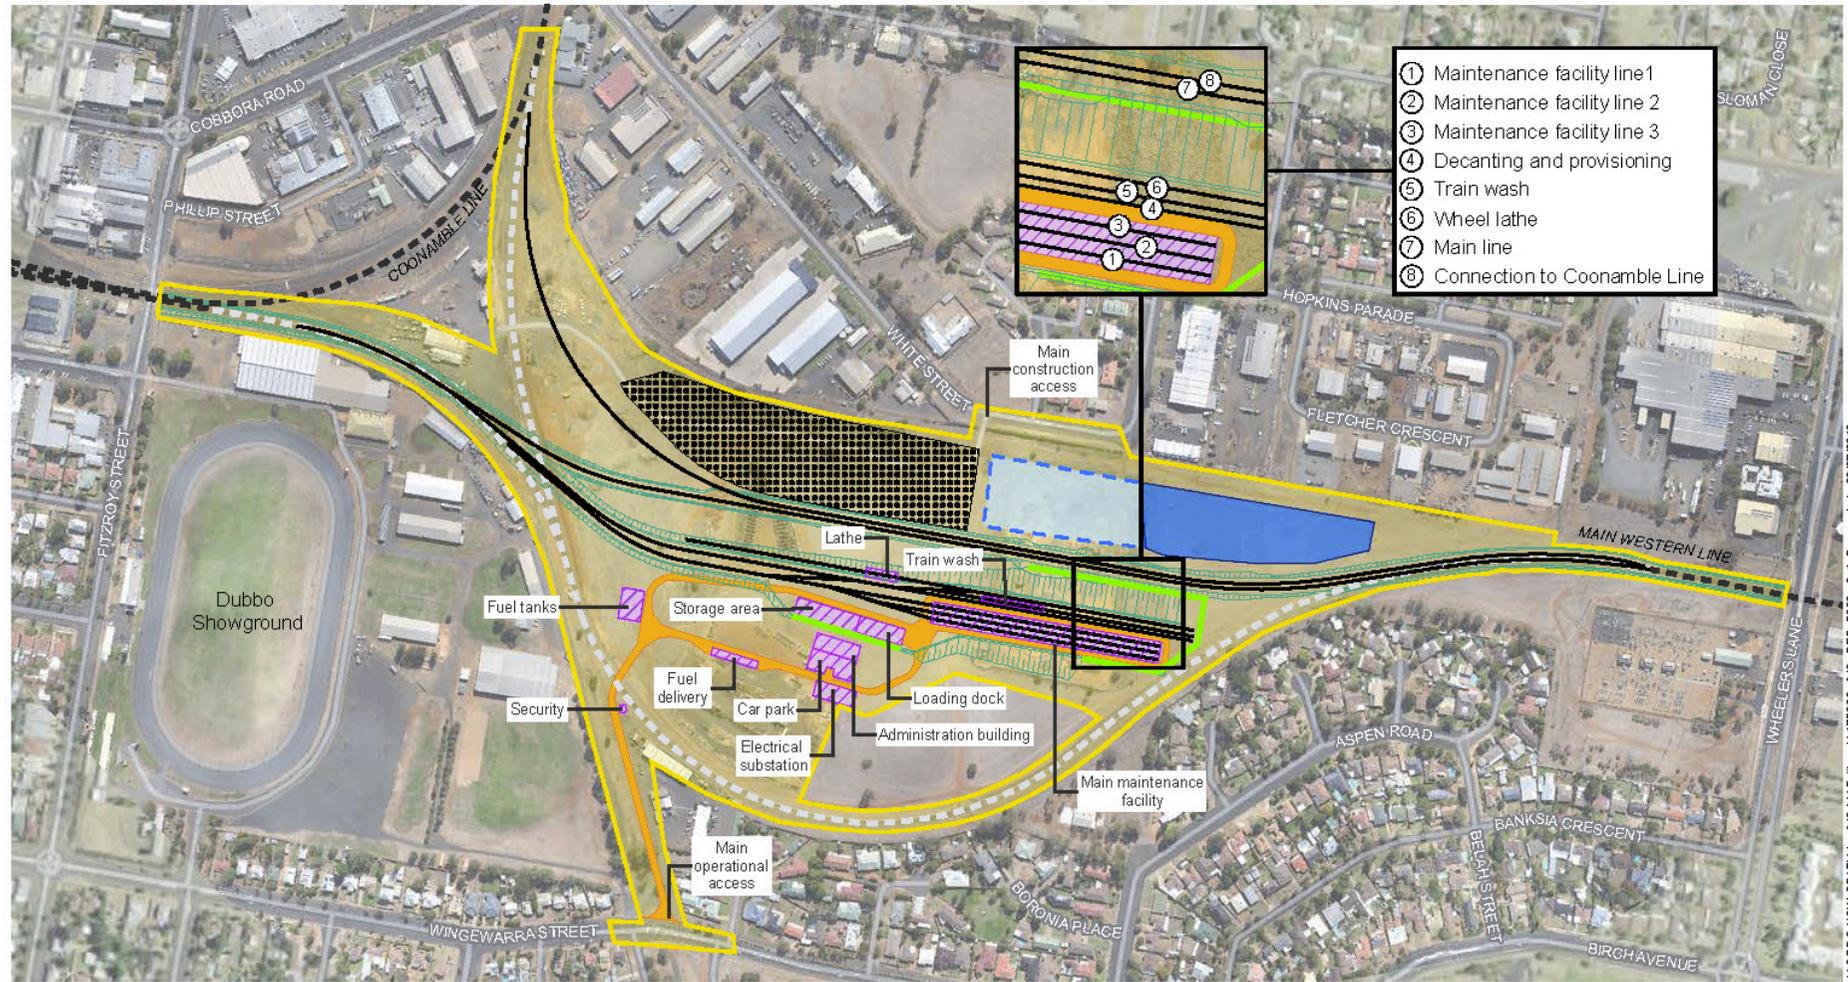
- ① Maintenance facility line 1
- ② Maintenance facility line 2
- ③ Maintenance facility line 3
- ④ Decanting and provisioning
- ⑤ Train wash
- ⑥ Wheel lathe
- ⑦ Main line
- ⑧ Connection to Coomamble Line

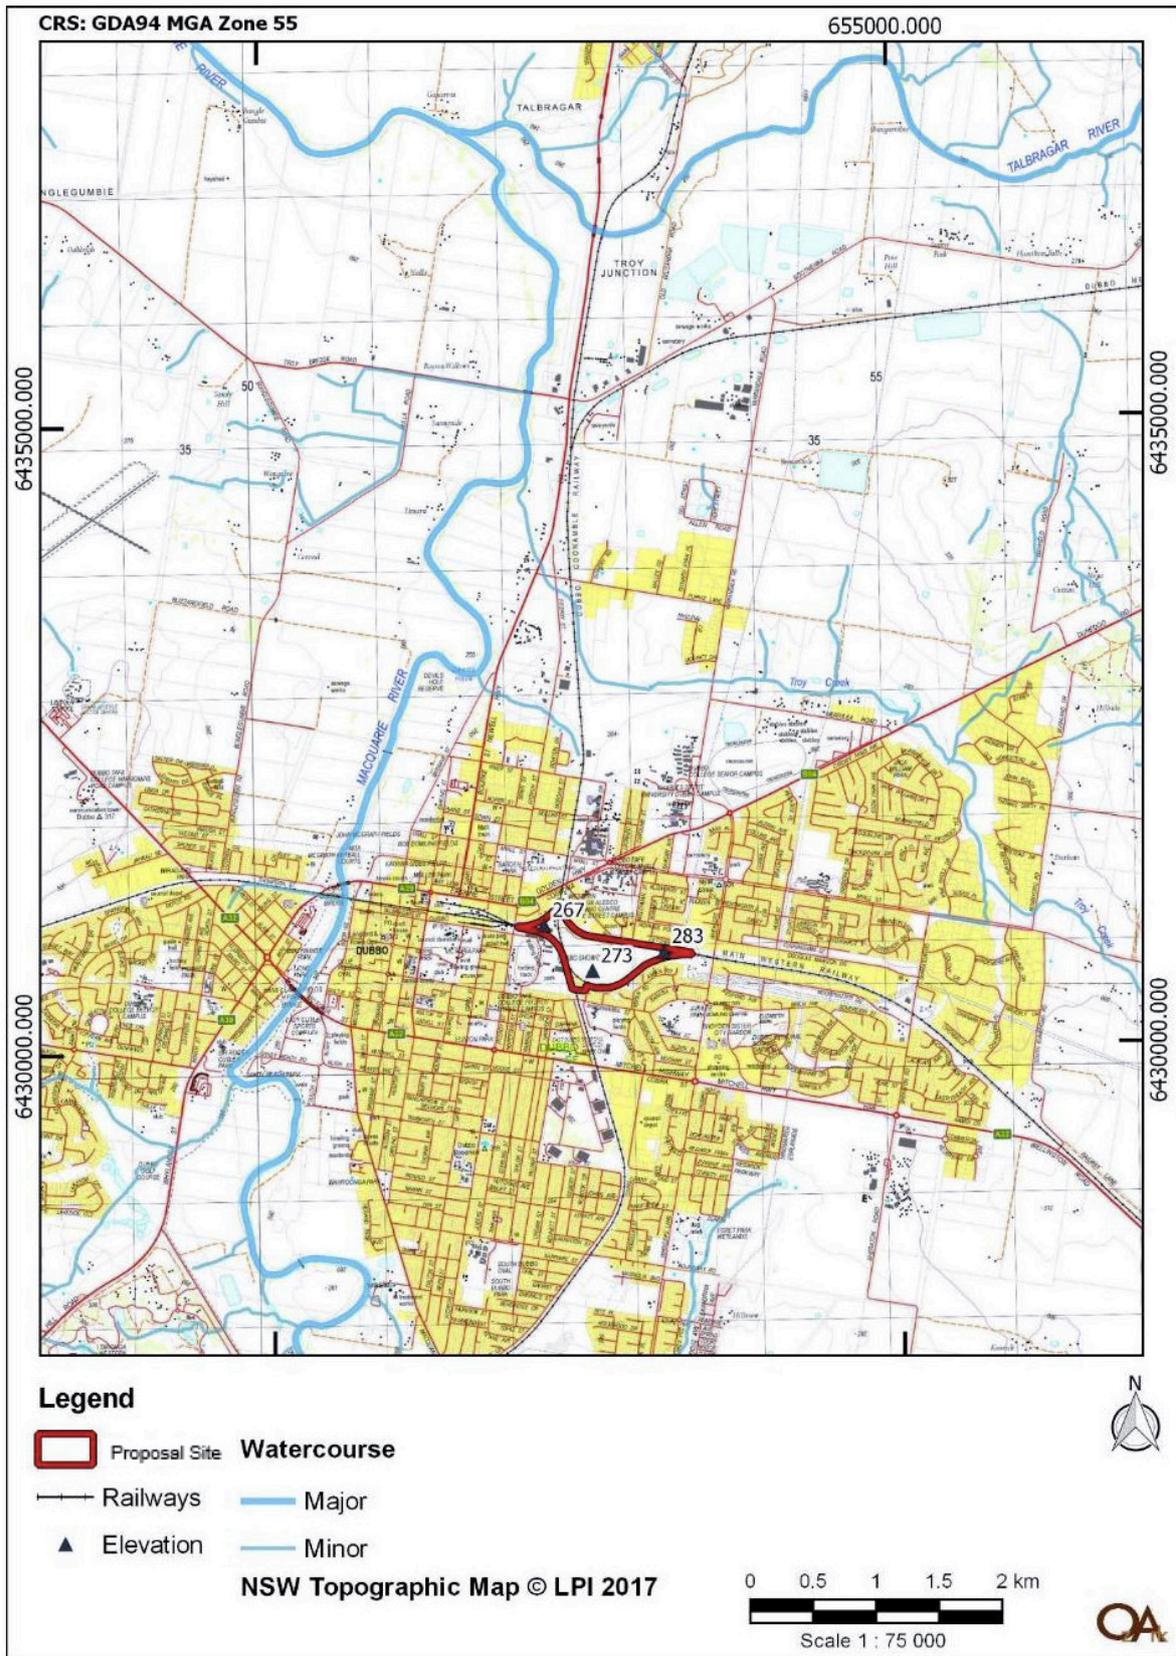
Figure 2-1: Topographic context of the study area

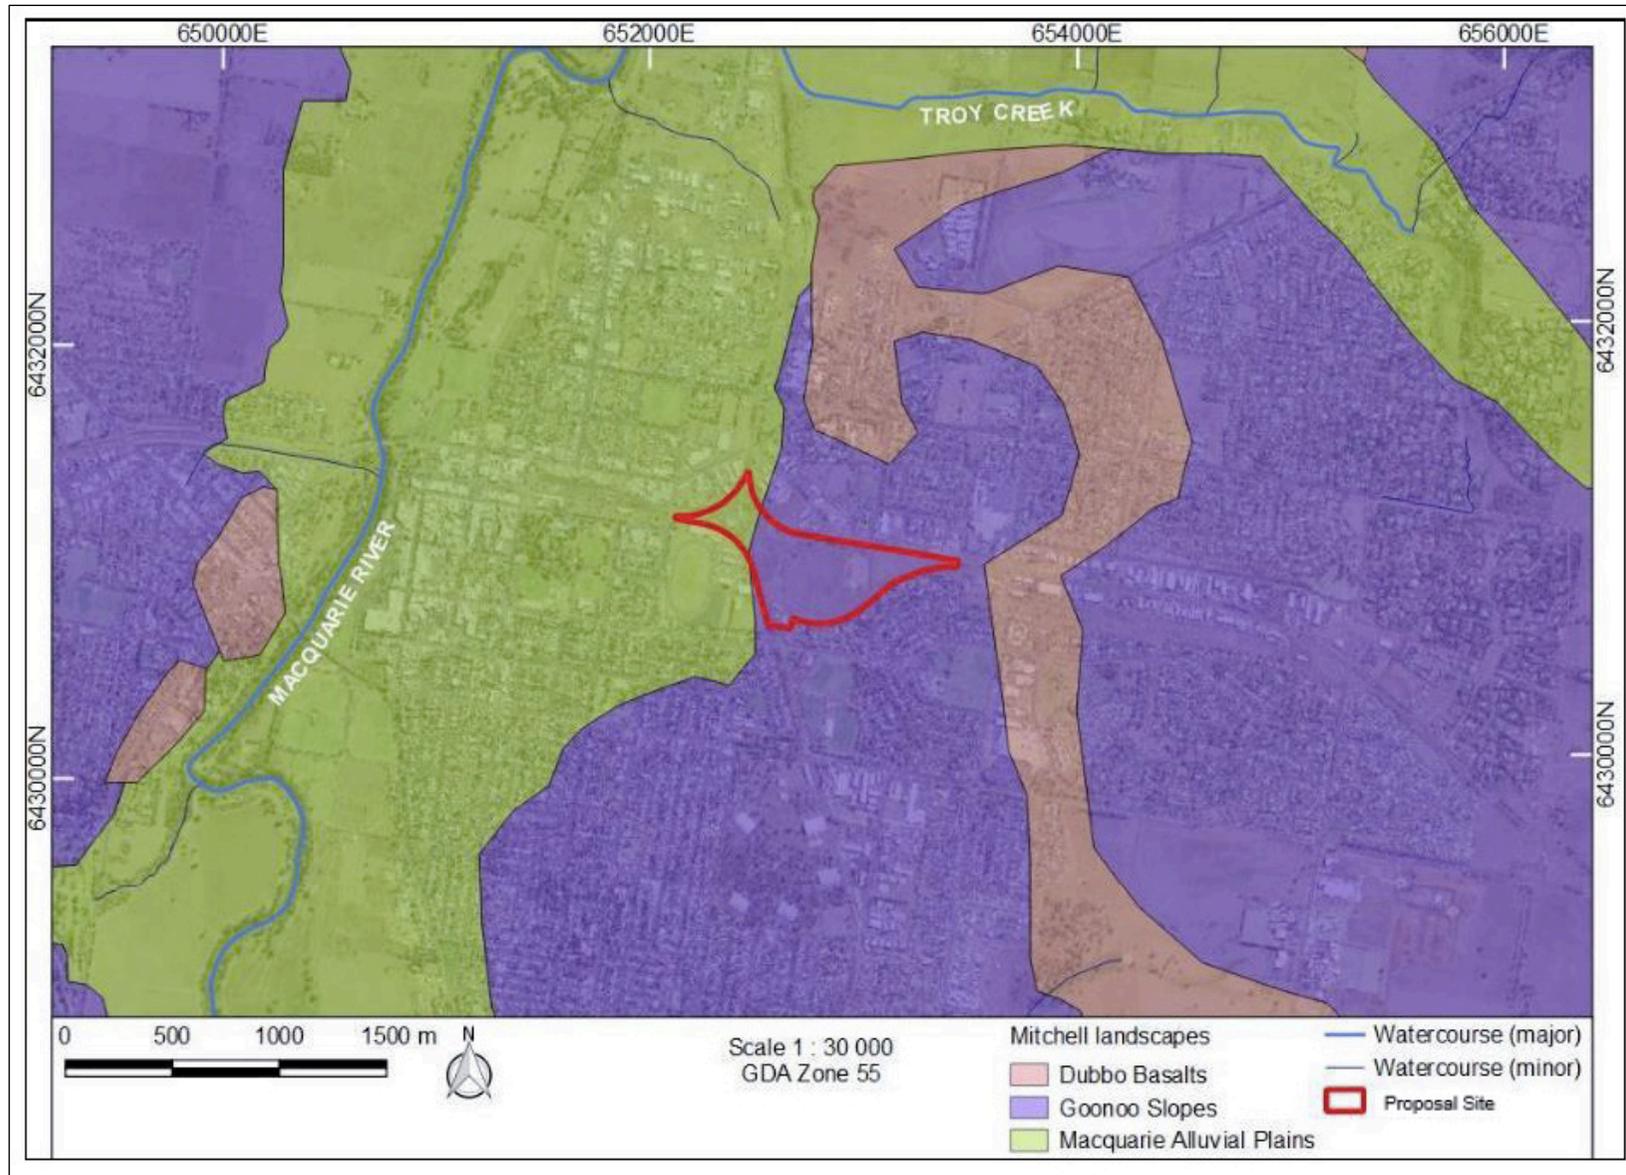
Figure 2-2: Mitchell landscapes of the study area

- The Macquarie Alluvial Plains landscape is comprised of Holocene fluvial sediments of backplain facies of the Marra Creek Formation associated with the Macquarie River main alluvial fan and distributary stream system. It has a local relief of one to three metres. Dark yellow-brown silty clay with patches of sand and carbonate nodules deposited from suspended sediments in floodwater, often with gilgai. Slightly elevated areas with red-brown texture-contrast soils.

The Proposal Site location is more aligned to the Macquarie Alluvial Plains landscape, being at lower elevation and on the gentle slope near a historic woodland swamp landscape with fine-grained brown soils.

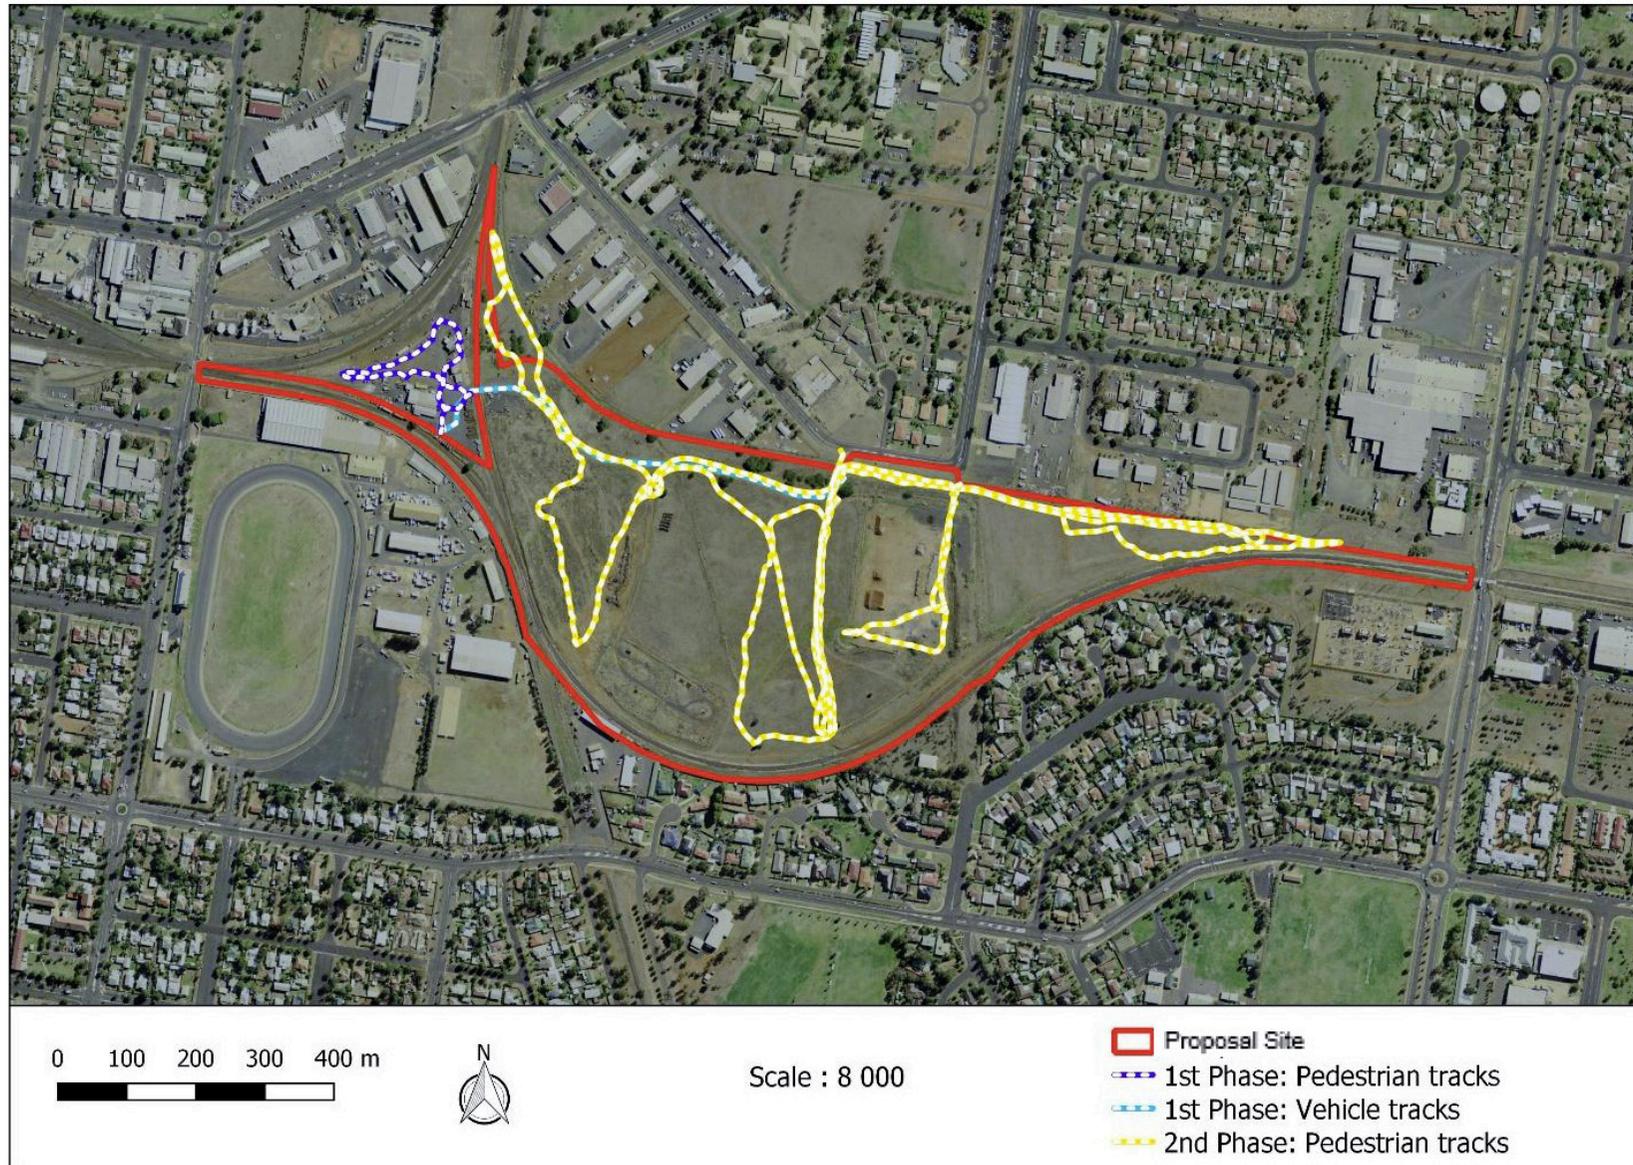
Figure 5-1: Survey coverage within the study area

Pedestrian transects were completed to ground-truth existing levels of disturbance, confirm the location and curtilage of previously recorded heritage items (**Section 4.4**), and to assess whether any other non-Aboriginal heritage items exist, or are likely to exist, in the study area. Emphasis was placed within areas displaying minimal ground surface disturbance, as well as landforms identified as having historic archaeological potential, such as the potential location of the former fettlers' camp.

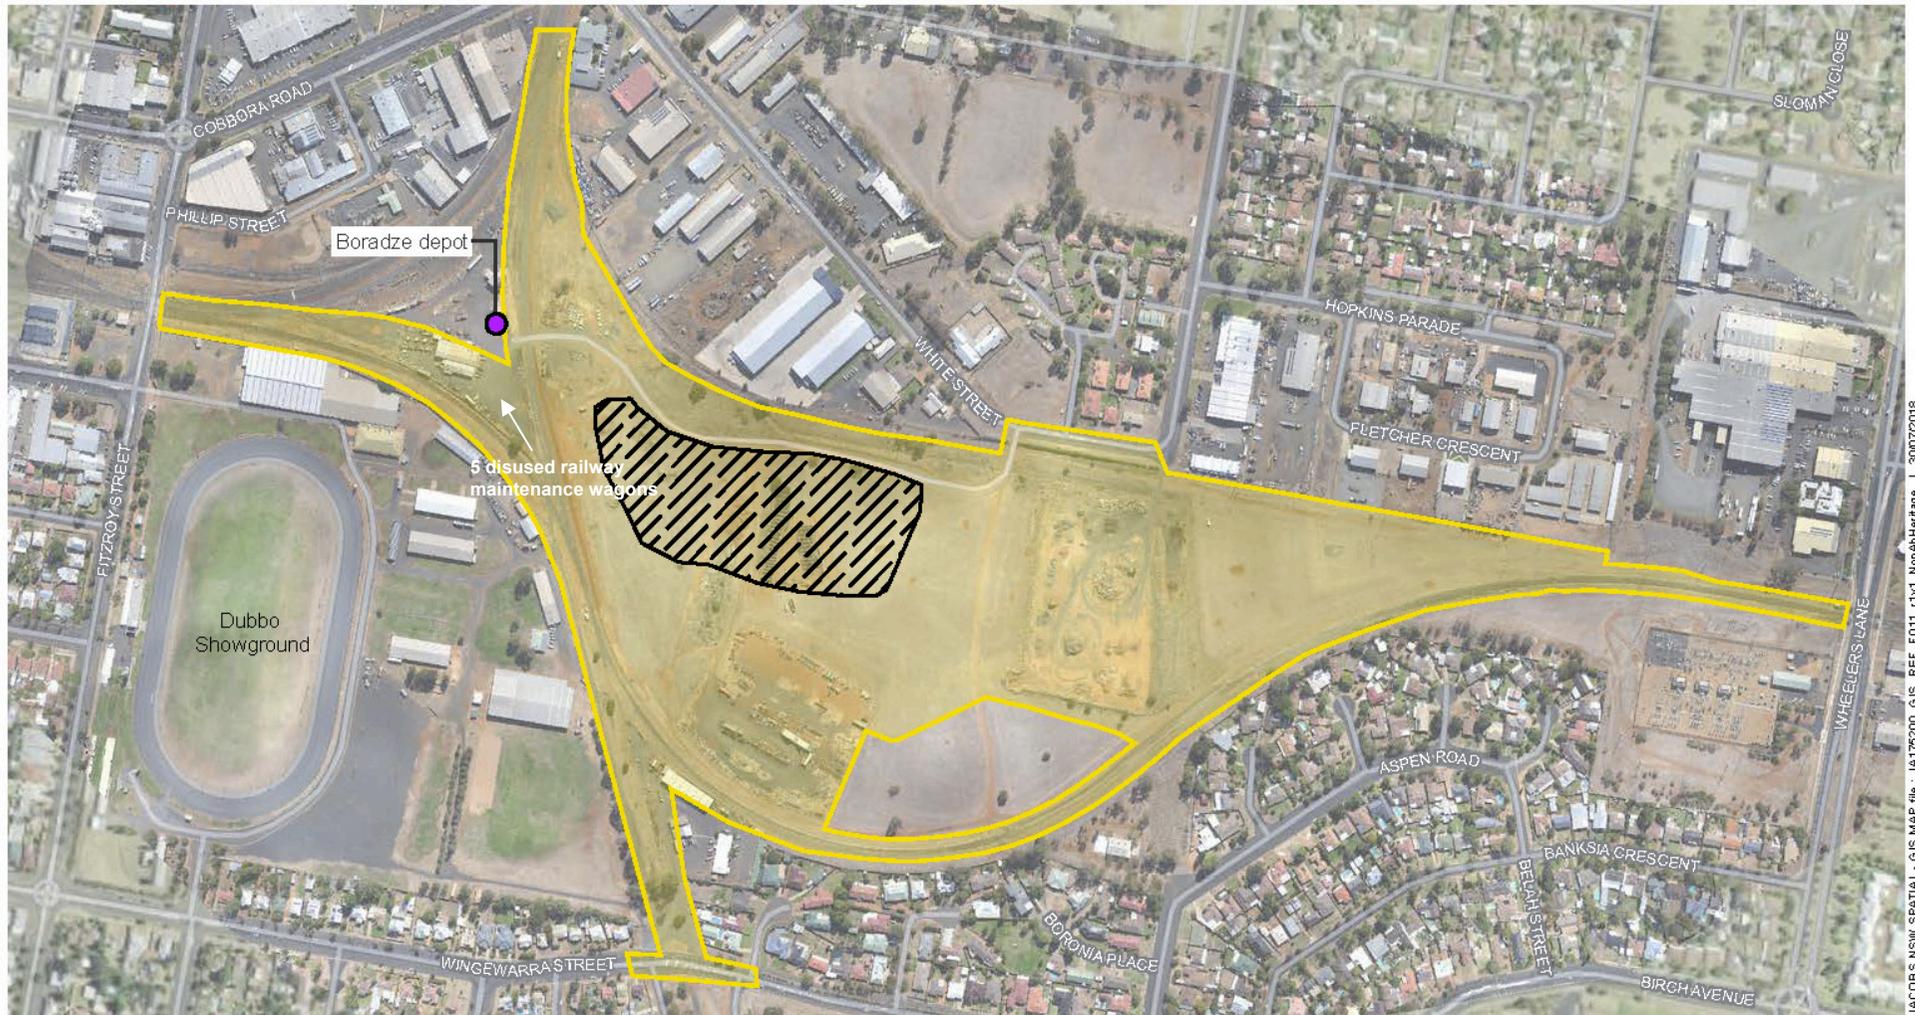
- Legend**
- Construction footprint
 - Potential fettlers' camp location

During the physical assessment, no surface manifestations of artefacts or features potentially associated with Tin Town, the fettlers camp or any house were identified. The location of the camp and house are likely to have been bulldozed once they were no longer in use. In addition, ground surfaces throughout the study area have been disturbed, sometimes at-depth and so, while isolated instances of buried historic relics is feasible, any that are present would be highly modified and disassociated with their context. Given the temporary nature of the fettlers' camp (**Section 4.3**) and current disturbances, the study area is unlikely to be associated with intact or significant subsurface deposits.

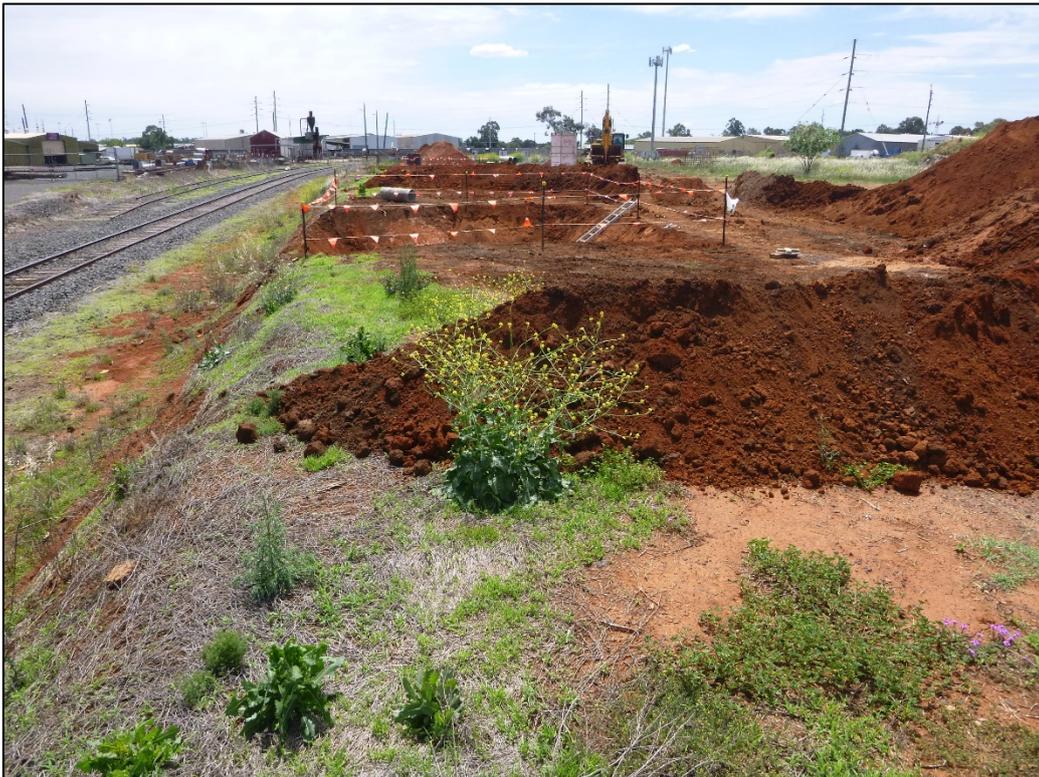
Plate 4: Drainage work being completed in the western end of the study area during the 2017 site visit

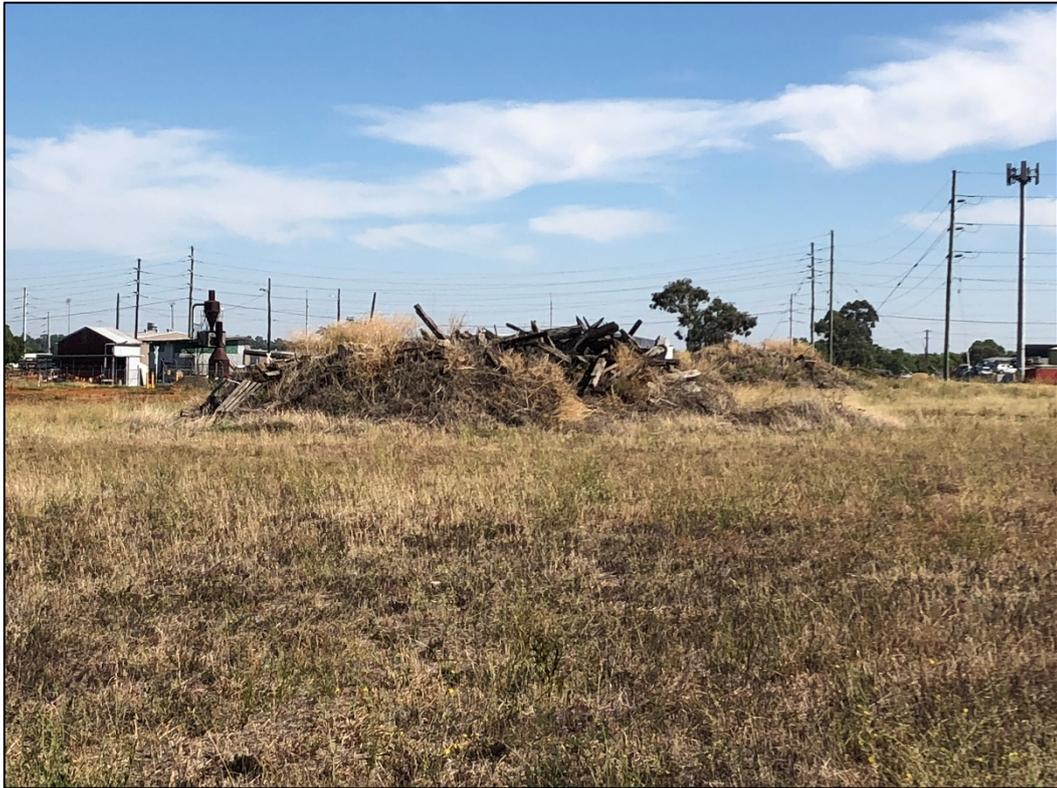
Plate 9: View over the area the fettlers' camp may have covered, showing dumped materials and flattened ground

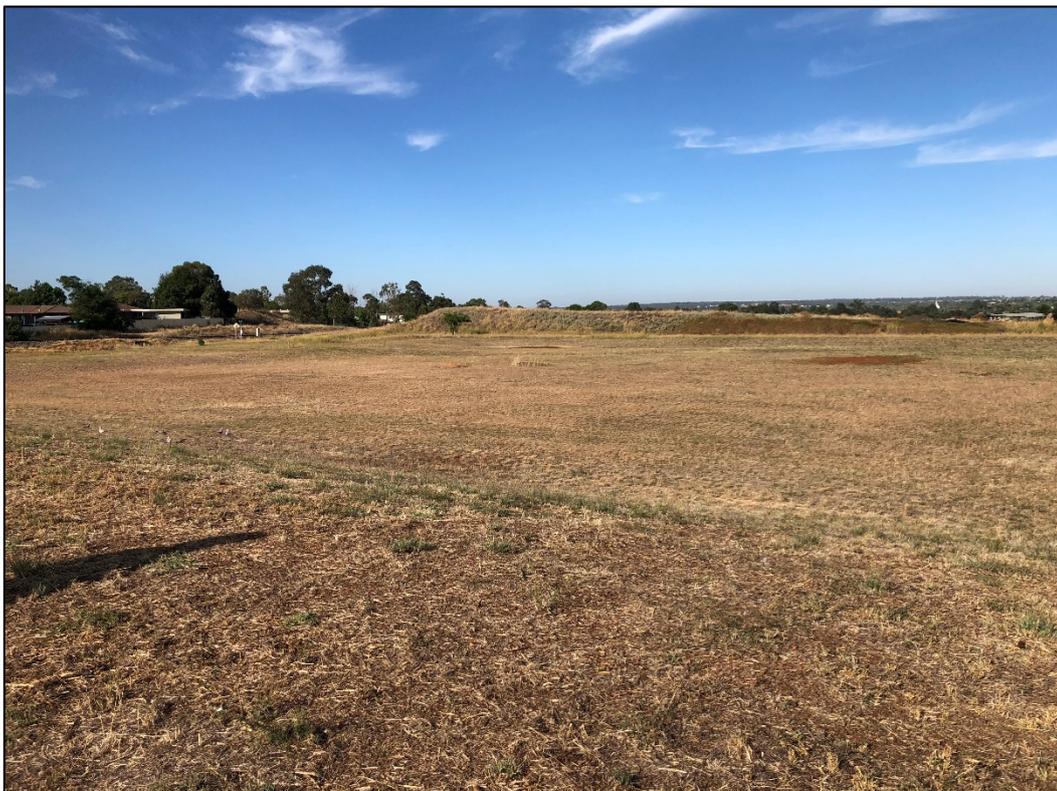
Plate 10: View south over the eastern end of the study area showing the machine levelled water detention basins that characterise this area, with the bridge abutment in the distance

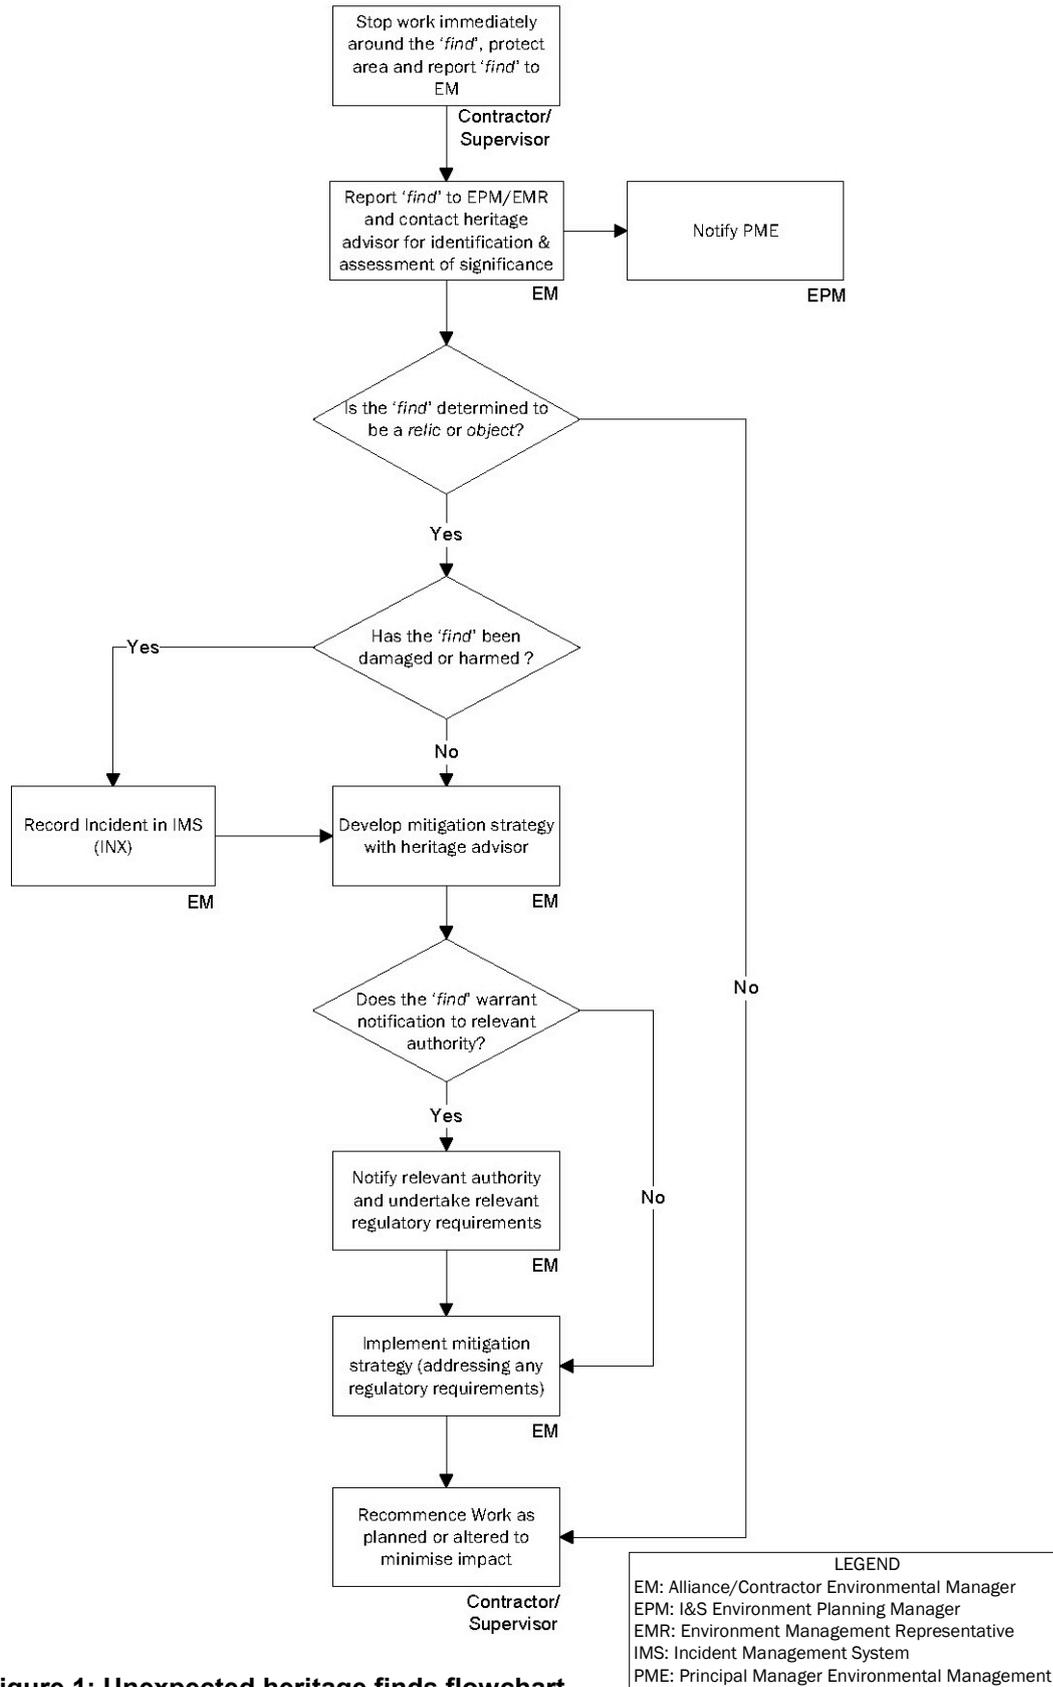
Figure 1: Unexpected heritage finds flowchart

In the event that an unexpected heritage find (the 'find') is encountered on a I&S site, the flowchart in Figure 1 should be followed. Table 2 indicates roles and responsibilities referred to in Figure 1.
