# New Intercity Fleet Great Zig Zag Railway deviation tunnels Modifications

Statement of Heritage Impact

Report to Transport for NSW

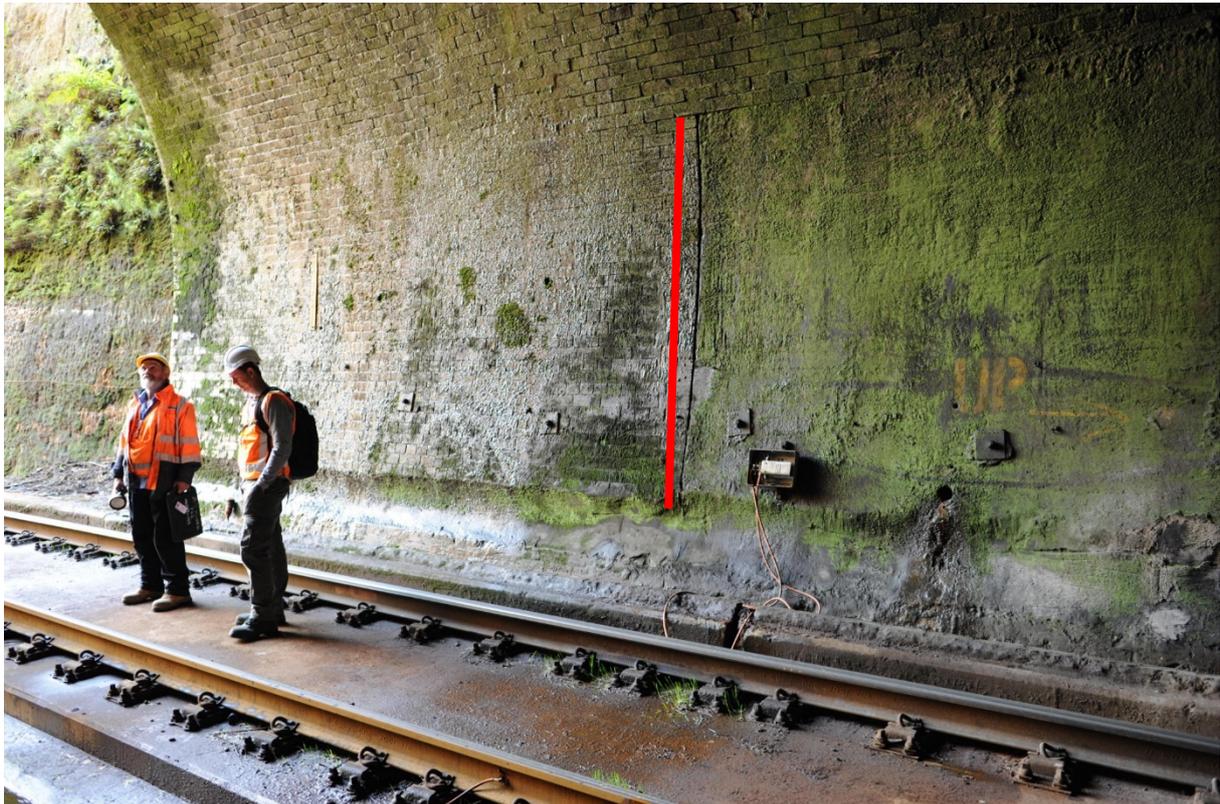
**Figure 13: Country end of Tunnel 1, showing brick tunnel portal and transition to concrete across the lower tunnel wall approximately six metres from the portal (red line placed adjacent to change from brick to concrete to highlight the interface)**

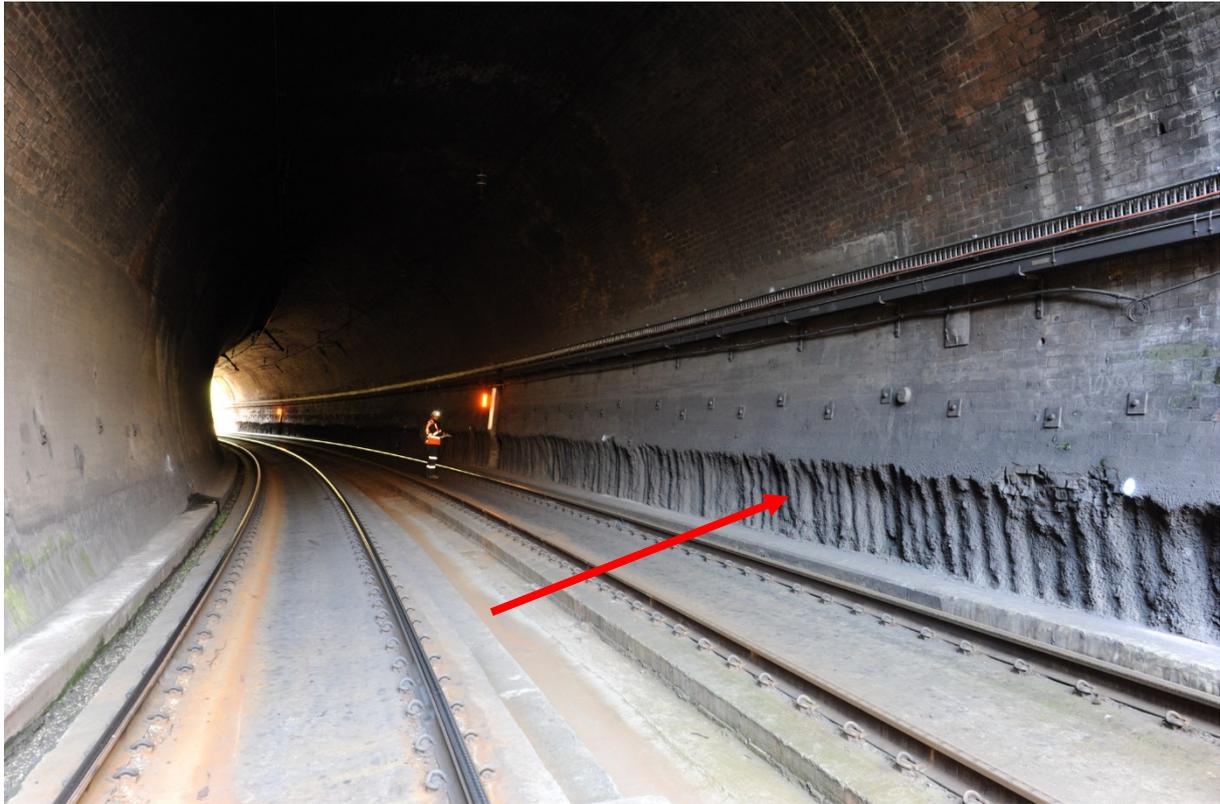
Figure 14: View up track within Tunnel 9, showing concrete track bed and notching at the toe of the tunnel wall from track bed lowering in the 1970s. Tunnel 9 is the only tunnel that is wholly lined with bricks (red arrow indicates previous notching).

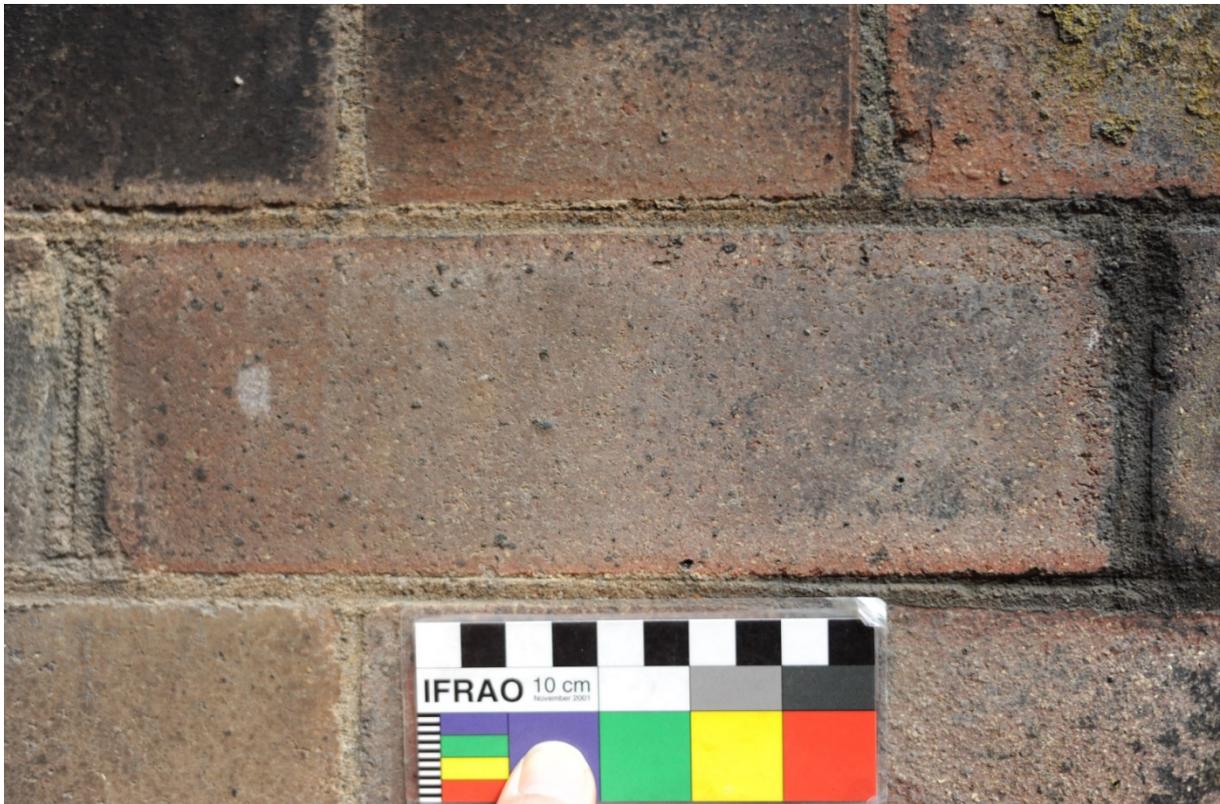
Figure 15: Example of English Cross bond from the country end portal of Tunnel 8

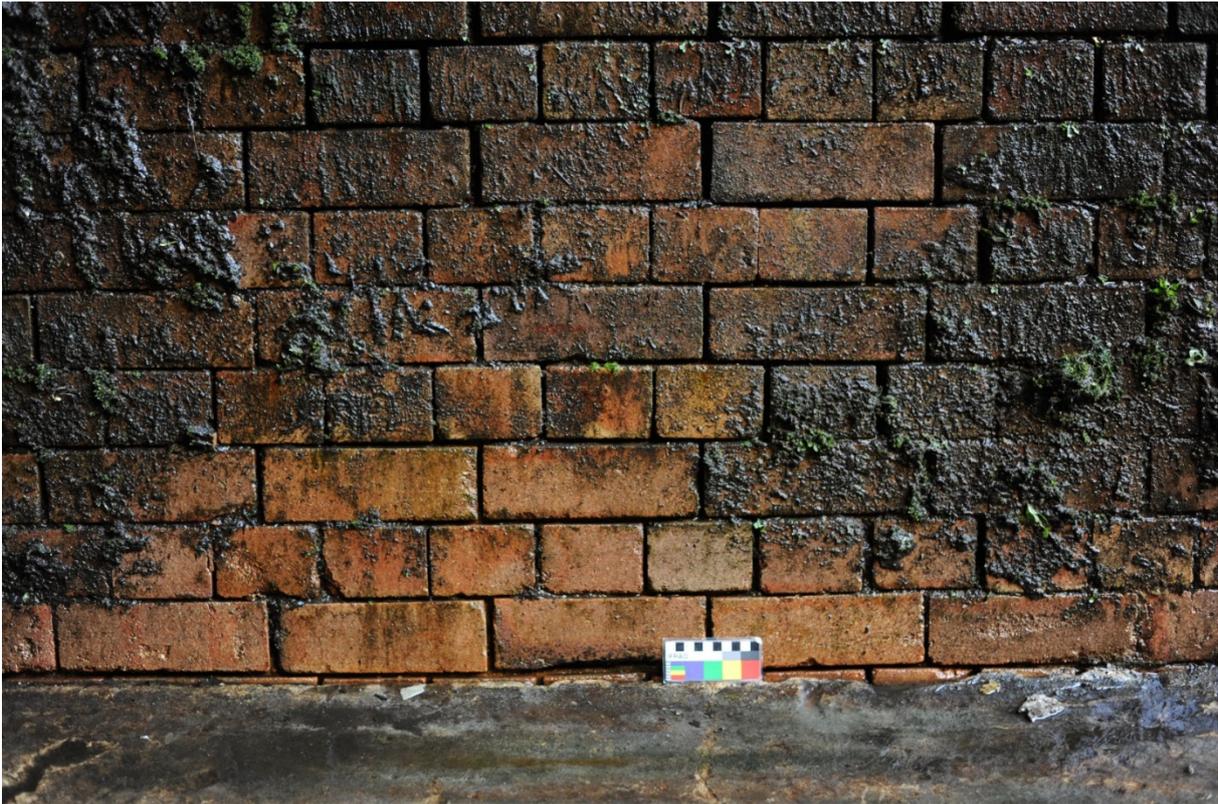
Figure 16: Example of English Cross bond from the city end portal of Tunnel 1, showing where water has removed some of the concrete bonding

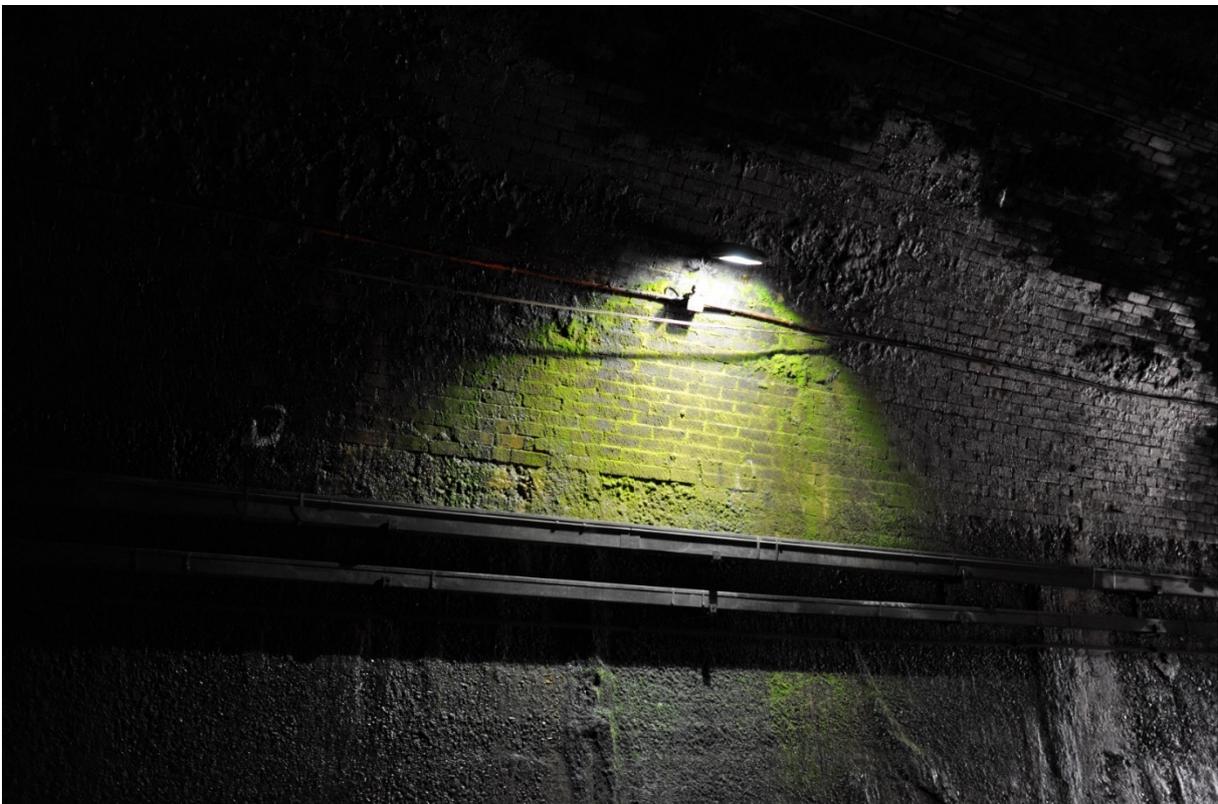
Figure 17: Example of stretcher bond within tunnel lining, this example from Tunnel 1

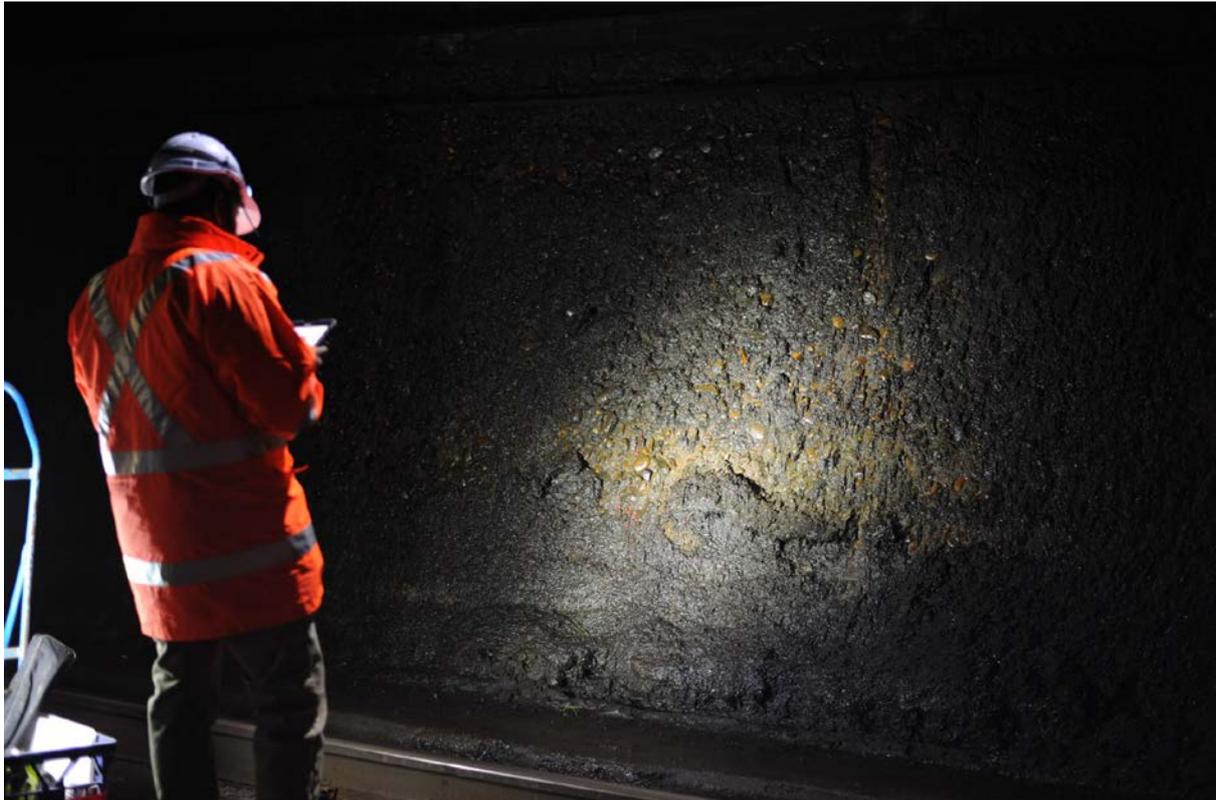
**Figure 18: Water damage to tunnel lining in Tunnel 10 emphasises the locally sourced water rolled gravels that form part of the aggregate**

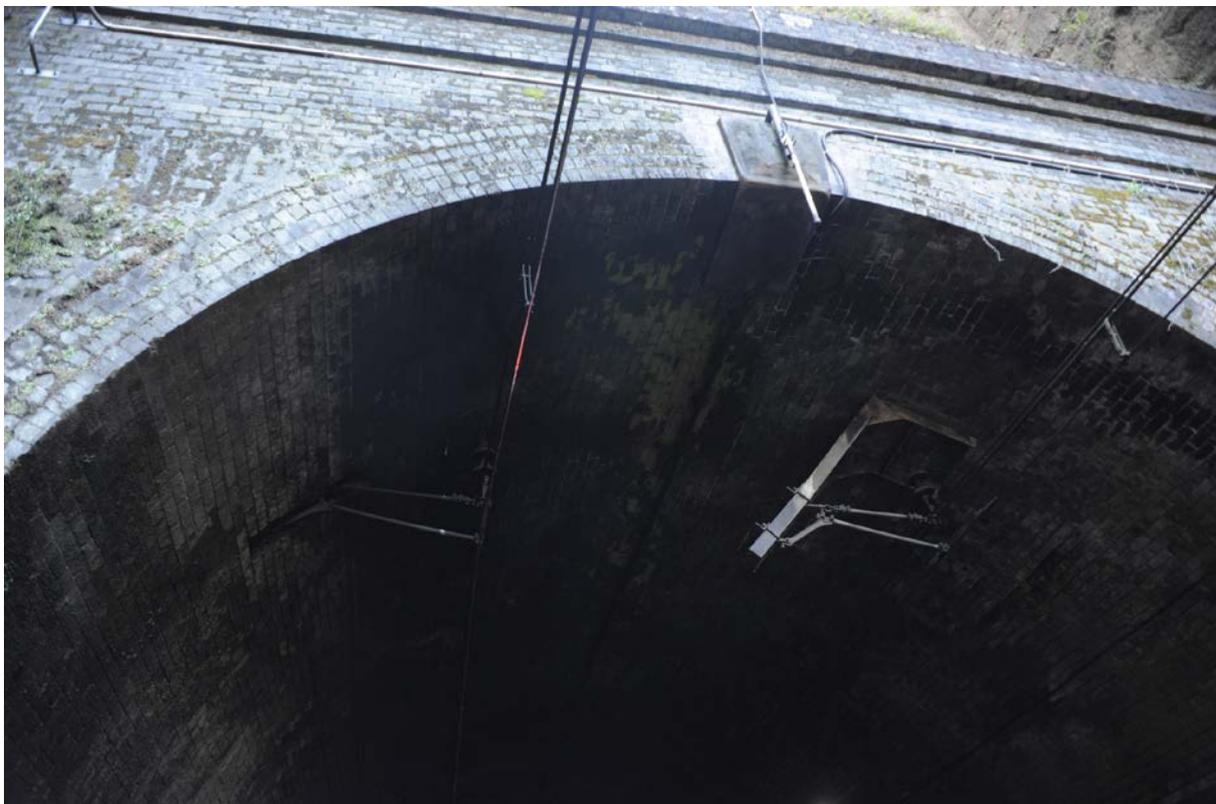
**Figure 19: Overhead wiring structures on the brick vault of Tunnel 1, Lithgow end portal**

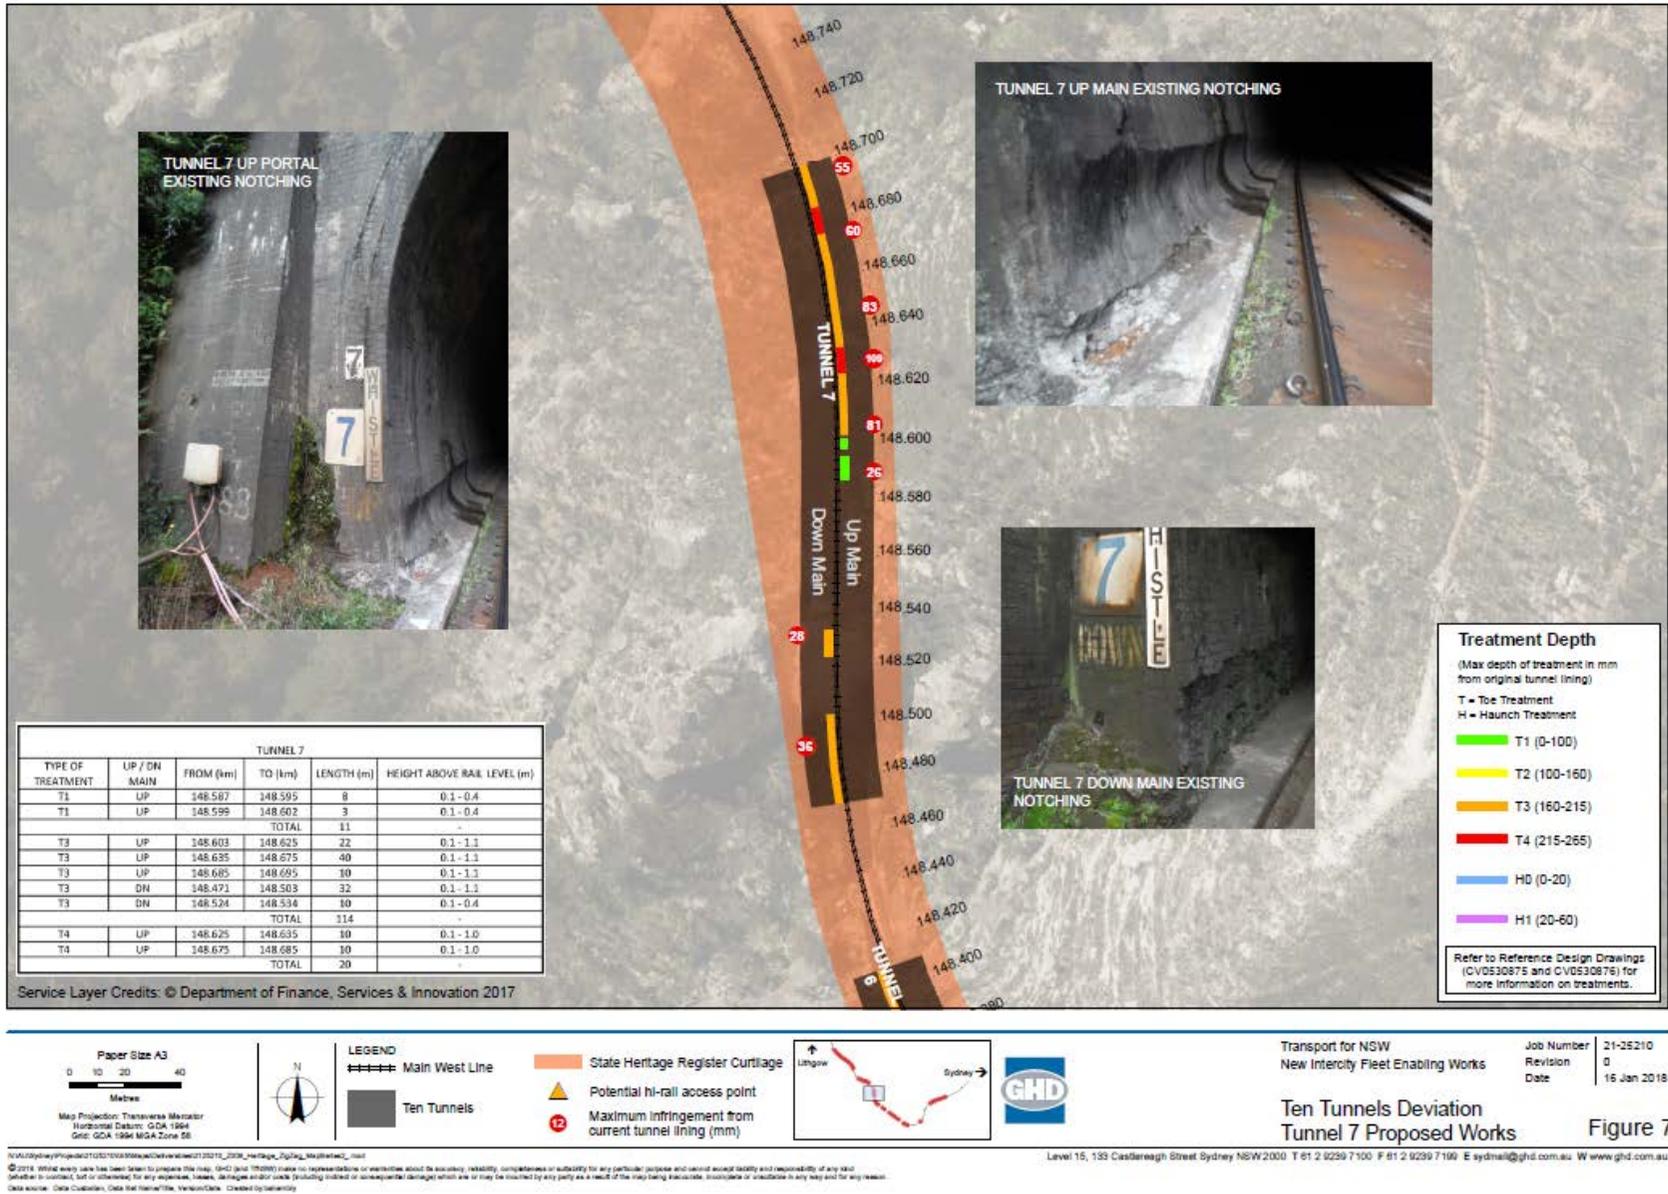
Figure 30: Proposed treatment overview for Tunnel 6 and Tunnel 7 (GHD Great Zig Zag Railway deviation tunnels Heritage Design Summary 2018)

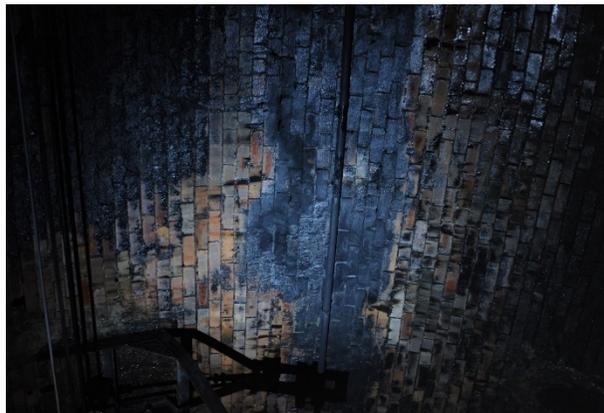
Figure 38: Detail of water seepage through brick vault

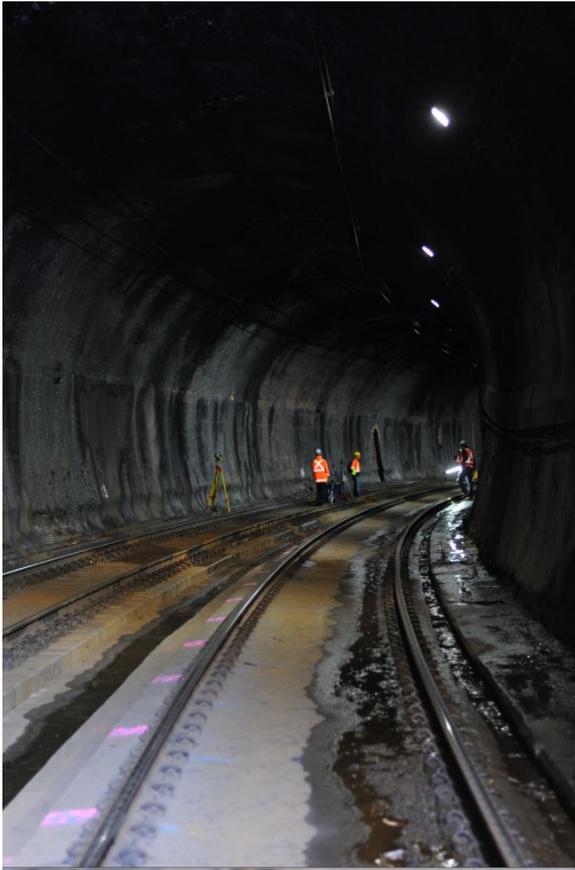
Figure 40: Tunnel 1, showing existing toe notching on the up track tunnel lining

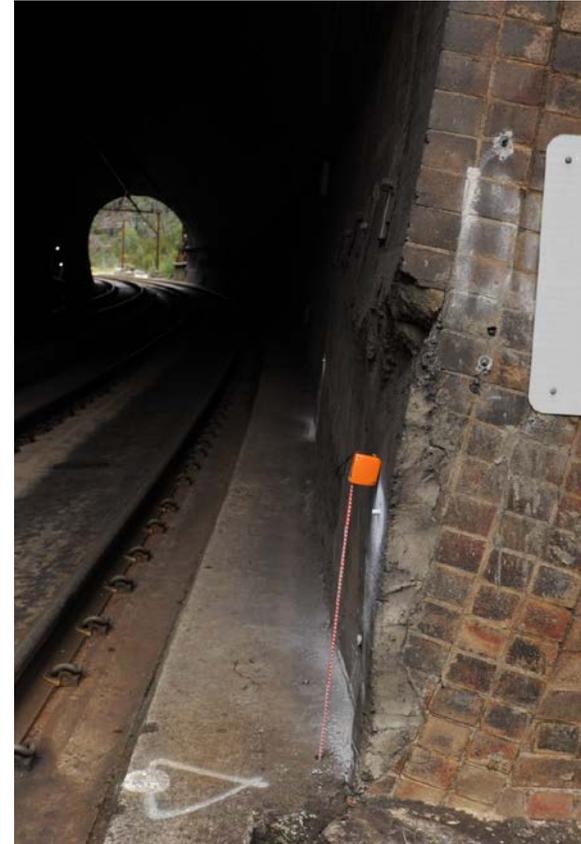
Figure 112: Lithgow end portal, down track, showing removal of up to three courses of brick during previous notching of tunnel lining

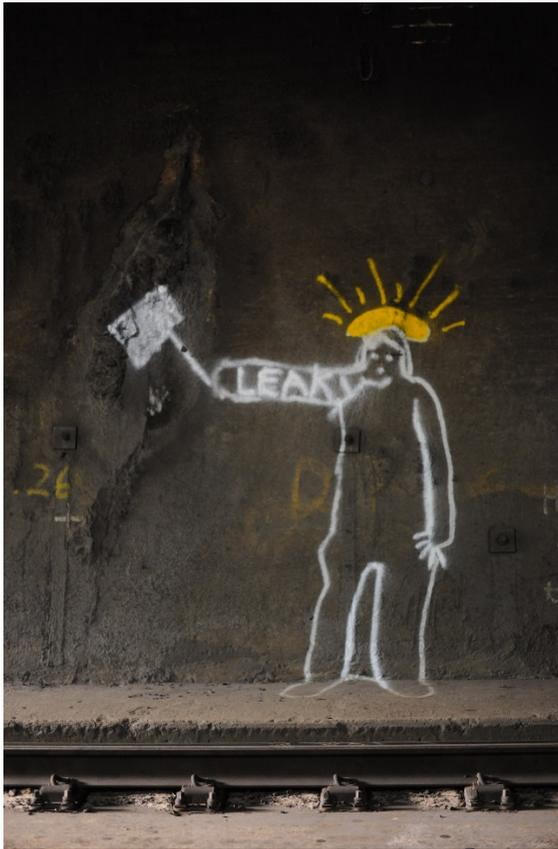
Figure 119: Detail shot showing graffiti and existing rock bolts within Tunnel 10

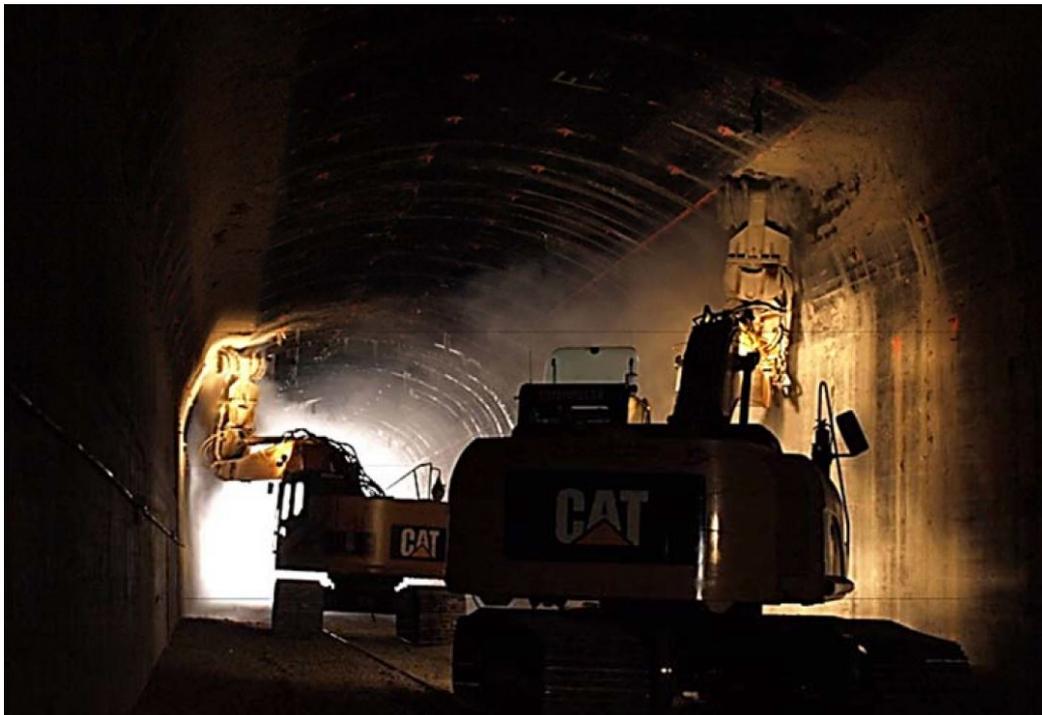
Figure 123: Example of excavator machinery with cutter head attachment

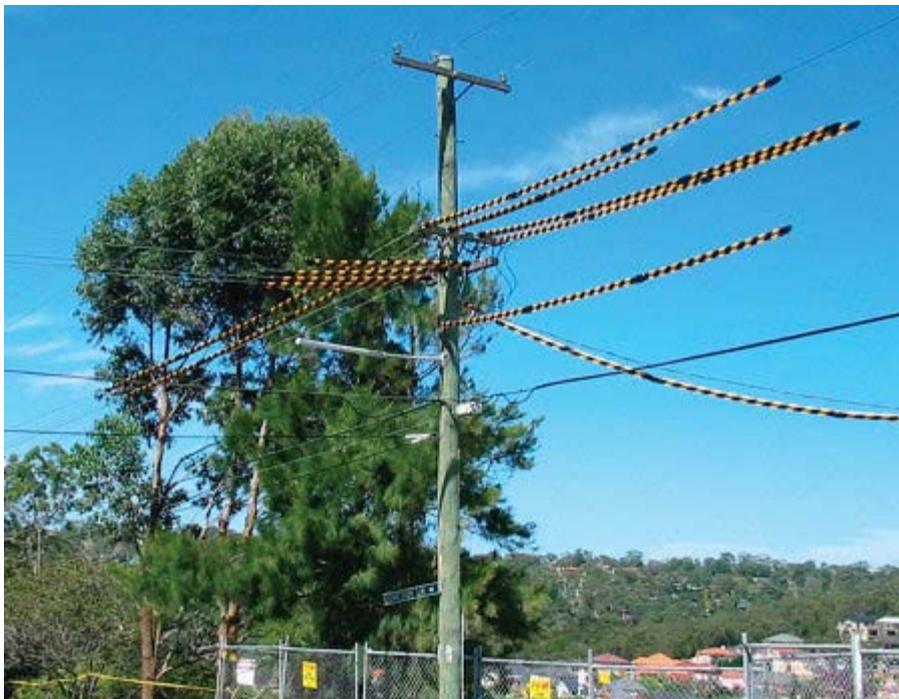
Figure 127: Example of Tiger Tail protection installed on a transmission line
