Petersham Station Upgrade

Arboricultural Impact Assessment Report

Petersham Station, PETERSHAM, NSW

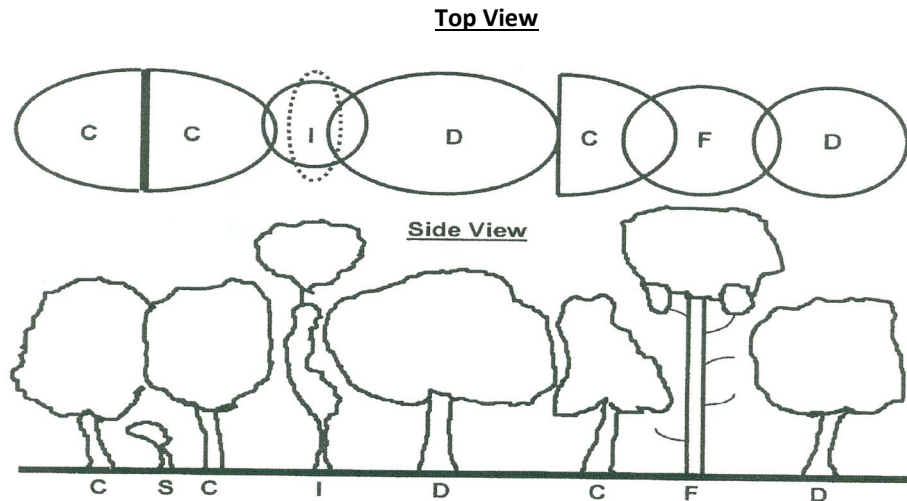
D – <i>Dominant</i>	Crown is receiving uninterrupted light from above and sides, also known as emergent.
C – <i>Codominant</i>	Crown is receiving light from above and one side of the crown.
I – <i>Intermediate</i>	Crown is receiving light from above but not the sides of the crown.
S – <i>Suppressed</i>	Crown has been shadowed by the surrounding elements and receives no light from above or sides.
F – <i>Forest</i>	Characterised by an erect, straight stem (usually excurrent) with little stem taper and virtually no branching over the majority of the stem except for the top of the tree which has a small concentrated branch structure making up the crown.

D C, I & S, and side view, after (Matheny, N. & Clark, J. R. 1998, Trees Development, Published by International Society of Arboriculture, P.O. Box 3129, Champaign IL 61826-3129 USA, p.20, adapted from the Hazard Tree Assessment Program, Recreation and Park Department, City of San Francisco, California).
