Transport Access Program

Wahroonga Station Upgrade

Supporting Studies

REPORT

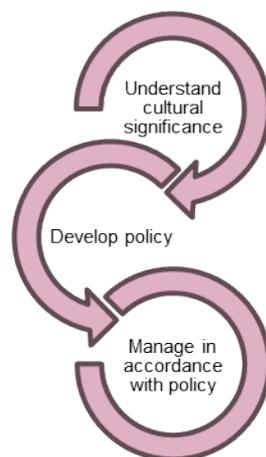
Graph 2.1: The Burra Charter Process (Australia ICOMOS Burra Charter)

The Burra Charter Process is a sequence of assessments, decisions and actions, related to the management of places of cultural significance. The Burra Charter Process is illustrated in Graph 2.1.

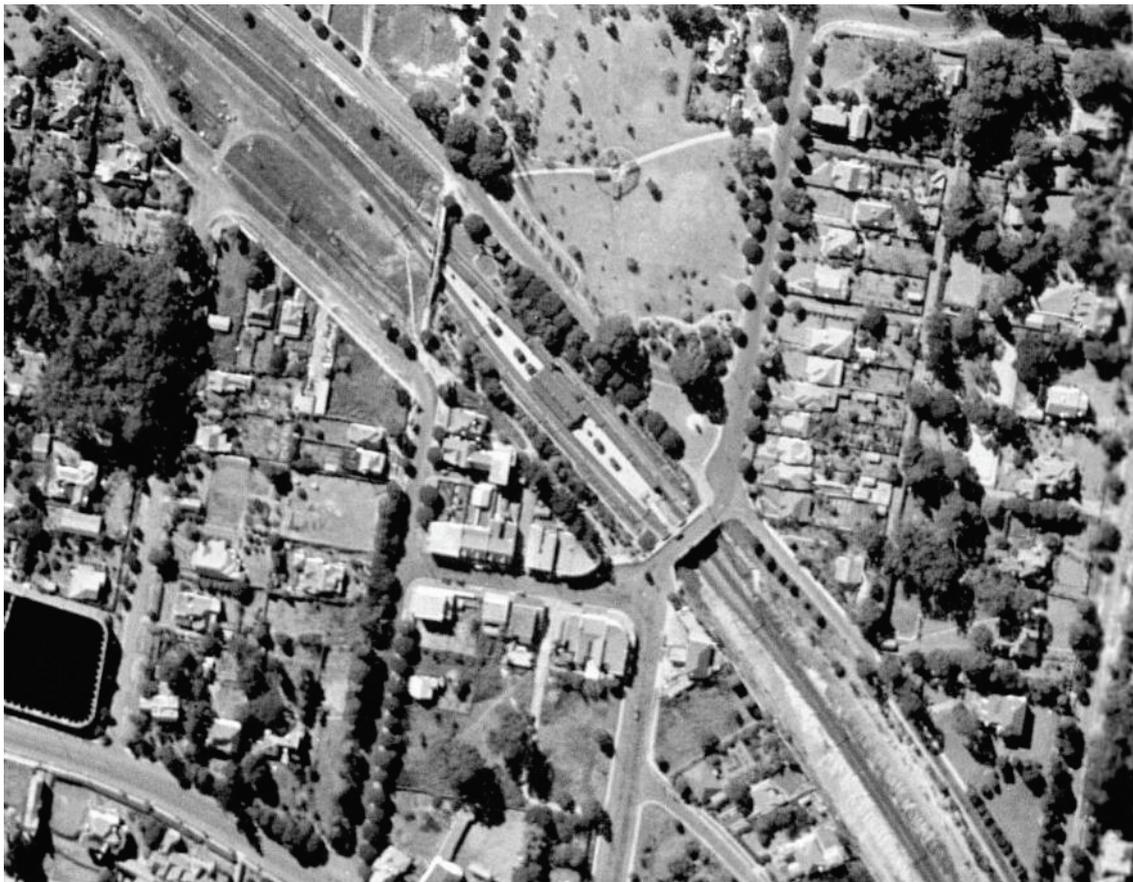
Plate 3.14: Wahroonga Station, 1943 (Source: Sixmaps)

Hill's fig trees were planted on the island platform in the 1920s or 1930s, replacing the earlier fan palm trees (OEH 2019a). Shrubs and trees have been planted in the centre line of the platform since the early days of the station (OEH 2019a). The goods yard was no longer extant by the mid-twentieth century (Scobie cited in OEH 2019a), however an aerial from 1943 shows the goods shed to the north west of platform (Plate 3.14).

The siding included a goods shed, which is shown on a 1943 aerial photograph (Plate 3.14). It is located beyond the SHR curtilage for Wahroonga Station and the proposed construction compound (Scouts Hall). Within the proposed construction compound, no additional infrastructure shown on the 1943 aerial photograph indicating that the potential for archaeological resources associated with the siding is limited to track and signalling and other infrastructure such as switches.

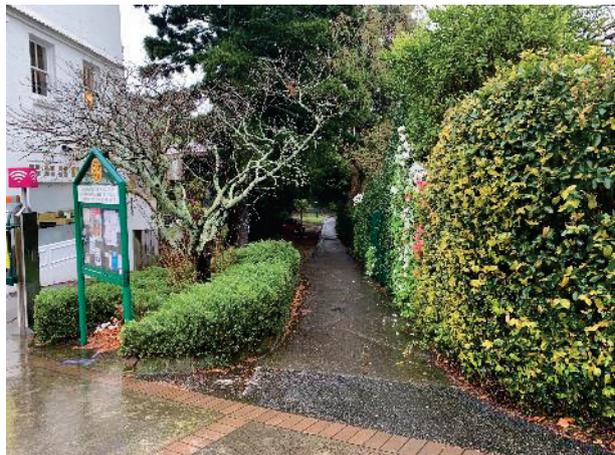
Plate 4.6 Garden bed proposed for removal at rear of Shopping Village (RPS 2019)

Between the Wahroonga shopping village on Railway Avenue and the Wahroonga Station landscaping, a footpath runs along the southern boundary of the station. The footpath along Railway Avenue rises as it approaches the station access point on the bridge. A garden bed is located along the rear of the shops, adjacent the footpath. Railway Avenue forms a major access route from the public car park to the south of Railway Avenue to the station (Plate 4.5, Plate 4.6).

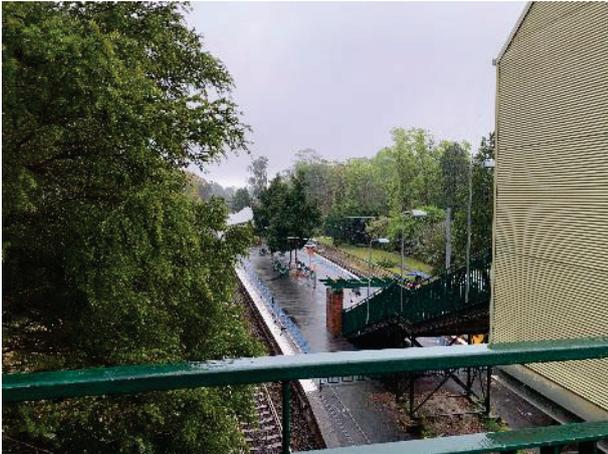
Plate 4.7 View towards platform from Redleaf Avenue bridge (RPS 2019)

Platform 1 (Up) and Platform 2 (Down) form a convex island platform with asphalt surface and original brick facing (Plate 4.7). Landscaping including bushes and ash trees are located along the platform. Evidence of resurfacing and subsurface utilities can be seen in various locations on the platform. Safety fencing is located on the northern and southern extents of the platform, Wahroonga Station signage and Opal Card readers are located along the platform. The southern end of the platform consists of a concrete slope, edged with brick, down towards the stair trestle and Redleaf Avenue bridge. The platforms face onto the landscaped garden bed surroundings (Plate 4.8, Plate 4.9, Plate 4.10).

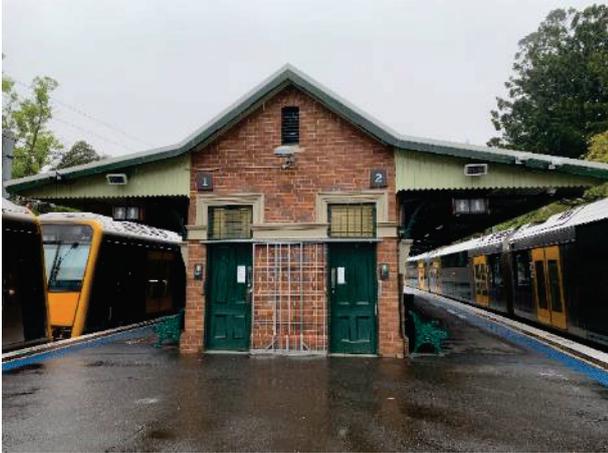
Plate 4.11 Station building – northern elevation (RPS 2019)

Constructed in 1906, the platform building is a good example of a Type 11 (Standard A8-10) and is located on the island platform formed by Platform 1 and Platform 2 (Plate 4.11, Plate 4.12). The Type 11 is typical of the early twentieth century station design for the Northern Line.

Later alterations to the exterior of the building include wayfinding signage such as platform numbers, indicator boards, lighting, public announcement speakers and safety features such as CCTV. The entrance to the northern end of the station building has also been altered from a single door to two doors with windows above. Safety features also include a sliding grill to cover the toilet doors. At the southern end of the platform a ticketing window has been installed with a ticket machine is located next to the window.

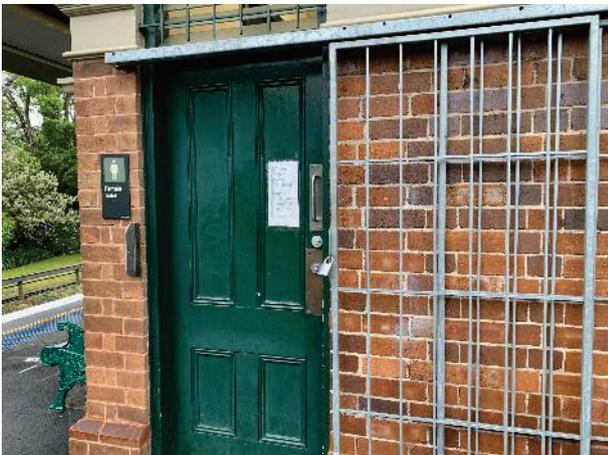
Plate 4.13 Exterior of female toilet (RPS 2019)

Inspection of the interior of the platform building was limited to the publicly accessible toilets on the northern extent of the building (Plate 4.13). The toilets include separate male and female toilets which have been updated with modern amenities. A sliding, metal security door has been attached to the northern exterior of the station building. The windows and shutters appear to be original to the building (Plate 4.14).

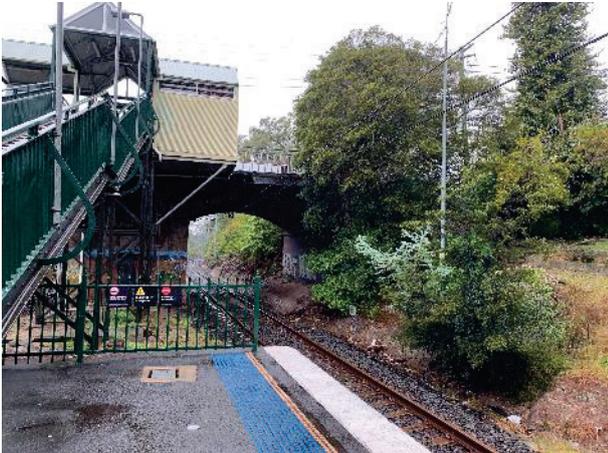
Plate 4.15 Redleaf Avenue bridge (RPS 2019)

The balustrade has been altered with the added top rail and full sections of balustrade over both tracks have been replaced.

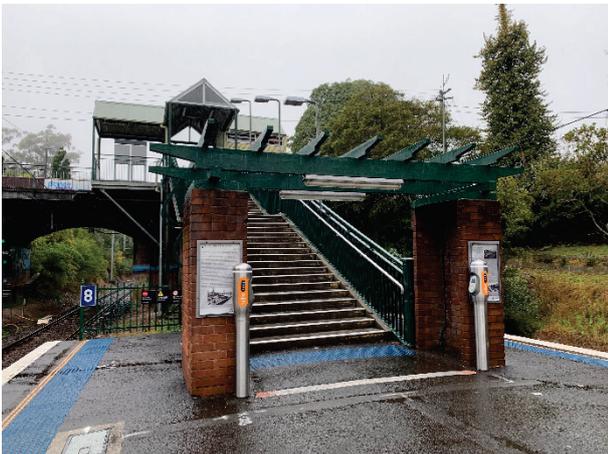
Access to the station platform is by a set of stairs descending from the footbridge adjoining the Redleaf Avenue bridge (Plate 4.17). The stairs are steel framed and are in original condition, with knob pattern type newel posts and treads of precast concrete. A rivetted steel trestle structure supports the stairs. The trestles are in a fenced area and are not accessible to the public (Plate 4.18). The trestles are largely intact. The staircase blocks the view of the trestles. At the base of the stairs there are two small ticket collecting booths. These booths are of red brick construction, with a concrete slab roof and are adjoined by an overhead wooden frame. Interpretation relating to Wahroonga Station signage is attached to the booths.

Plate 4.17 Steel stairs and ticket boots (RPS 2019) Plate 4.18 Trestle beneath stairs (RPS 2019)

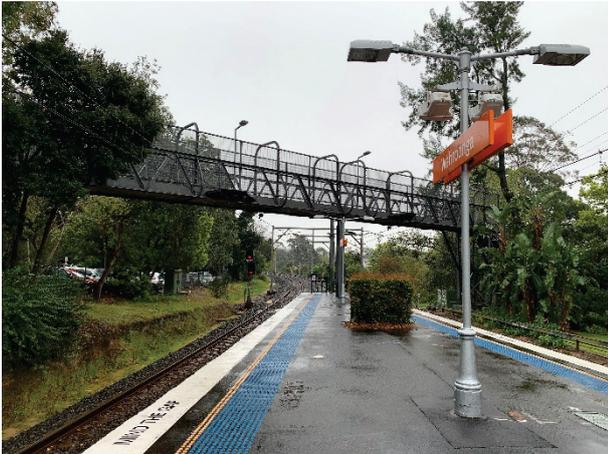
Plate 4.19 Warren truss footbridge (RPS 2019)

A footbridge across the northern end of the platform links Warwilla Avenue and Coonanbarra Road, however it does not provide access to the platform. The footbridge is a steel framed, Warren truss structure with concrete deck and stair treads. Steel framed stairs with star type newel posts lead to the deck. A c.2003 safety fence with arching steel supports has been added to the deck. The footbridge has also had typical freestanding light poles installed.

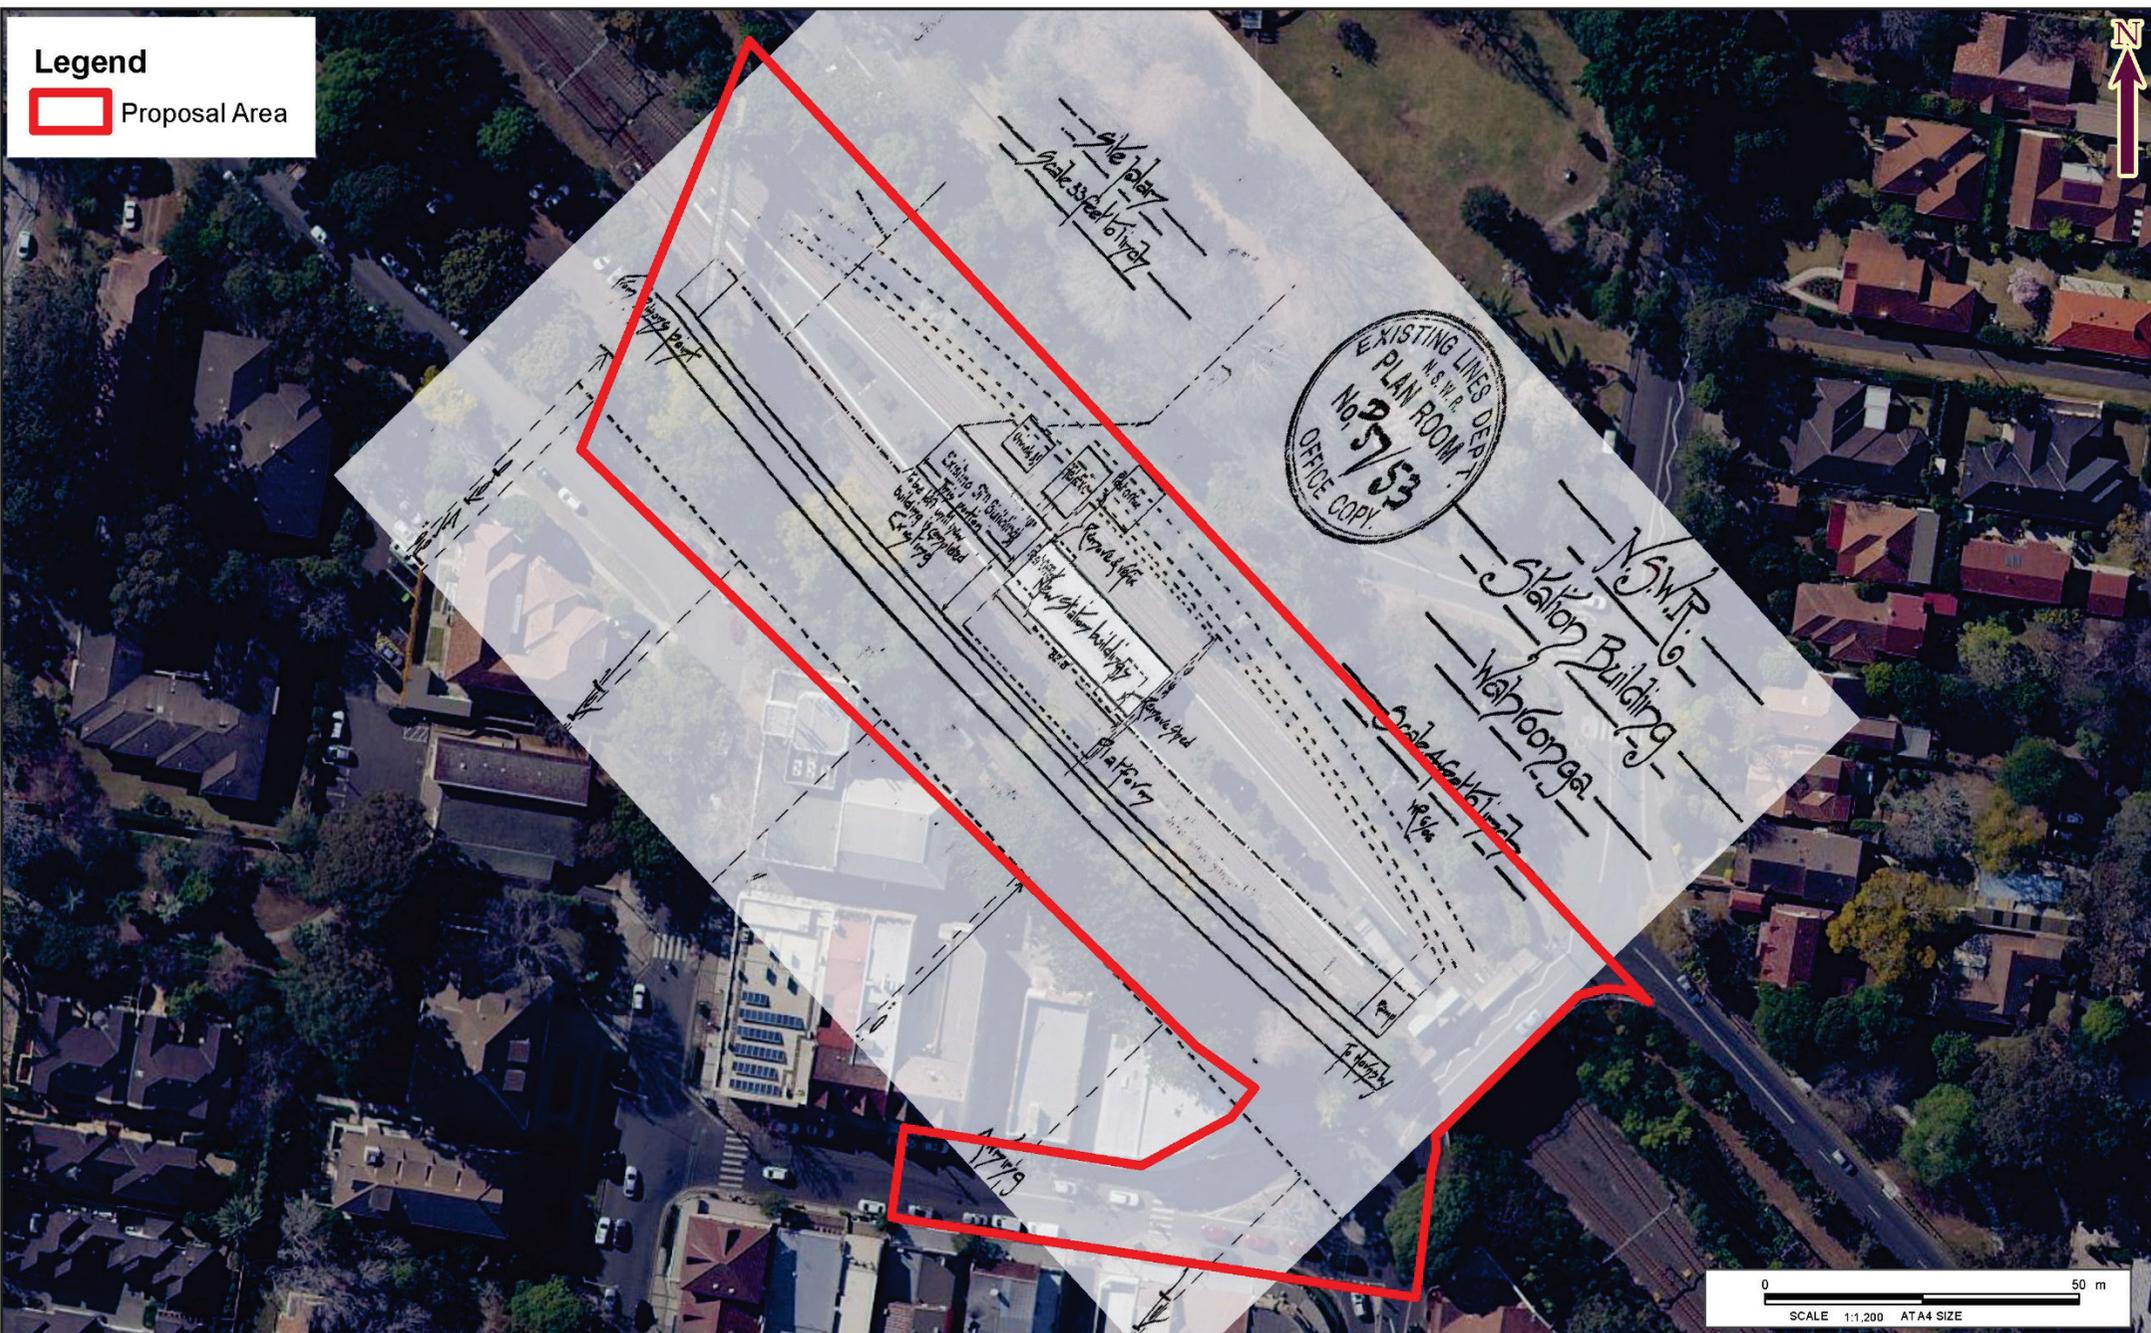
Figure 5.1: 1906 Wahroonga Station plan

The 1906 station building plan shows multiple buildings located to the rear of the original station building, including urinals, telephone exchange and post office. The overlay of the 1906 station building plan is based on the location of the existing building; however, it indicates that the buildings would not be located within an area of proposed impact (Figure 5.1). It is therefore unlikely that archaeological resources associated with the buildings would be identified through the Proposal. Further, the potential for archaeological resources associated with the buildings shown on the 1906 station building plan is low due to the level of ground disturbance associated with the duplication of the line in 1909 and the construction of the island platform at Wahroonga Station.

Due to the impact associated with the cutting for the station, the construction of the station including the 1890 station building, 1906 station building, and other elements such as the Redleaf Avenue bridge, and with consideration of the low level of alterations and high degree of intactness of the 1906 layout of Wahroonga Station, the archaeological potential within the proposed areas of impact within the SHR curtilage is assessed as **low**.

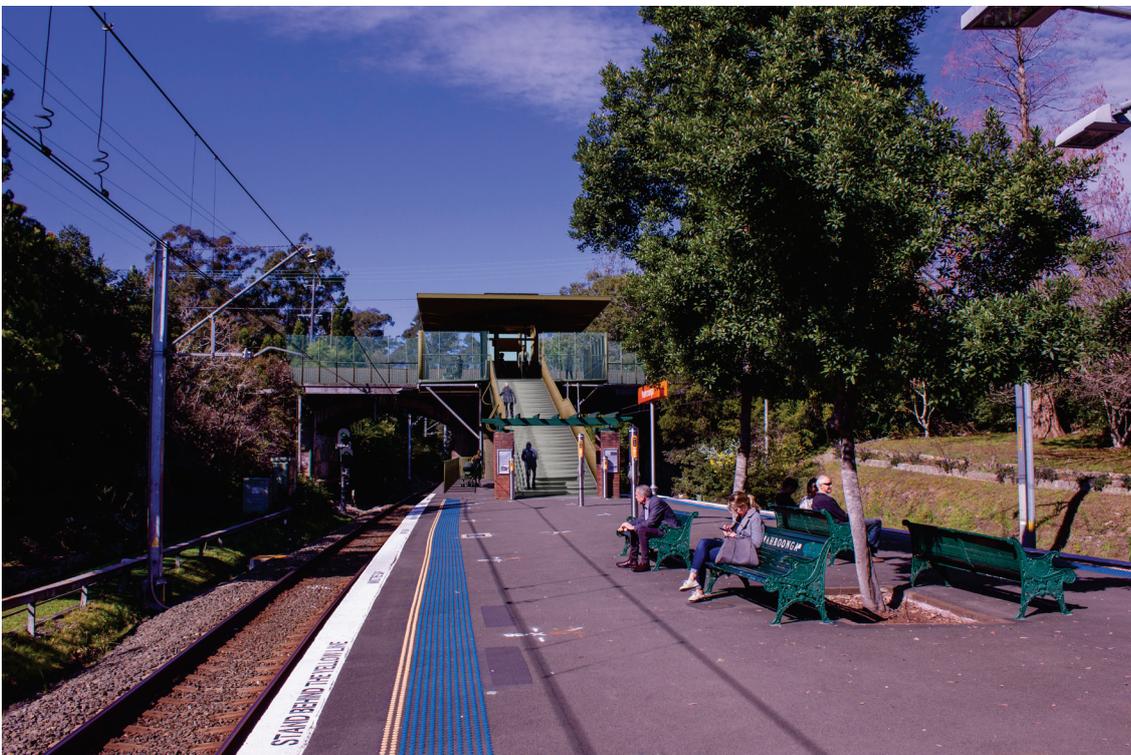
Figure 7.3: View 1 - platform

Indicative renders of the Proposal are shown in Figure 7.3 to Figure 7.5.

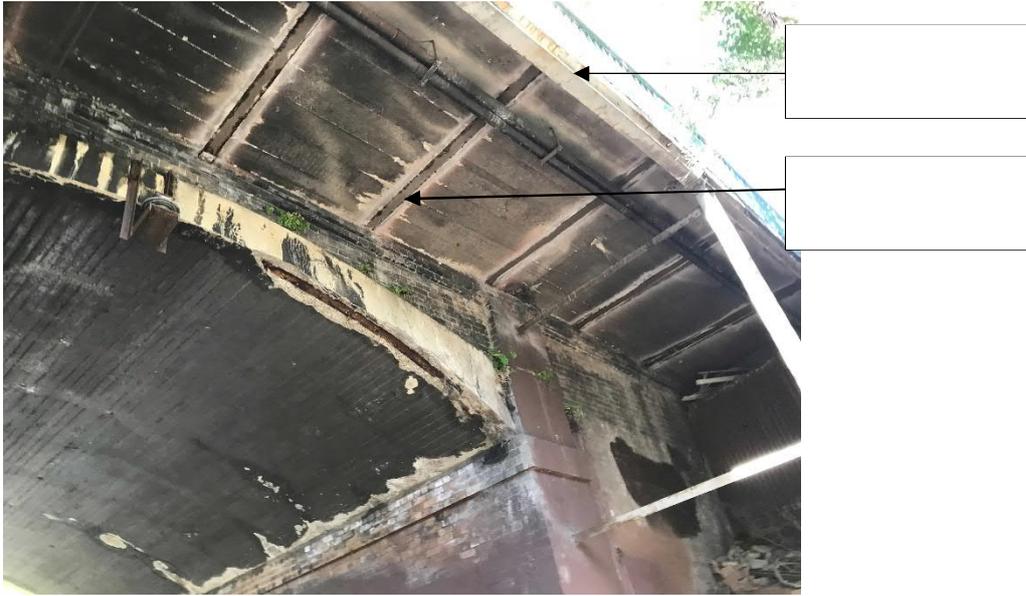
Footbridge and Road Over-Bridge (TfNSW Photo)

Note the edge beam and the cross beams.

- Reduction in capacity of the edge beam due to corrosion section loss
- Corrosion jacking to the footbridge slab edge

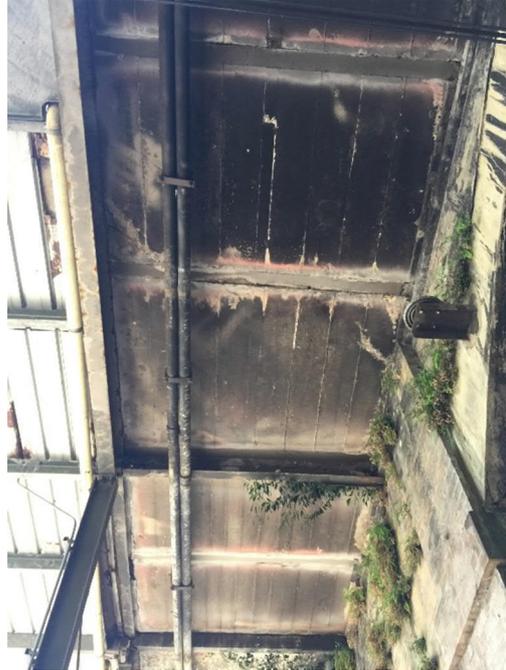
Footbridge from below (TfNSW Photo)

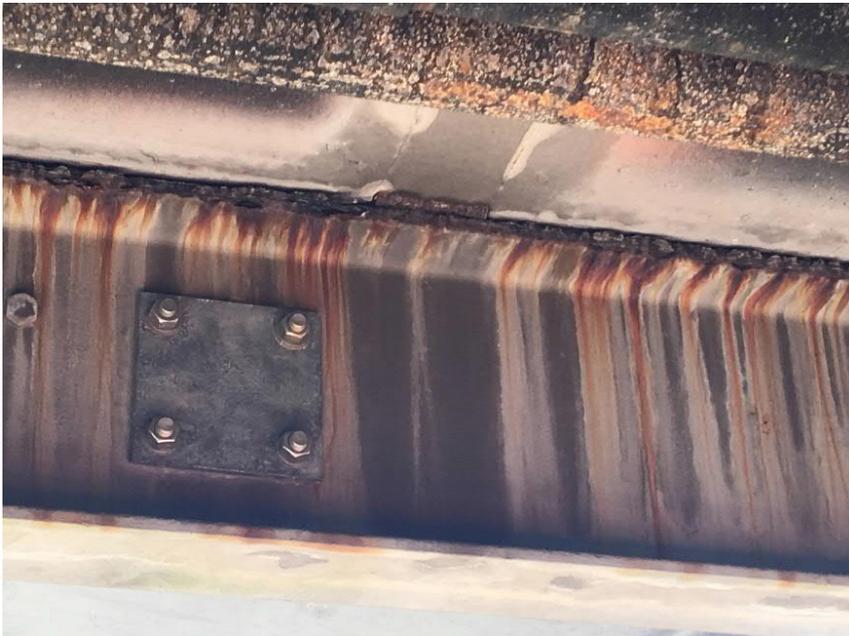
Inner Face of Edge Beam (GHD Photo)

Note top flange corrosion.

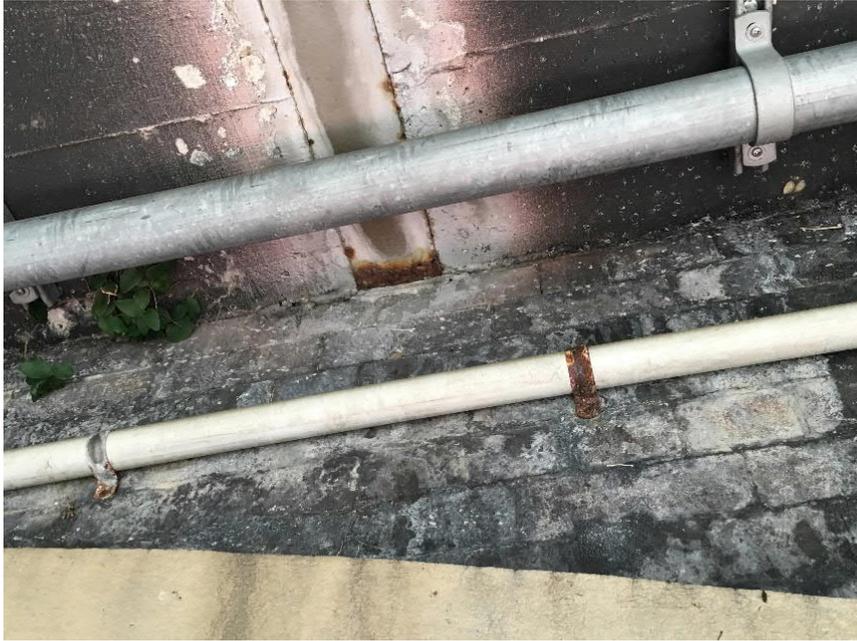
Cross Beam at Face of Road Over-Bridge (GHD Photo)

Note cross beam corrosion, particularly at embedded end.

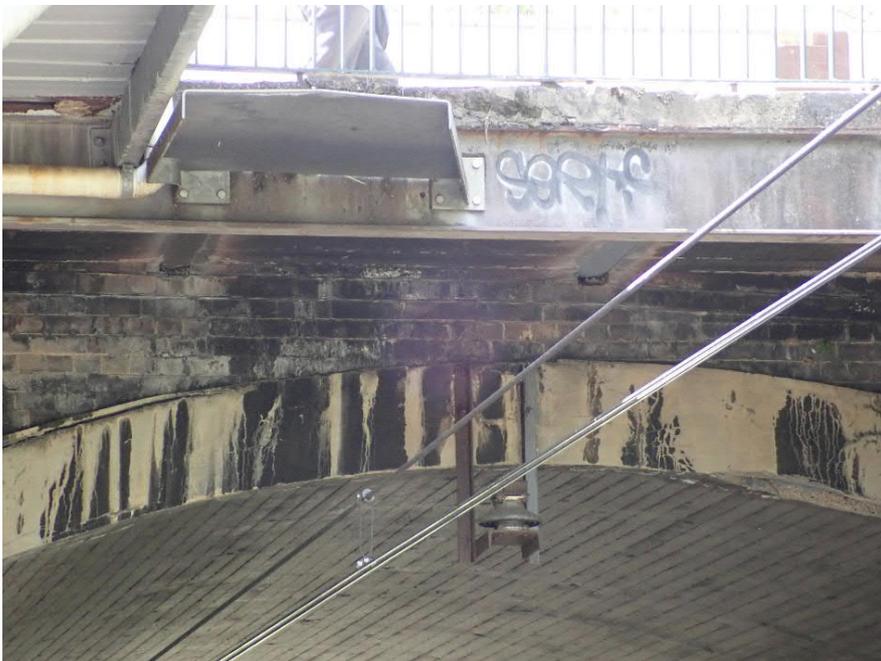
Footpath and Road Over-Bridge (MM Photo)

Note damage to deck edge and corrosion at cross beam embedments

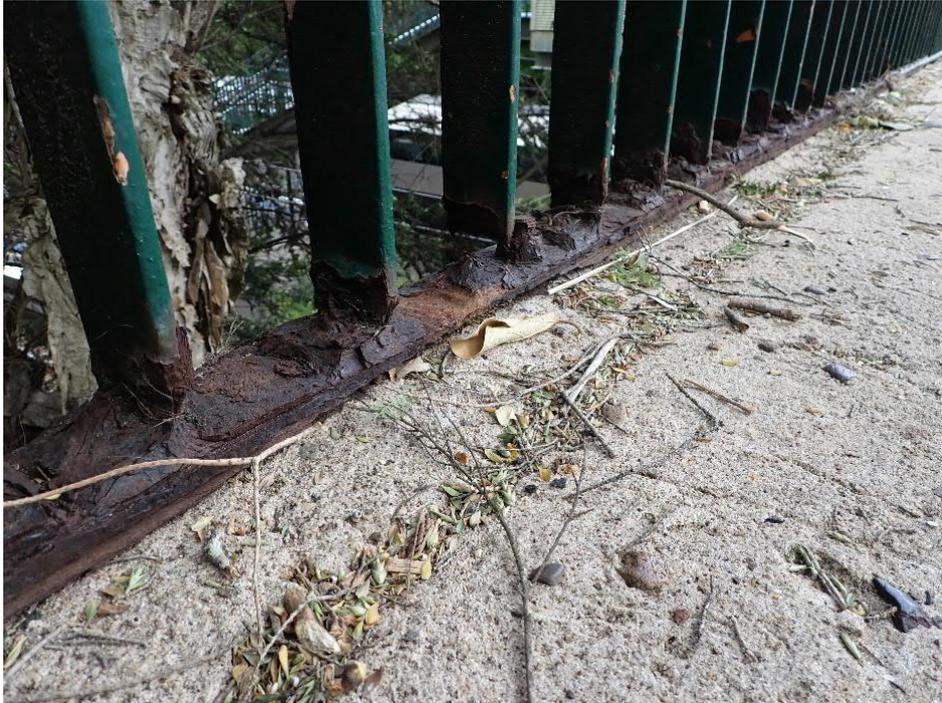
Balustrade Base (MM Photo)

Note proximity of bottom rail to deck and corrosion to bottom rail

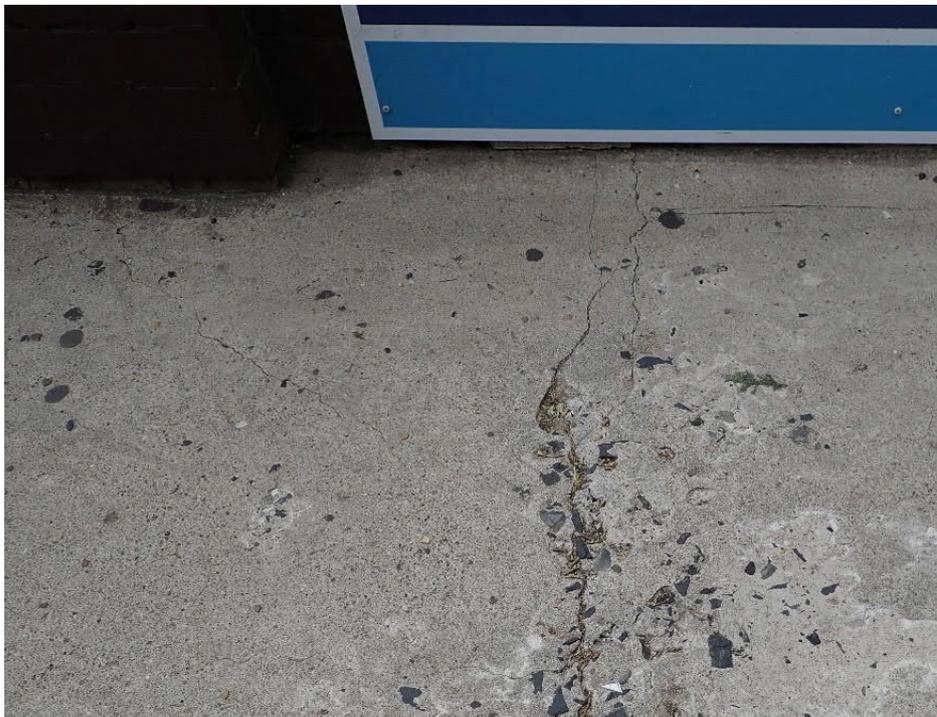
Deck Crack Over Cross Beam (MM Photo)
