Inside the rail corridor

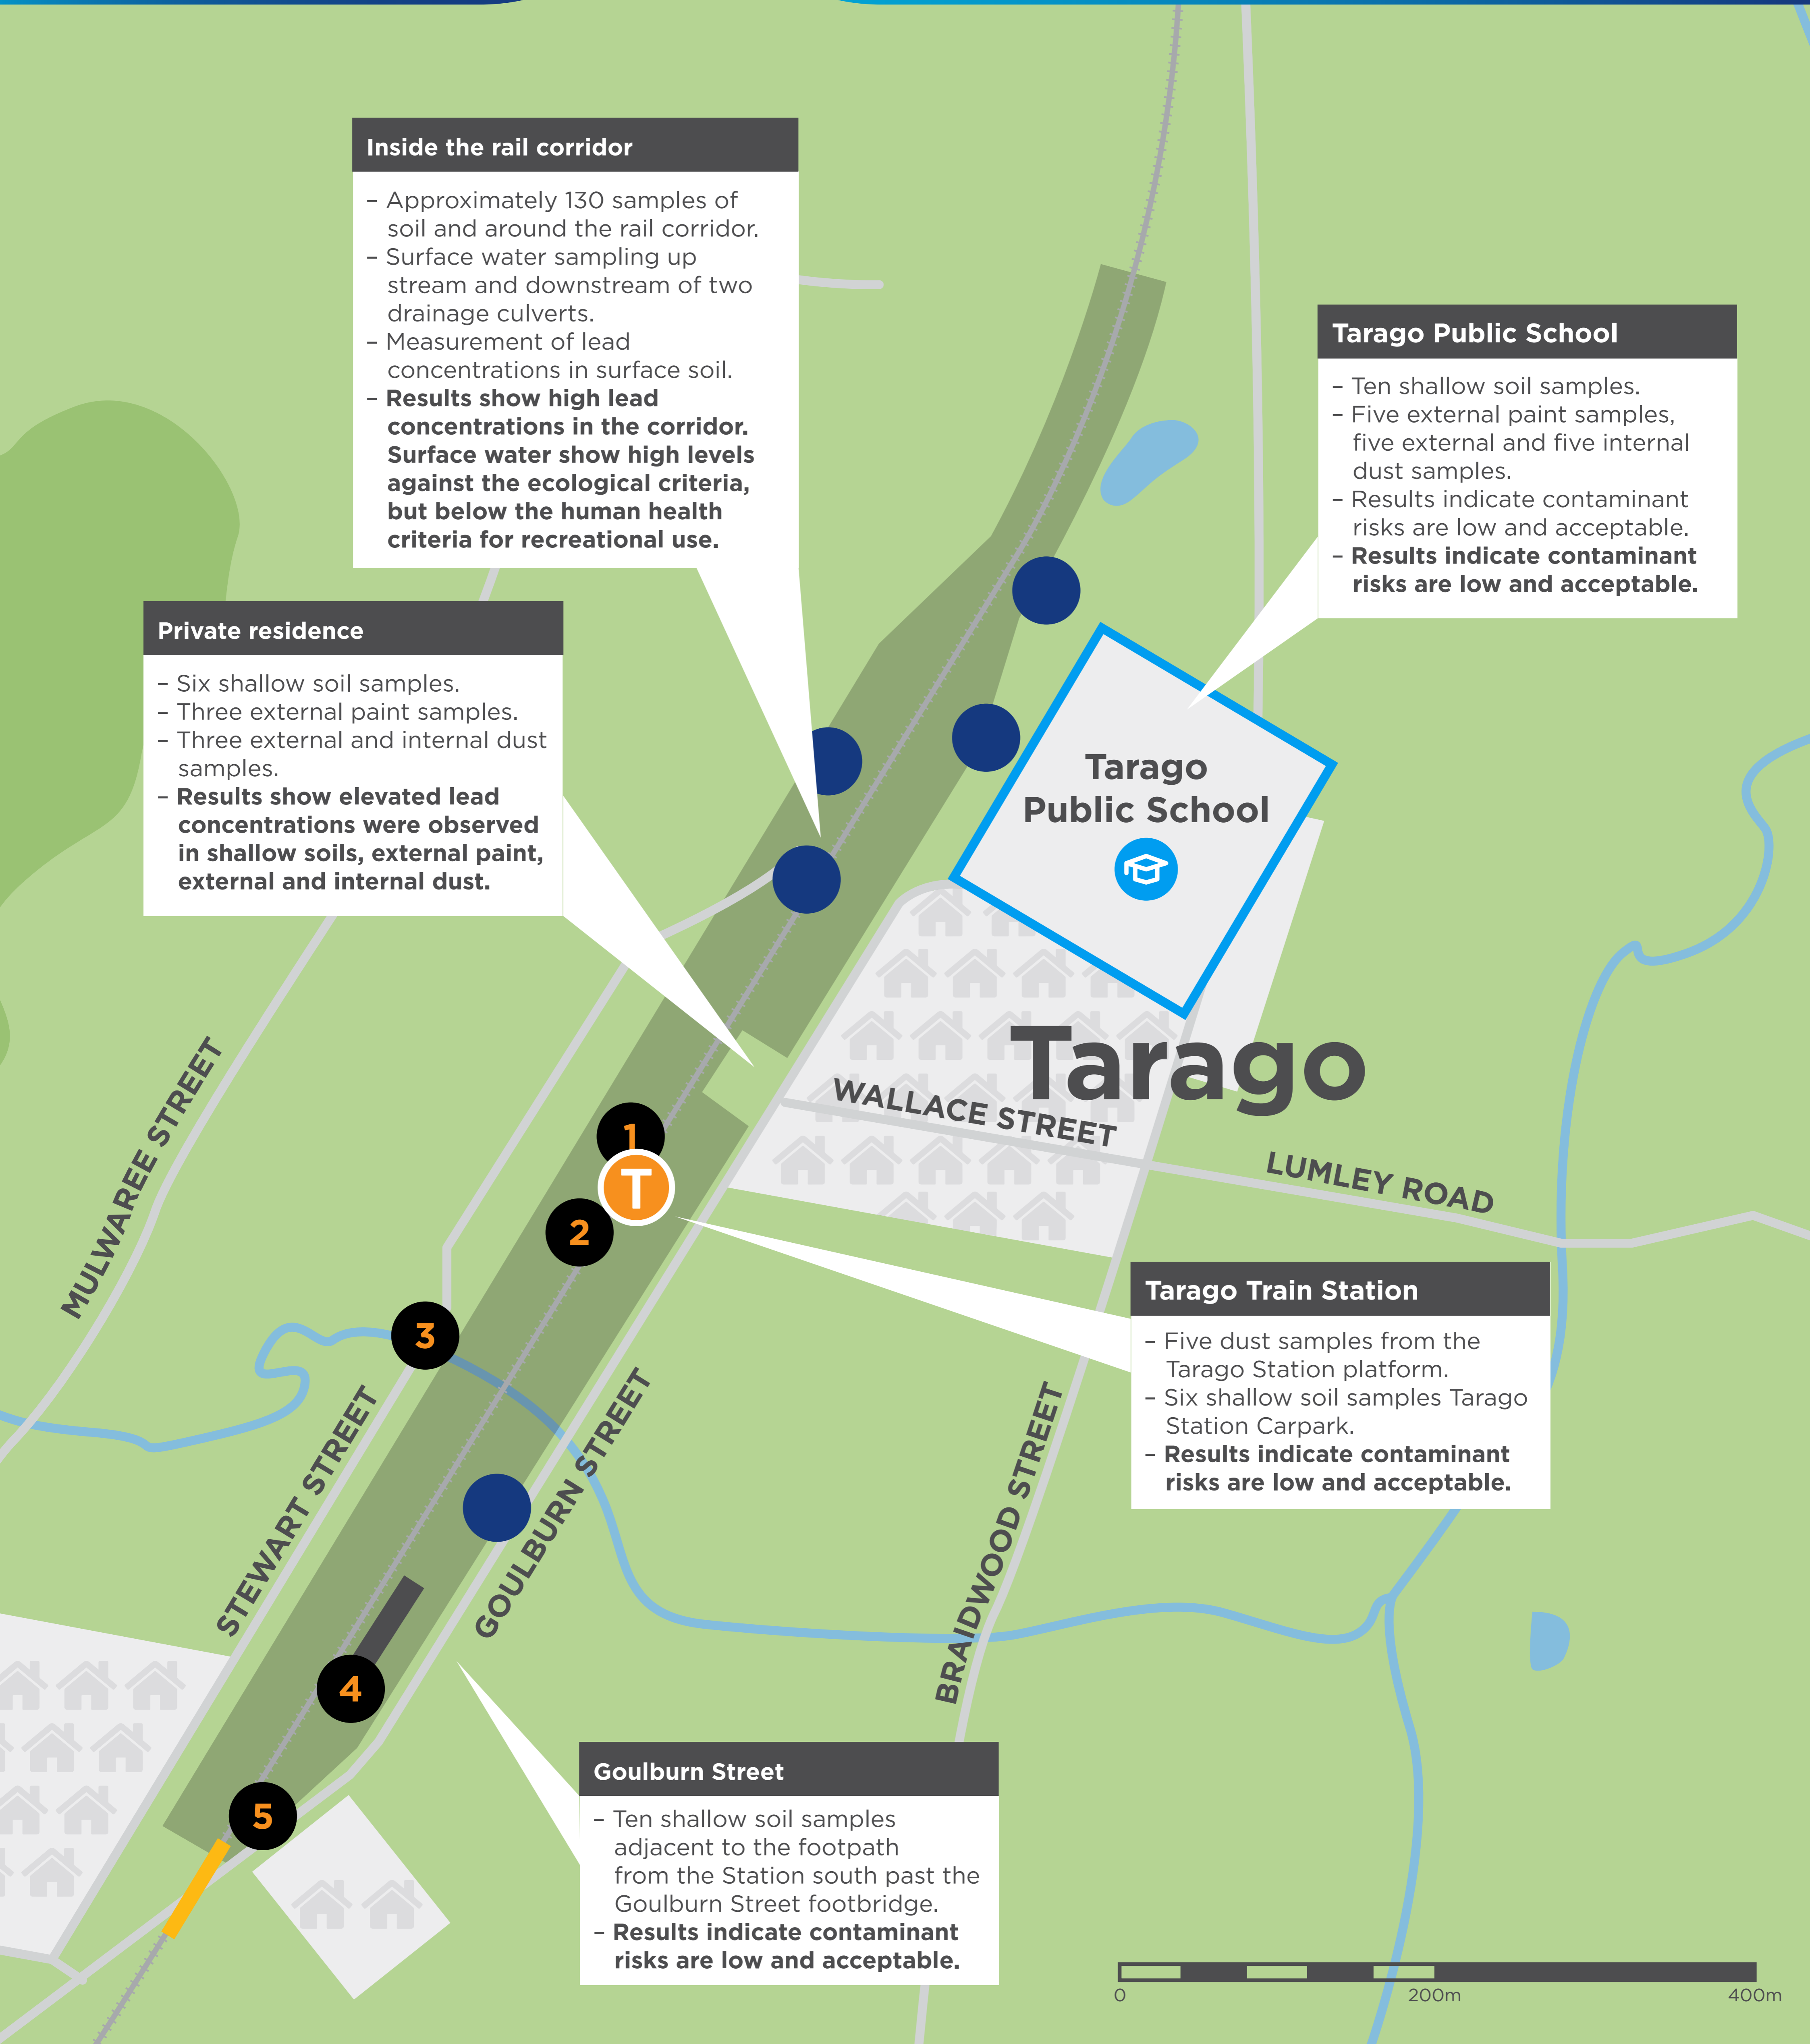
- Approximately 130 samples of soil and around the rail corridor.
- Surface water sampling up stream and downstream of two drainage culverts.
- Measurement of lead concentrations in surface soil.
- **Results show high lead concentrations in the corridor. Surface water show high levels against the ecological criteria, but below the human health criteria for recreational use.**

- Ten shallow soil samples.
- Five external paint samples, five external and five internal dust samples.
- Results indicate contaminant risks are low and acceptable.
- **Results indicate contaminant risks are low and acceptable.**

- Six shallow soil samples.
- Three external paint samples.
- Three external and internal dust samples.
- **Results show elevated lead concentrations were observed in shallow soils, external paint, external and internal dust.**

- Five dust samples from the Tarago Station platform.
- Six shallow soil samples Tarago Station Carpark.
- **Results indicate contaminant risks are low and acceptable.**

- Ten shallow soil samples adjacent to the footpath from the Station south past the Goulburn Street footbridge.
- **Results indicate contaminant risks are low and acceptable.**
