ARBORICULTURAL IMPACT ASSESSMENT REPORT

TRANSPORT ACCESS PROGRAM (TAP) 3

WOLLSTONECRAFT (RAILWAY) STATION

SHIRLEY ROAD, WOLLSTONECRAFT

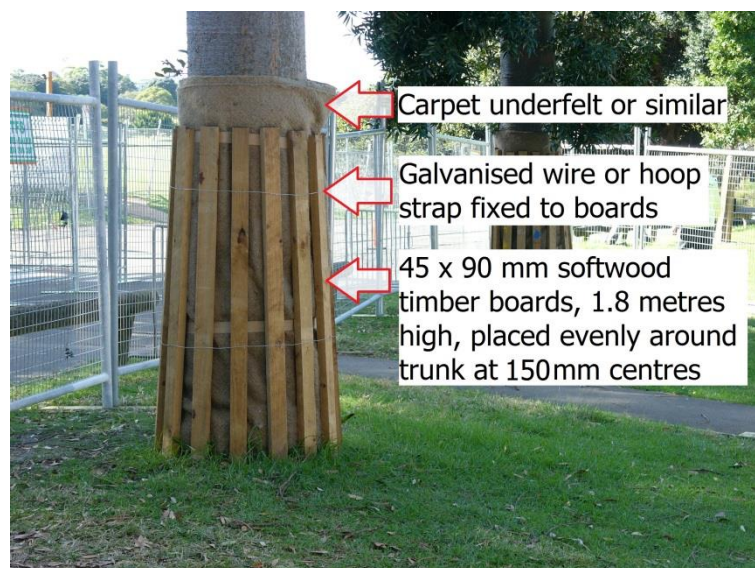
Figure 3 – Detail of Trunk Protection

- 10.6.1 Trunk protection boarding shall be erected around Trees [T6] to avoid accidental damage, as indicated on the Tree Protection Plan (**Appendix 6**). The trunk protection shall consist of a layer of carpet underfelt (or similar) wrapped around the trunk, followed by 1.8 metre lengths of softwood timbers (90 x 45mm in section) aligned vertically and spaced evenly around the trunk at 150mm centres (i.e. with a 50mm gap) and secured together with 2mm galvanised wire or galvanised hoop strap as shown in **Figure 3**. Recycled timber (such as demolition waste) may be suitable for this purpose, subject to the approval of the Project Arborist. The timbers shall be wrapped around the trunk (over the carpet underfelt), but not fixed to the tree to avoid mechanical injury or damage to the trunk. Trunk protection should be installed prior to any site works and maintained in good condition for the duration of the construction period. Carpet underfelt (alone) is sufficient for trees with a trunk diameter of less than 200mm. This shall be wrapped around the trunk in a double layer and held in place with heavy-duty fibre reinforced adhesive tape (e.g. Gaffer Tape).

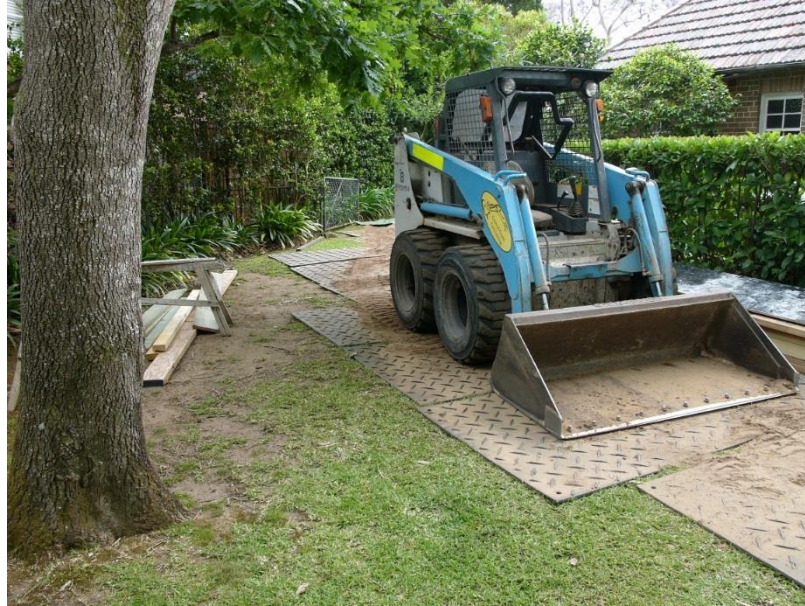
Figure 4 – Showing typical detail for truck mats.

- 10.7.1 A 100mm layer of woodchip mulch shall be installed within fenced areas of the TPZs of trees [T3 & T4] to minimise moisture stress during construction.
- 10.7.2 Construction haul routes shall be confined to existing paved areas wherever possible. Where this is not feasible and construction haul routes or access for plant and equipment must traverse soft landscape areas within TPZs of [**any tree nominated for retention**], 20mm thick marine ply

sheets or truck mats (such as Envirex Versadeck® access mats) (refer **Figure 4** shall be placed over the top of the ground surface to minimise compaction and disturbance of the underlying soil profile and root zone.

- 10.7.3 Ground protection shall be installed prior to any site works and maintained in good condition for the duration of the construction period. On completion of the works, ground protection shall be removed without damage or disturbance to the underlying soil profile.
