TAP 3.0 Ourimbah Railway Station

Statement of Heritage Impact

Report to SNC-Lavalin

May 2020

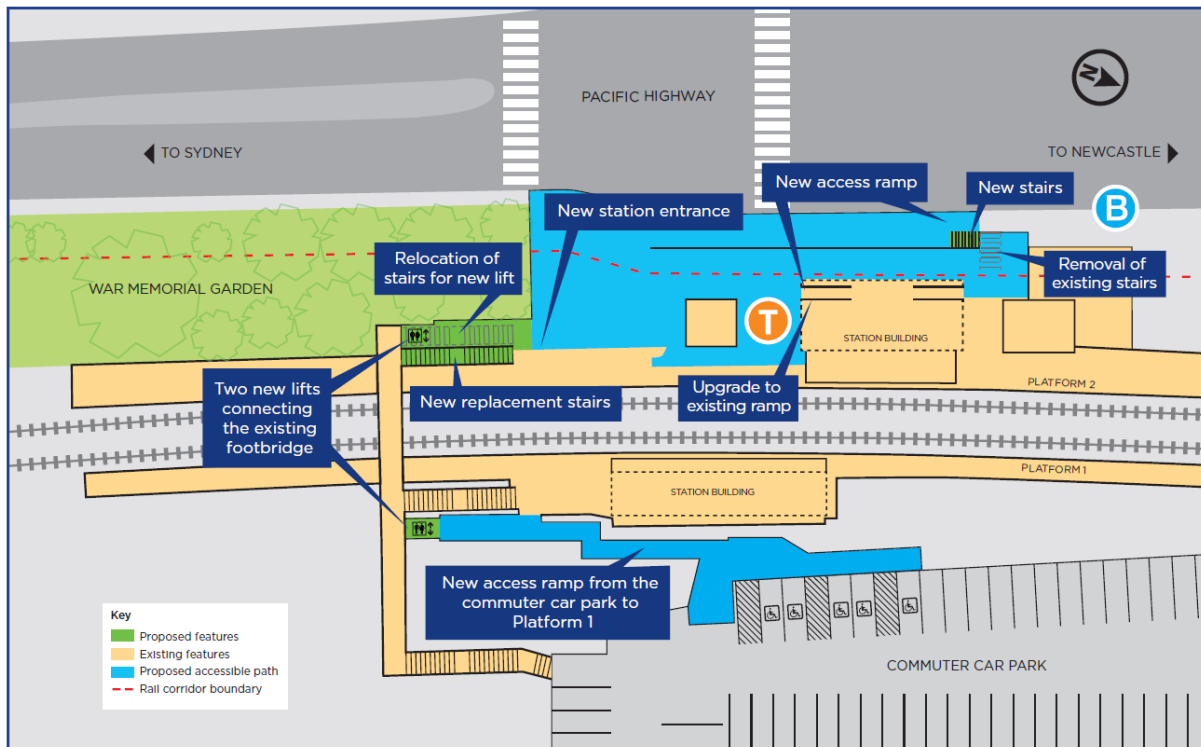
Figure 1-2: Image of the general layout of key elements of the Proposal based on the strategic concept design

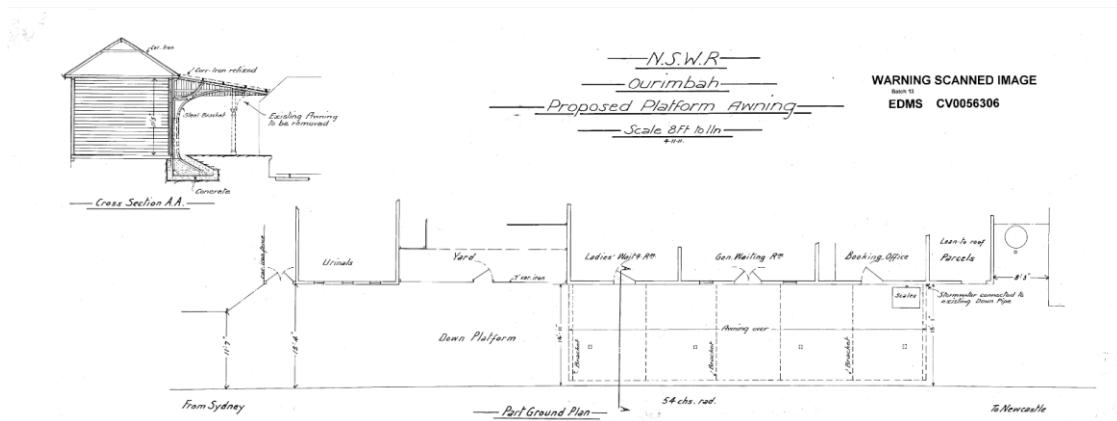
Figure 3-11: Image of the original plan of the proposed awning to the station building on Platform 2, c1911. Source: Sydney Trains Plan Room

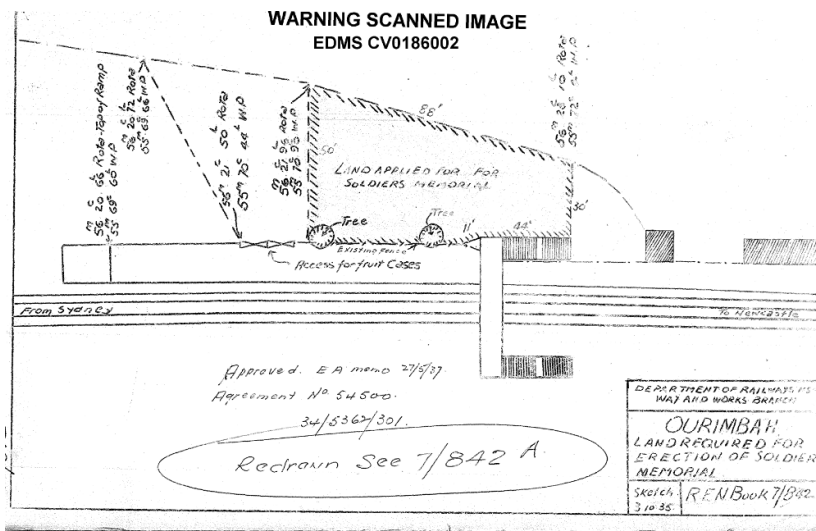
Figure 3-15: Image of the original plan of land allocated to the establishment of the War Memorial, c 1937. Source: Sydney Trains Plan Room

The World War 1 memorial monument was constructed on Sunday May 1, 1938, after much deliberation regarding its siting and construction. Early plans depict the site was selected by 1937 (Figure 3-15) and provided by the Department of Railways NSW for the introduction of the World War 1 Memorial. Efforts to establish an Ourimbah memorial were in effect by 1933,⁵⁶ with fundraising events created by a local committee to support the cause. Many residents of the area would later take part in plays⁵⁷ and other crowd fundraising events to raise money for the development of the project. The delay in the construction of the memorial was in part due to the reservation of the land the memorial currently resides upon⁵⁸ and a lack of funding during the Depression years.⁵⁹ The memorial was opened by Mr. L.A Robb, the State president of the Returned Soldiers' League and many returned soldiers, including the Ourimbah light horsemen, and local citizens came out to the service, which had been postponed a week to allow New Zealand Diggers to attend the service.⁶⁰ The commemoration of the Great War on the cusp of the beginnings of the Second World War was not lost on the attendees, with Mr Robb stating that 'he would say to the boys and girls present that the sacrifice commemorated would never be real to them unless they also cherished the spirit of service and sacrifice, resolved to surrender their all if the call came to them in the dark days ahead'.⁶¹ Contemporary accounts note the memorial consisting of 'gates to a small park; and on the pillars are plaques bearing the names of men who enlisted from the district. The enclosure adjoins the railway station and is intended as a rest refuge, between railway and highway, for young children and aged people'.⁶² Other newspaper accounts note that each division and society were given a plot of land for the introduction of garden beds within the small park.⁶³

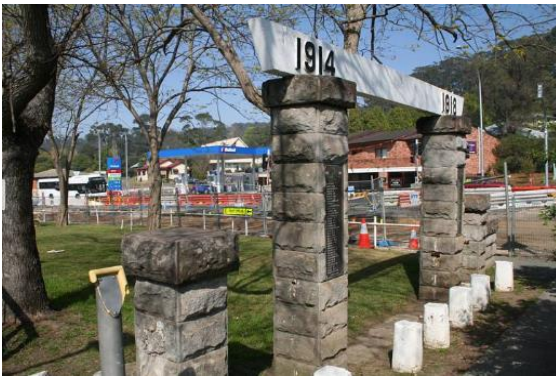
Figure 3-17: Image of the WWI Monument at Ourimbah Station, n.d. Note removal of dwarf wall to left of frame and earlier concrete posts.
Source: David Scobie

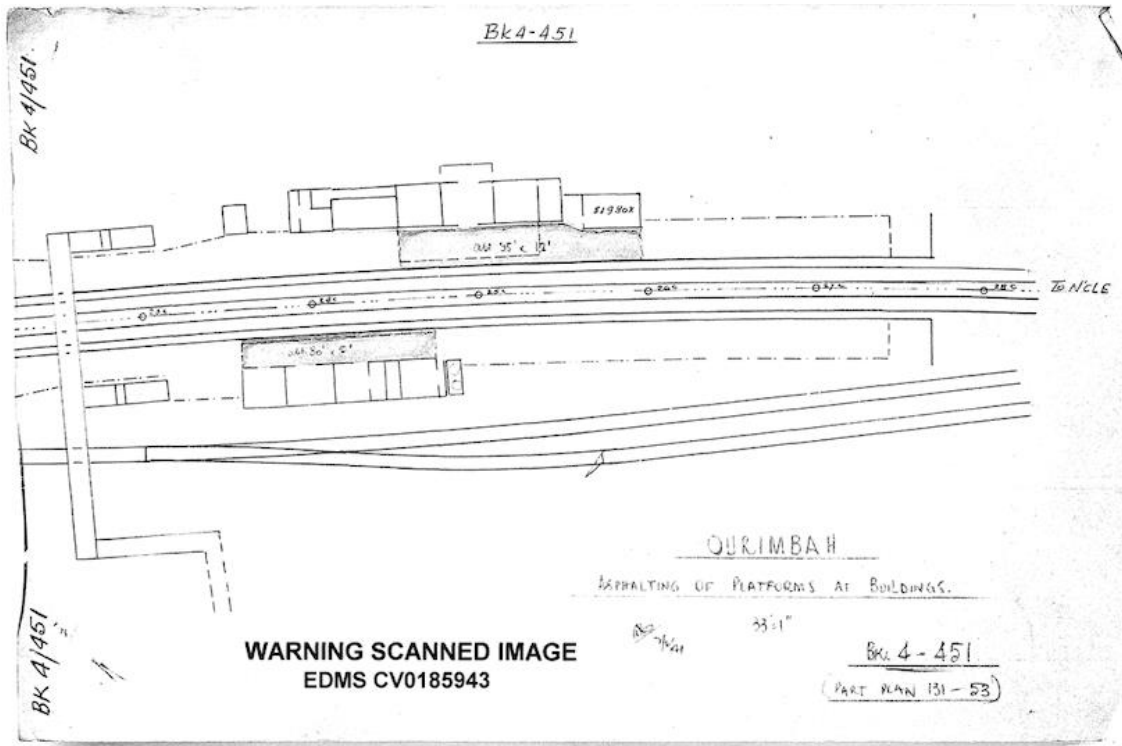
Figure 4-9: Image of the regrading plan, c1953. Source: Sydney Trains Plan Room

Platform 1 is a convex side platform made of precast concrete with a concrete surface. Platform 2 is a concave side platform made of brick with asphalt surface. Both platforms were resurfaced in the 1950s, resulting in an uneven grade (Figure 4-9).

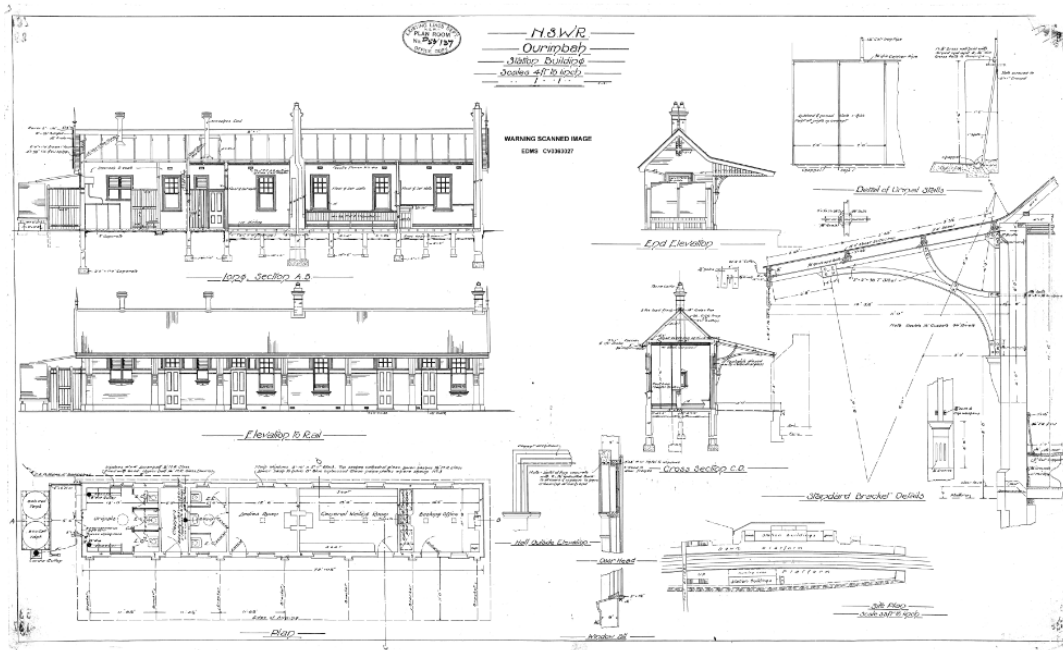
Figure 4-10: Image of the Platform 1 building plans, c1910. Source: Sydney Trains Plans Room

Internally, the original configuration of the building has been altered, with the Waiting Room now located within the original Station Master's Office. The original men's bathroom, located to the northern end of the building, has been modified and recently renovated, while the original privacy screen has been replaced with intrusive hooped fencing. The remaining areas are not open to the public and consist of modified interior rooms for the Station Master's Office and facilities. In the Waiting Room, the original ticket window has been relocated further east along the northern wall of the room. Original elements include the ripple iron ceiling, ceiling rose, timber skirting and the original fireplace. Internal walls have smooth rendered finish with profiled timber skirting. The original timber floorboards may reside underneath the existing laminate flooring.

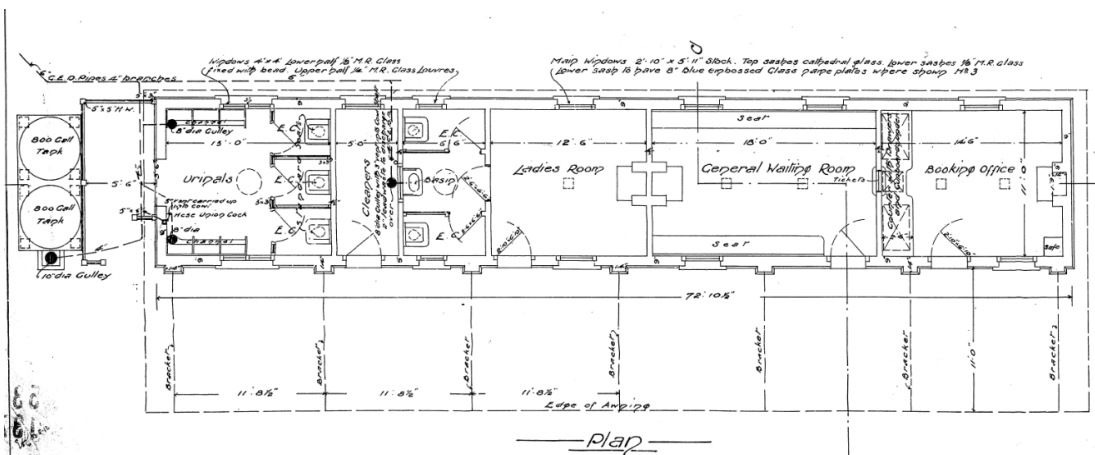
Figure 4-11: Image of the Platform 1 building layout, c1910. Source: Sydney Trains Plans Room

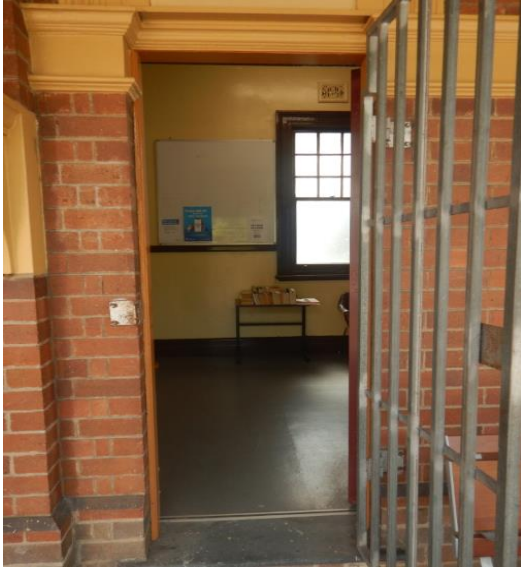
Figure 4-14: View west towards the stone threshold and interior of the Waiting Room.

- In order to mitigate any impact upon the entrance and façade of the building, it is recommended that the existing stone threshold be sympathetically removed, stored and reintroduced to the same entryway upon completion of the floor lowering.

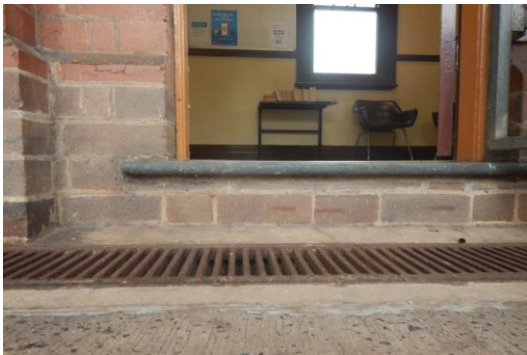
Figure 4-16: View of the regraded platform and brick course.

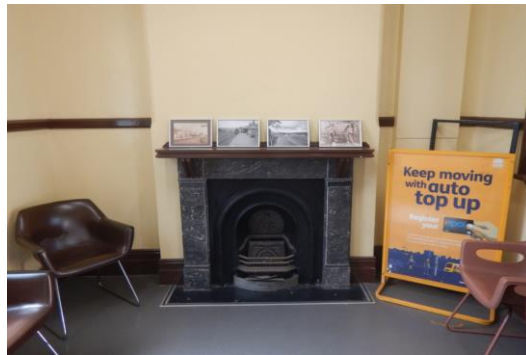
Figure 4-17: View of original fireplace and laminate flooring in the Waiting Room.

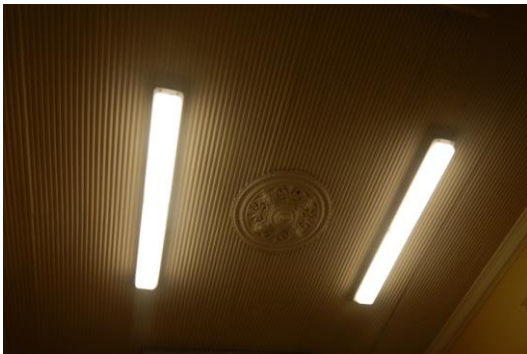
Figure 4-18: View of the Waiting Room ceiling, including original ceiling rose and intrusive lighting.

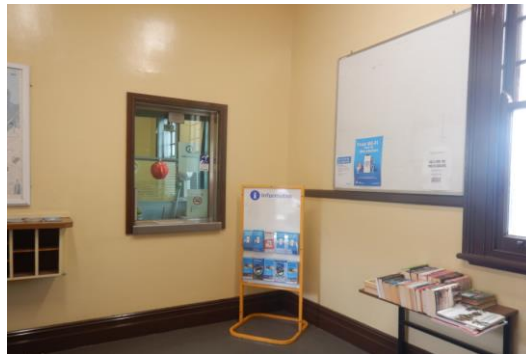
Figure 4-19: View of timber skirting boards and ticket window placement.

- Final drawings should depict the closure of the ticket window within the Waiting Room. Although not in its original location and of modern construction, it is recommended that the window be locked rather than infilled to preserve the original intention of the station ticket window within the context of the Waiting Room.

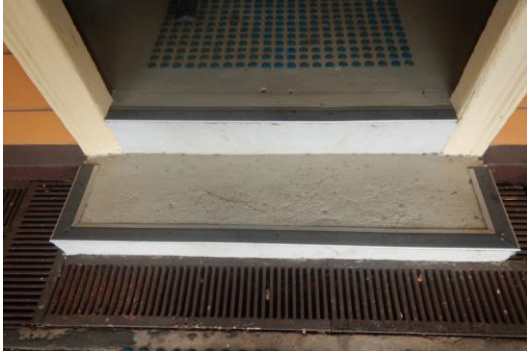
Figure 4-22: View towards the later step addition to the Waiting Room on the eastern elevation.

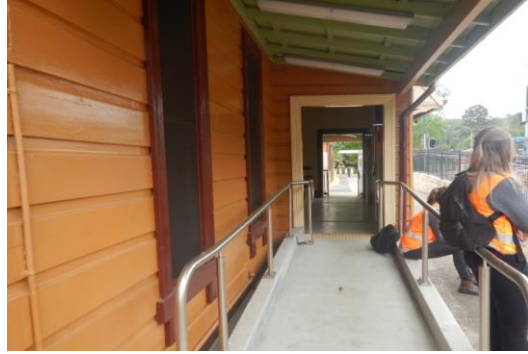
Figure 4-23: View towards the later ramp additions to the western elevation.

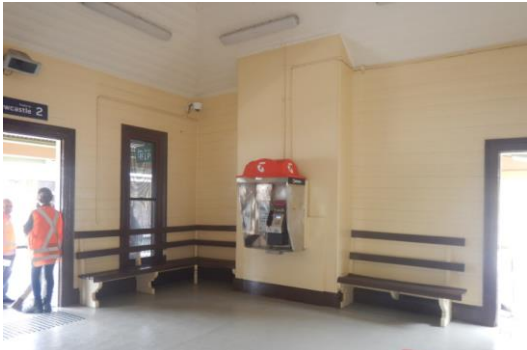
Figure 4-24: View of the interior area of the General Waiting Room and infilled fireplace.

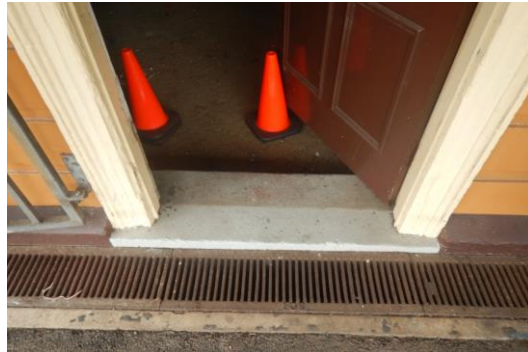
Figure 4-27: View of the grading to the Ladies Waiting Room.

The three rooms of the building are all sited at different grades: the former Ladies Waiting Room floor is below the current grade of the station platform, the General Waiting Room flooring is sited above the current grade of the platform and the former Station Master's Office is at grade to the platform. Physical evidence and historical research denote that the General Waiting Room flooring has been altered since construction, however other elements within the room (seating) have been sympathetically reinstated within the room.

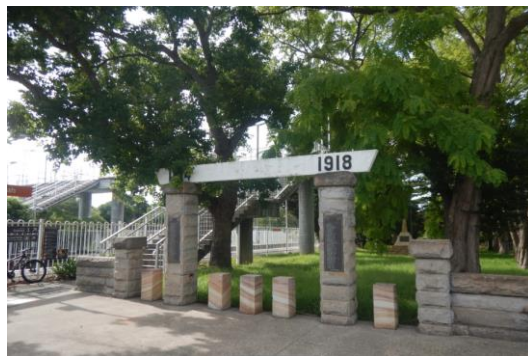
Figure 4-33: View south towards the element. Note later sandstone plinth additions and the two mature trees located at the park entranceway.

As depicted in Figure 4-32 to Figure 4-35, the World War 1 Monument and memorial park consists of a simple gateway of a beam inscribed with dates '1914' and '1918', supported on rusticated stone piers, and flanked on either side by low dwarf stone walls. All stonework is capped. Commemorative plaques are located on each pier. The memorial is weathered and has been intrusively modified with a cement sand mix mortar to some areas of the structure. However, the plaques are clean and legible. Historical research could not identify the construction date of the dwarf walls, although there is evidence that the eastern wall was constructed or reconstructed in the last two decades (Figure 3-17). Despite an unclear construction date, the dwarf walls contribute to the garden setting of the memorial and share a similar dressed finish to the sandstone piers. The sandstone plinths are of an intrusive element of recent construction, replacing the earlier, smaller plinths. The World War 1 Monument features as a gateway into the small memorial parkland. The existing landscape of the area consists of large mature trees which feature along the boundaries of the park. Two large trees are located to the south of the dwarf walls and flank the entrance to the park (Figure 4-33). The existing garden landscape (although currently poorly maintained) contributes to the setting of the heritage item, as does the intrinsic value and placement of the World War 2 Monument, which is located within the garden.

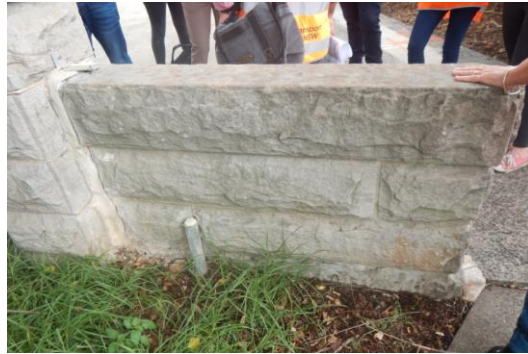
Figure 4-35: View of the dwarf stone wall and intrusive cement sand mix mortar.

| Element | Description | Condition | Significance Grading |
|---|---|---|---|
| Monument Columns | A simple gateway of a beam inscribed with dates '1914' and '1918', supported on rusticated stone piers. All stonework is capped. Commemorative plaques in each pier. The monument is weathered. However, the plaques are clean and legible. The mortar mix and stonework appear to be cracking and the mortar mix is intrusive to the element. | Moderate | High |

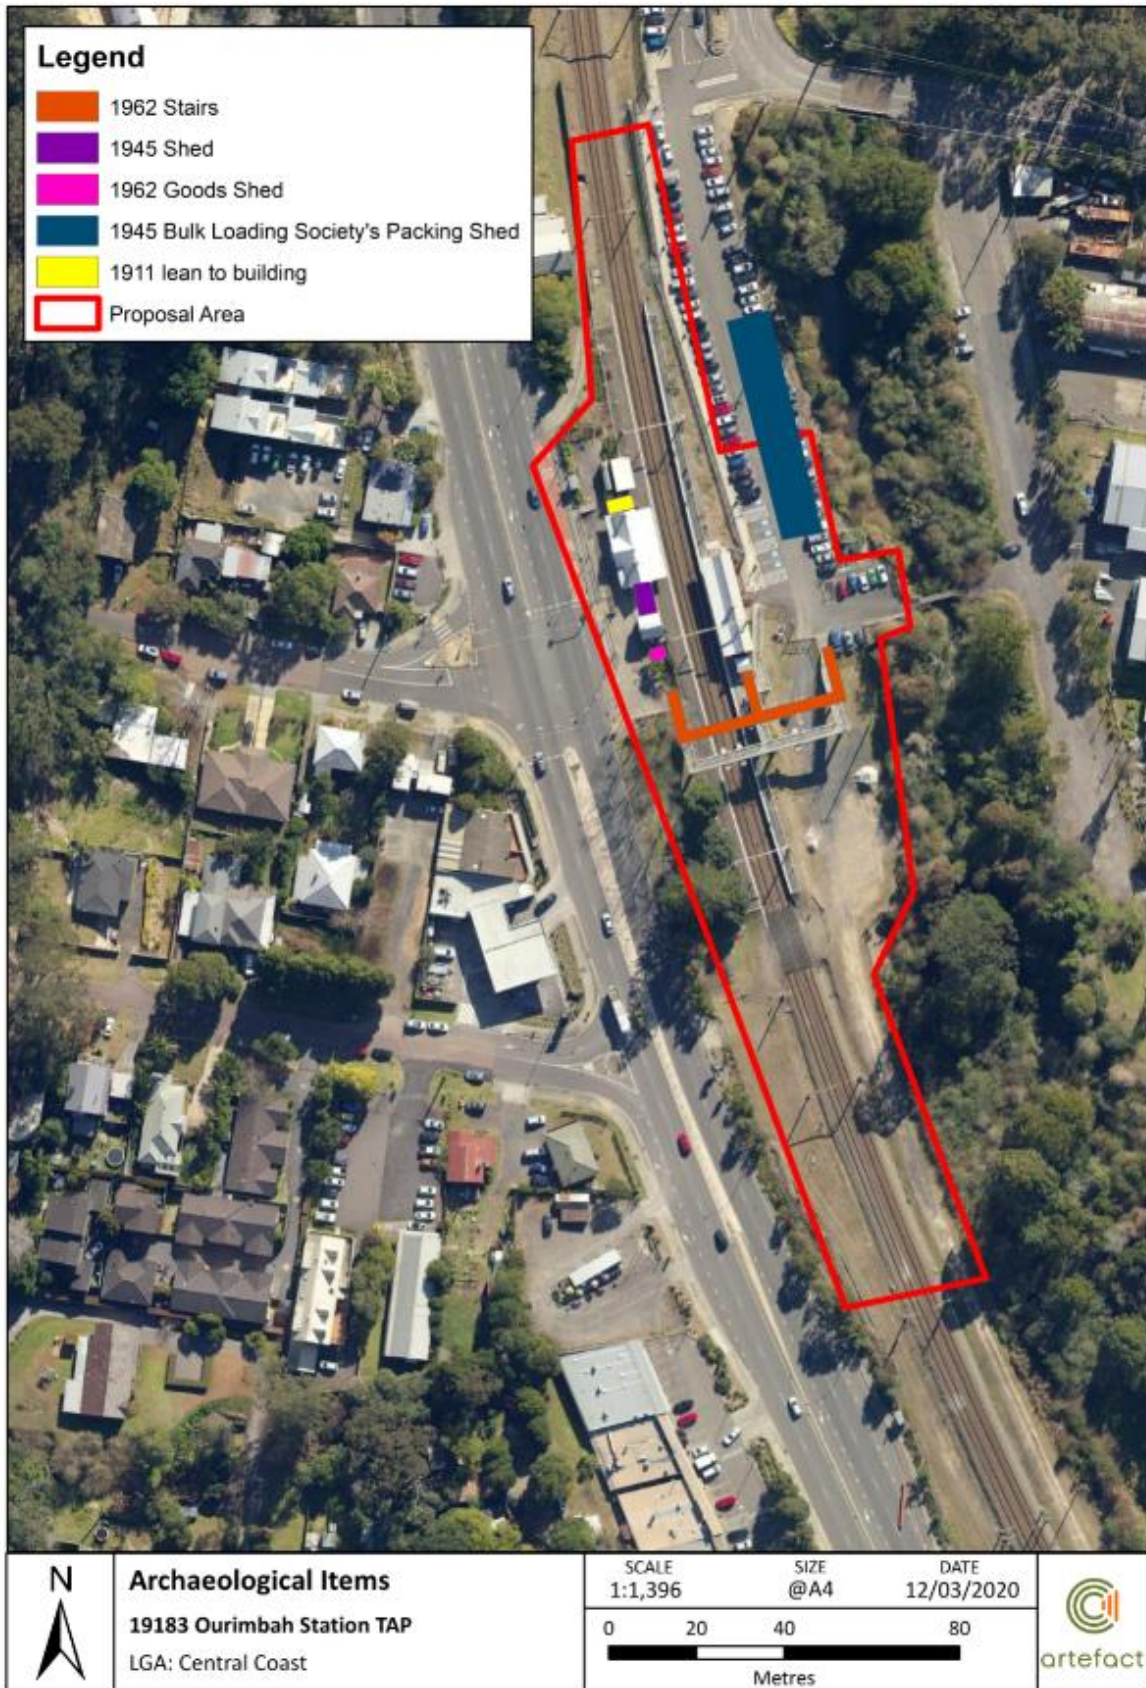
Figure 6-1: Image of the location of former structures

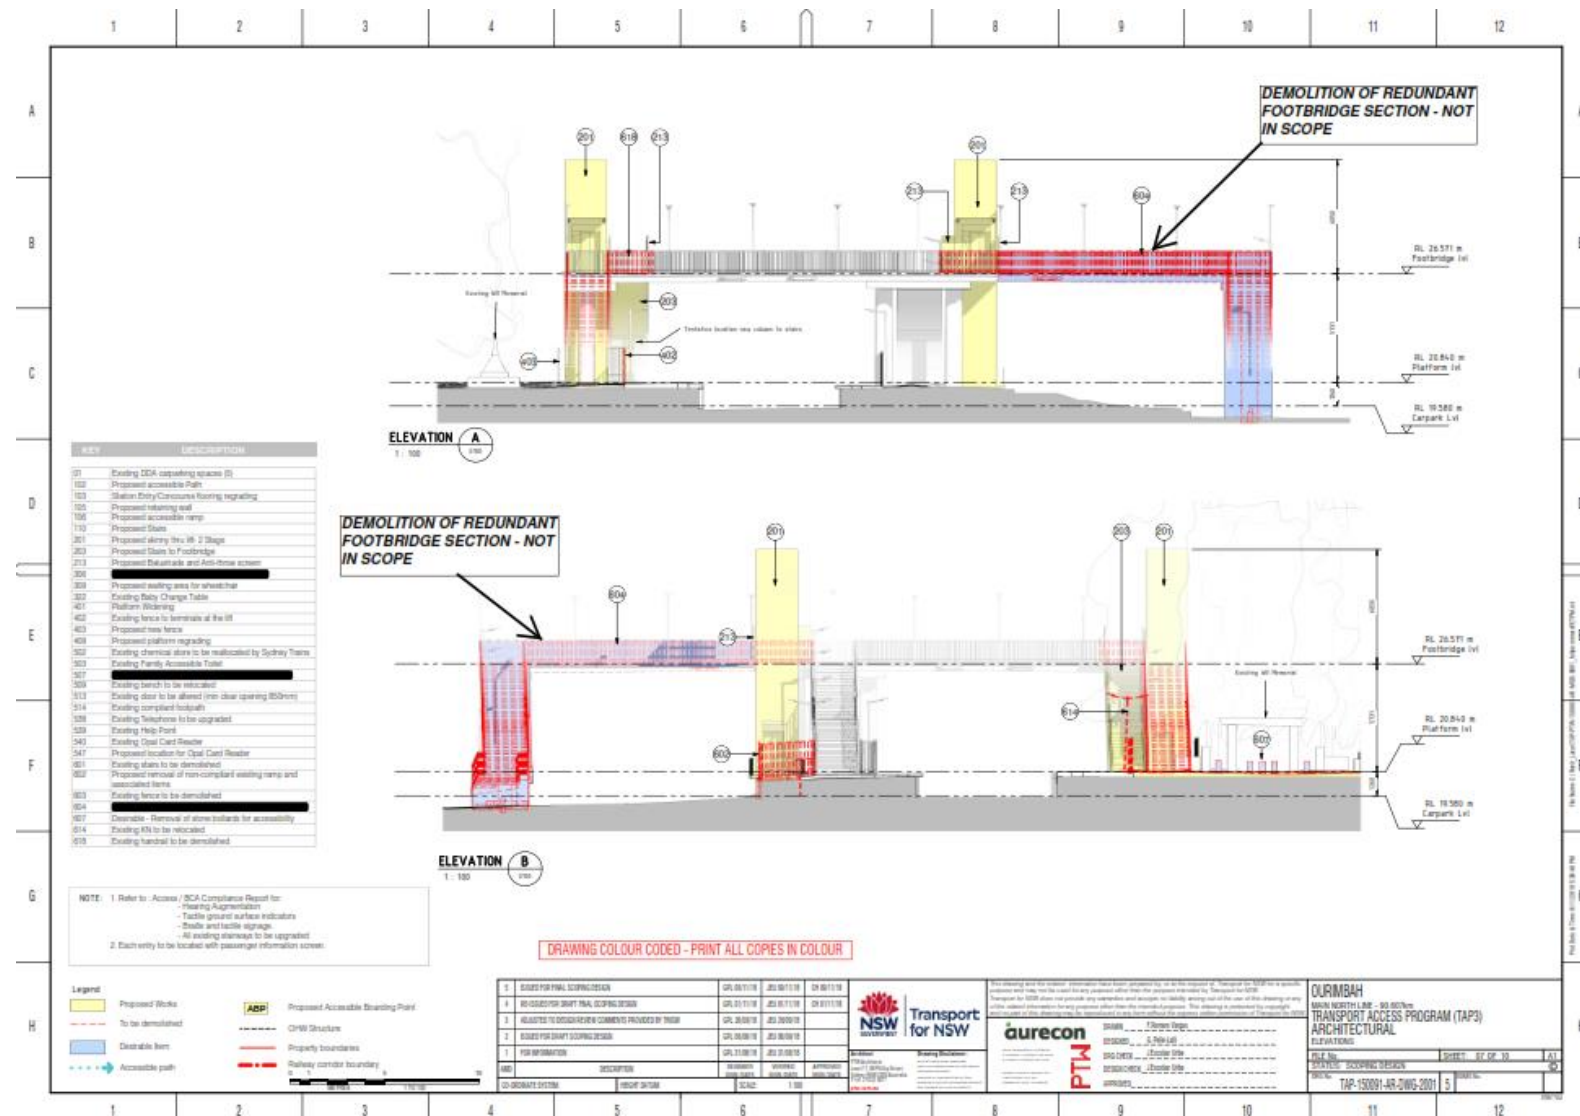
Figure 7-5: Image of the proposed elevations
