# TARAGO RAIL CORRIDOR ENVIRONMENTAL SITE ASSESSMENT

Project name **Tarago Crossing Loop Extension**  
Project no. **318000780**  
Recipient **Michael Hooper**  
Document type **Report**  
Report ref. **318000780-04**  
Version **0**  
Date **18/10/2019**  
Prepared by **Stephen Maxwell**  
Checked by **Kirsty Greenfield**  
Approved by **Fiona Robinson**  
Description **This report presents the results of a detailed site investigation targeting lead within the Goulburn – Bombala rail corridor at Tarago, NSW.**

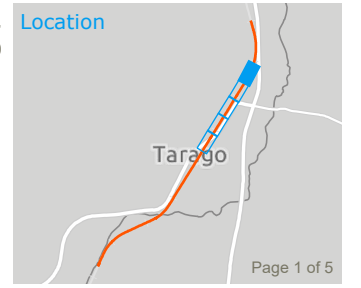
Figure 2a | Assessment of Lead in Soil in the Tarago Rail Corridor

Tabulated assessment of analytical results from recent and historic sampling (integrating works described here-in and Ramboll 2019a and 2019c) against site assessment criteria is presented in **Appendix 3**. TRH, BTEXN, PAH, and asbestos were assessed in 30 primary samples and found to fall below site assessment criteria at all locations. Metals (in particular lead) were reported above site assessment criteria at a number of locations. A statistical summary of metals concentrations is shown in **Table 6.1**. Results exceeding site criteria are presented in **Appendix 1, Figures 2a – 2d**.

*Note: X-Ray fluorescence sampling results were conservatively assessed against a management threshold of 1200 mg/kg Pb to mitigate uncertainty associated with these.*

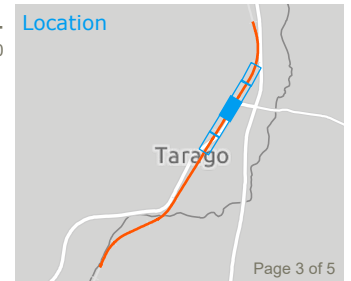
Figure 2c | Assessment of Lead in Soil in the Tarago Rail Corridor

- The lay-out and specific operation of the historic lead ore concentrate load-out facility remains unclear and so potential exists for localised impacts to remain and/or potential for impacts to extend deeper than the shallow soil currently identified. An example of potential deeper migration exists around the remnant infrastructure within the Woodlawn Siding around CH: 262.450 (depicted on **Figure 2c, Appendix A** set by a rectangular polygon from apparent survey).

Note: X-Ray fluorescence sampling results were conservatively assessed against a management threshold of 1200 mg/kg Pb to mitigate uncertainty associated with these.
