ARBORICULTURAL IMPACT ASSESSMENT & TREE PROTECTION PLAN

**Thornleigh Station Upgrade
Transport Access Program (TAP)**
Version 1

Prepared for:
EMM Consulting Pty Ltd

4 January 2021

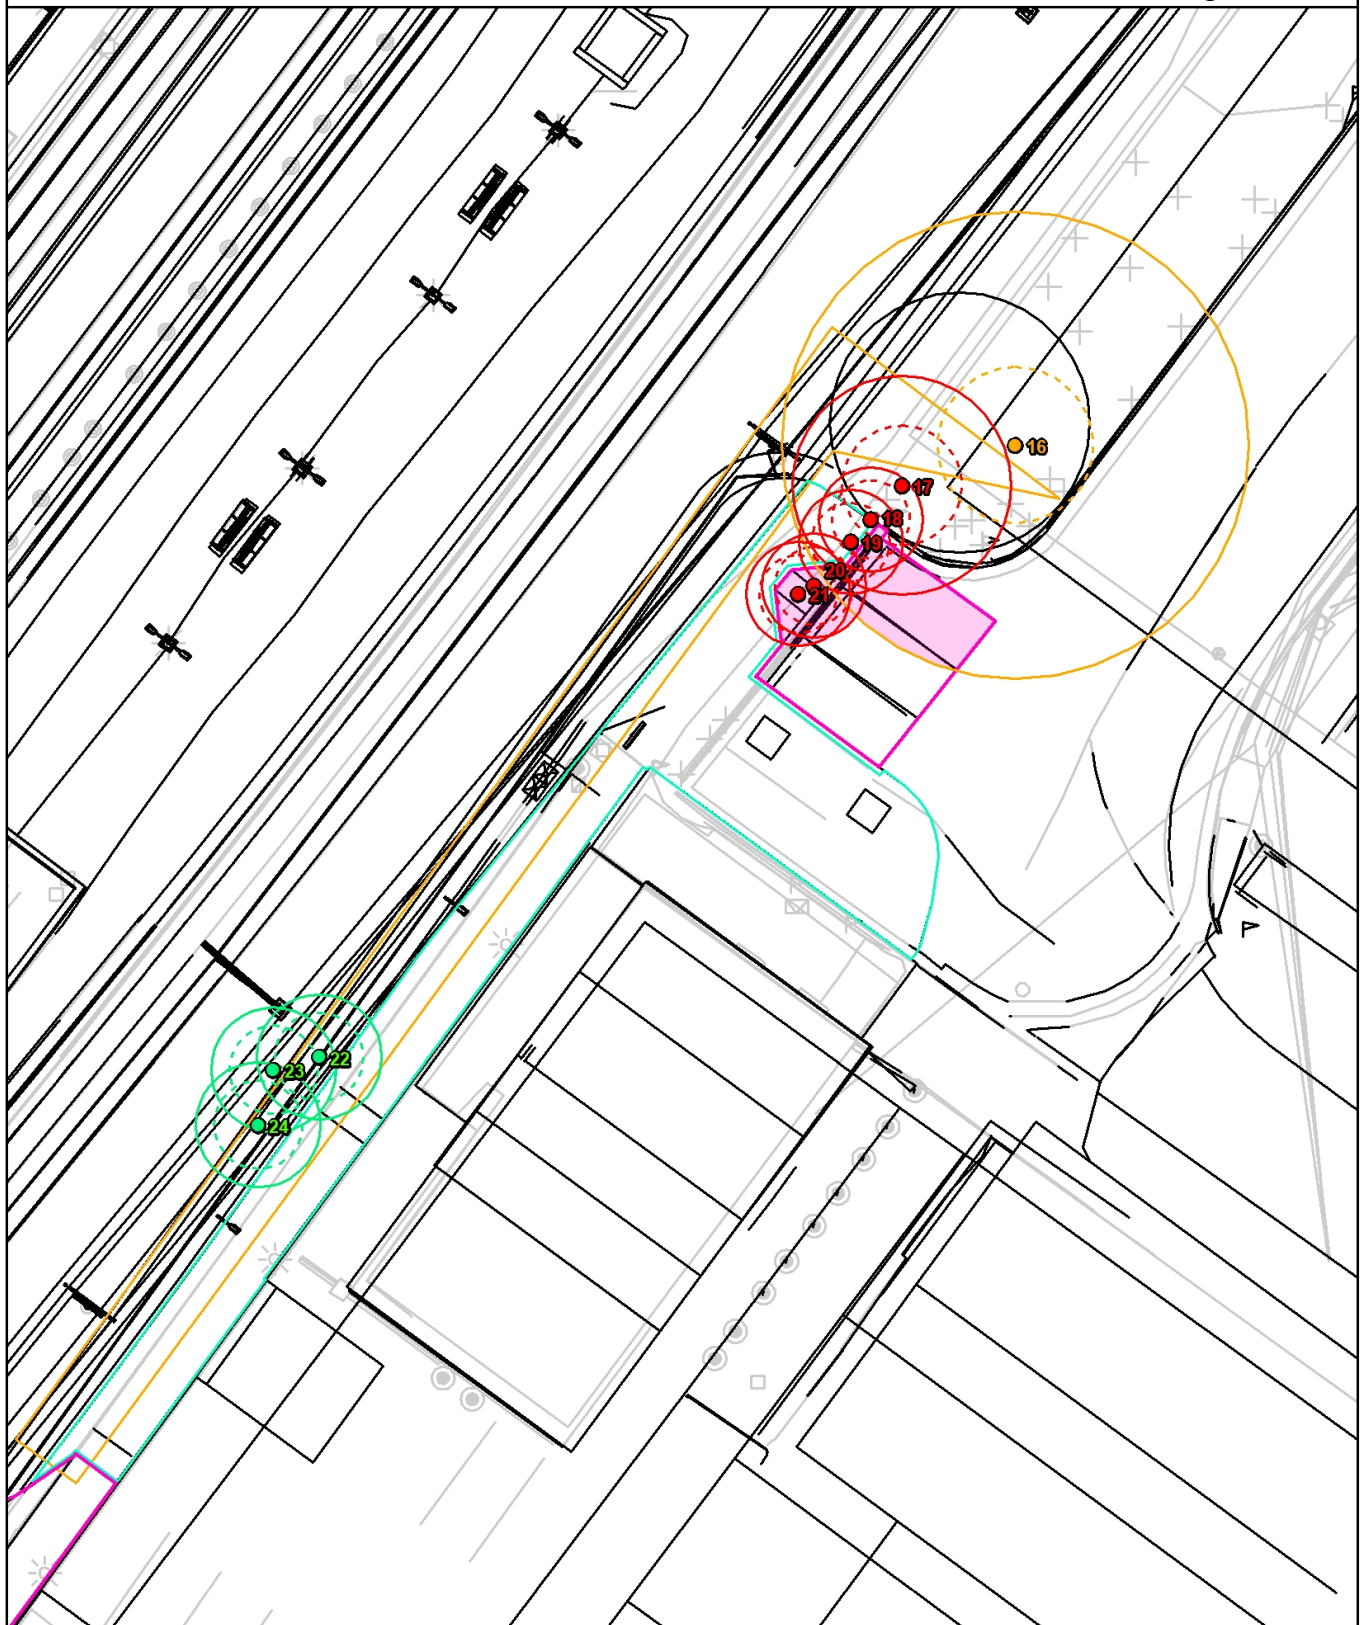
Page 7 of 11

The subject trees

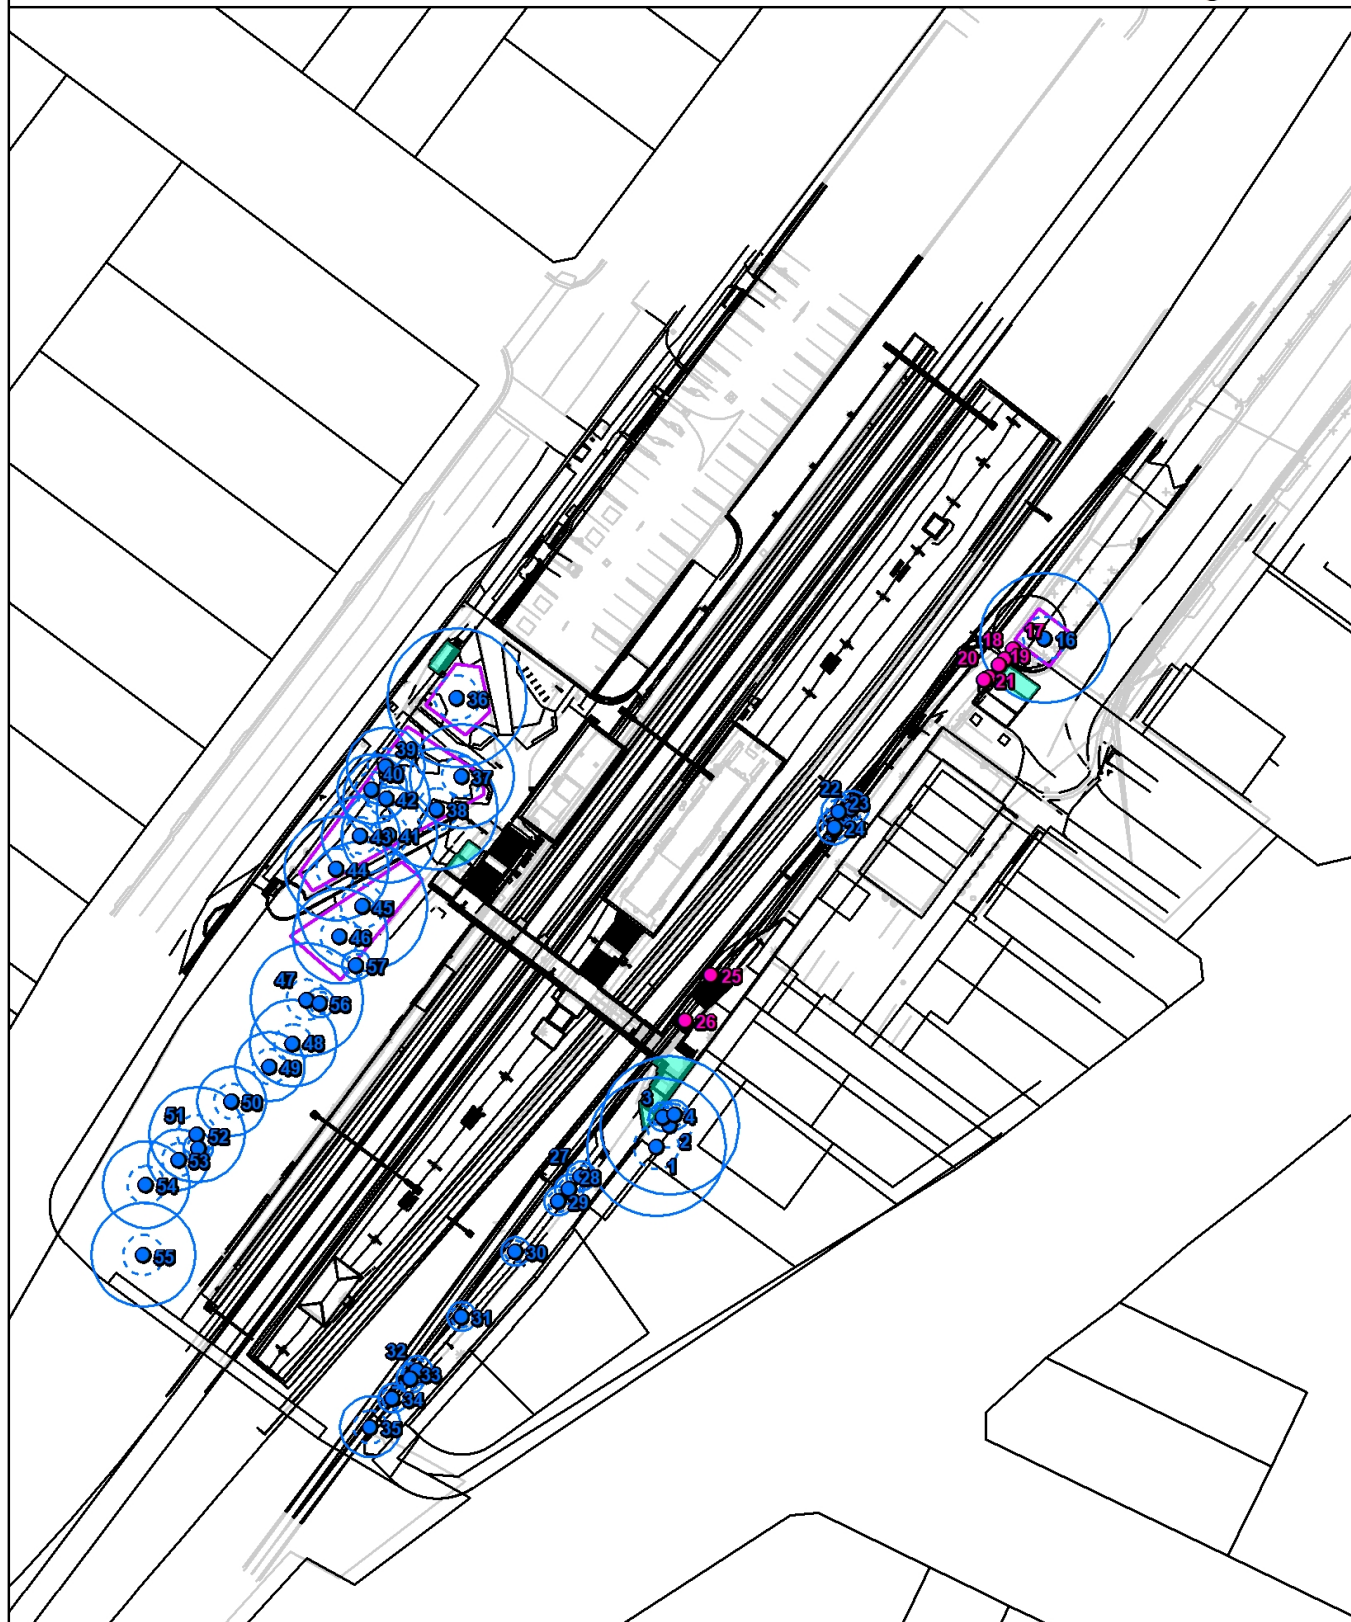
Page 2 of 11

The subject trees	Protection zones	Tree protection measures
● Retain (50)	TPZ (continuous line)	Arborist supervision
● Remove (7)	SRZ (dashed line)	Tree protection fence

Trees proposed for retention: A total of **50** trees are proposed for retention. The following recommendations apply to these trees:

Trees proposed for removal: A total of 7 trees are proposed for removal. All trees will require offsetting in accordance with the Transport for NSW Vegetation Offset Guide (DMS-SD-087). A total of eighteen (18) replacement trees are required to be planted in accordance with this guideline.
