**RESPONSE TO EPA PREVENTION NOTICE 3503607
MANAGEMENT OF TARAGO RAIL YARD CONTAMINATION**

Project name **Management of Tarago Rail Yard Contamination**
 Project no. **318001376**
 Recipient **Joanne McLoughlin, Transport for New South Wales**
E: Joanne.McLoughlin@transport.nsw.gov.au
 Document type **Report**
 Description **Response to EPA Prevention Notice 3503607 addressing all directions to take preventative action.**

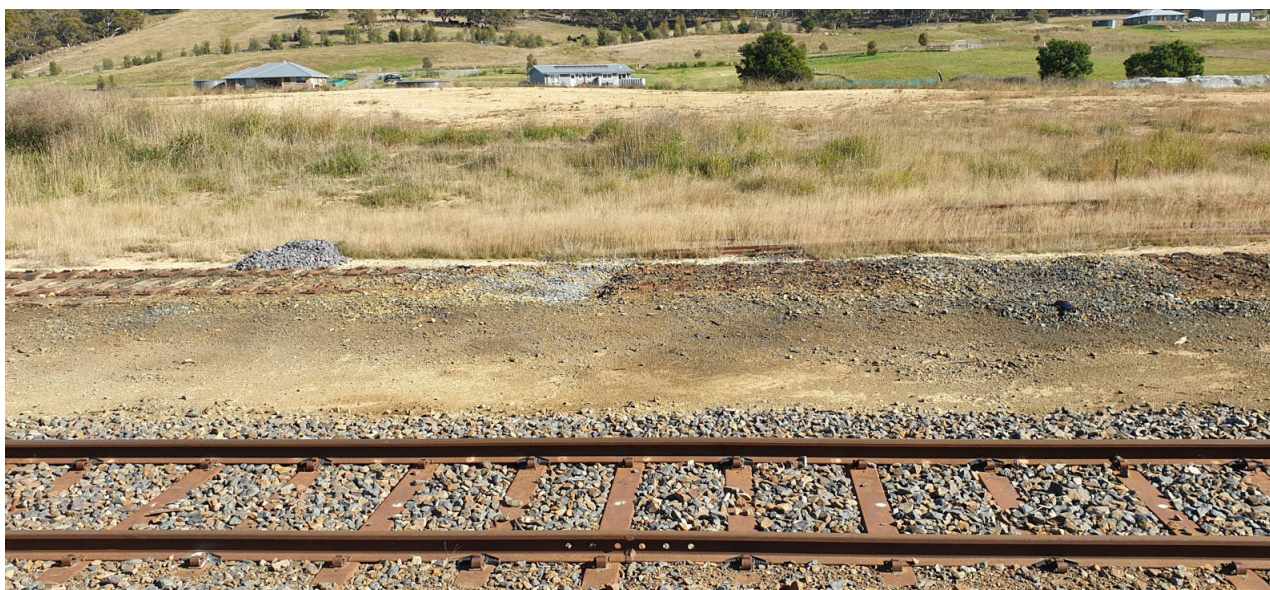
Photograph 1: Polymer Sealant on the Woodlawn Siding in January 2021

In June 2021 it was identified that records for inspection of the polymer sealant didn't adequately describe the condition of the sealant and so Ramboll inspected sealed areas (from the Station platform). **Photograph 1** below presents the Woodlawn Siding opposite the train station platform as observed by Ramboll in June 2021.

Darker and lighter patches of surface soil visible in **Photograph 1** were evident adjacent the Woodlawn Siding close to the former loadout area in June 2021. The observed colour differential was considered indicative of polymer sealant degradation or movement of unsealed sediments over the top of sealed soils. While this indicated potential for increase offsite contaminant migration recent monitoring of surface water and air quality indicated that risks associated with potential offsite contaminant migration remain low. Within this context Ramboll recommended to the site auditor (Ramboll email 2021a) that reinstatement of the polymer sealant was not required.

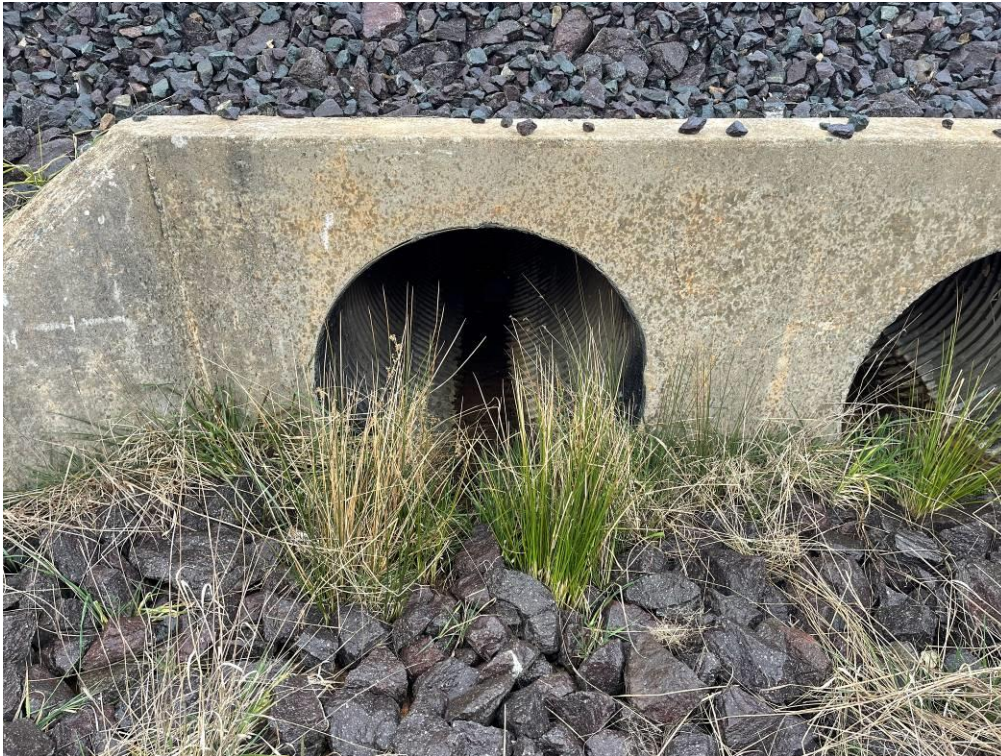
Photo 5: Sample location SW5 adjacent to the rail corridor, facing south-east. Unable to take sample due to the location being dry with very little water (12 September 2022)

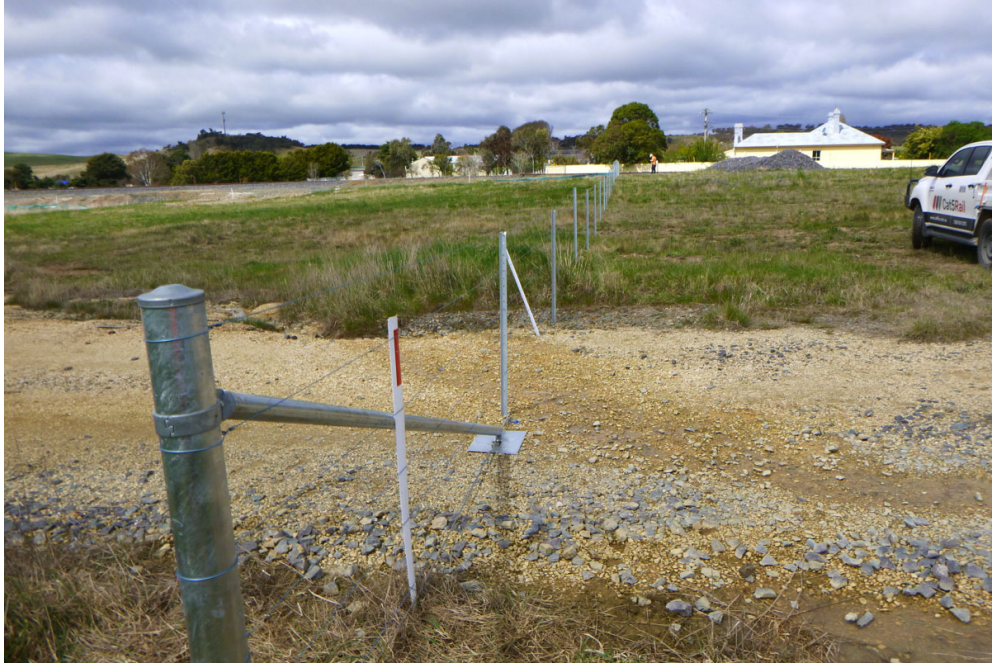
Photo 1: Fencing to limit vehicular access to the northern portion of the Tarago Rail Yard including upstream of the middle and northern culverts. 106 Goulburn Street visible in the background provides a reference point.

- The results of surface water sampling should be reviewed to assess the adequacy of existing erosion and sediment controls.
- Controls should be implemented to prevent future vehicular access over contaminated soils. Results of air monitoring should be reviewed to assess the adequacy of dust mitigation measures. If elevated dust levels are observed, reapplication of polymer sealant may be warranted. Specific controls to be implemented comprised additional signage and fencing as described on Figures presented as **Appendix 1**.

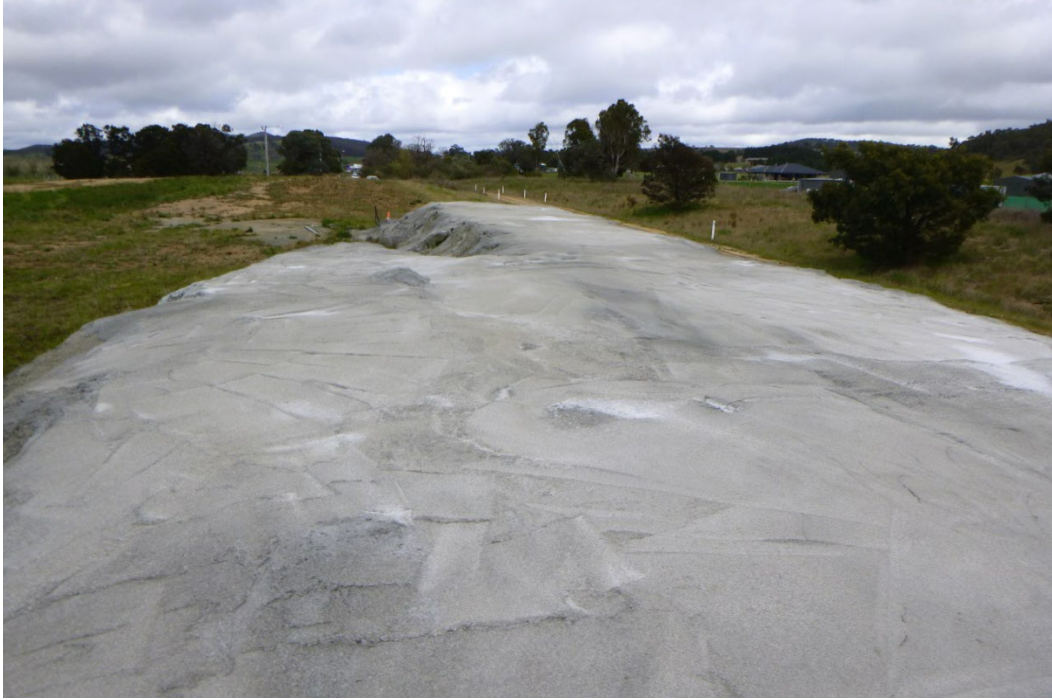
Photo 3: Stabilised sand applied as stockpile capping (top of stockpile)

- Damage / degradation of the stockpile cap should be repaired through application of additional stabilised sand to ensure the geofabric and any visible excavation spoil is completely covered to achieve a minimum capping thickness of 0.1 m and a free draining final surface.

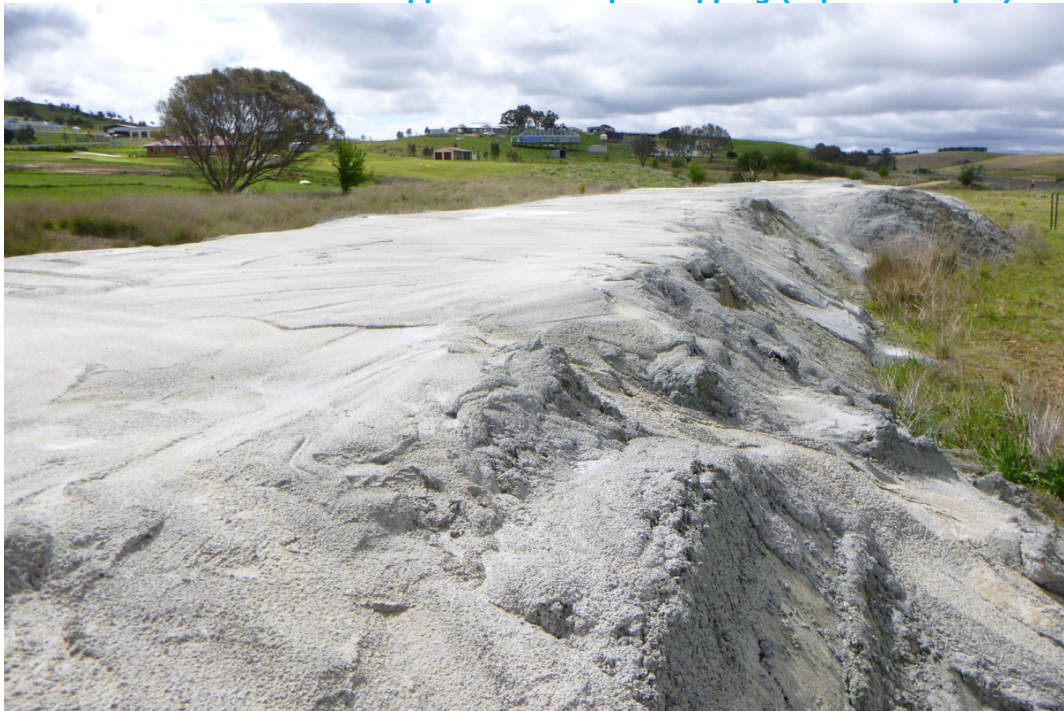
Photo 4: Stabilised sand applied as stockpile capping (top and eastern side of stockpile)

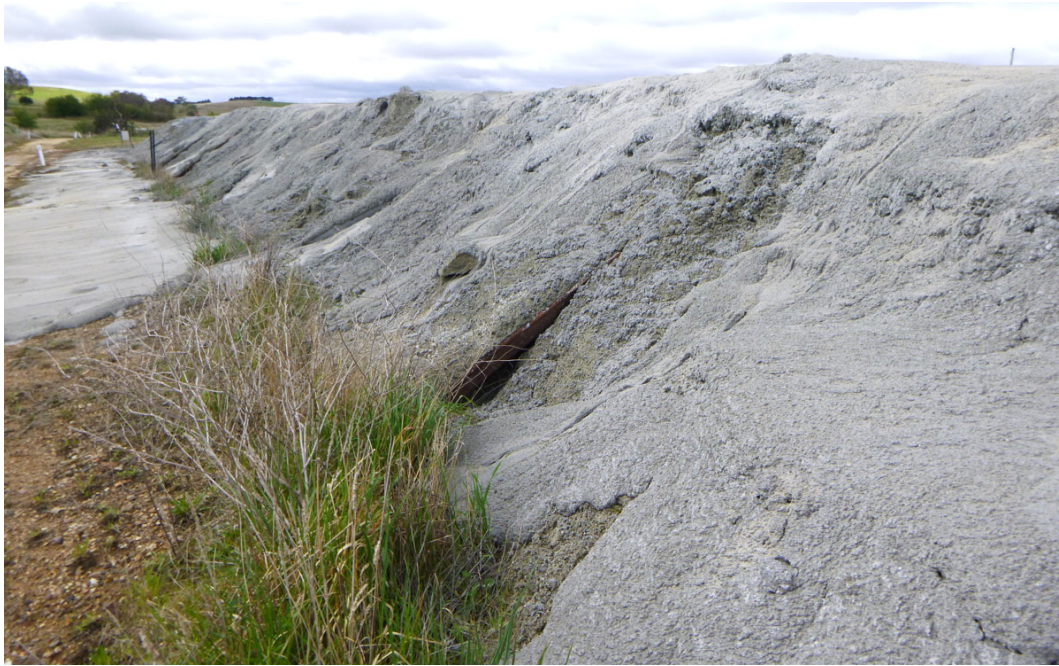
- Geofabric marker layer and contaminated spoil was observed indicating that stockpile capping is compromised at several locations however the sand cement capping was otherwise competent and erosion from the stockpile was not evident.

Photo 5: Stabilised sand applied as stockpile capping (western side of stockpile). Metal sleepers used as weights during initial placement of geofabric marker layer remain partially visible.

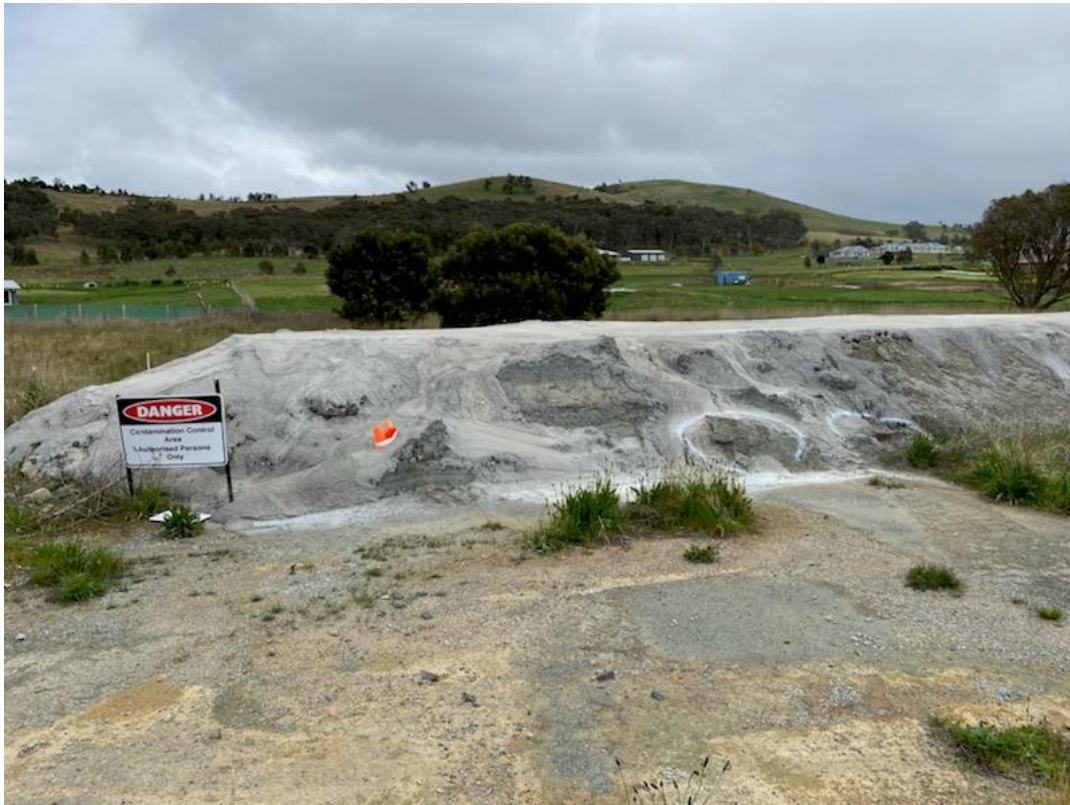
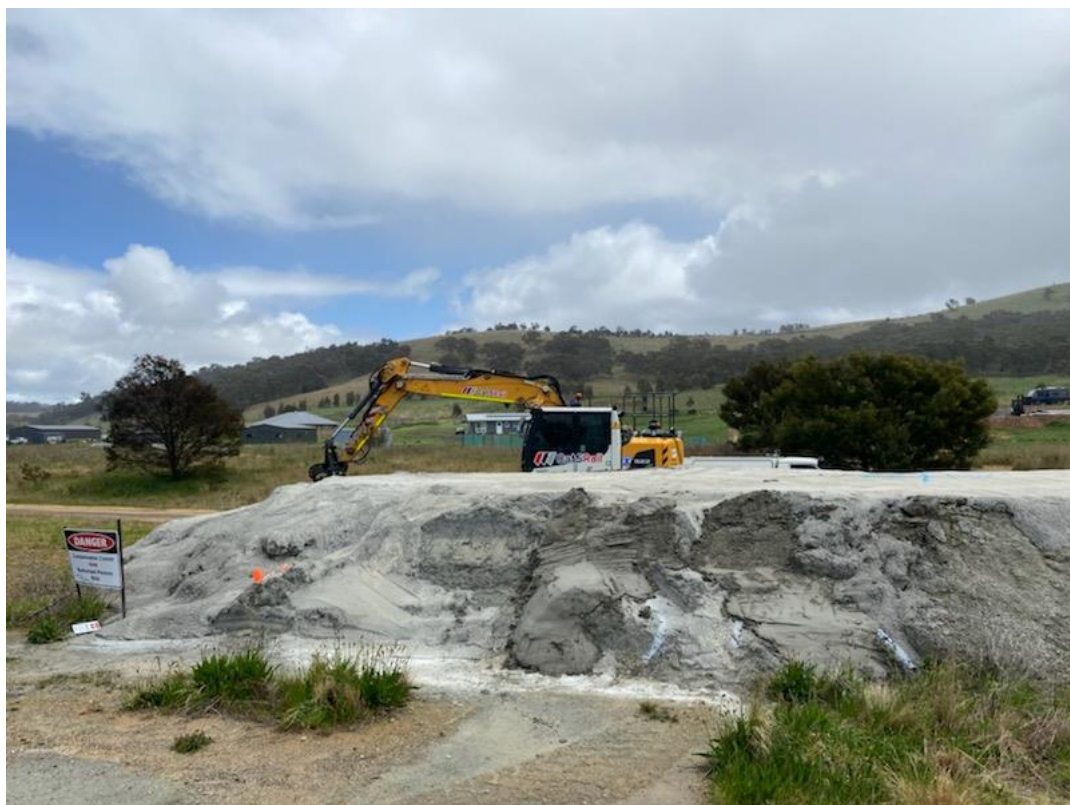
South Eastern Corner – Prior to final application of capping

South Eastern Corner – Post final application of capping

The following photos were all taken on Friday 29th September following the instruction to provide additional capping/cover where steel sleepers were exposed. They include a before and after photo.
