# TREE SURVEY

**ARBORICULTURAL IMPACT ASSESSMENT & TREE PROTECTION PLAN**

**Chullora Heritage Hub  
Tank Annex Building No. 22  
Version 2**

**Prepared for:  
Transport Heritage NSW**

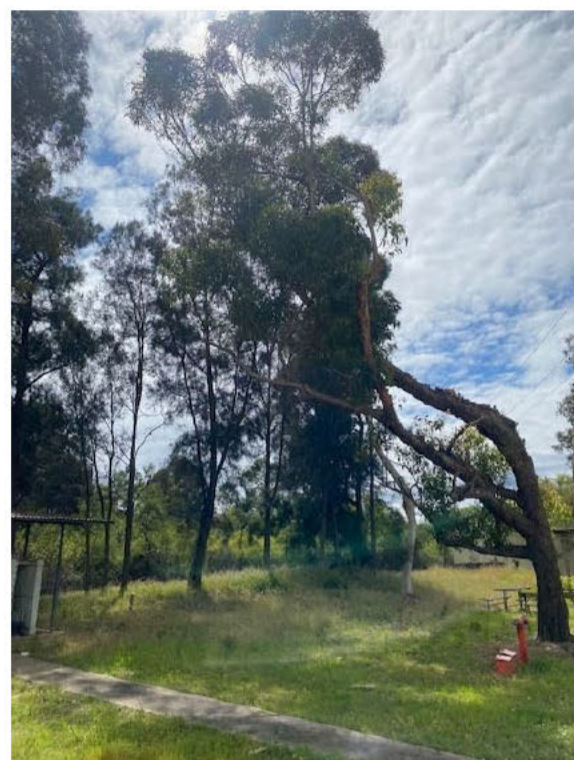
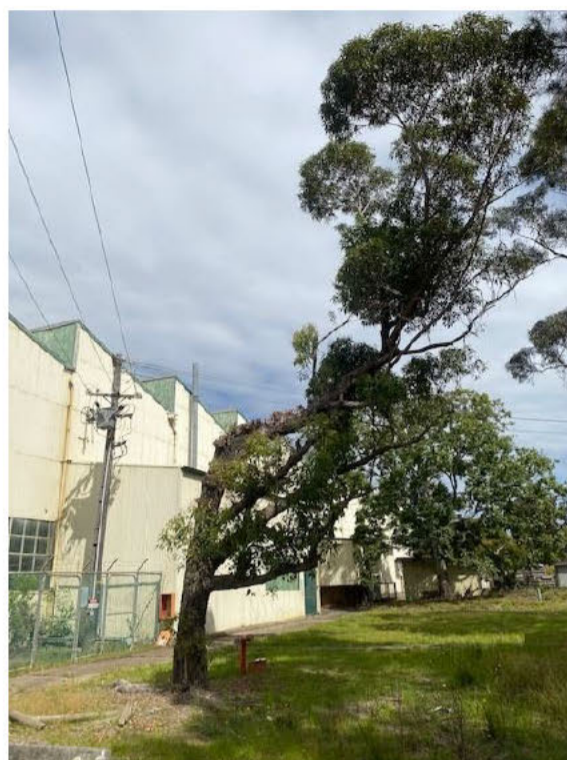
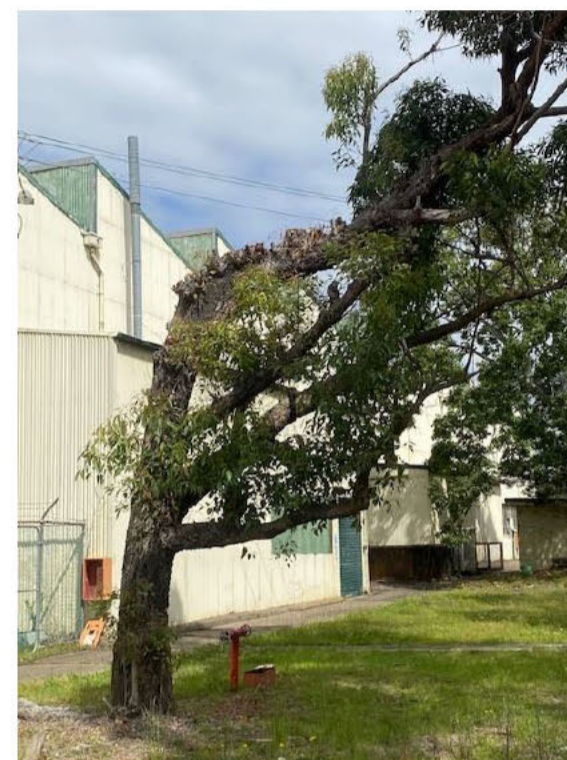
**Item 3 (Native Tree Removal)**

Item 3 (Eucalyptus botryoides) is located within the proposed construction footprint. This tree has been assessed as a low priority for retention due to structural defects and should but not be considered a constraint on the proposed works. This tree has been assessed as having a non-significant heritage grading due to it being self-sown specimen on cleared land and having structural defects. This tree is recommended for removal.
