Project name: Goulburn Wheat Yards - Contaminated Land Audit  
Project number: SCL220020.01

**Subject: IAA#1 Review of Existing Environmental Reports and Plans**

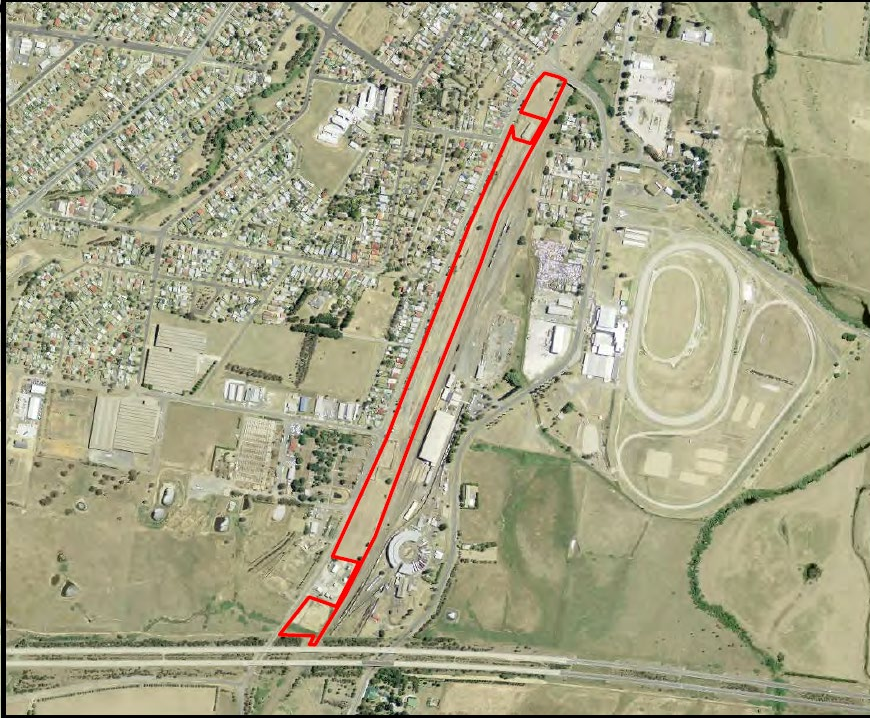
**Figure 1. Goulburn Wheat Yards Site Boundary**

The site is legally described as part Lot 1 in DP 1185735 and part Lot 1 in DP 1187262 with an approximate site area of 76,903 m<sup>2</sup>. The site boundary is shown in **Figure 1**, below, as well as on the site location and layout plan provided in the attached **Figure F1**.

The site is owned by TfNSW and is located at the southeast edge of Goulburn, immediately adjacent (to the west) to the ARTC Goulburn Roundhouse site. The site is comprised of five railway sidings, referred to in

previous reports as the 'No. 1 to No. 5 Up Sidings'. The site has a long history of rail related uses, which has included different tenants and associated land-uses.

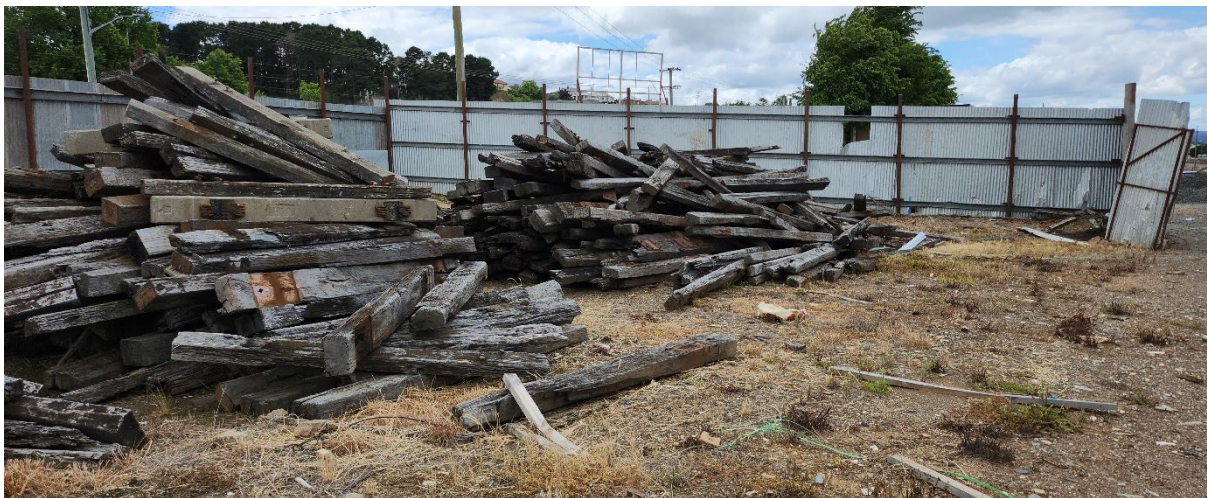
**Plate 2. Timber stockpile Area E**

Stockpiled debris and wastes	Small to large gravel roadbase, ballast and waste stockpiles are present over the site. Rubbish, debris and wastes are present are also present on the site surface, generally consisting of drums, steel, timber, concrete, pallets and general rubbish. Bonded asbestos fragments were noted scattered over the site.
Waste disposal to ground or site filling	The site appears to have been cut and filled to provide flat topography for the rail corridor and siding. Further localised surface fill is apparent consisting of ballast/ gravels and fill soils.
Underground or above-ground fuel storage	No evidence of any existing above or below ground fuel storage infrastructure was observed.
Electrical transformers, substations or capacitors	No evidence of any electrical transformers or substations were noted on the site, however these are likely to have been present in the past.
Staining/odours and evidence of vegetation dieback/ stress	Large areas of the site contain evidence of vegetation dieback/ stress. Localised areas of staining were present, however no significant odours were noted.

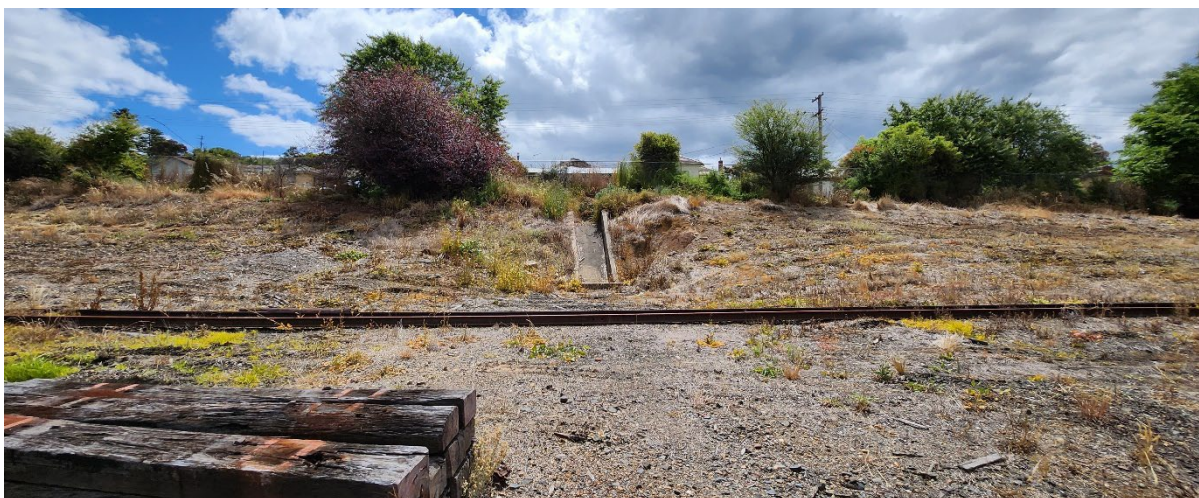
**Plate 10. Stormwater infrastructure from Sloane Street**

Other observations	Stormwater infrastructure was noted on site, which receives stormwater from upgradient Sloane Street, which discharges via overland channels to an onsite earth stormwater channel, which flows to stormwater infrastructure on the rail corridor and rail yards to the east, ultimately discharging to the Mulwaree River, approximately 600m to the east. Some minor ponding of surface water was observed.
Photographs:	Attached: Plate 1 – Wheat yard siding looking north Plate 2 – Timber stockpile Area E Plate 3 – Waste and timber stockpiles Plate 4 – Wheat yard siding looking east Plate 5 – Wheat yard siding looking toward Ampol fuel depot (off site) Plate 6 – Wheat yard siding looking north, showing covered material stockpile Plate 7 – Wheat yard siding surface debris and fill Plate 8 – Wheat yard siding showing bonded asbestos fragments Plate 9 – Wheat yard siding looking north, showing cut and fill

Surface water flows and formal stormwater channels on the whole site may present offsite migration pathway for contamination, either as dissolved contamination or suspended sediments, potentially impacting the Mulwaree River or residential areas to the east. The auditor recommends that sampling and analysis of surface waters as well as sediments in the stormwater system be carried out for the contaminants of concern, to update the conceptual site model and inform remediation approaches and site management.
