# Transport Access Program: Stanmore Station

Statement of Heritage Impact

Report to Transport for NSW

January 2022

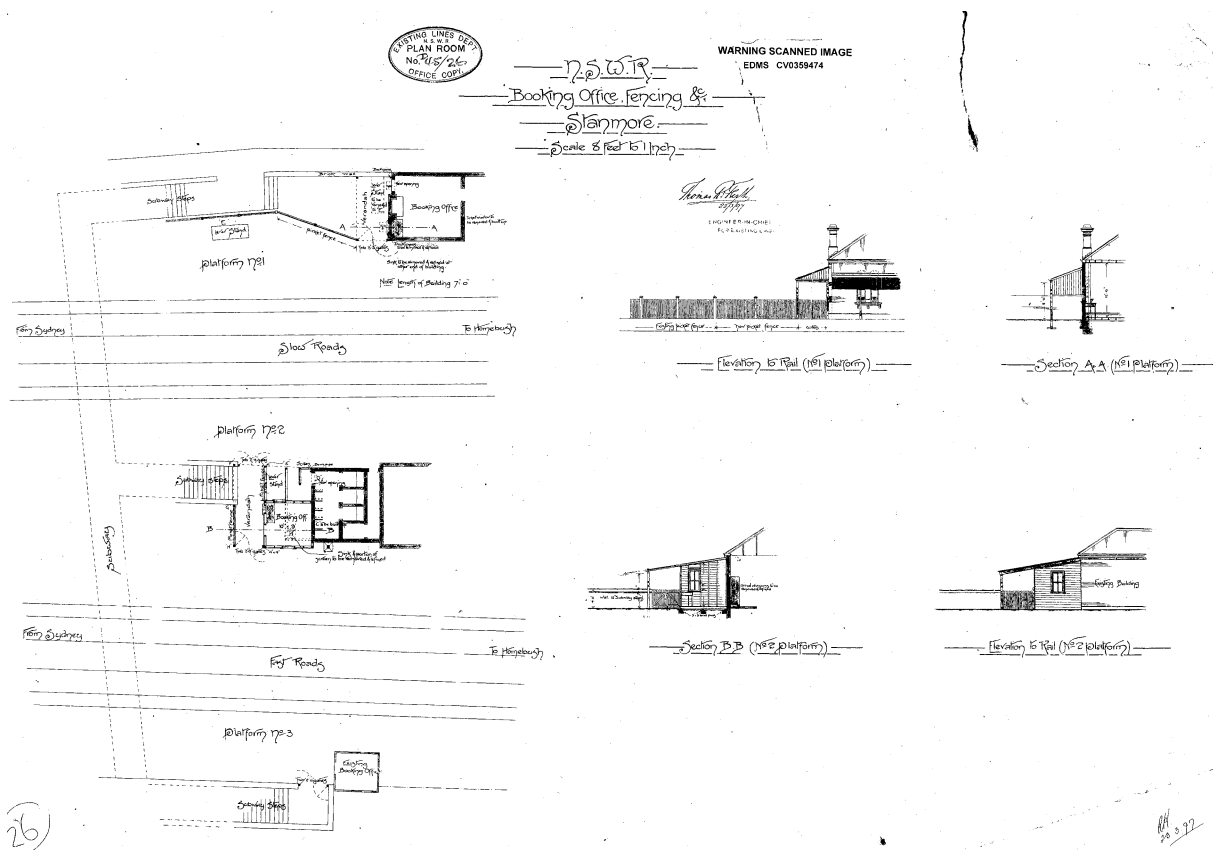
Figure 11. An 1897 plan of Stanmore Station showing the 1885 subway alignment and alterations to the platform buildings (Source: Sydney Trains Archives, 0359474 A0C)

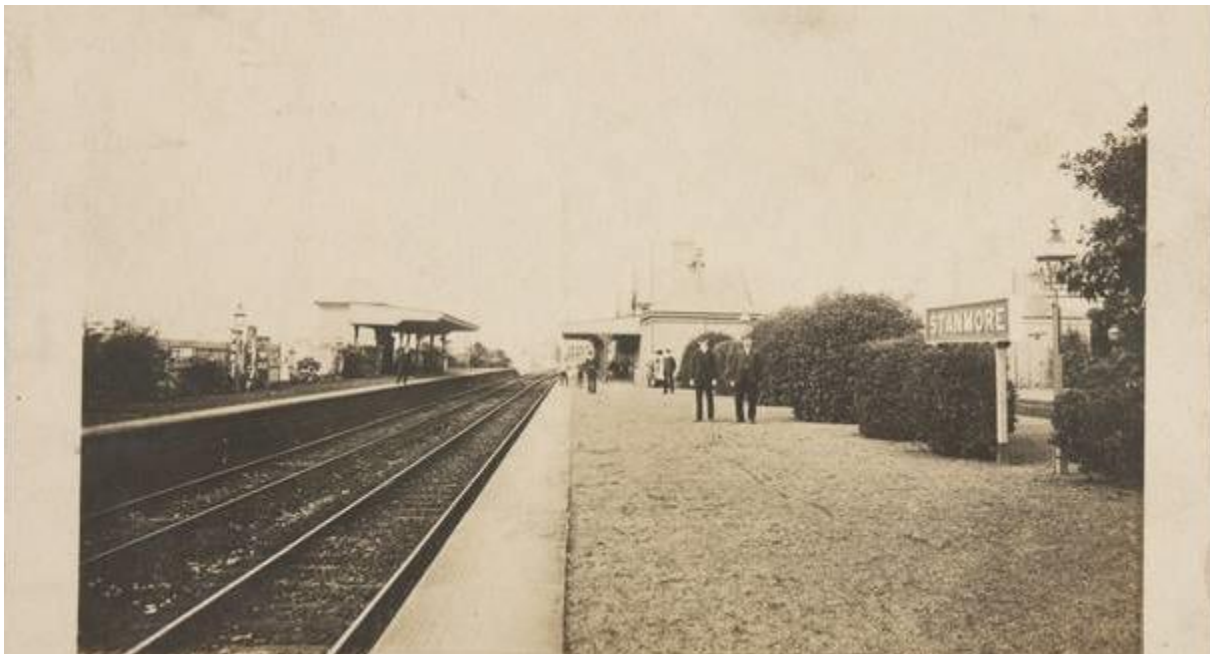
Figure 15. 1914 photograph of Stanmore Station, showing the view along Platform 1/2 from the east, with the platform buildings in the background (Source: National Museum Australia, 1986.0117.4606, <http://collectionsearch.nma.gov.au/object/172277>)

1891 saw the quadruplication of the station, which involved the extension of the platforms to 156m, the conversion of Platform 1/2 into an island platform and the construction of an additional island platform (the Up Suburban platform) to the north of Platform 1/2 (Figure 15). This led to the extension of the subway between the new platform and Douglas Street, and the construction of a parcels office on the new north frontage along the new Up Suburban platform (Figure 16). An awning was also added to the north-western side of the Platform 1/2 building, creating an almost wrap-around verandah. These changes are attributed to George Cowdery, the then Engineer-in-Chief for Existing Lines, who was appointed in 1863.<sup>42</sup>

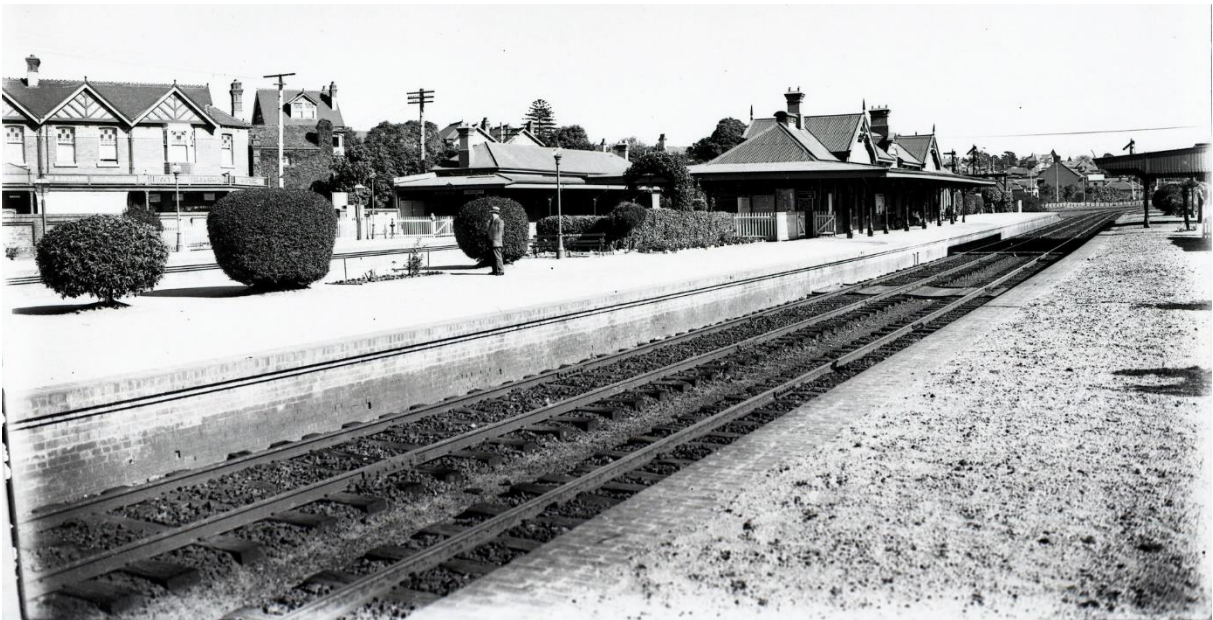
**Figure 19. View of the station platforms at Stanmore from the now demolished Up Suburban platform, photograph dating to between 1891 and 1926.** (Source: Australian Railway Historical Society, ARHSBox064\_1763).

The 1920s also saw a number of changes to the station (Figure 17 to Figure 19), including the works relating to the sextuplication of the tracks in 1926 (six track configuration), such as the demolition of the Up Suburban platform, provision of new tracks and the construction of a new subway with new staircases and a lantern on the staircase to Platform 1/2 (Figure 20 and Figure 21). The c.1926 subway incorporated some of the elements of the c.1886 subway into its construction,<sup>44</sup> including the southern original brick staircase wall on Platform 3. The c.1926 subway also reused the entrance to the Up Suburban Staircase as a bookstall area (Figure 20 and Figure 21). Soon after these works were complete, the Local and Suburban lines were electrified to Homebush.<sup>45</sup>

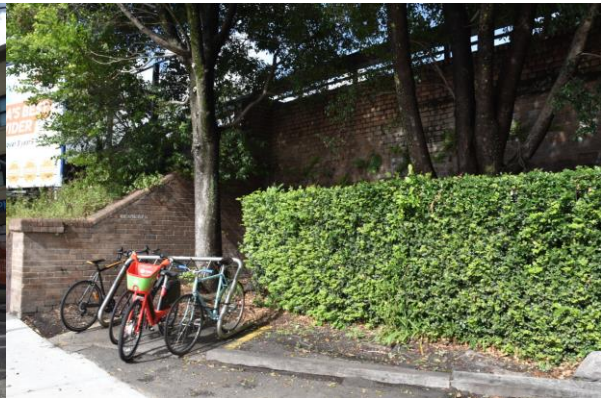
**Figure 26. Brick retaining wall along Douglas Street escarpment (Source; Artefact, 2021)**

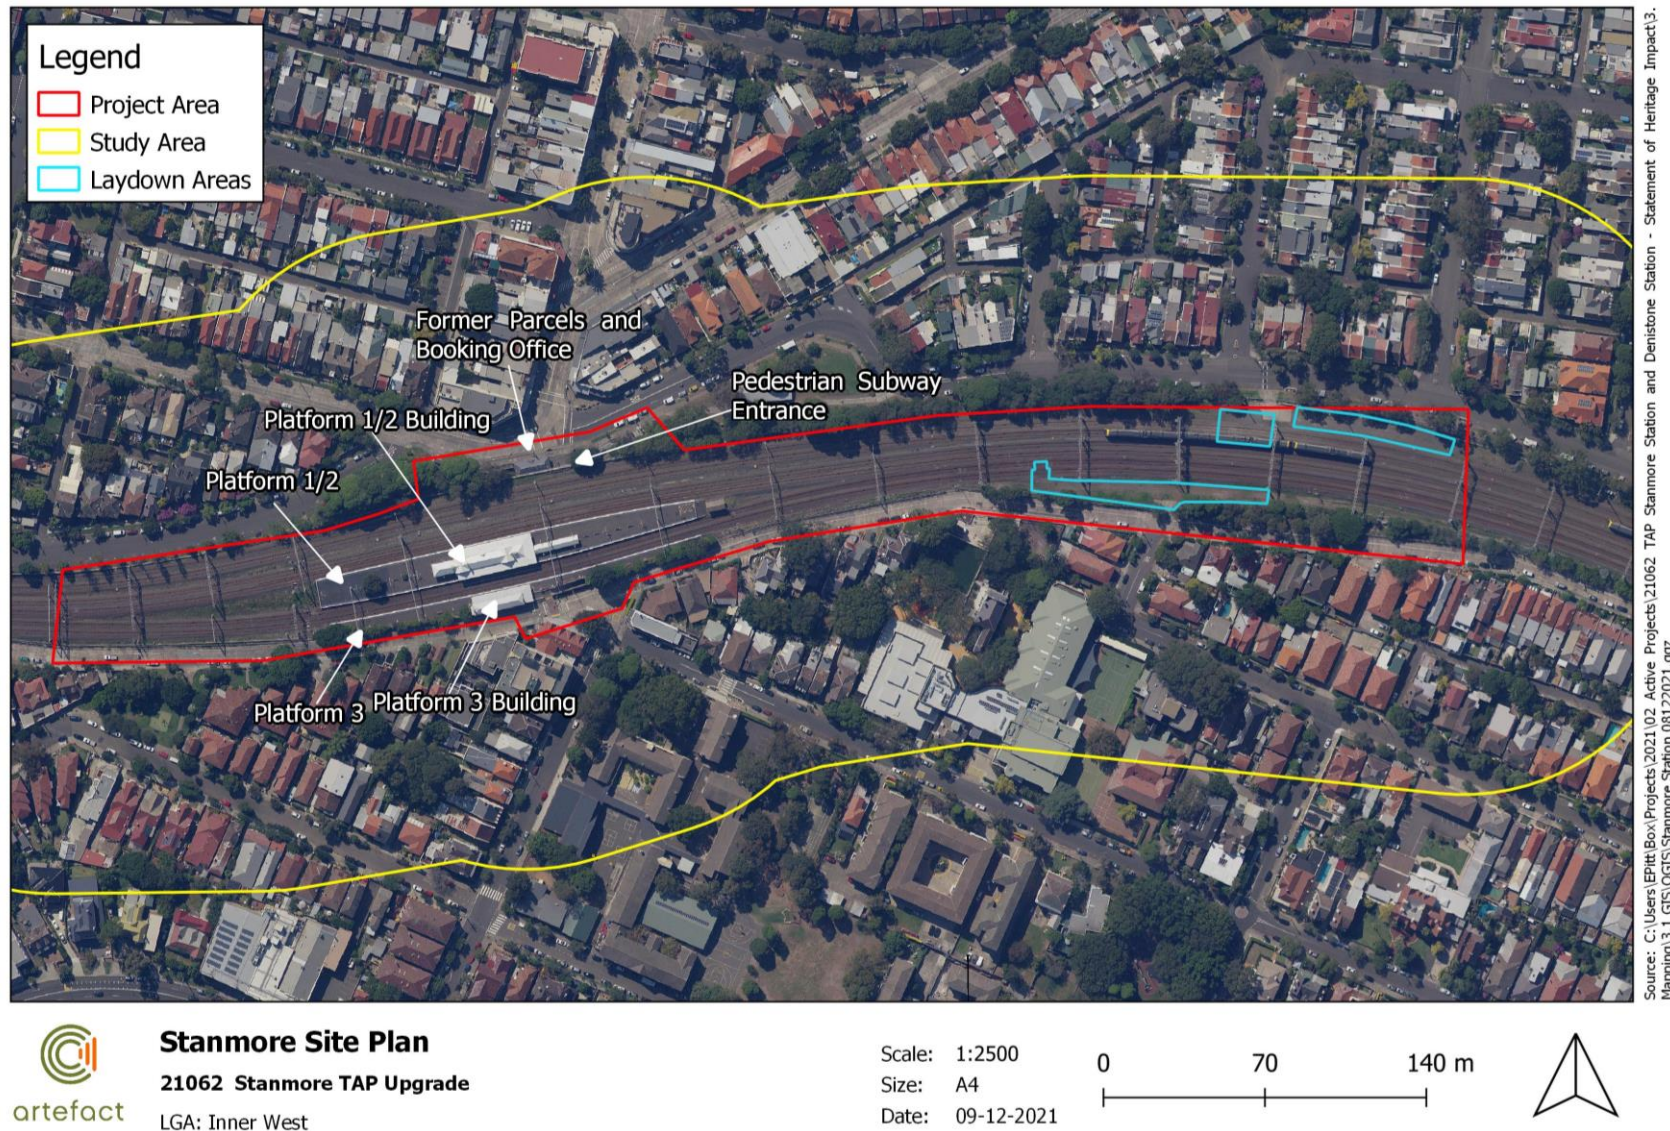
Figure 33. Site plan of Stanmore Station, showing the individual components (Source: Artefact, 2021)

The following section provides a description of the individual elements of Stanmore Station which form part of the Station's state significance. A site plan showing the location of the key elements of the station is provided in Figure 33 below.

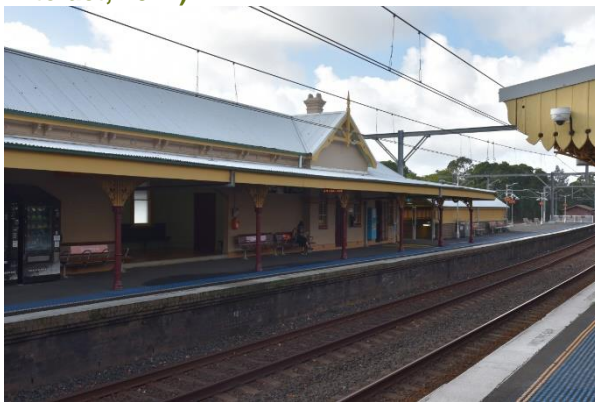
Figure 36. Platform 1/2 platform building, with original awning extending the length of the building (Source: Artefact, 2021)

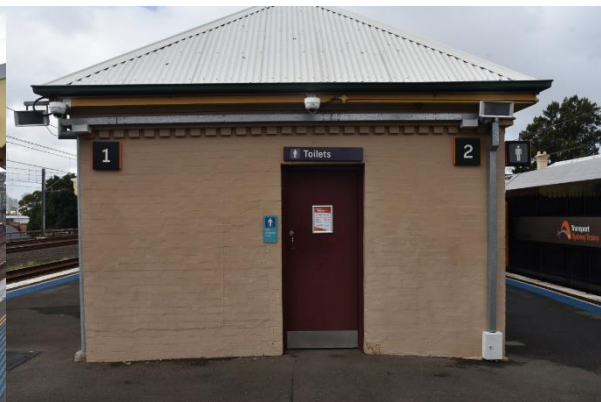
Figure 37. Platform 1/2 platform building, toilet entry and hipped roof (Source: Artefact, 2021)

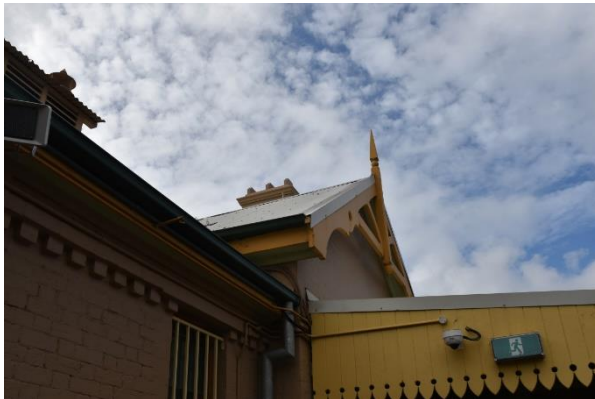
Figure 38. Original decorative timber barge board and finial details to gable end (Source: Artefact, 2021)

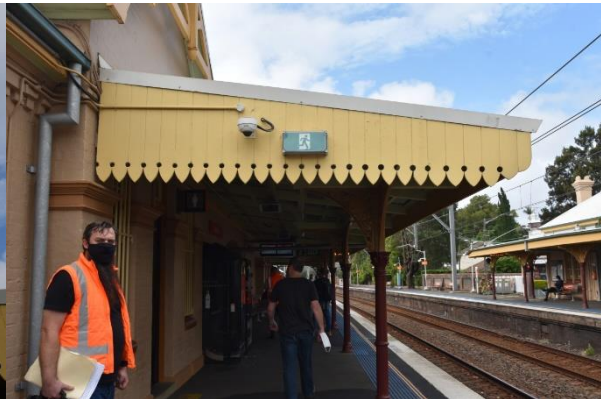
Figure 39. Decorative timber valance to the awning ends (Source: Artefact, 2021)

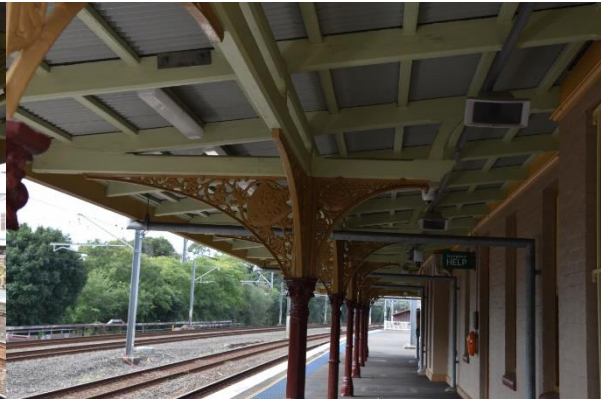
Figure 41. Original cast iron columns and decorative filigree brackets with the 'NSWGR' insignia (Source: Artefact, 2021)

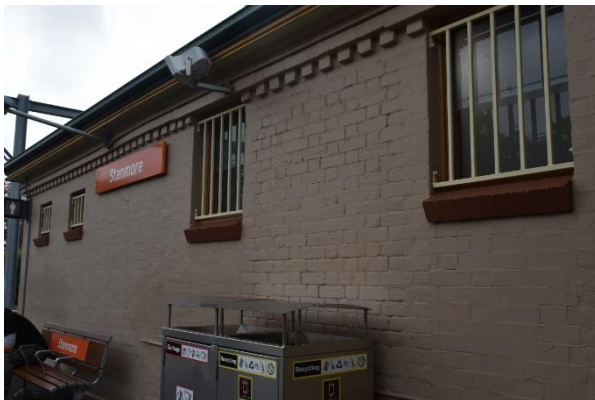
Figure 42. Dentilled stringcourse detail to building (Source: Artefact, 2021)

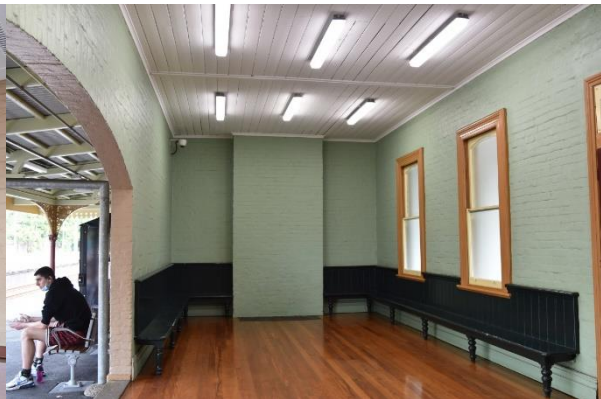
Figure 45. Interior of the large waiting room, features original timber boarded ceilings, painted brick walls with painted original high profiled timber skirting, and timber floorboards (Source: Artefact, 2021)

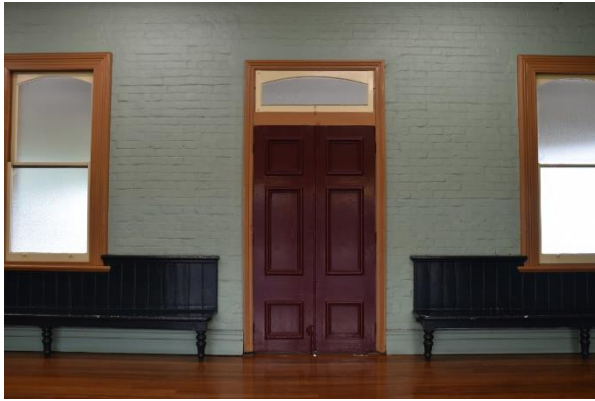
Figure 46. Interior of the larger waiting room, original timber architraves, window and door joinery. Original timber bench seating lines the perimeter walls. (Source: Artefact, 2021)

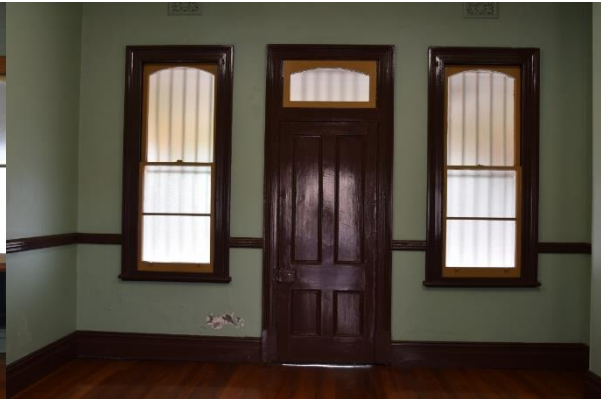
Figure 47. Interior of smaller waiting room, features painted rendered masonry walls, timber dado, high profiled timber skirting, original timber architraves and window and door joinery, and timber floorboards (Source: Artefact, 2021)

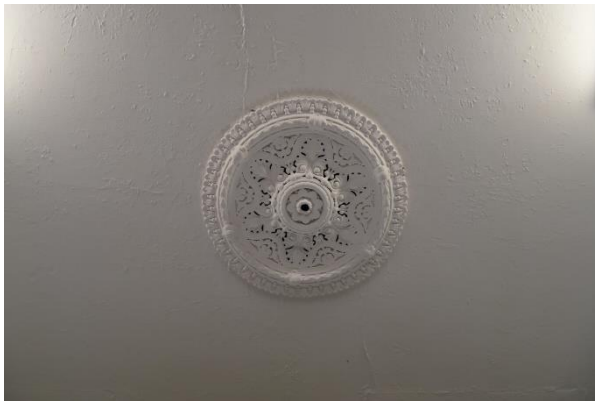
Figure 48. Original plaster ceiling with decorative plaster ceiling rose to the small waiting room (Source: Artefact, 2021)

The south-western end of the room contains an original chimney breast and hearth, although the fireplace has been infilled. The smaller waiting room to the south-west of the main waiting room, which was originally used as the ladies' waiting room, has retained its original ceiling rose, dado, timber skirting, timber panelled door, timber architraves, timber-framed windows and floorboards. Although the original chimney breast and hearth are extant, the fireplace has been infilled. The toilets in the south-western wing on the building exhibit twenty-first-century fit-outs, including toilets, basins, white rectangular tiles, urinals and cubicles.

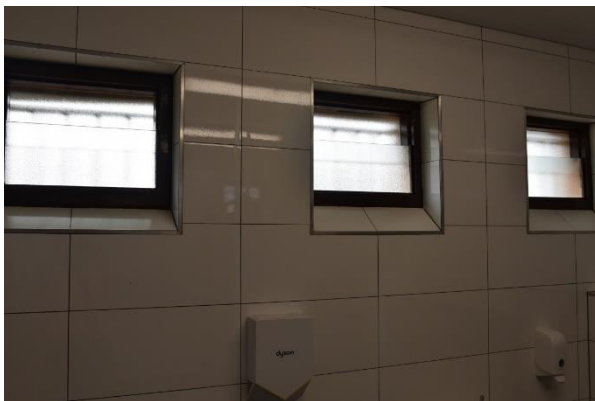
Figure 50. Interior of existing toilet facilities, tiling around original high level windows (Source: Artefact, 2021)

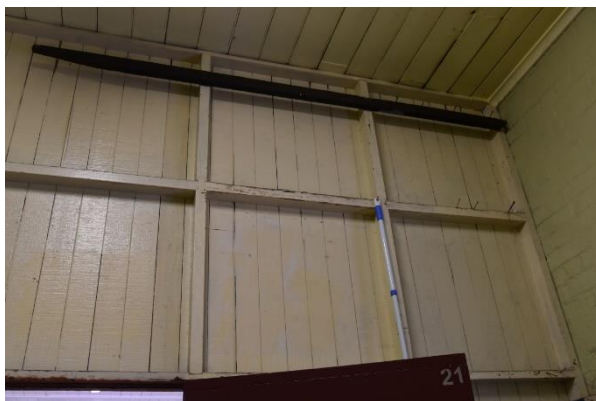
**Figure 52. Original timber partition and timber boarded ceiling in the store room (Source: Artefact, 2021)**

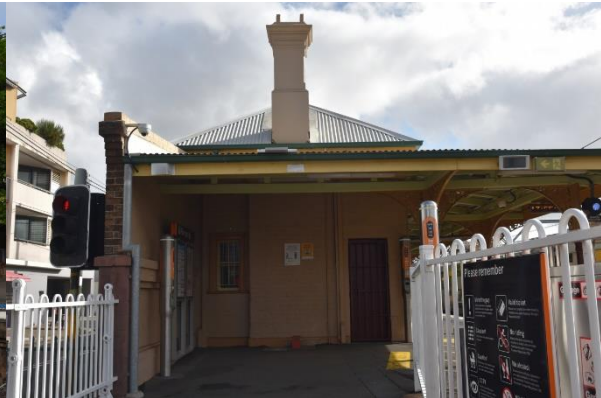
**Figure 57. View of platform building as entering from Trafalgar Street or pedestrian subway, with wrap around verandah and original chimney (Source: Artefact, 2021)**

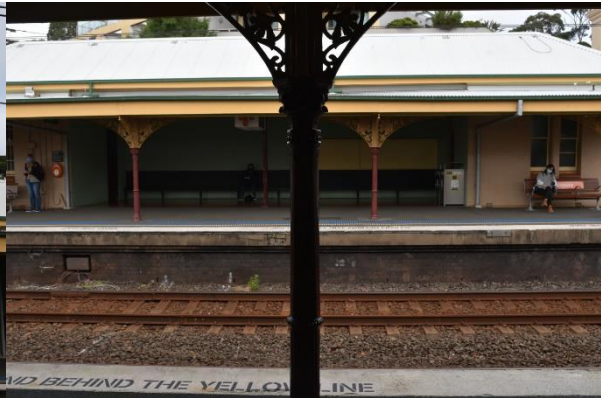
**Figure 59. Platform 3 building and waiting area as viewed from platform 2 (Source: Artefact, 2021)**

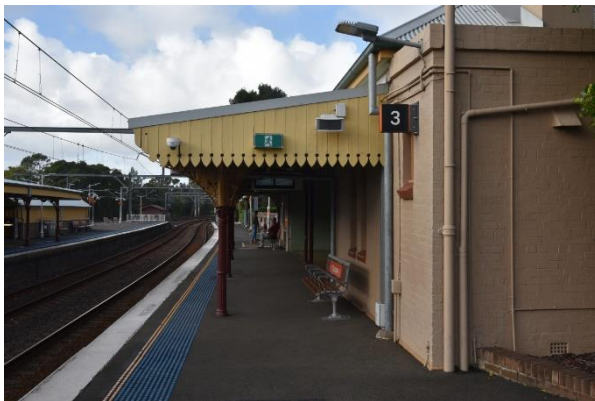
**Figure 60. View of platform building and awning, awning with decorative timber valance at ends (Source: Artefact, 2021)**

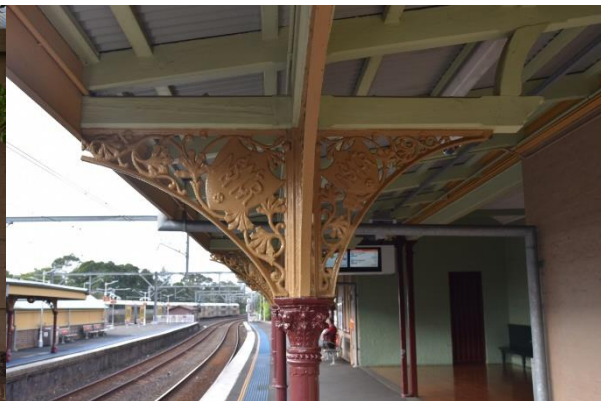
**Figure 61. Decorative cast iron awning columns and filigree brackets. Brackets include 'NSWGR' insignia, their tapered ends have been cut off when the awning was foreshortened (Source: Artefact, 2021)**

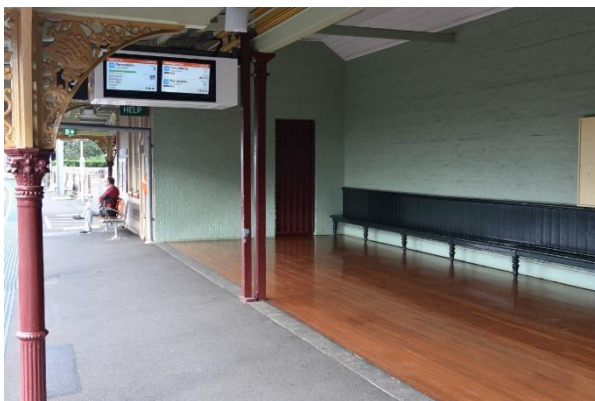
**Figure 62. Platform 3 waiting room, features original timber floorboards, painted brick walls and timber bench seating (Source: Artefact, 2021)**

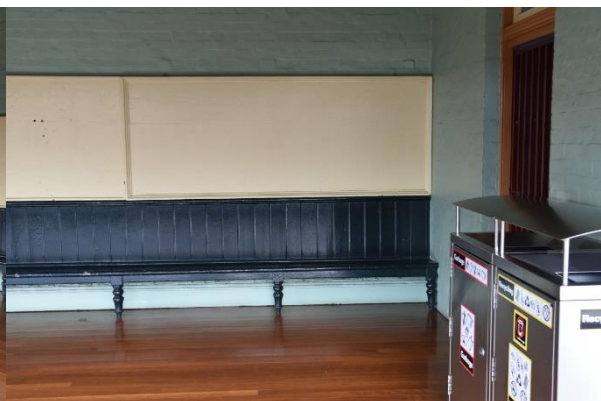
**Figure 63. Original fixed timber bench seating beneath early timber advertising boards (Source: Artefact, 2021)**

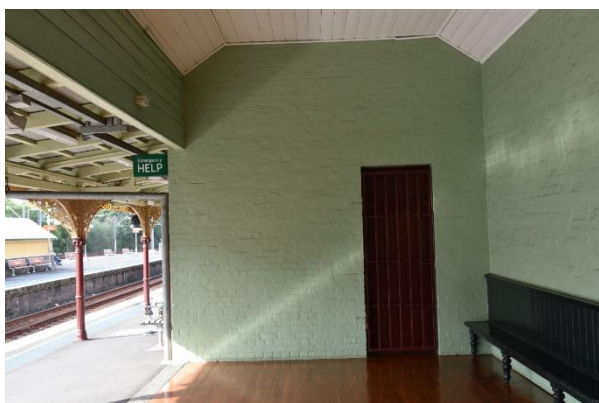
**Figure 64. Early timber panelled door in original painted masonry walls (Source: Artefact, 2021)**

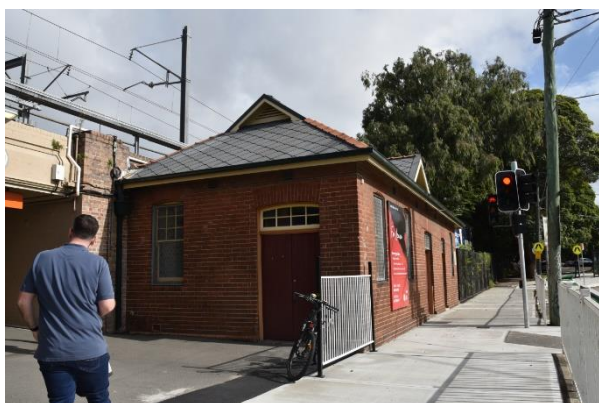
**Figure 66. Former Parcels and Bookings Office and its relationship with street and pedestrian subway from Douglas Street (Source: Artefact, 2021)**

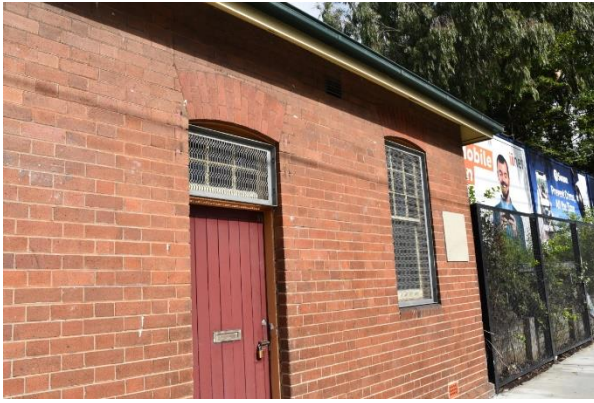
**Figure 68. Flemish bond brick walls, brick voussoirs above original timber boarded door with highlight window and multipaned double hung timber sash windows (Source: Artefact, 2021)**

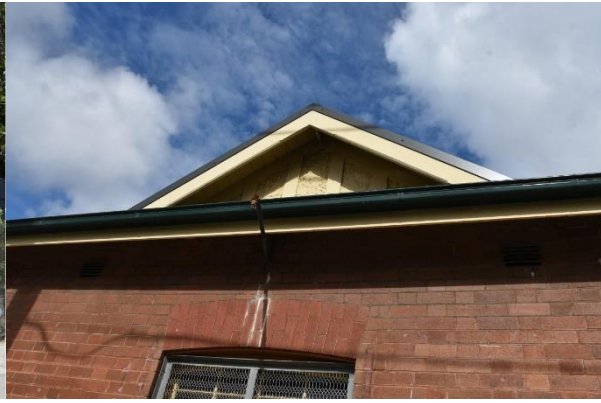
**Figure 69. Half gable, with cement fibre and timber cladding (Source: Artefact, 2021)**

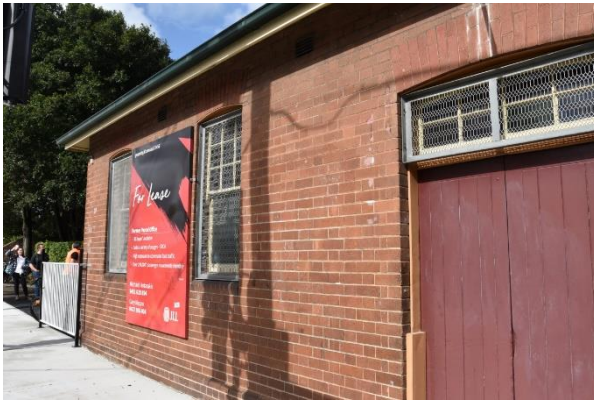
**Figure 70. Original timber boarded double entry doors at centre of Douglas Street façade (Source: Artefact, 2021)**

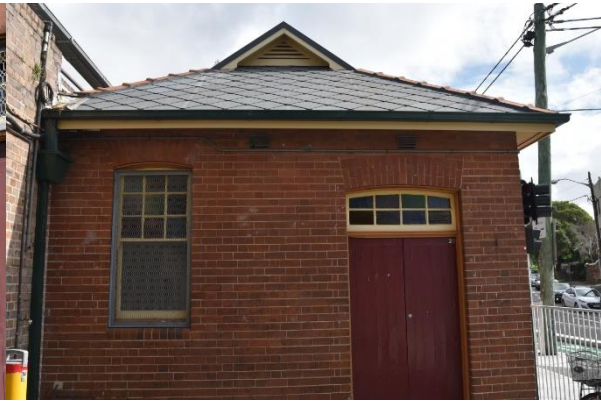
**Figure 71. Original diamond pattern fibre cement roof tiles in a slate finish with terracotta ridges. Half gable features timber barge board and timber ventilation slats (Source: Artefact, 2021)**

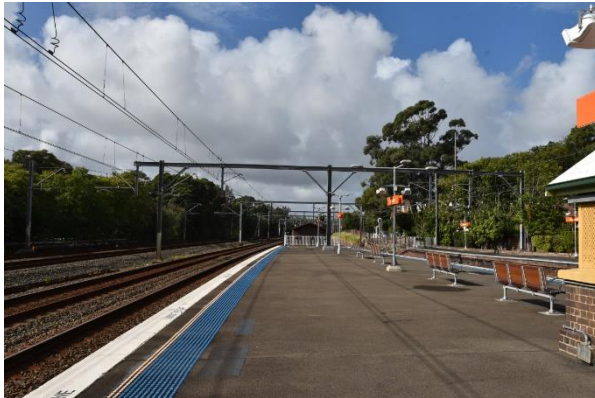
**Figure 74. Platform 1/2 in approximate location of proposed new lift (Source: Artefact, 2021)**

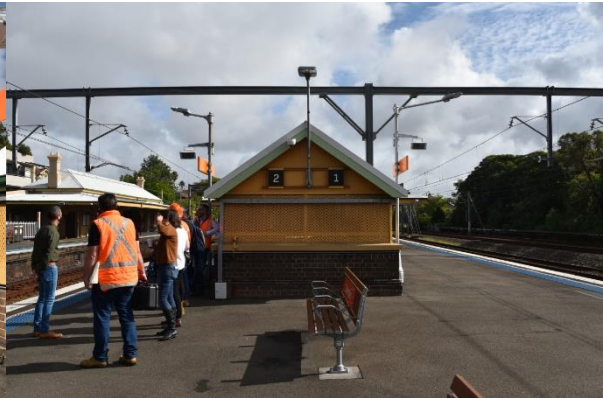
**Figure 75. Platform 1/2 subway lantern as viewed from gable end, metal mesh to clerestory windows, brick plinth (Source: Artefact, 2021)**

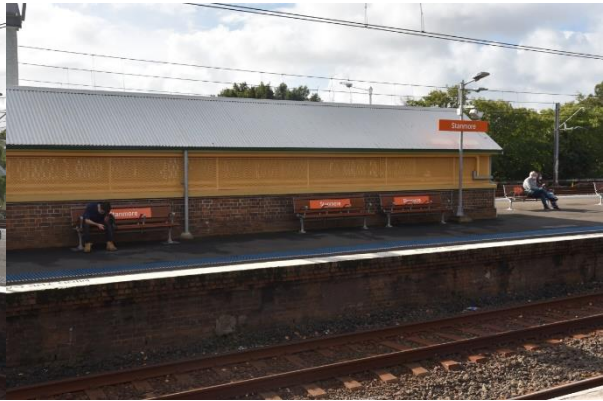
Figure 83. English bond brick retaining walls and brick coping to construct platform 1/2 as visible from platform 3 (Source: Artefact, 2021)

Platform 1/2 (c.1880s, 1891)	Platform 1/2 is generally in good condition, although the brickwork exhibits evidence of staining and poorly covered or removed graffiti.	Good - Fair
Platform 3 (c.1880s)	Platform 3 is generally in good condition, although the brickwork exhibits evidence of staining, graffiti and minor displacement near the eastern end, while the concrete render on the brick coping has spalled off in localised areas.	Good - Fair
Pedestrian Subway (c.1886- 1926)	The subway is in a good to fair condition. The brickwork is in good condition, displaying evidence of past repairs, while the concrete subway ceiling displays evidence of water damage, with staining and failing paint layers. The asphalt floor, and tiled concrete stairs are in good condition.	Good - Fair
Moveable Items	The late nineteenth-century safe in the in the former Station Manager's Office, timber desk/shelving unit in Station Manager's Office and the timber bench seating in the waiting rooms are in good condition.	Good

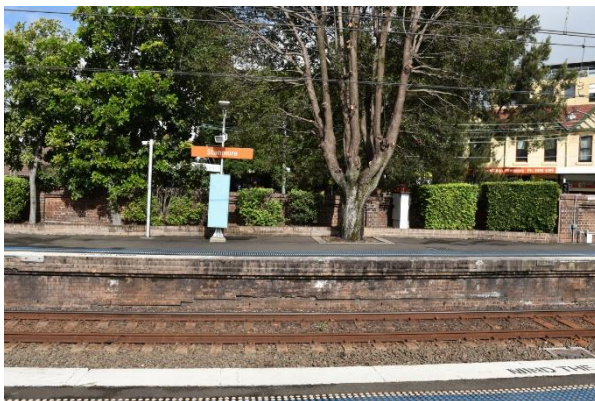
Platform 3 comprises a concave wayside platform with vertical brick retaining walls and corbelled brick coping originally constructed in the 1880s. The retaining wall of Platform 3 appears to have retained its original brickwork. Some of the corbelled brickwork has been cement-rendered. The southern end of the platform exhibits a brick c.1913 extension and a c.1990s concrete extension. The surface of the platform is covered in asphalt sitting on a thin concrete slab, with tactiles along the edge of the platform. The southern side of the platform is flanked by English-bonded walls comprising a mix of 1880s and 1926 fabric, with some later repairs. A subway staircase access is located on the eastern end of the platform. Low-height English-bonded brick walls with bull-nose headers likely dating to the early twentieth-century are located between the staircase to the subway and the platform building, with late-twentieth century loop-top fencing above.

**Figure 84. English bond brick retaining wall and brick coping used to construct platform 3 visible from platform 2 (Source: Artefact, 2021)**

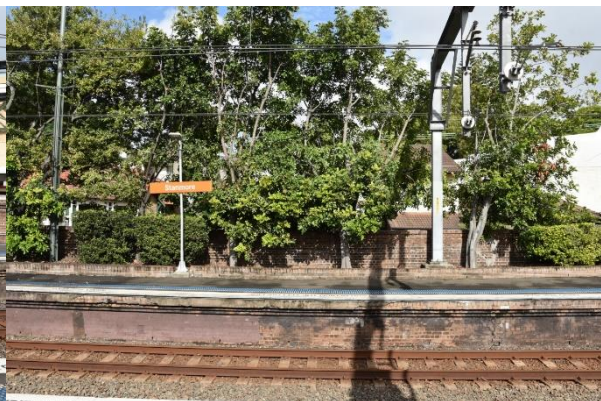
**Figure 85. Brick retaining wall, hedging and trees on platform 3. Areas of the platform retaining wall have been rendered and painted, evidence of repair or replacement (Source: Artefact, 2021)**

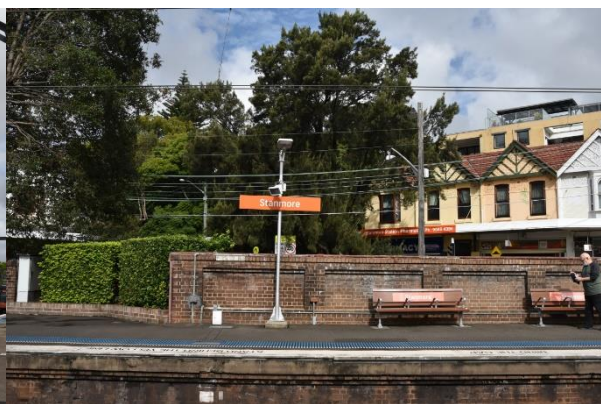
**Figure 87. Brick wall with niches which surrounds the stairs from platform 3 to the pedestrian subway as viewed from platform 2 (Source: Artefact, 2021)**

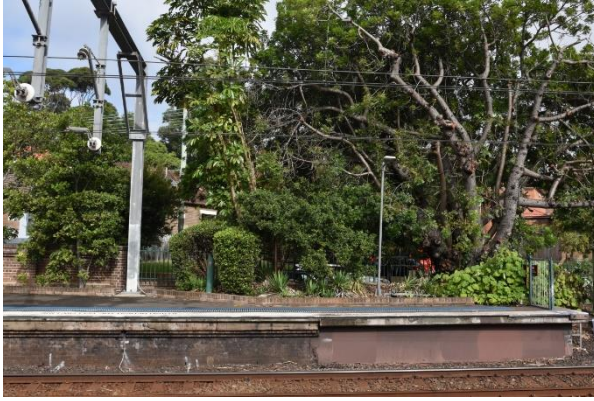
Figure 88. Concrete platform extension to the western end of the platform (Source: Artefact, 2021)

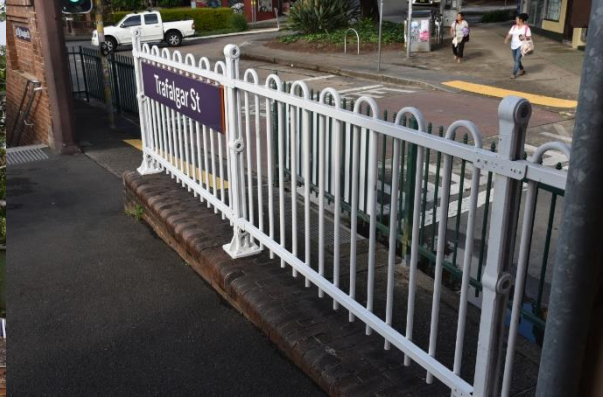
Figure 89. Trafalgar Street entry to platform 3, original dwarf brick wall, with non-original steel loop top fencing (Source: Artefact, 2021)

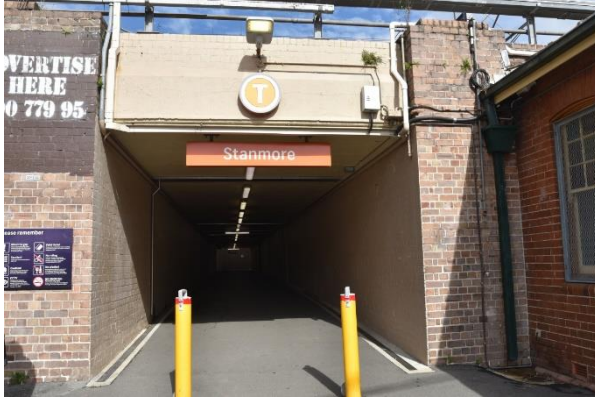
The existing northern entrance to the subway on Douglas Street appears to have retained the English-bonded c.1913 engaged piers, which have been set into a brick retaining wall that exhibits at least two stages of construction likely dating to the 1880s and 1890s, as the bottom half of the wall exhibits stretcher bonded brickwork and the top of the wall exhibits English-bonded brickwork. An English-bonded wing wall with a pitched bull-nose coping extends from the eastern side of the wall to a short English-bonded wall with a bull-nose coping.

**Figure 96. Entrance to pedestrian subway from Douglas Street (Source: Artefact, 2021)**

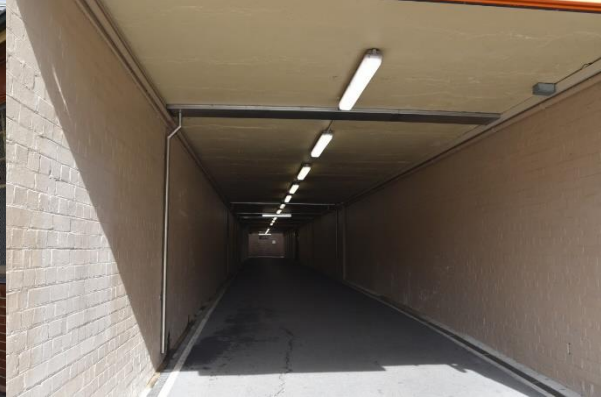
**Figure 97. Pedestrian subway as you enter from Douglas Street, painted brick walls, concrete ceiling and asphalt floor (Source: Artefact, 2021)**

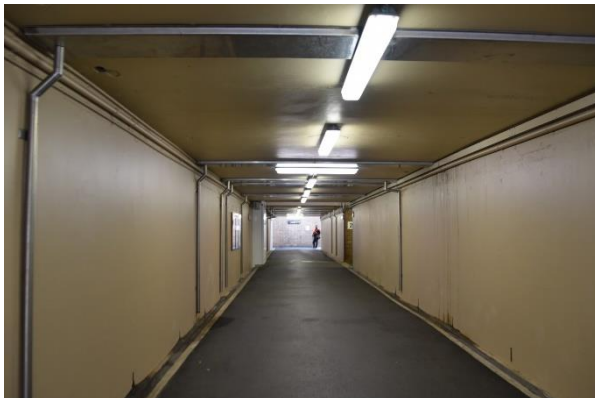
**Figure 98. Pedestrian subway, walls become rendered midway through (Source: Artefact, 2021)**

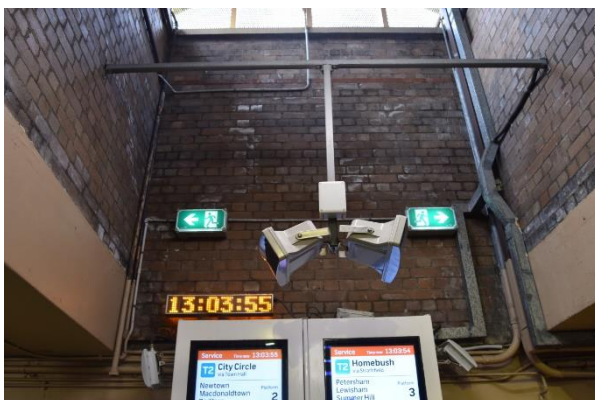
**Figure 100. Looking back to the rear subway wall, beneath the lantern on platform 1/2, unrendered brick in this section (Source: Artefact, 2021)**

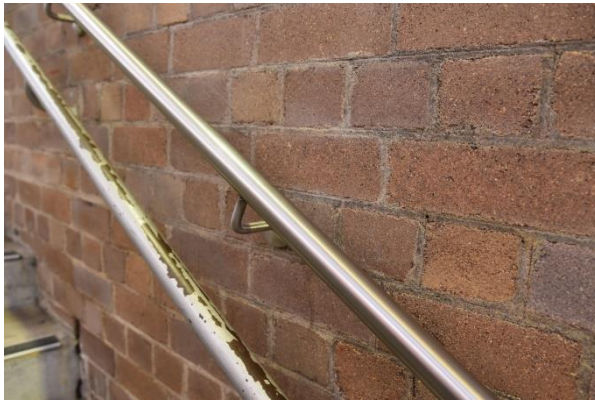
Figure 104. Original handrail retained beneath contemporary to code handrail (Source: Artefact, 2021)

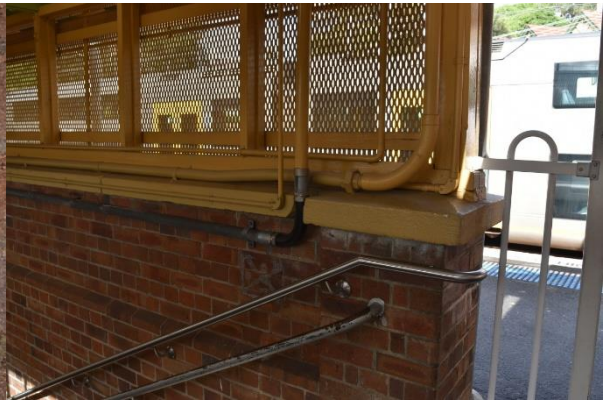
Figure 105. Metal mesh to clerestory windows, brick wall with rendered cement coping (Source: Artefact, 2021)

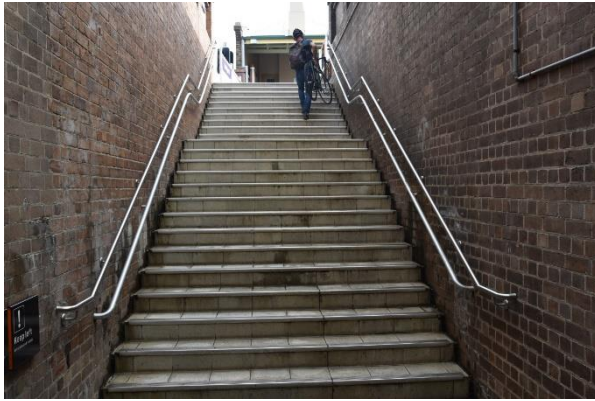
**Figure 108. Concrete tile lined stairs to Platform 3. Original handrail retained beneath compliant contemporary handrail (Source: Artefact, 2021)**

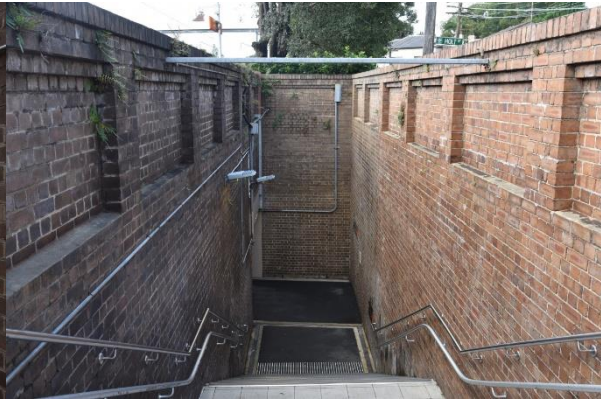
**Figure 109. Open air, and brick walls with brick niches surround the stairs leading to the pedestrian subway from Platform 3 (Source: Artefact, 2021)**

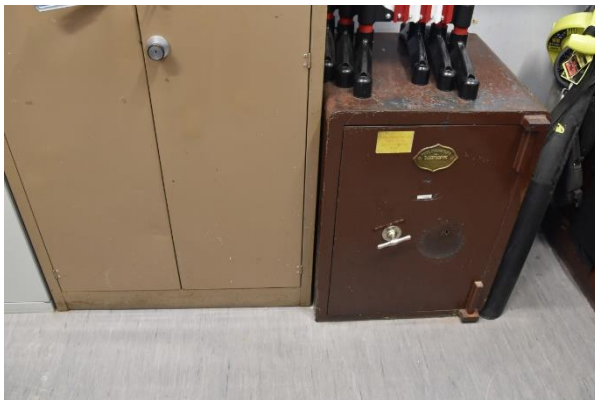
**Figure 110. Safe in Station Master's Office (Source: Artefact, 2021)**

A small number of moveable heritage items are located at Stanmore Station. These include a late nineteenth-century safe in the in the former Station Manager's Office, a timber desk/shelving unit in Station Manager's Office and the timber bench seating in the waiting rooms.

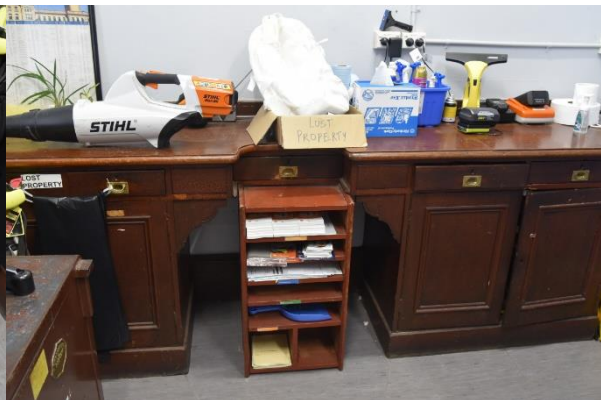
**Figure 111. Timber desk and under-desk shelving in Station Master's Office (Source: Artefact, 2021)**

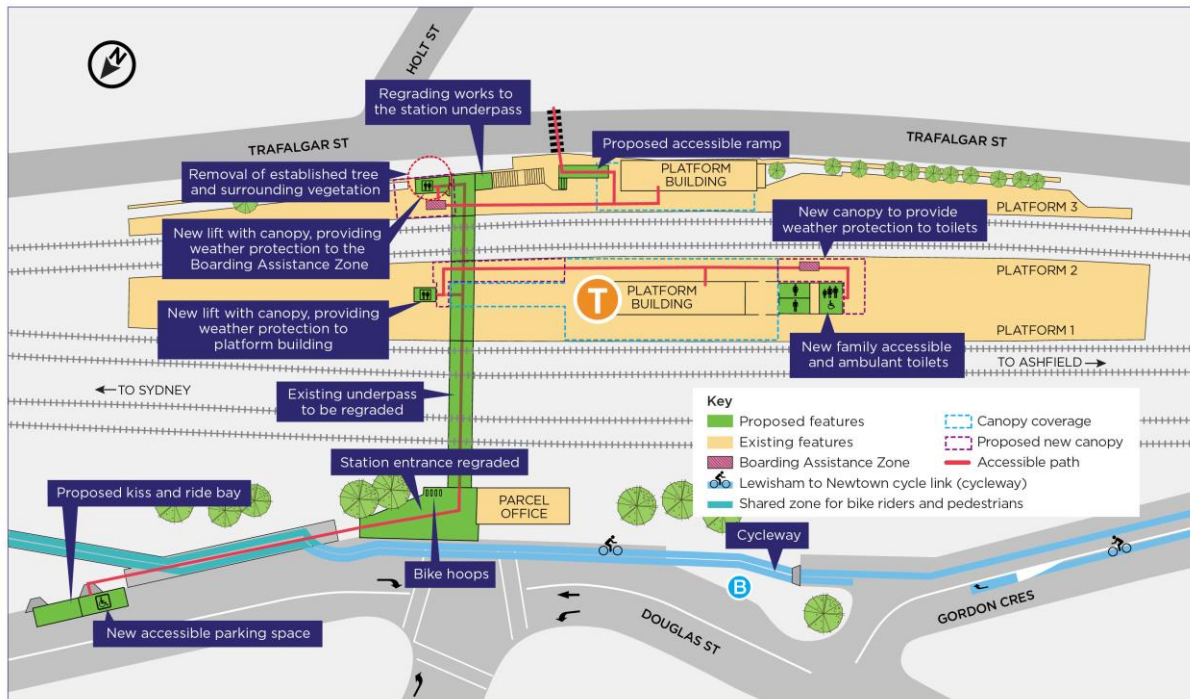
Figure 114. Key features of the proposal (Source: TfNSW)

An overview of the Proposal is shown in Figure 114 below. Detailed drawings of proposed demolition and new works are shown in Figure 115 and Figure 116, whilst architectural renders for depicting the views of the proposed works are shown in Figure 117 to Figure 119.

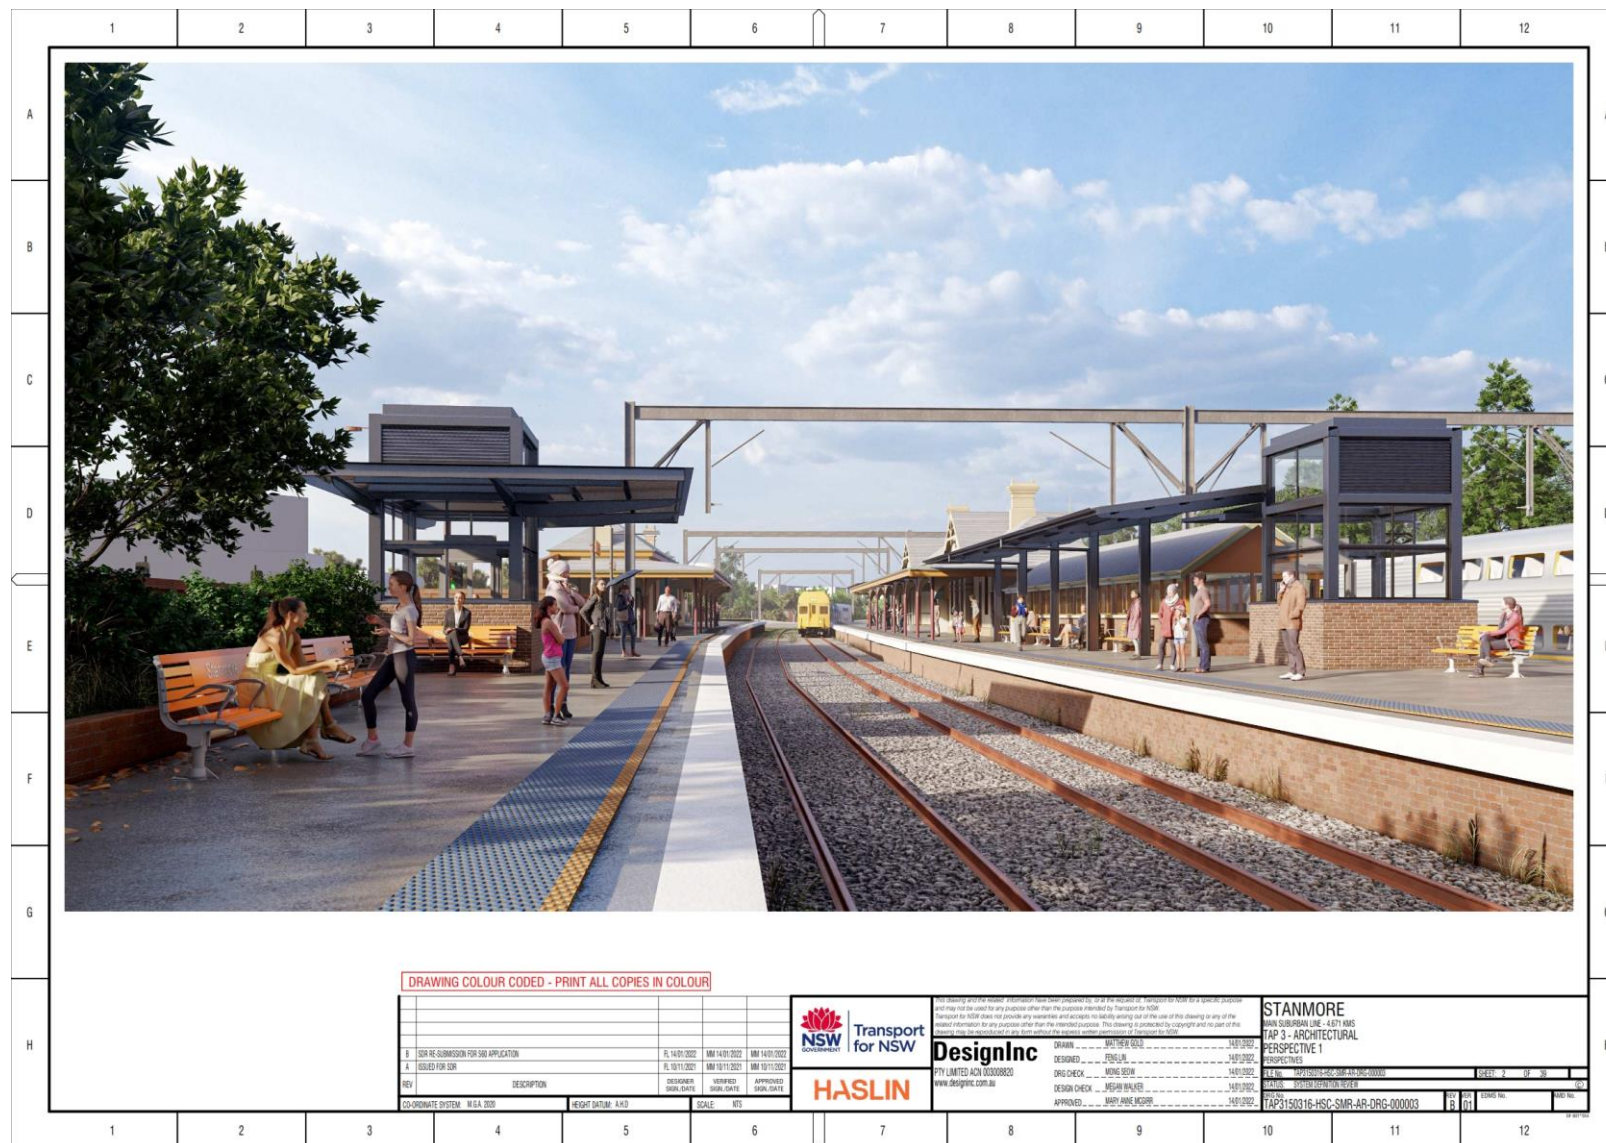
Figure 117. Architectural renders of proposed works (Source: DesignInc, 2022)

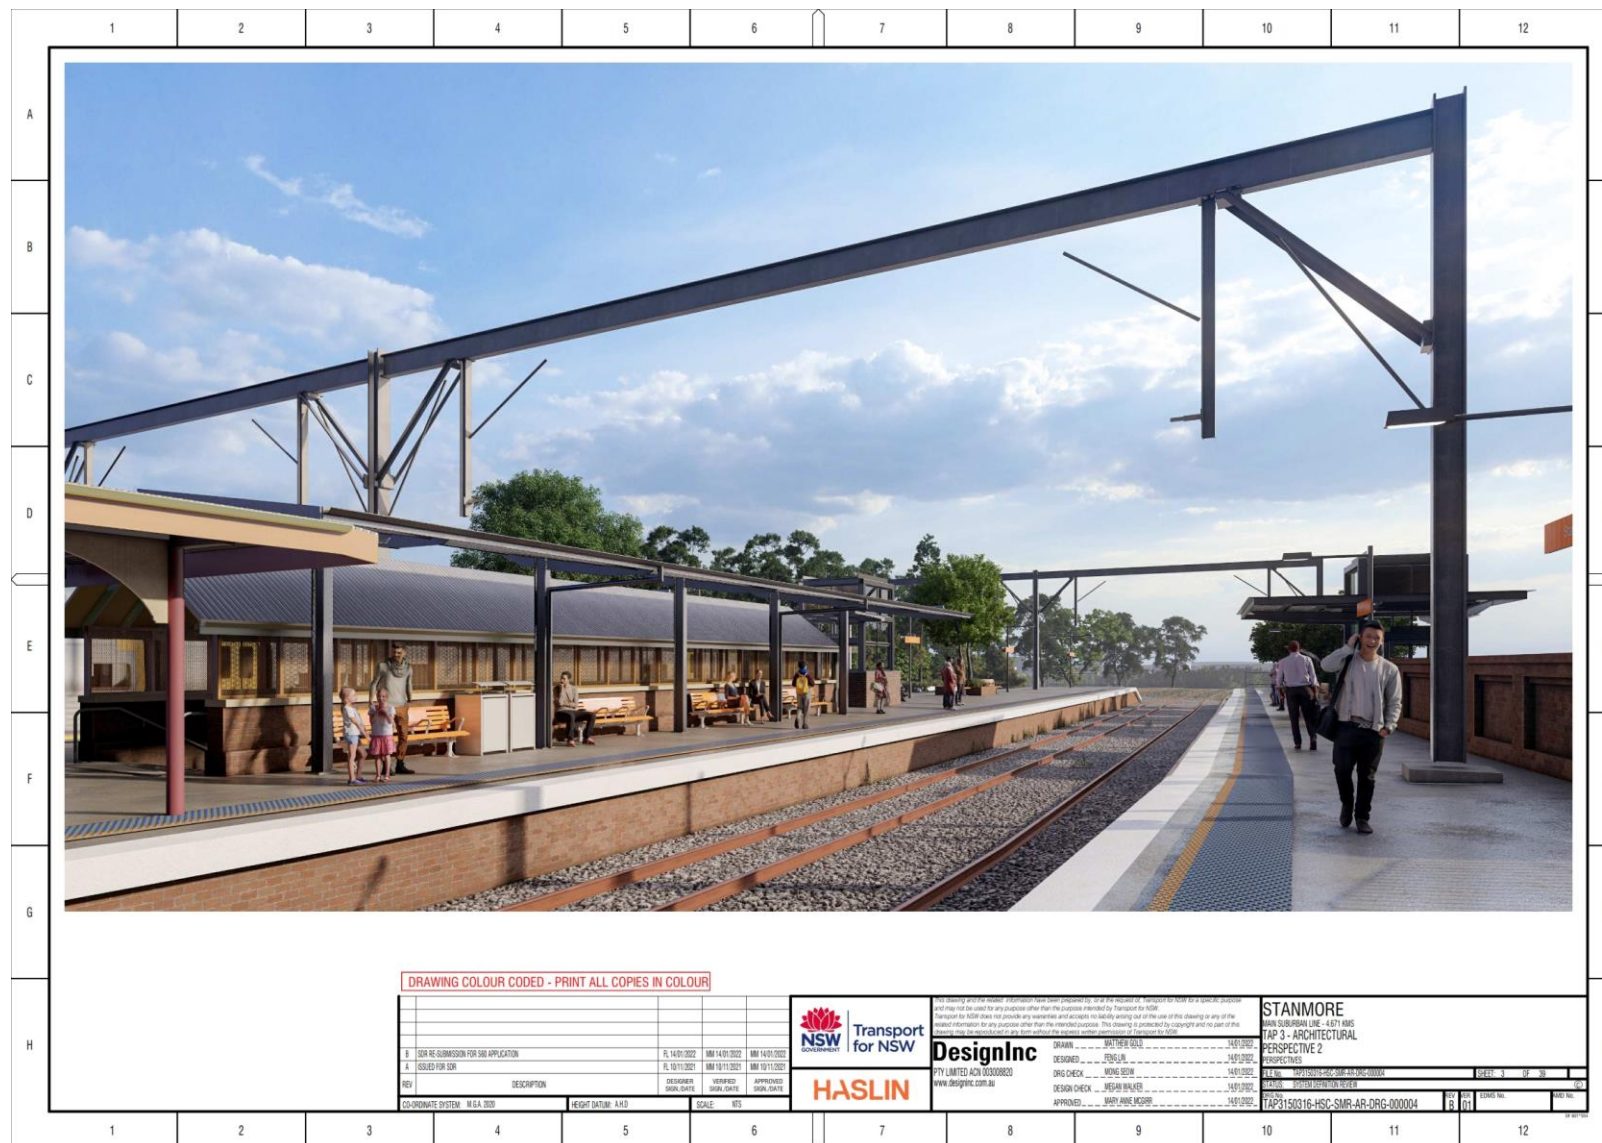
Figure 118. Architectural renders of proposed works (Source: DesignInc, 2022)
