# Transport Access Program: Stanmore Station

Statement of Heritage Impact

Report to Transport for NSW

January 2022

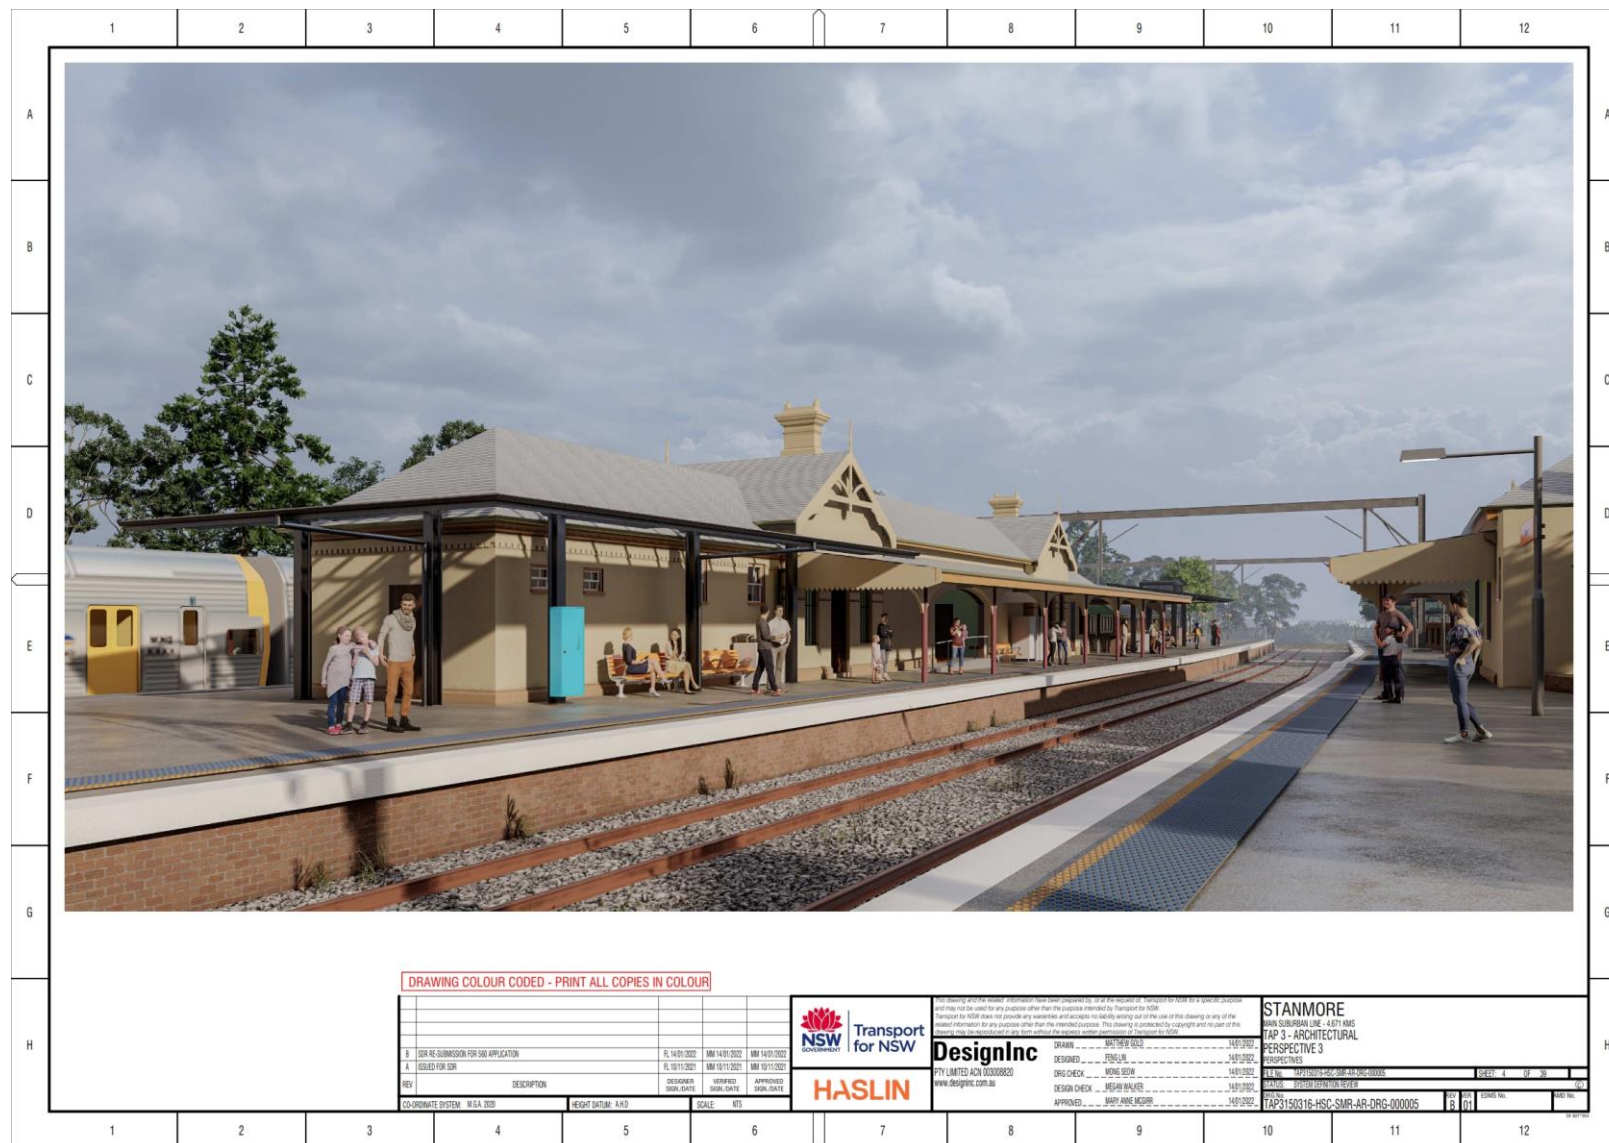
Figure 119. Architectural renders of proposed works (Source: DesignInc, 2022)

An overview of the Proposal is shown in Figure 114 below. Detailed drawings of proposed demolition and new works are shown in Figure 115 and Figure 116, whilst architectural renders for depicting the views of the proposed works are shown in Figure 117 to Figure 119.

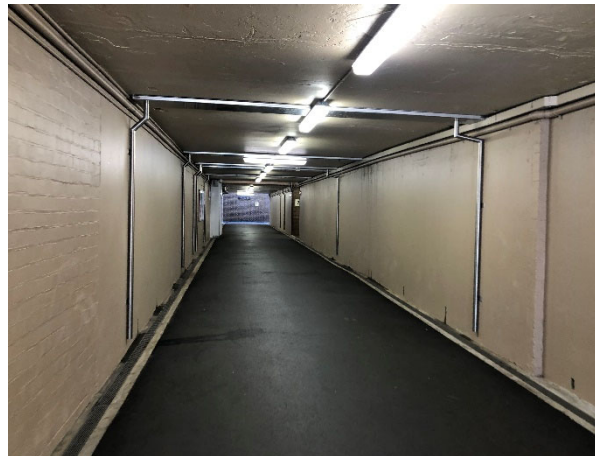
Subway looking towards the Trafalgar Street entry.

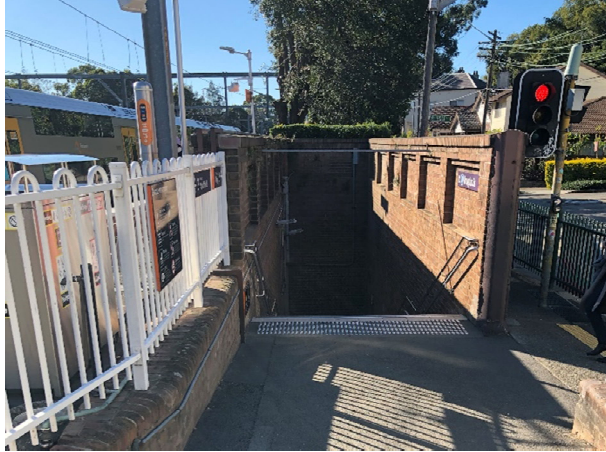
Entry from Trafalgar Street to the Subway.  
Source: DesignInc August 2021.

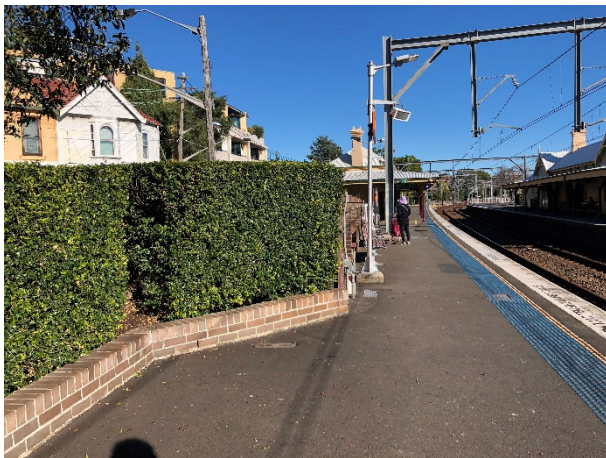
Platform 3 looking west with Trafalgar Street to the left.  
Source: DesignInc August 2021.

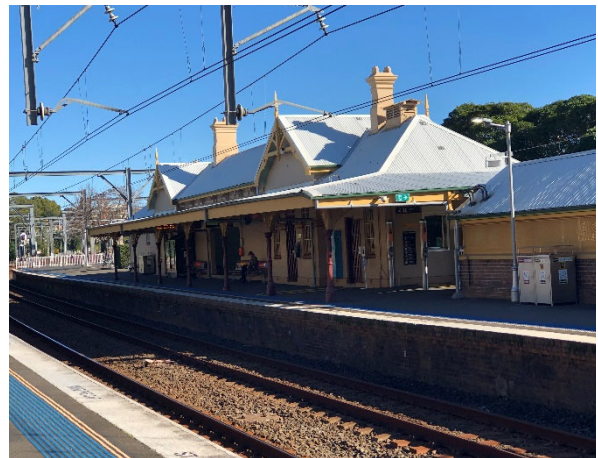
Station building, Platform 1-2.  
Source: DesignInc August 2021.

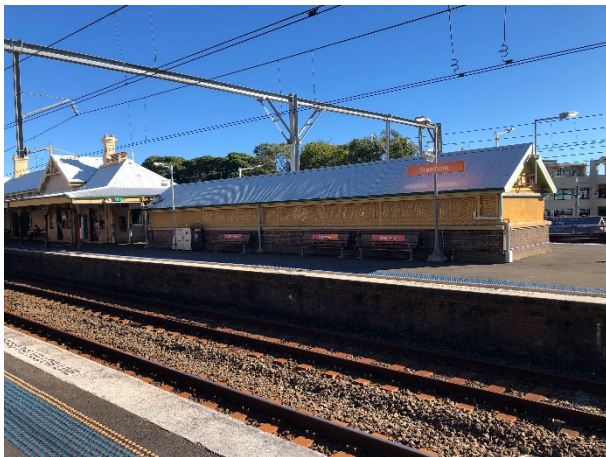
Platform 1-2 lantern over the stair.  
Source: DesignInc August 2021.

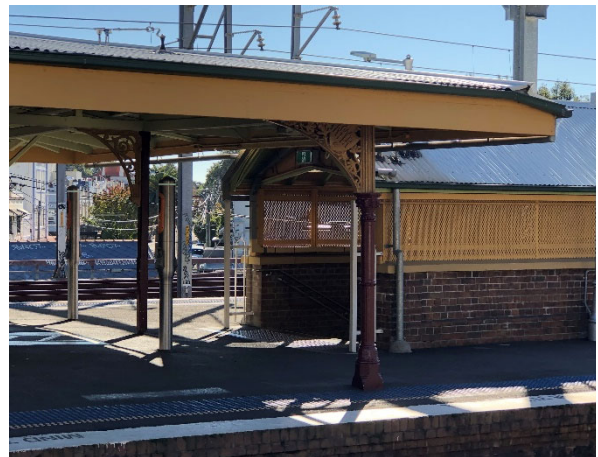
Platform 1-2 lantern of the stair.  
Source: DesignInc August 2021.

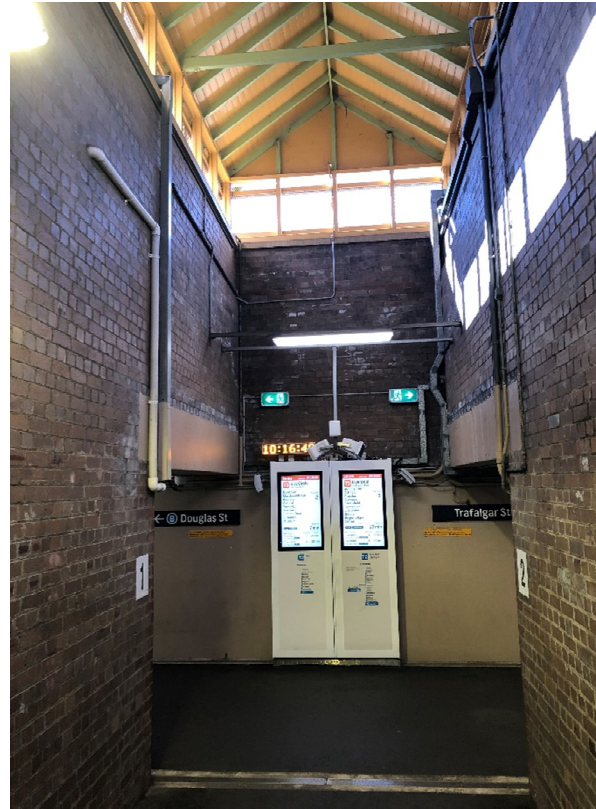
Covered entry over platform access stair looking towards the tunnel.  
Source: DesignInc August 2021.

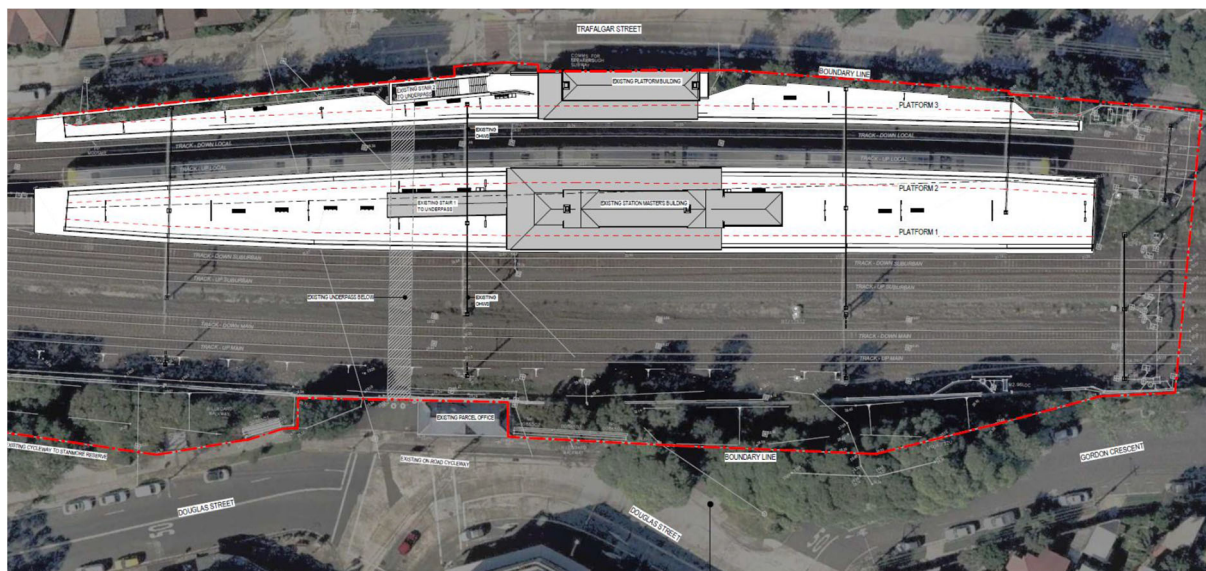
Existing site plan. Source: DesignInc

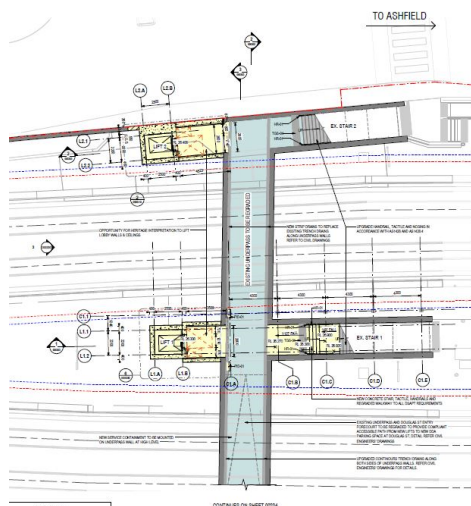
Proposed plan of underpass showing new lift lobbies, Revised SDR submission, 14 January 2022. Source: DesignInc.

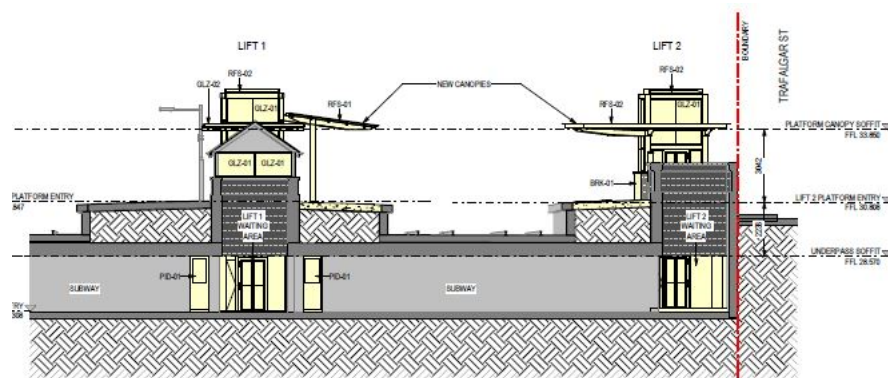
Proposed section through underpass, Revised SDR submission, 14 January 2022. Source: DesignInc.

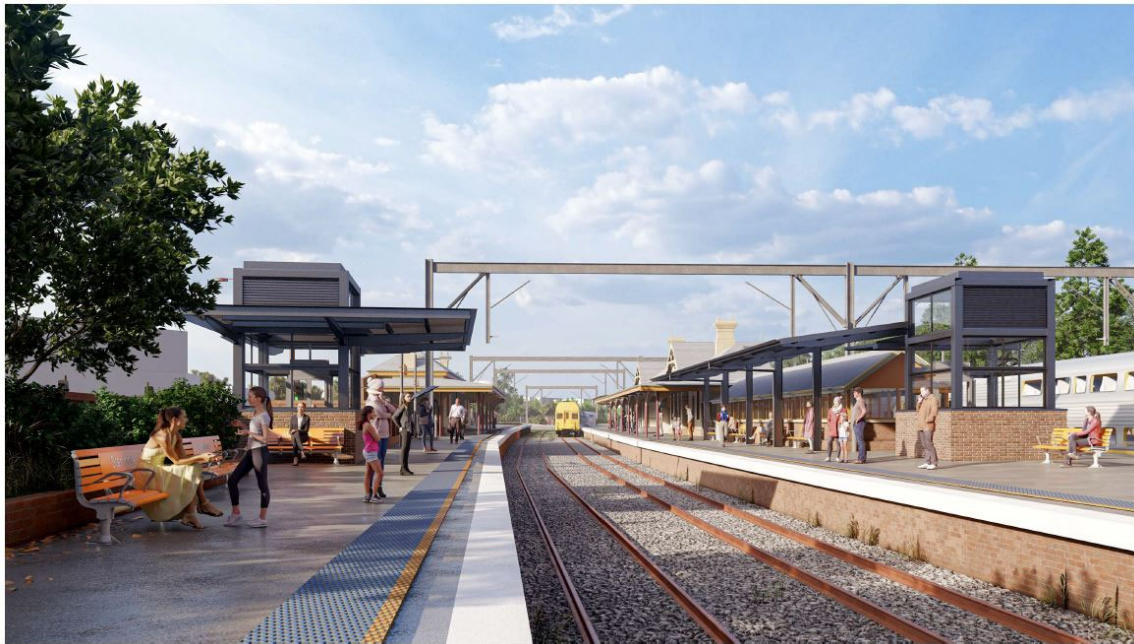
*Proposed lifts to Platform 1-2 and Platform 3, Revised SDR submission, 14 January 2022.*

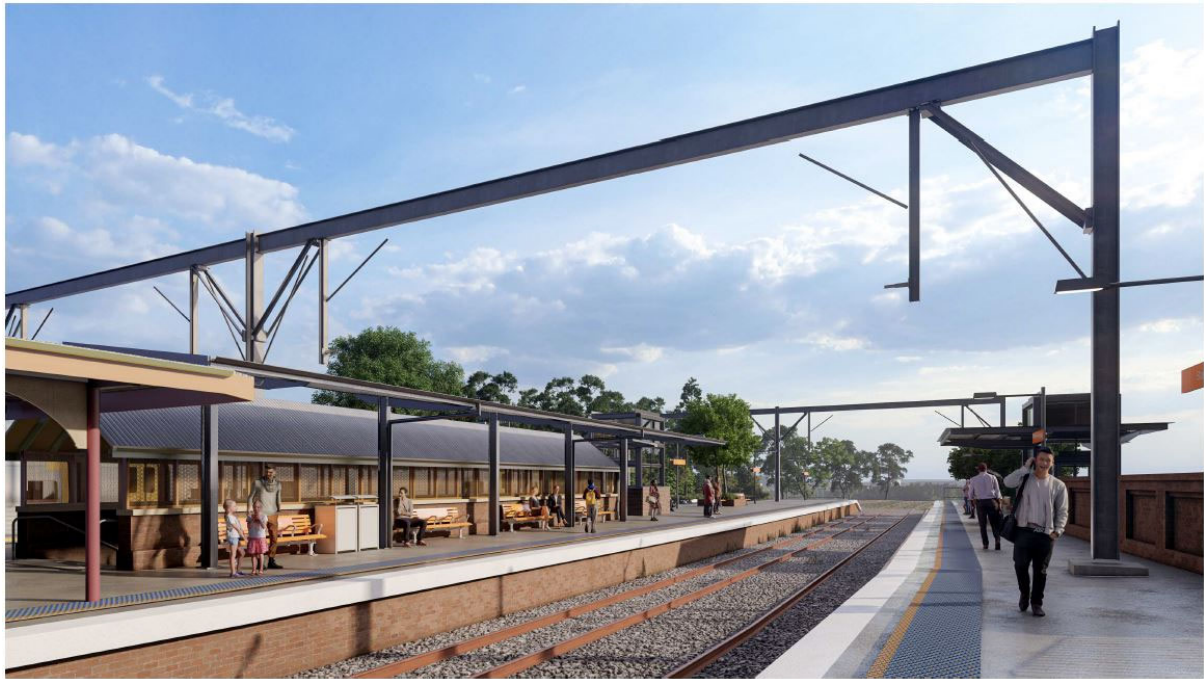
*Proposed canopy to Platform 1-2 (east end), Revised SDR submission, 14 January 2022.*

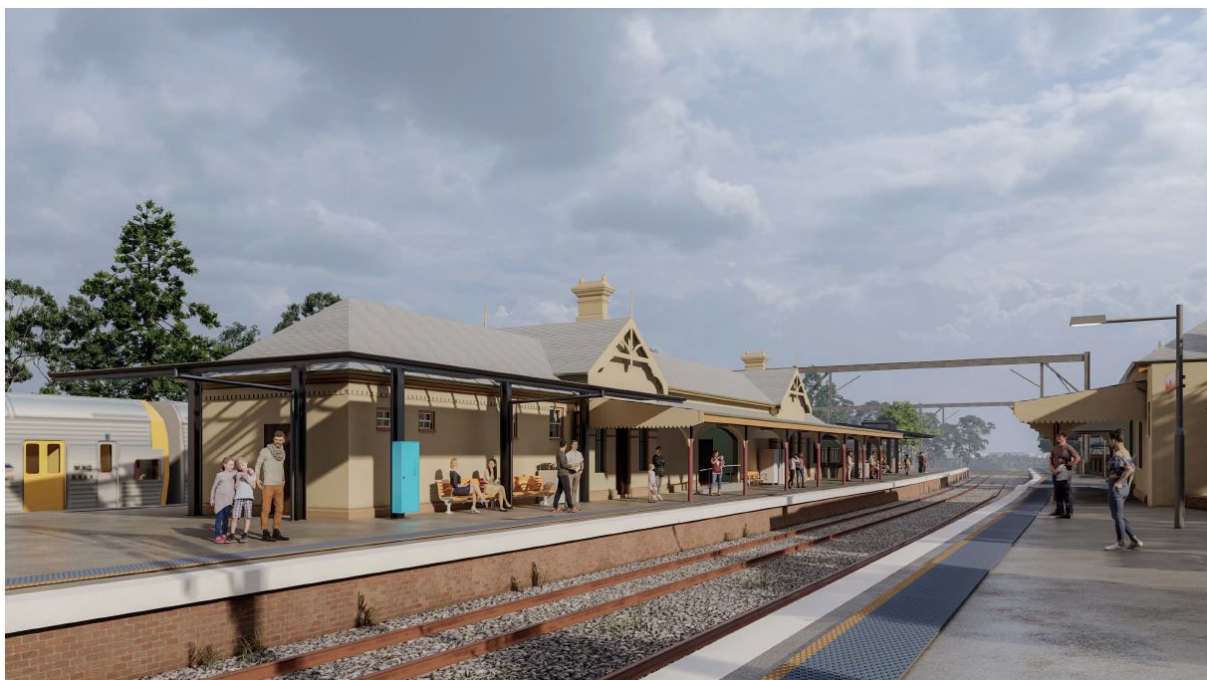
*Proposed canopy to Platform 1-2 (west end), Revised SDR submission, 14 January 2022.*

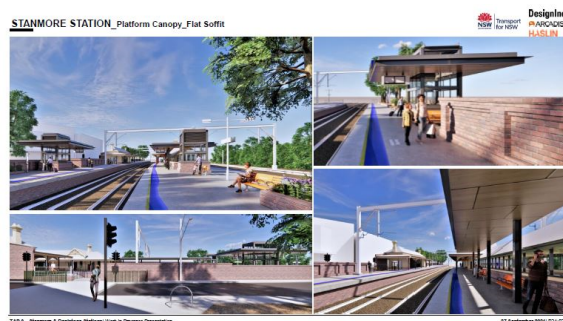
*Platform canopy, flat soffit Option 1.*

Option 1 (27 September 2021) included a flat and lined soffit, with a hidden roof falling away from the concourse edge.

This option was discounted as it did not reflect the existing typology at Stanmore Station.

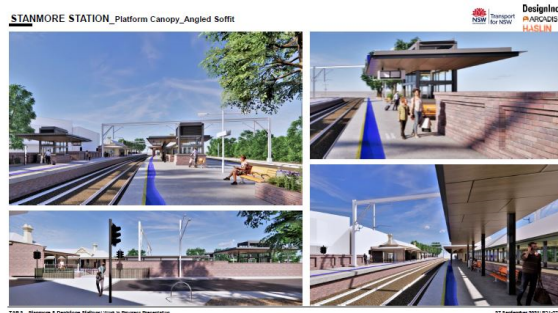
*Platform canopy, angled soffit Option 2.*

Option 2 (27 September 2021) was similar to Option 1, and included an angled and lined soffit.

This option was discounted as it did not reflect the existing typology at Stanmore Station.

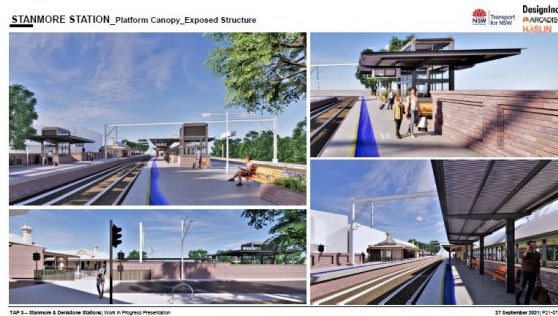
*Exposed structure and soffit Option 1.*

This option was deemed preferable as it reflected the existing condition of the verandahs to the heritage buildings.

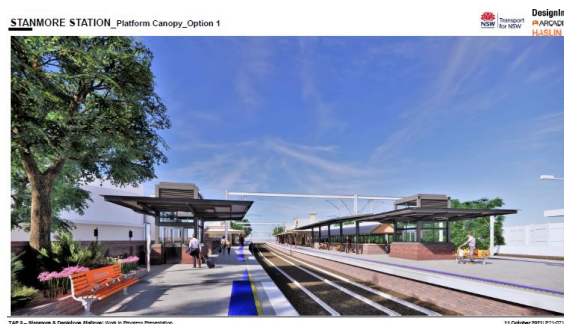
*Exposed structure and soffit Option 1.*

Alternative options (11 October 2021) for the extent of the canopy to Platform 1-2 were considered as follows:

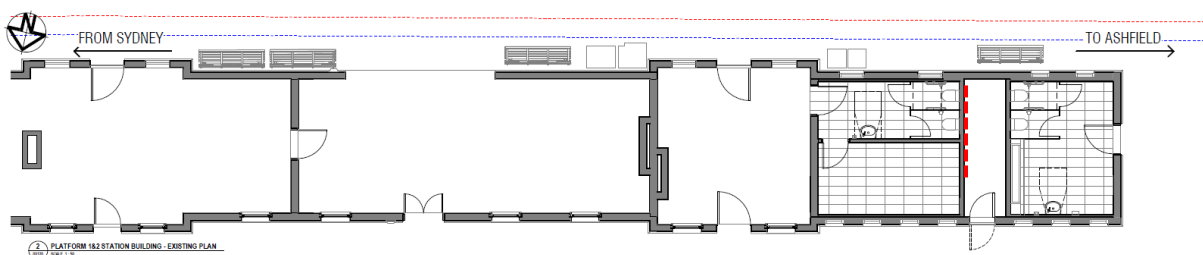
*Existing layout of Platform 1-2 Station Building. The location of original wall tiling is indicated in red.*

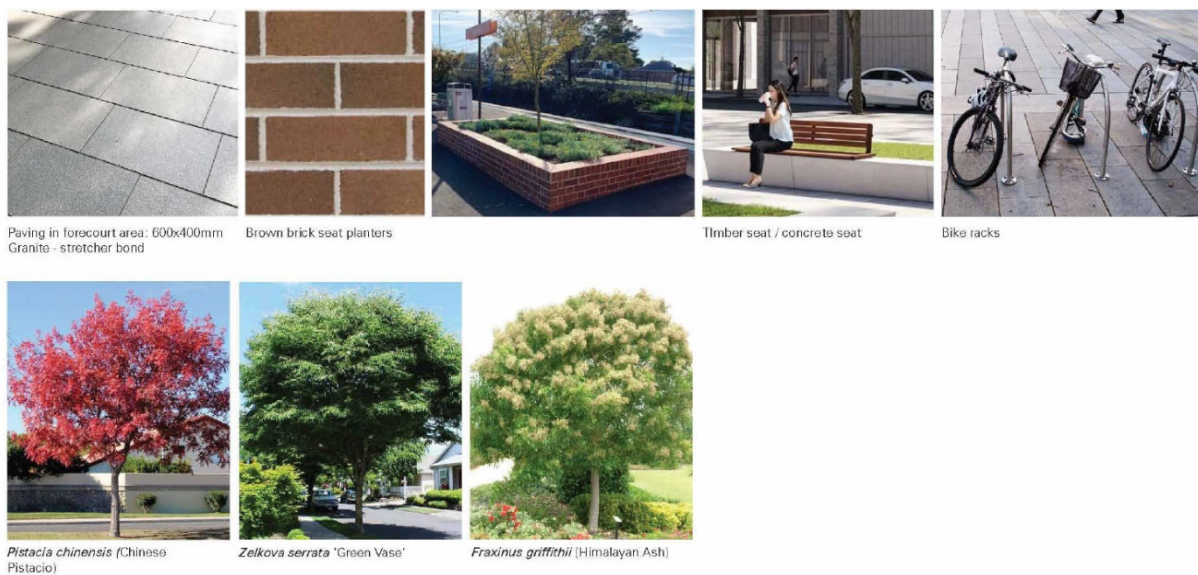
*Proposed landscape material palettes. 13 September 2021. Source: DesignInc*
